REPORT ON THE CAPSIZE OF THE
FISHING VESSEL
"FV QUO VADIS"
ROSSLARE HARBOUR,
CO. WEXFORD
ON
11th FEBRUARY 2015

REPORT NO. MCIB/244
(No.10 OF 2015)

Report MCIB/244 published by The Marine Casualty Investigation Board.
Printed 8th December 2015.

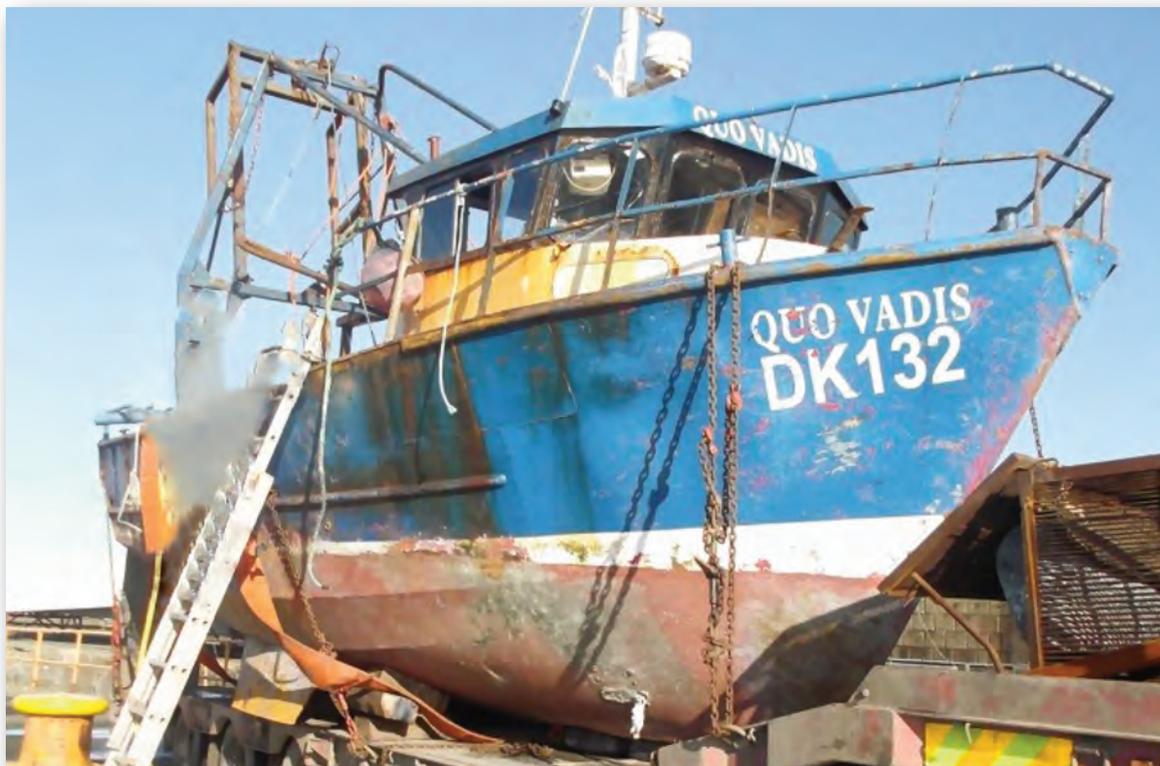
Appendix 7.1 Photograph of “FV *Quo Vadis*” after salvage on 13th February 2015.

Steel half decked vessel with wheelhouse and accommodation forward. Winches aft of the wheelhouse. A steel dredge is suspended from behind the transom on a gantry. Lifting gantry and table on the aft deck. Dredge dimensions 0.8 m high x 1.04 m wide and 1.75 m long. Water jet delivery system, with the delivery line on the port side and the by-pass on the starboard side. The vessel had bilge keels of a combined area of 1.5 square metres (See Appendix 7.1 - *"FV Quo Vadis"* after salvage on the 13th February 2015).

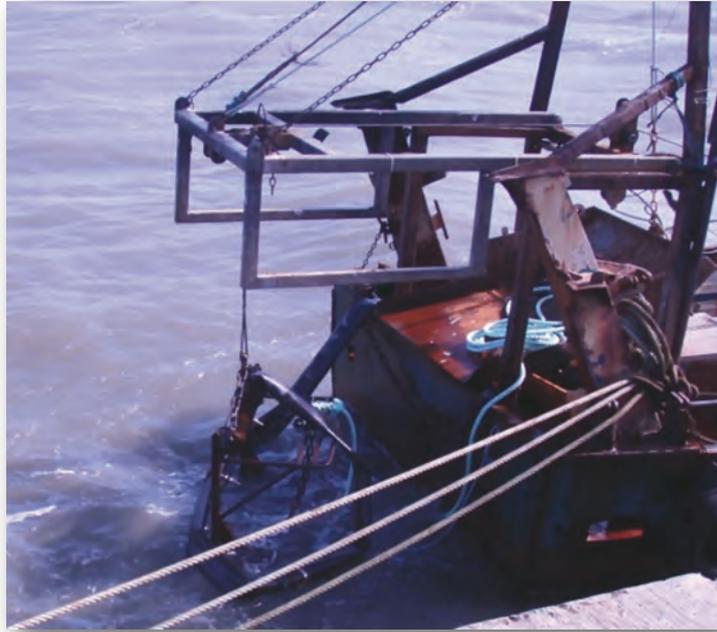
- 3.2 When the dredge is being towed the tow points are on the top of the gunwale aft, about 0.6 m above the deck level. When the dredge just breaks the surface it is suspended from the gantry and the point of suspension is about 2 m above the deck level (See Appendix 7.4 - Photograph No. 1).

Photograph No. 1 - A similar dredge lifting arrangement on another vessel

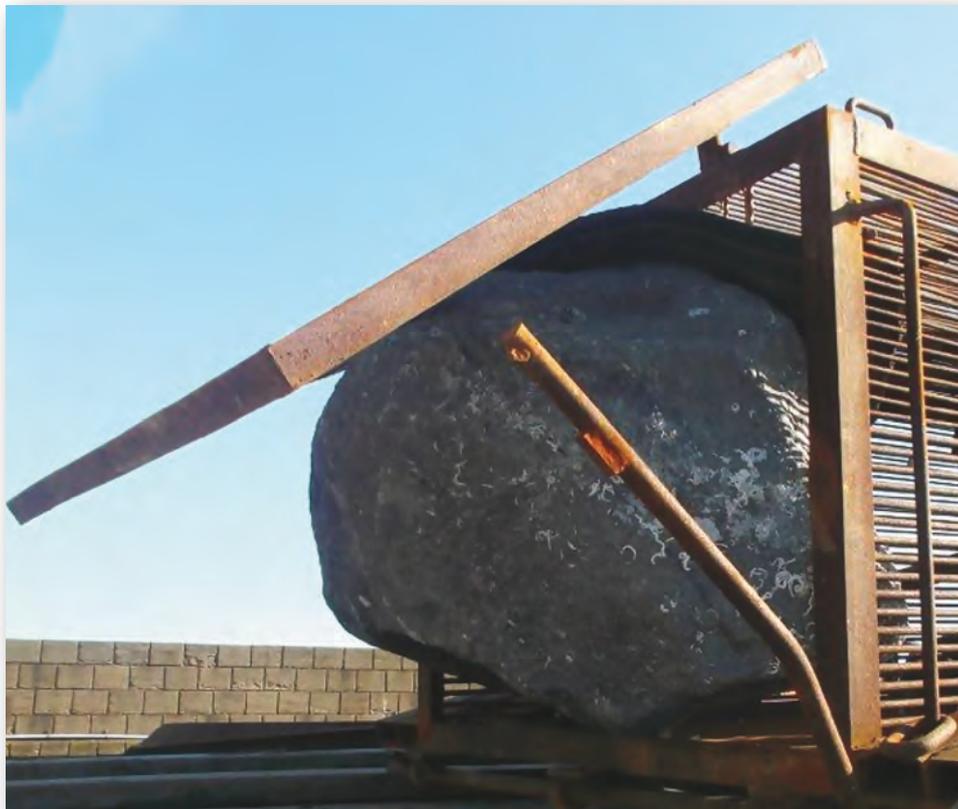
- 3.10 On the 13th February 2015 the “*FV Quo Vadis*” and the dredge were salvaged and brought ashore. The boulder was still jammed in the dredge (See Appendix 7.4 - Photograph No. 2).

- 3.12 The boulder was subsequently weighed using a crane dynamometer and was approximately 750 kg. Approximate weight calculated by measurement confirms this figure.

- 3.13 The power of the winch was enough to lift 400 kg of dredge plus 40 kg of catch and 750 kg of boulder. At this stage the vessel trimmed to more than 0.3 m by the stern due to the weight of the boulder. This caused water to come onto the deck aft. Therefore the estimated depression of the stern was about 0.45 m (45 centimetres).

- 4.1.3 The size of the boulder picked up in the dredge was not anticipated as the vessel always fished on a sandy bottom. The vessel was close to the breakwater at Rosslare Harbour. There was a possibility that the boulder was washed off the breakwater and pulled offshore. There had recently been some dredging work in the vicinity of the harbour and this may have uncovered the boulder.

Photograph No. 2 - large boulder jammed in dredge

- 4.1.6 The dredge mouth had no protection fitted to restrict ingress of large objects. Restricting the dredge mouth with vertical bars would prevent large objects lodging in the dredge, however it would still be possible for the dredge to foul on an obstruction or to fill with a large weight of smaller stones.

- 6.3 The Minister for Transport, Tourism and Sport should consider amending the Code of Practice for the Design, Construction and Operation of Small Fishing Vessels of less than 15 m Length Overall to include requirements to restrict the mouth of dredges by the installation of bars or limiters to prevent ingress of large objects.

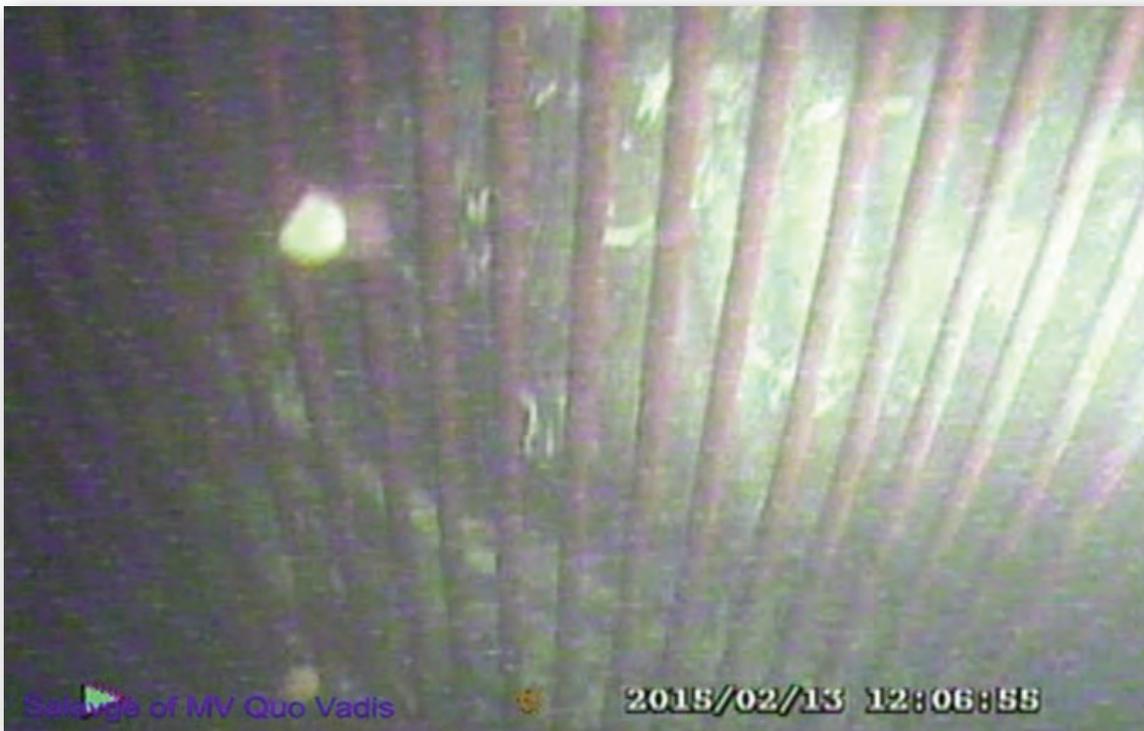
- 3.11 The Photographic Survey, taken by a dive team, before salvage showed a boulder in the dredge on top of the catch of razor shells (See Appendix 7.4 - Photographs Nos. 3 & 4).

Photograph No. 3 - Showing exposed rock when the river is at a low level

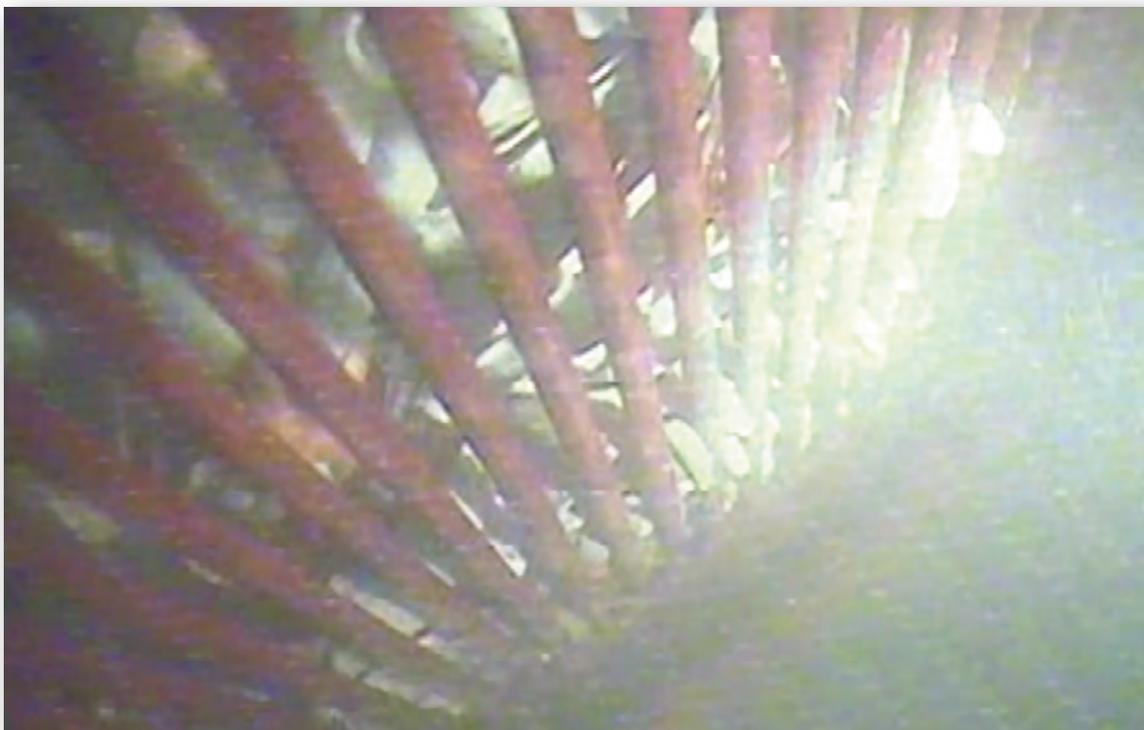
Photograph No. 4 - Underwater photo of catch of razor shells under the boulder

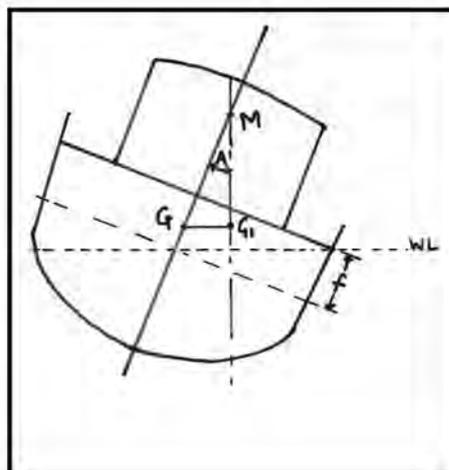
Appendix 7.5 "FV Quo Vadis" - Assessment of stability and angle of heel.

included a stability test (See Appendix 7.5 - Assessment of stability and angle of heel). With the existing depth, beam and free board it can be shown that the deck edge would be immersed at 10° of heel (See Appendix 7.5 Assessment of stability - Calculation 2).

- 4.2.2 The extra weight on the vessel imposed by the boulder, the weight of water on the aft deck and the free surface effect of that water would all cause a change in the centre of gravity of the vessel and a reduction in the metacentric height. The estimated GM when these reductions are made is 0.092 m (9.2 centimetres) (See Appendix 7.5 Assessment of Stability - Calculation 1). It should be noted that the effect of the free surface of water had the greatest reduction of almost 45 centimetres. Although the vessel still had a small positive GM this is only effective at small angles of heel (less than 10°). Once the vessel heels more than 10° and/or trims excessively then other factors affect the stability. When the vessel rolled with the swell the water on deck flowed to one side causing the vessel to heel over. The estimated angle of heel due to the weight of water on one side was almost 14°, which means the deck edge was immersed allowing more water on deck (See Appendix 7.5 Assessment of Stability - Calculation 2).

<u>Angle at which deck edge is immersed A</u>	
Tan A = f / 0.5B	0.177515
angle A	0.175685
	10.07: Degrees
<u>Angle of heel due to water on side deck</u>	
$GG1 = w \times \text{dist m} / W$	0.0488
Cot Angle of heel = GM / GG1	4.032787
	0.243065
	13.93: Degrees
