**REPORT OF INVESTIGATION INTO  
A FATAL INCIDENT INVOLVING A  
CAPSIZED PUNT OFF  
BROWNSTOWN HEAD,  
TRAMORE BAY, CO. WATERFORD  
ON  
10th JANUARY 2013**

**REPORT No. MCIB/229  
(No.11 of 2013)**

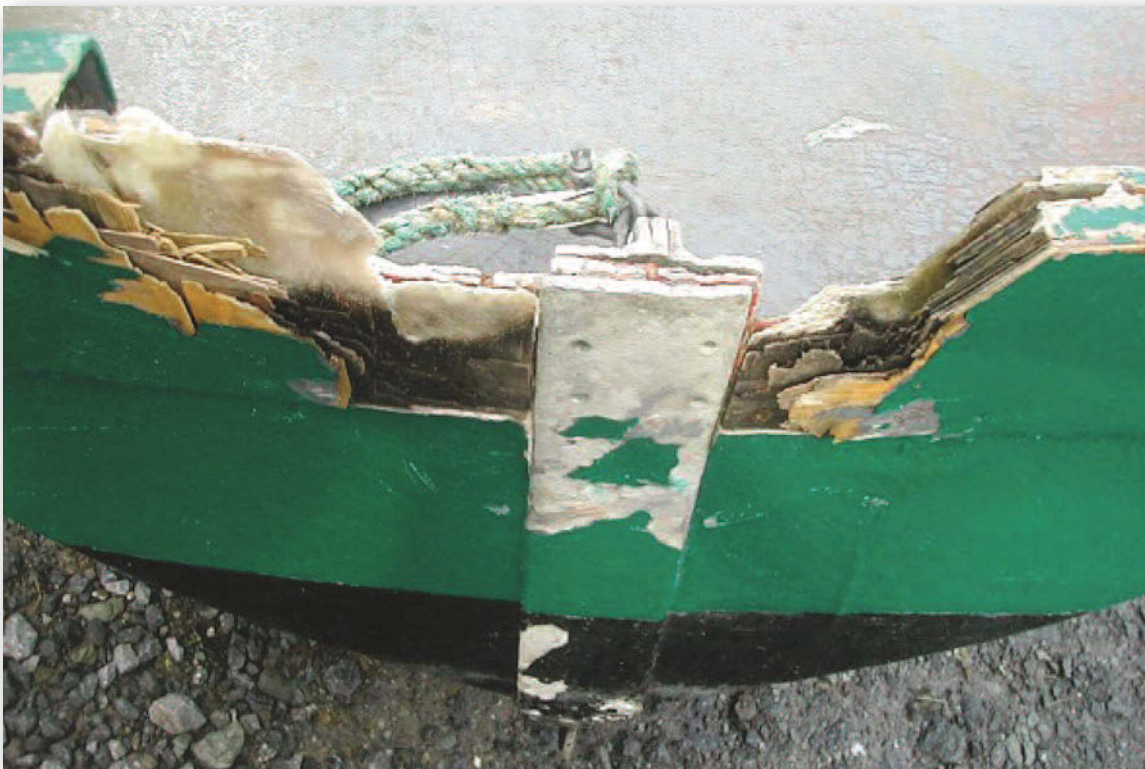
Construction:	GRP solid laminate hull with transom stern and moulded deck. Aluminium keel band, through bolted, running from stem to stern Single wood thwart forward Buoyancy chamber forward, inspection hatch and cover missing Helmsman's seat aft Transom cut away to accommodate outboard engine
Hull Colour:	Green, rough fibreglass finish without gelcoat
LOA:	4.9m (16')
Beam:	1.8m (5' 11")
Depth:	0.77m (2'6") from gunwale to keel
Engine:	Honda 4 stroke outboard engine 15 hp. Remote petrol tank stored under helmsman's seat, aft
Equipment on board:	Handheld VHF Radio Handheld GPS
Condition:	Hull solid, transom delaminating, for'd buoyancy chamber delaminating inside and inspection cover missing, helmsman's seat delaminating underneath, moulded GRP floor soft and water logged, wood thwart rotting

- 5.1 As an un-decked open boat, it was very vulnerable to breaking waves coming over the side and filling the boat with water. However, in order for a single large wave to totally swamp the vessel, it must have been floating very low in the water with very little freeboard. This conclusion is supported by the general condition of the vessel when inspected following the incident which showed it to be quite waterlogged in places and probably much heavier than as originally built. The aft buoyancy chamber had also been cut open providing storage for the fuel tank, further reducing the inherent buoyancy of the boat.

The delaminating transom of the boat.

- 6.1 It is recommended that owners and/or skippers check their small boats regularly and that the inherent buoyancy of a vessel is not tampered with in any way.

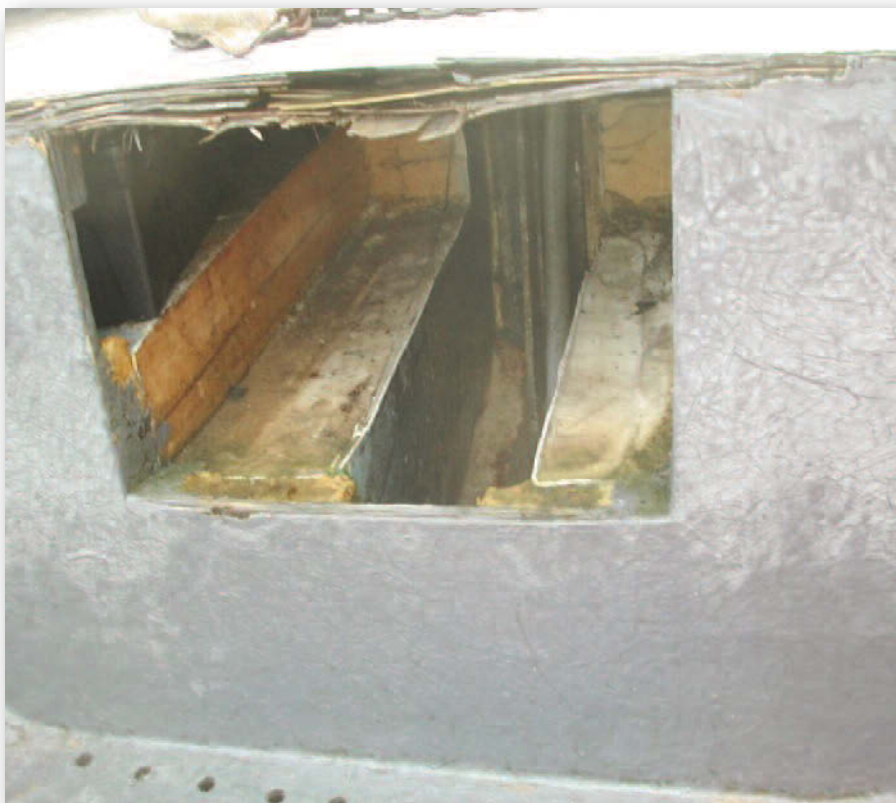
The cut away under the helmsman's seat showing delamination.

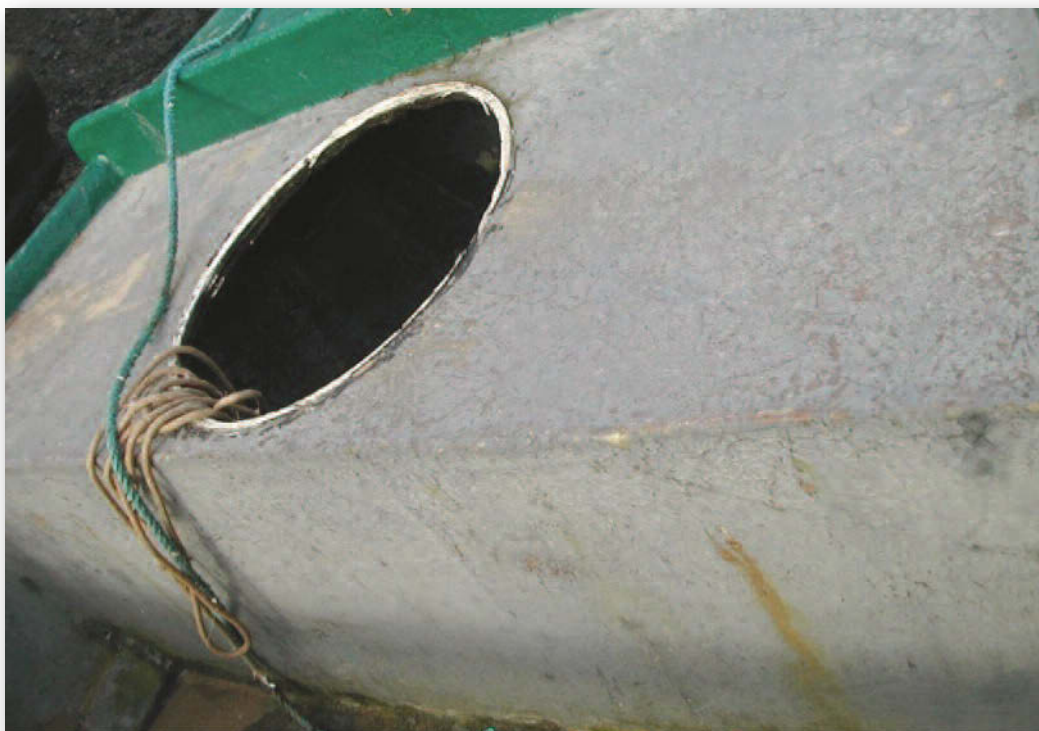
The for'd buoyancy chamber showing the missing inspection hatch and lid.

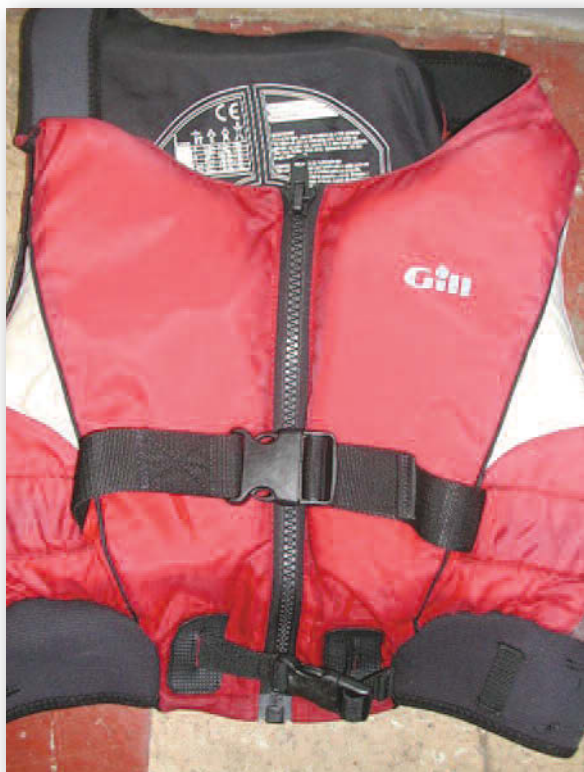
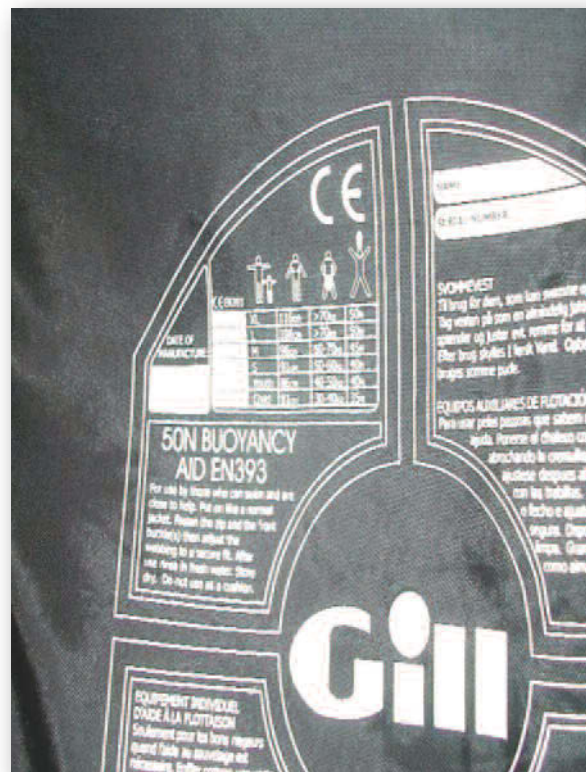
### Appendix 7.2 Mr Flynn's buoyancy aid.

- 4.6 Whilst both men were wearing personal flotation devices of suitable size and buoyancy for their weight, neither was equipped with a collar to keep the wearer on his back and his head above the water or crotch / thigh straps to prevent the jacket from riding up over the wearer's head. Nor was either buoyancy aid equipped with a light or a whistle.

- 5.4 If the personal flotation device worn by Mr Flynn were fitted with a collar, it would have likely helped to keep his head above water and could have contributed to his possible survival. Further, had it been equipped with a light and a whistle, it would have made Mr Tate aware of his whereabouts.

- 6.2 It is recommended that personal floatation devices must be worn by persons in open boats less than 7m such as detailed in S.I. 921 of 2005, as amended.

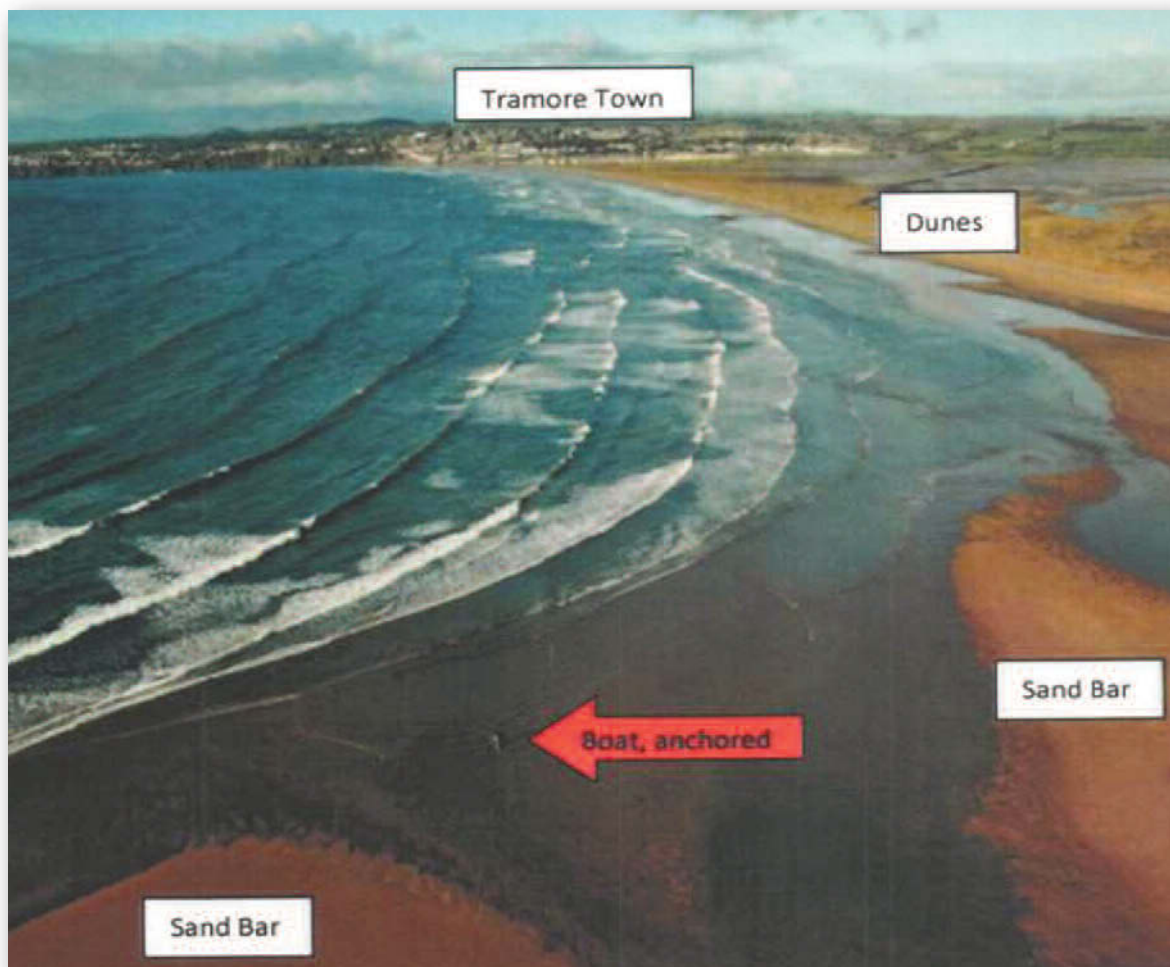
**Appendix 7.3** Aerial view of incident location approximately 7 hours after incident.

Boat upright anchored on sand bar with tide flooding approximately 7 hours after incident.
