**REPORT ON FATAL INCIDENT
INVOLVING A CAPSIZED BOAT
AT COD'S HEAD,
KENMARE BAY, WEST CORK
ON
13th AUGUST 2012**

**REPORT No. MCIB/222
(No.9 of 2013)**

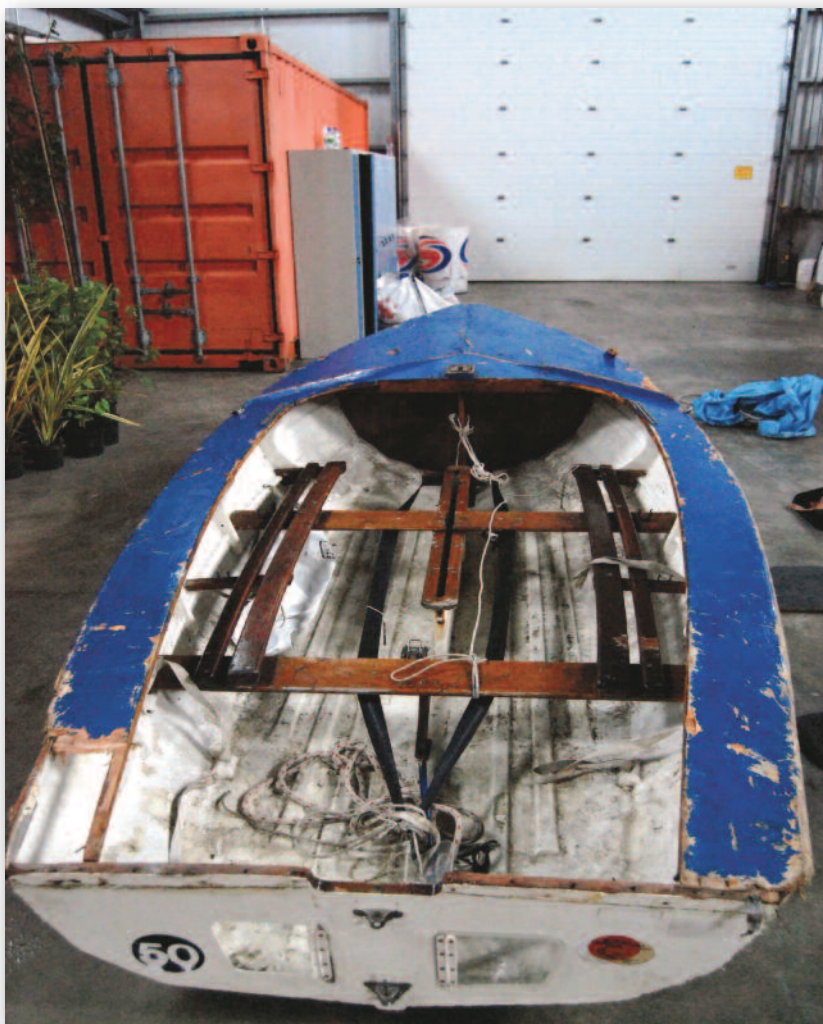
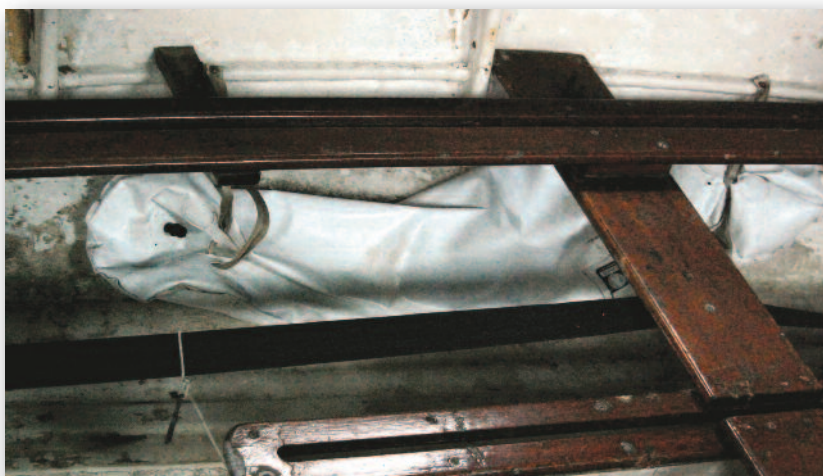
Appendix 7.3 Dinghy at time of inspection in Castletownbere Coast Guard station.

- 4.1 When inspected, the sailing dingy was found to be very badly damaged. However, in interview with both Mr Christy O’Leary and Mr Julian Brown of the Castletownbere Coast Guard, it was determined that the vessel was in good order prior to the incident. Mr Julian Brown went on to explain that the vessel was in good condition at 12:00hrs on Tuesday the 14th when Julian and his colleague Derek Lowes found the upturned vessel wedged in the rocks close to where Christy O’Leary had come ashore.

The night of the 14th and morning of the 15th saw high winds and heavy seas which caused the majority of the damage.

- 4.3 During the vessel inspection it was noted that the forward buoyancy tank and the forward port buoyancy bag were in place. It was confirmed that before departure, the forward starboard buoyancy bag was in place. Mr Julian Brown confirms that, when he righted the boat on the 14th, both the forward buoyancy bags were in place and inflated. It is assumed that the starboard bag was lost during the recovery or during the bad weather the night before the recovery.

The only remaining deflated buoyancy bag.
