**REPORT OF INVESTIGATION INTO  
“MAN OVERBOARD”  
FROM A RIB IN CORK HARBOUR  
9th JUNE 2012**

**REPORT No. MCIB/217  
(No.3 of 2013)**

Report MCIB/217 published by The Marine Casualty Investigation Board  
Printed 31st January 2013.

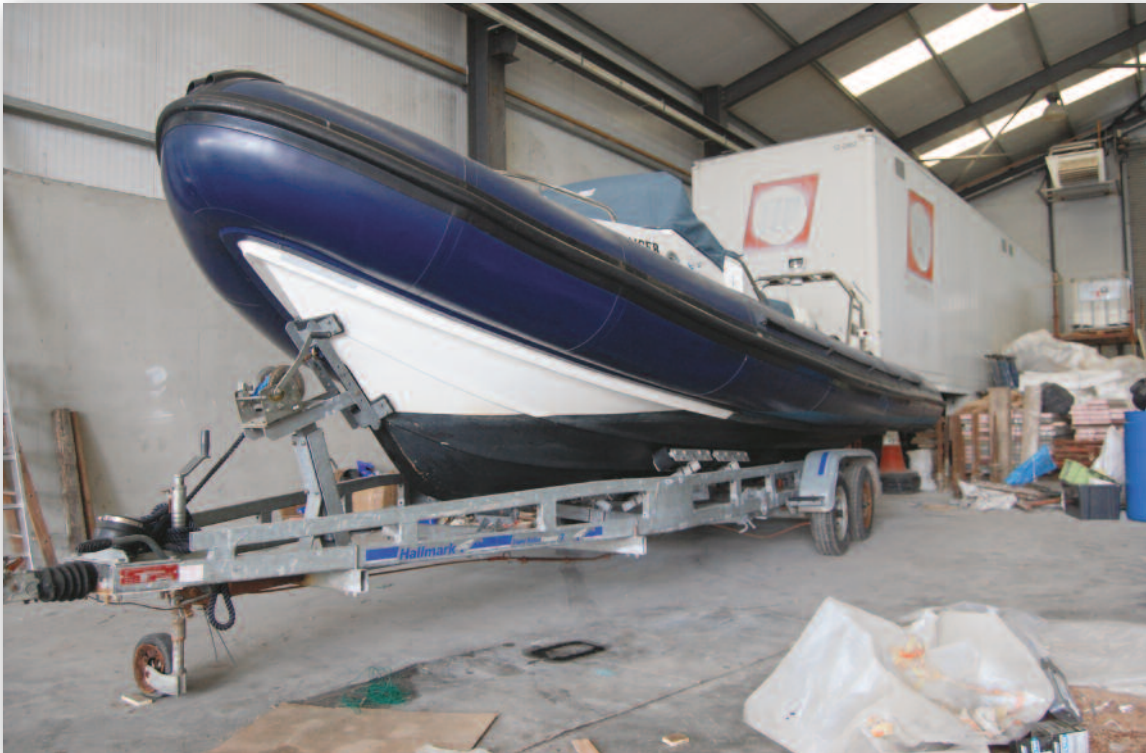
### Appendix 7.5 RIB at time of inspection in Safe Haven.

- 4.1 When inspected, the RIB was found to be free from damage. There was however no CE mark or evidence that the vessel was Recreational Craft Directive (RCD) approved.

7.5.1 The hull and shaft were inspected during the investigation, there was no sign of impact damage found.

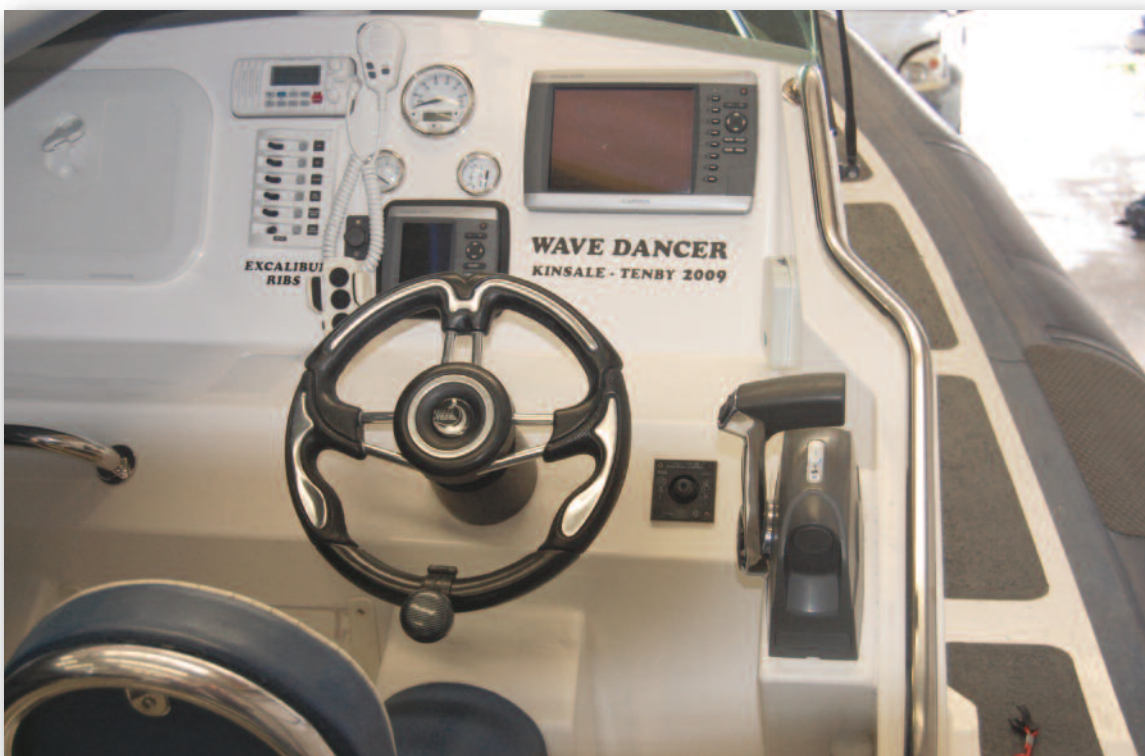
7.5.2 Helm Position and chair.

- 4.3 In interview Mr Corkery explained that he was aware of the malfunctioning Kill Cord arrangement and as a result he did not have it attached to his person at the time of the accident. During the same interview Mr Corkery went on to explain that he was not seated whilst driving his RIB and was standing beside the helm position on the deck between the helm console and the sponson.

- 5.5 Mr Owen Corkery was standing beside the wheel rather than sitting on the pilot seat, this would have made him considerably more likely to be thrown from the vessel.

- 6.1 The Kill Cord is an essential part of safety equipment for all open motorboats. They should always be used and should be checked regularly.
- 6.2 The helm of a high-speed craft should always remain seated, even at low speed, as a small throttle shift or turn of the wheel can have profound effects on centrifugal and G forces.
- 6.3 All pleasure craft owners should complete a recognised powerboat handling course, regardless of previous experience.
- 6.4 Owners and operators of recreational craft should be aware and follow the Department of Transport, Tourism and Sport's Code of Practice for the Safe Operation of Recreational Craft.
