**REPORT OF THE
INVESTIGATION INTO
THE COLLISION BETWEEN
THE YACHT "DAI MOUSE"
AND THE U.K. REGISTERED
WORK BOAT "VOE TRADER"
IN DUBLIN BAY
ON 12TH MAY 2001.**

The Marine Casualty Investigation Board was established on the 5th, June 2002 under The Merchant Shipping (Investigation of Marine Casualties) Act 2000

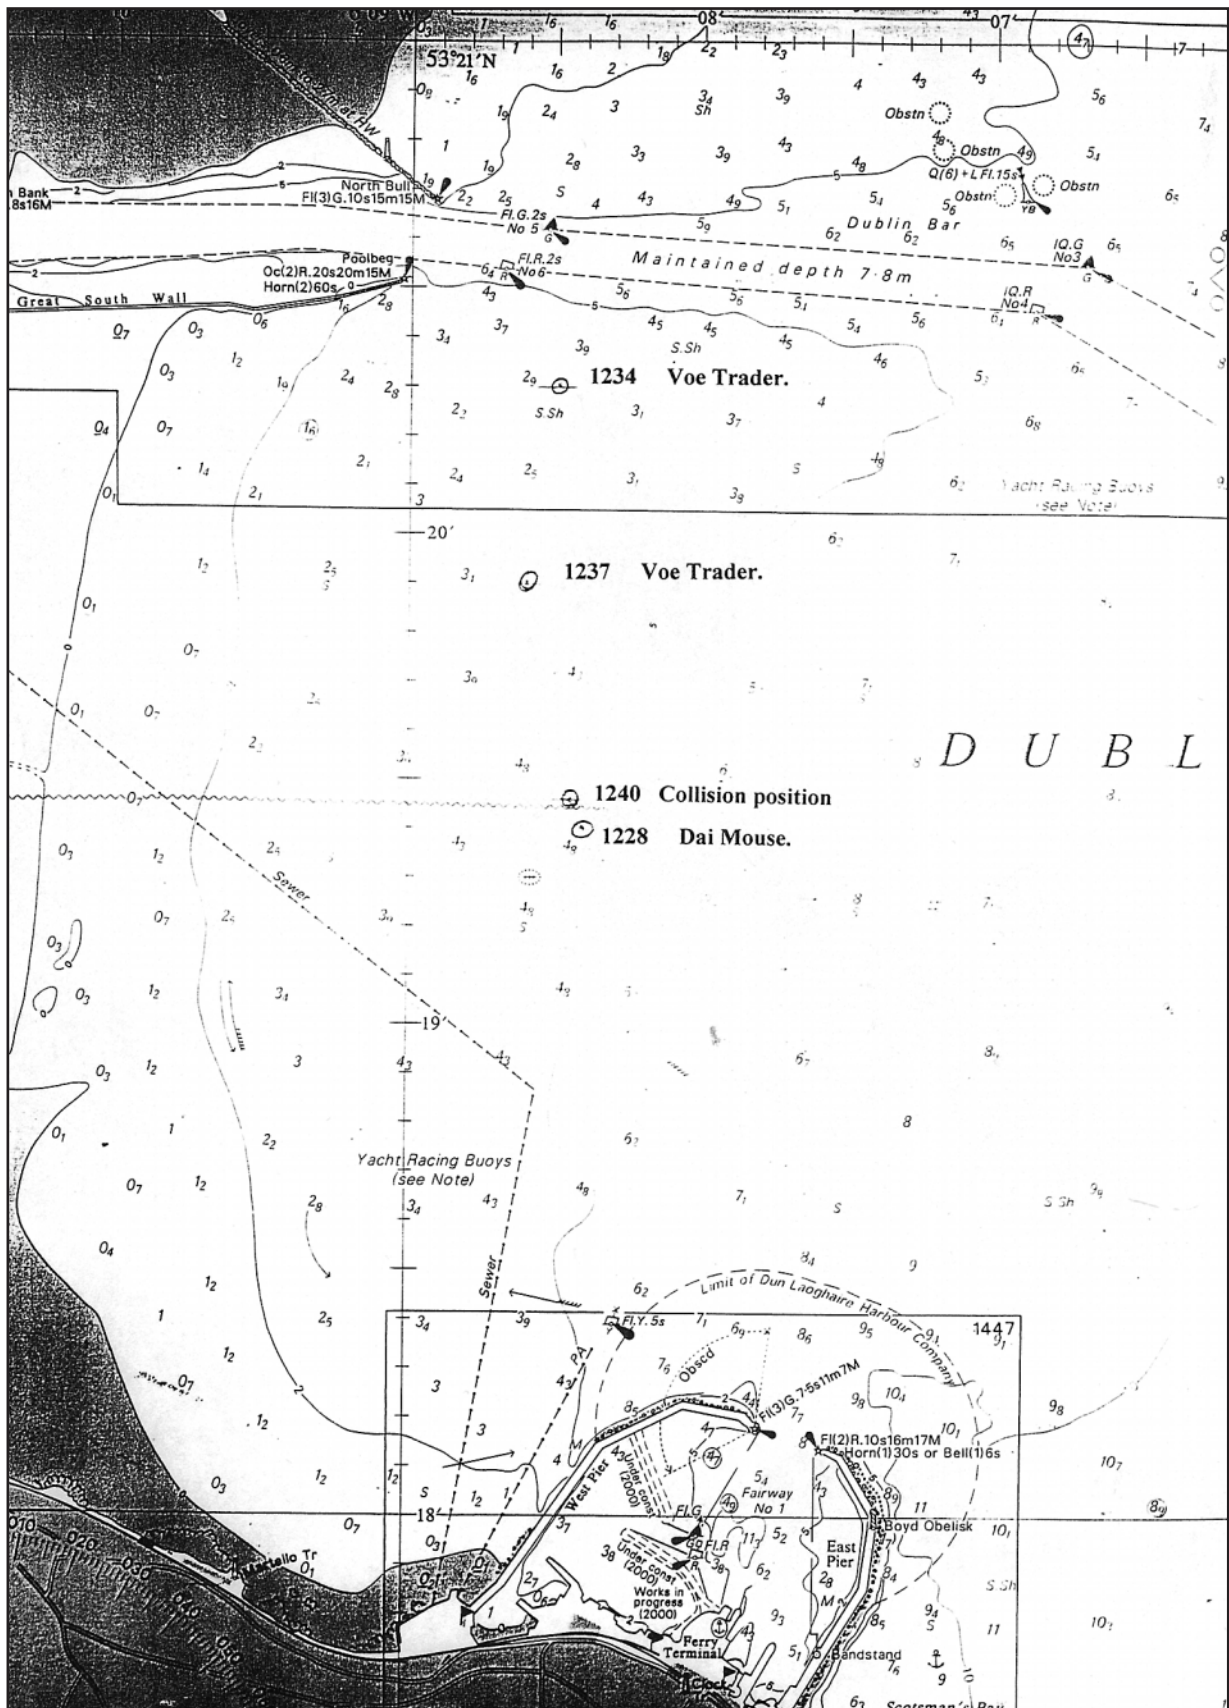
10.3 Appendix C. Chart extract-showing position of collision.

- 4.17 The collision position is given on the chart extract of Dublin Bay in Appendix C.

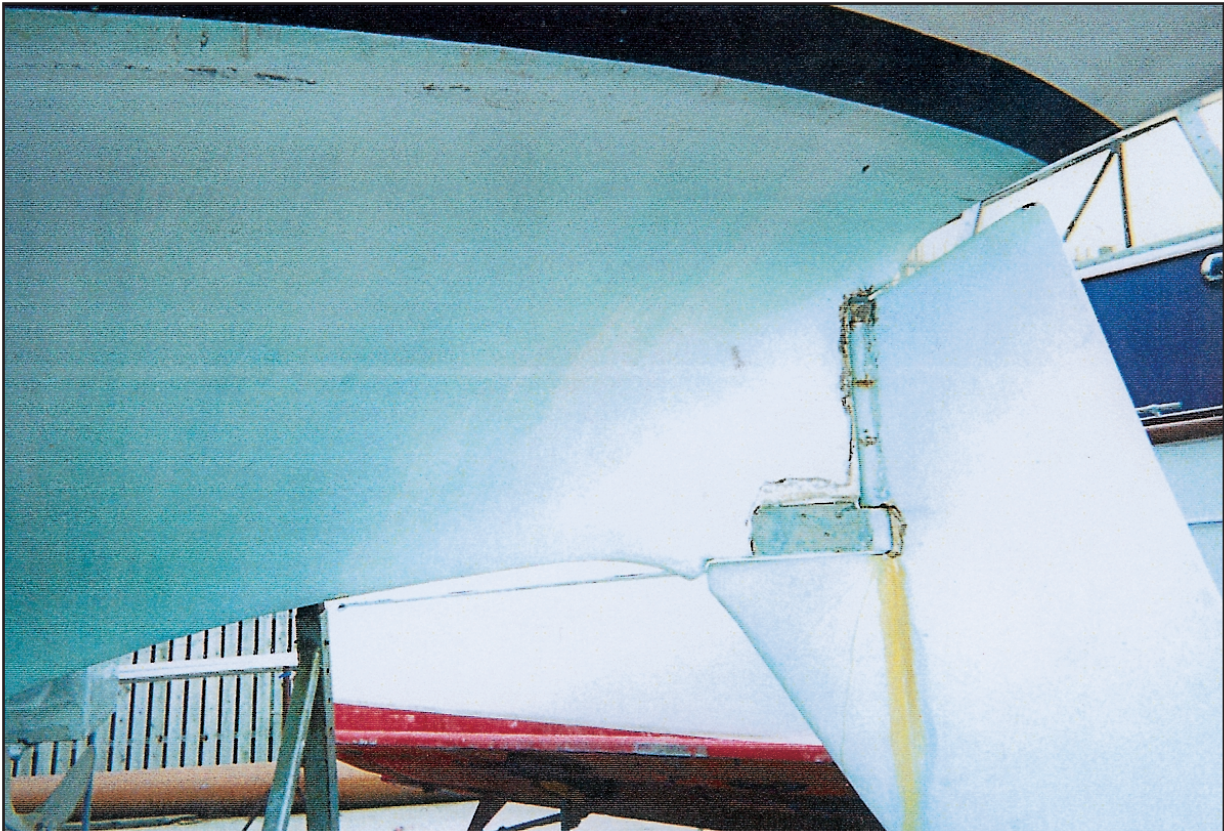
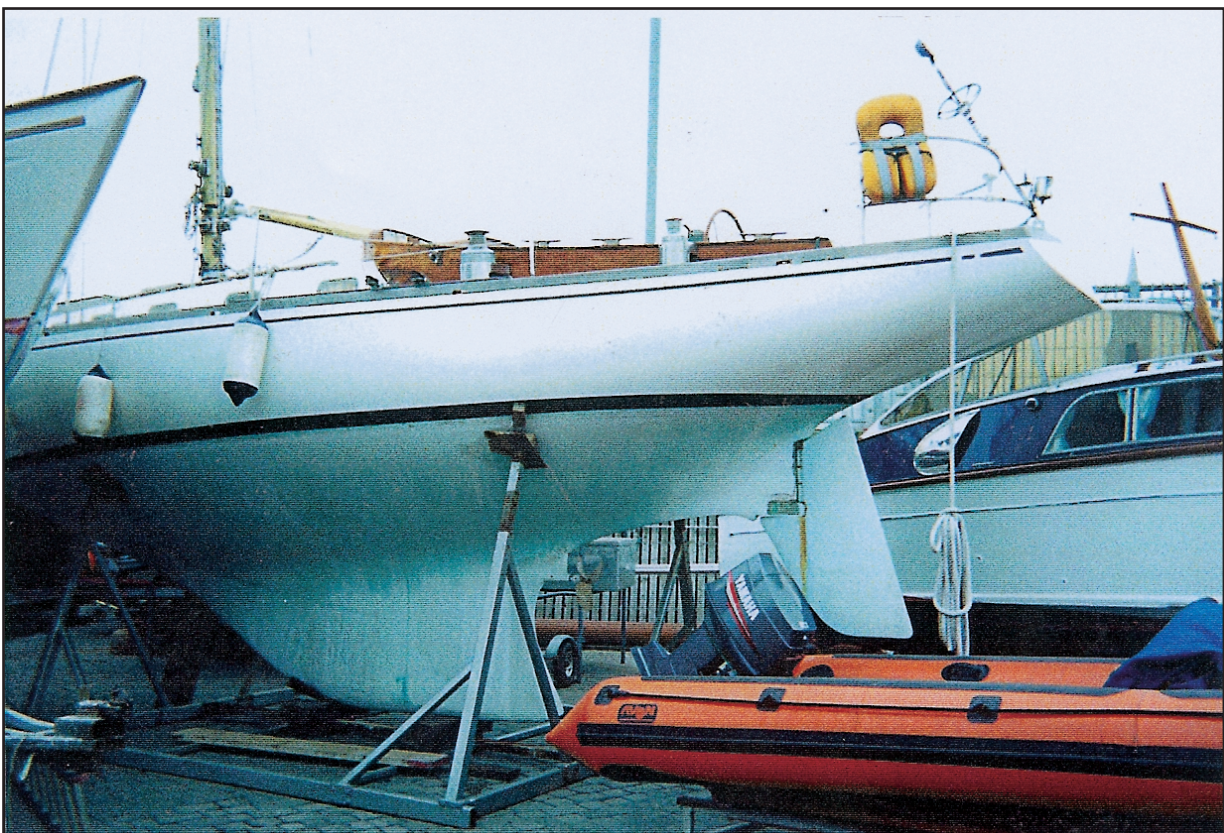
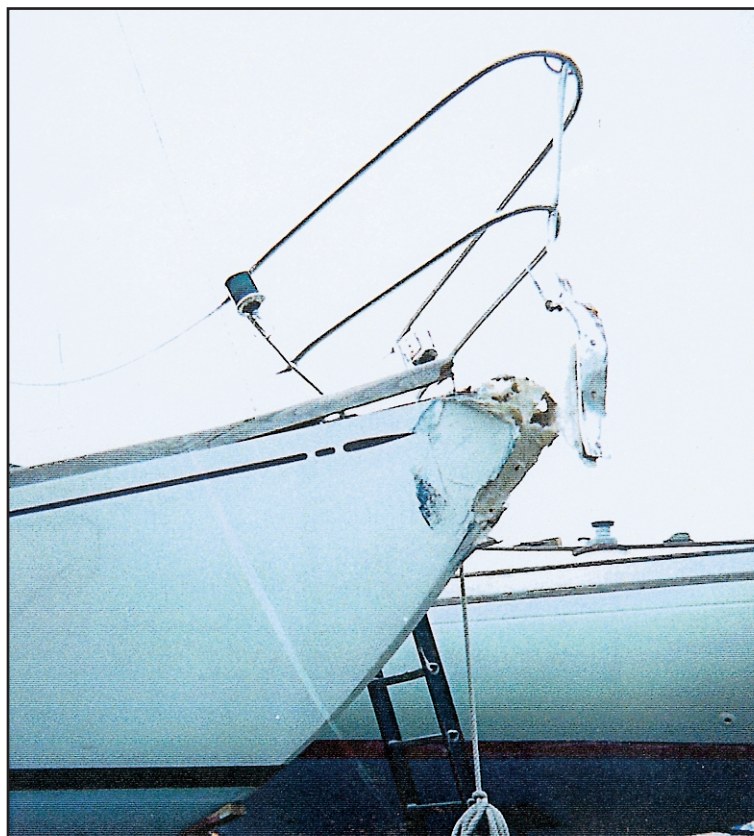
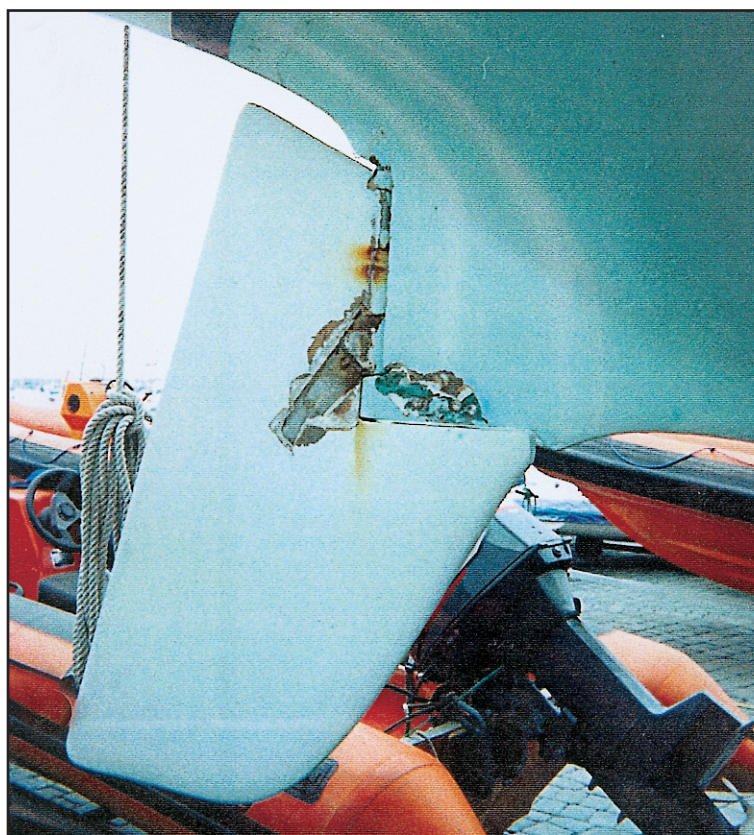
10.4 Appendix D.

5.2 The bow area of the yacht was damaged in the collision. The cockpit was filled with water, as it would appear that as the bow was raised the stern of the boat was submerged, filling it with water. It was found that the drain from the cockpit had sheared and was filling the boat. There was also water entering under pressure from the outside. The leak was plugged and one of the boat’s bilge pumps was used to pump out the yacht. The steering gear was also damaged in the incident. Photographs of the damaged yacht are given in Appendix D.

Photographs showing damage to the yacht "Dai Mouse".

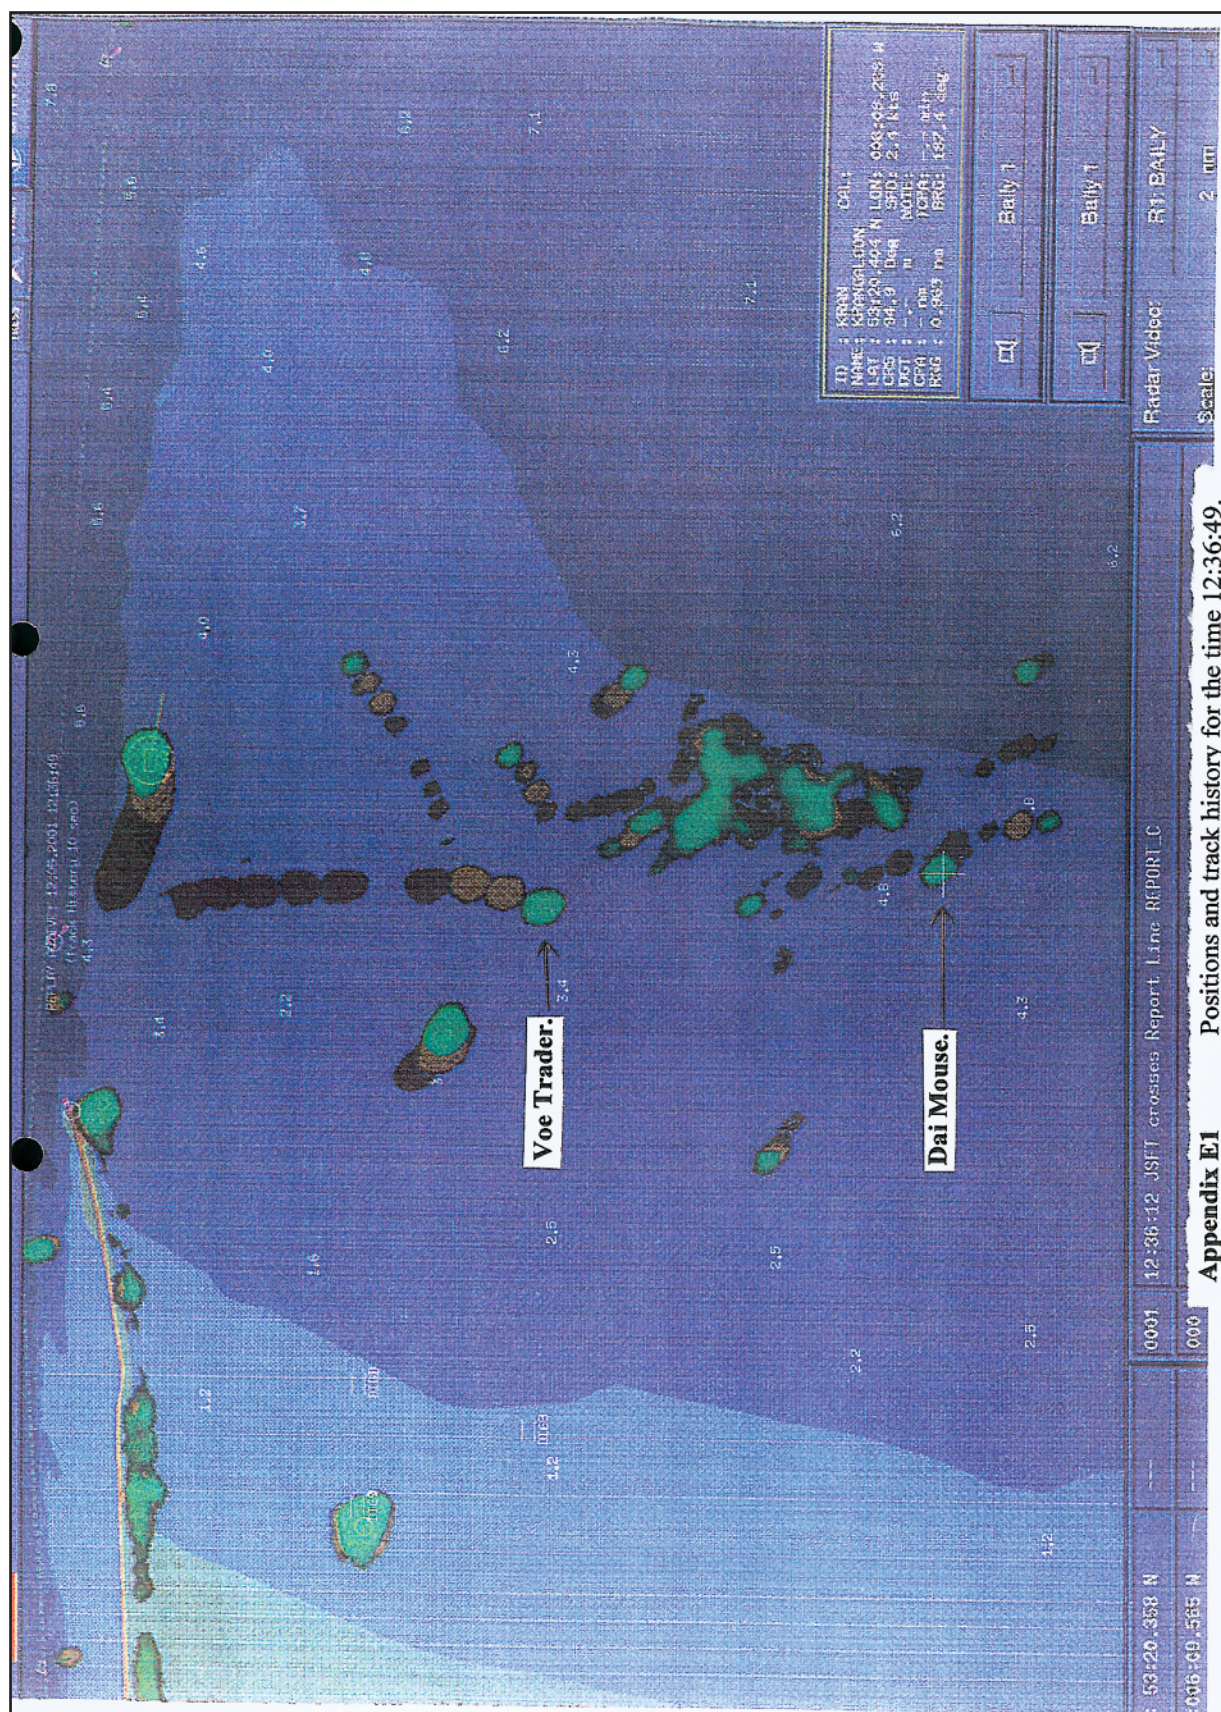
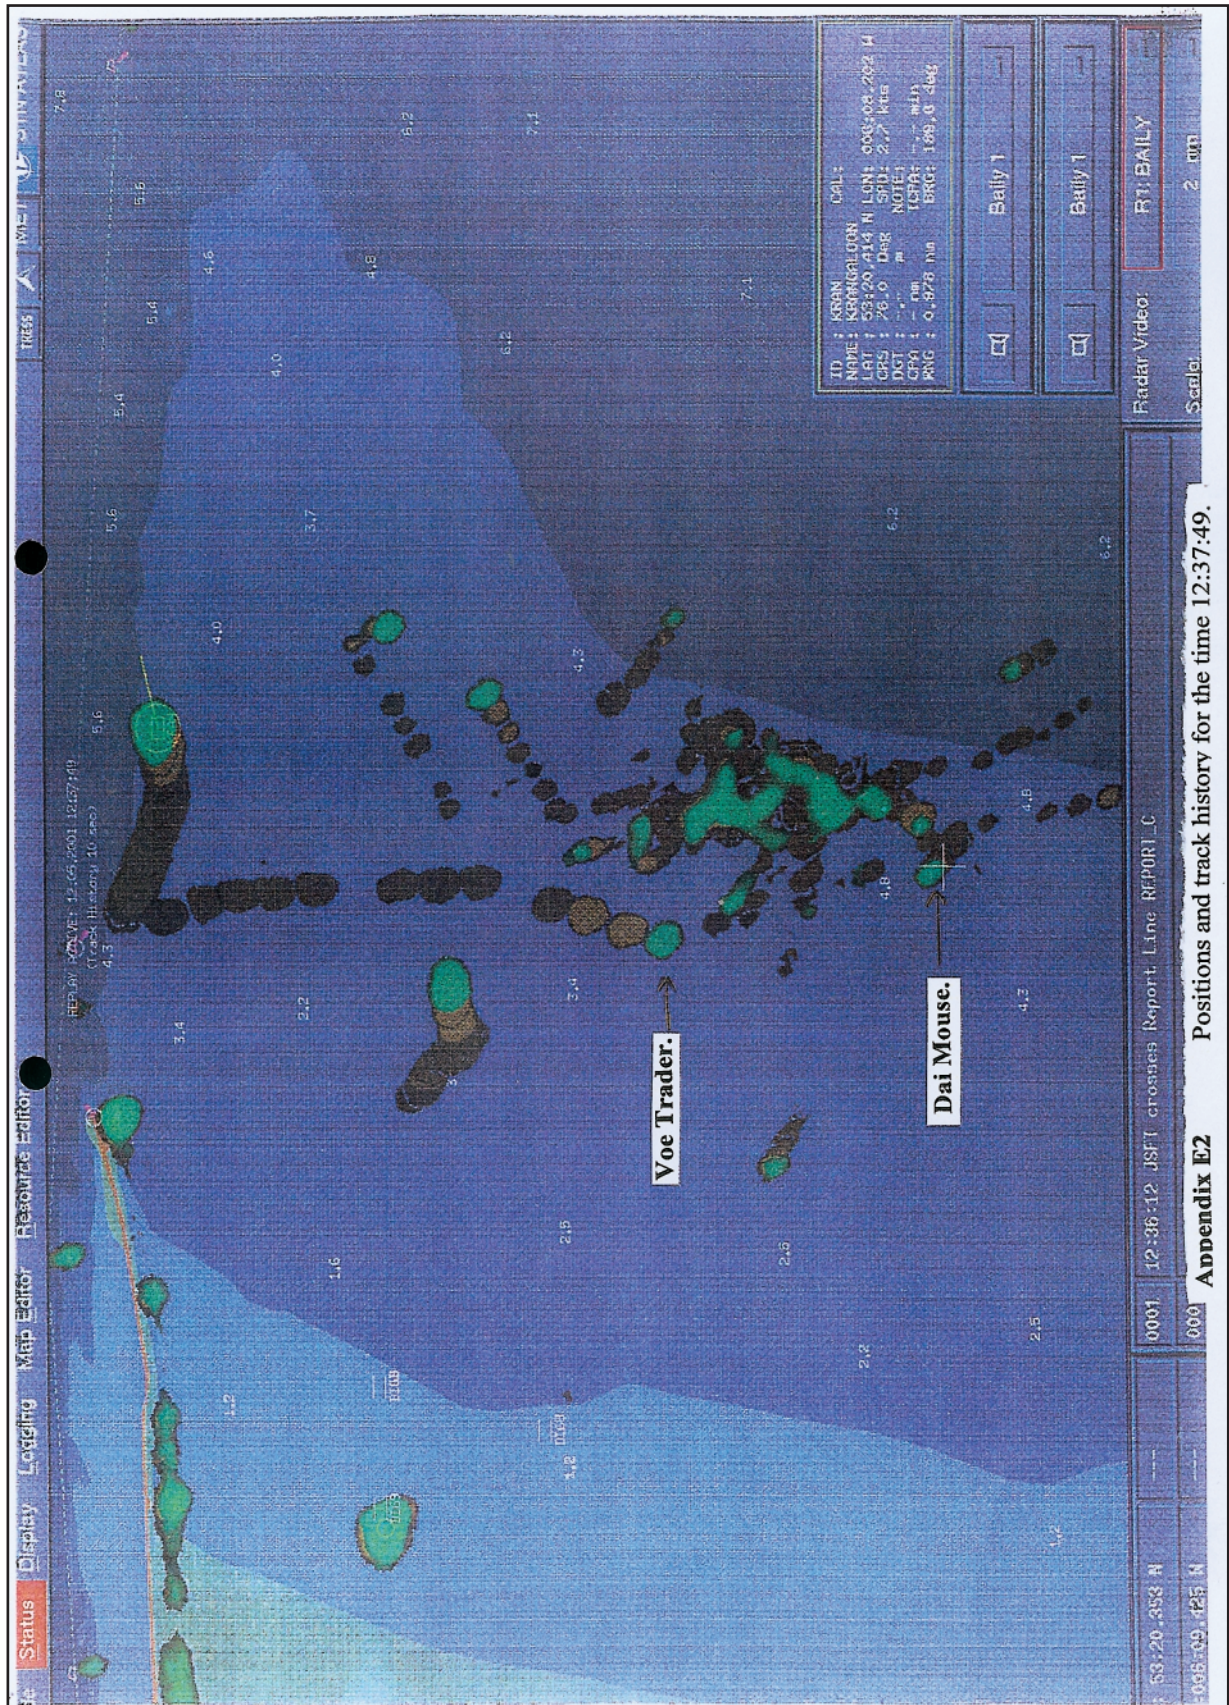
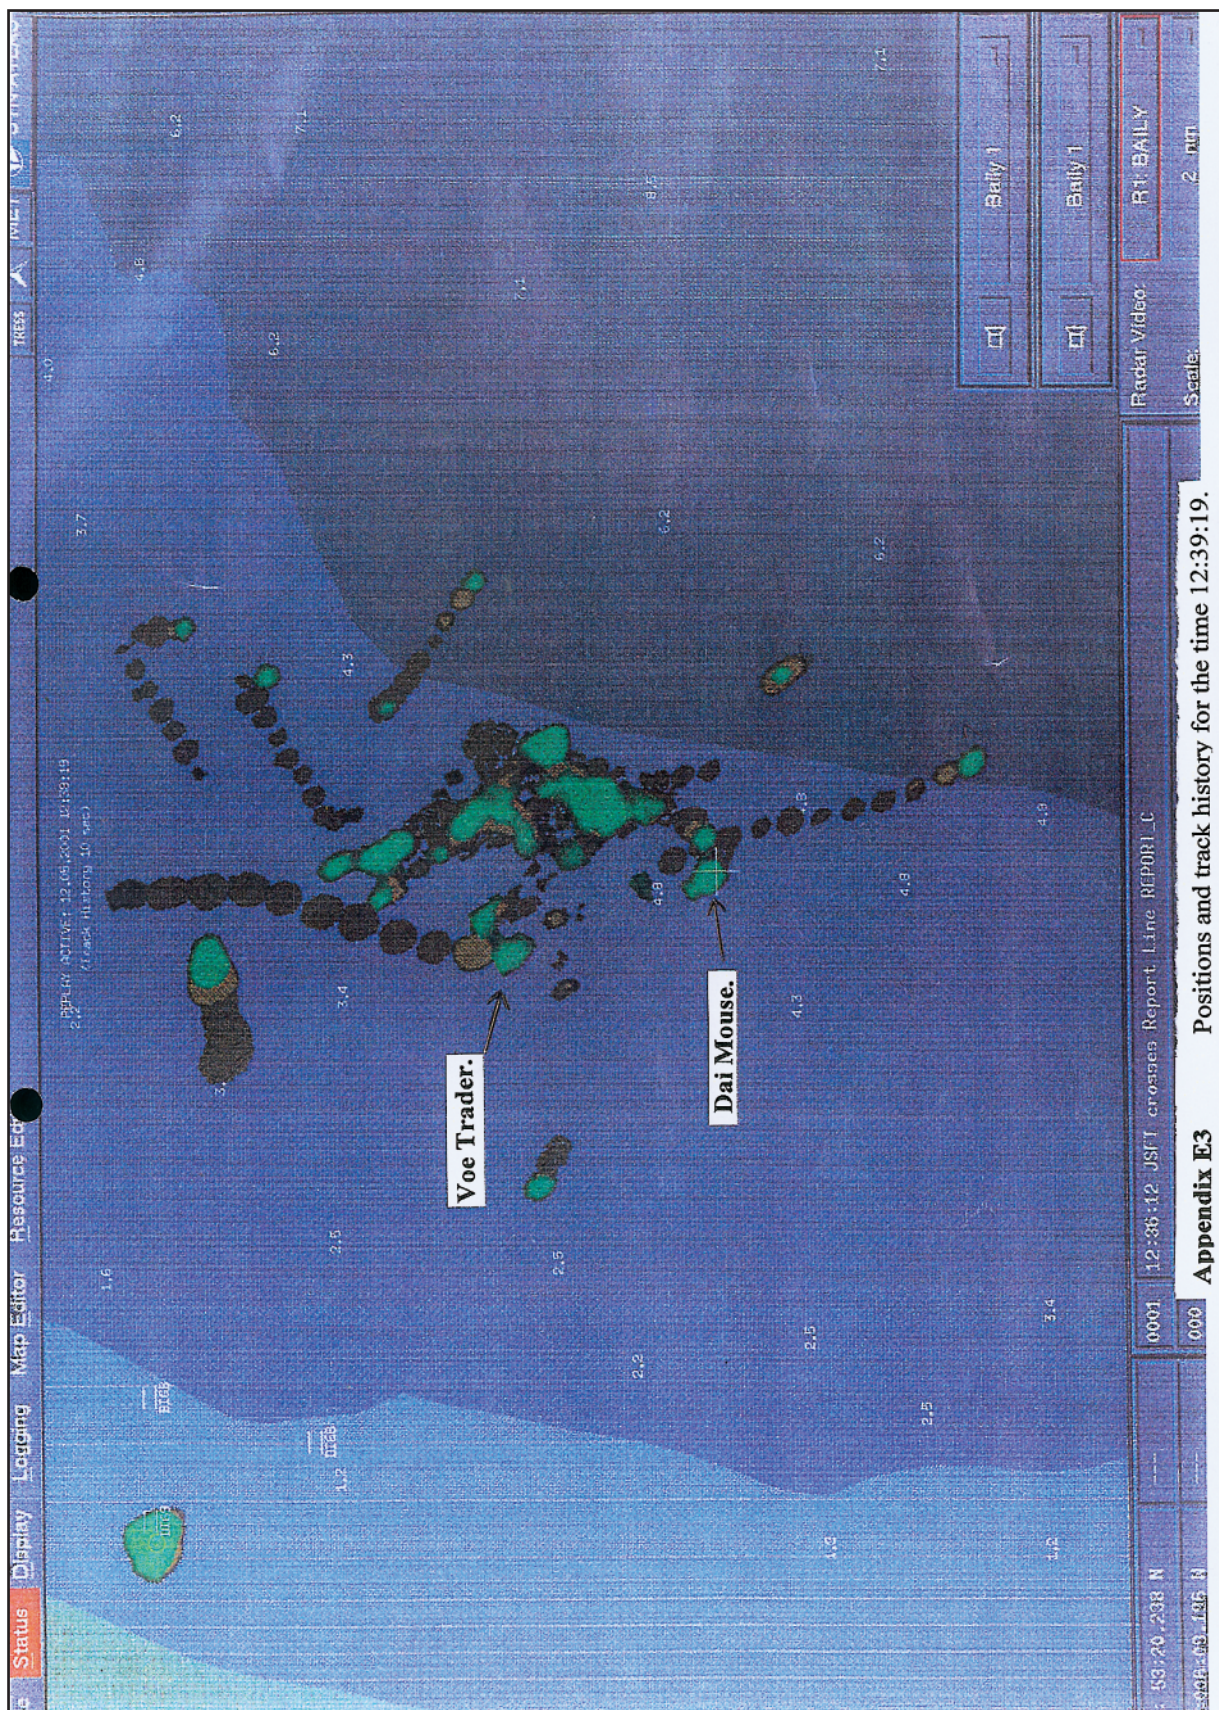
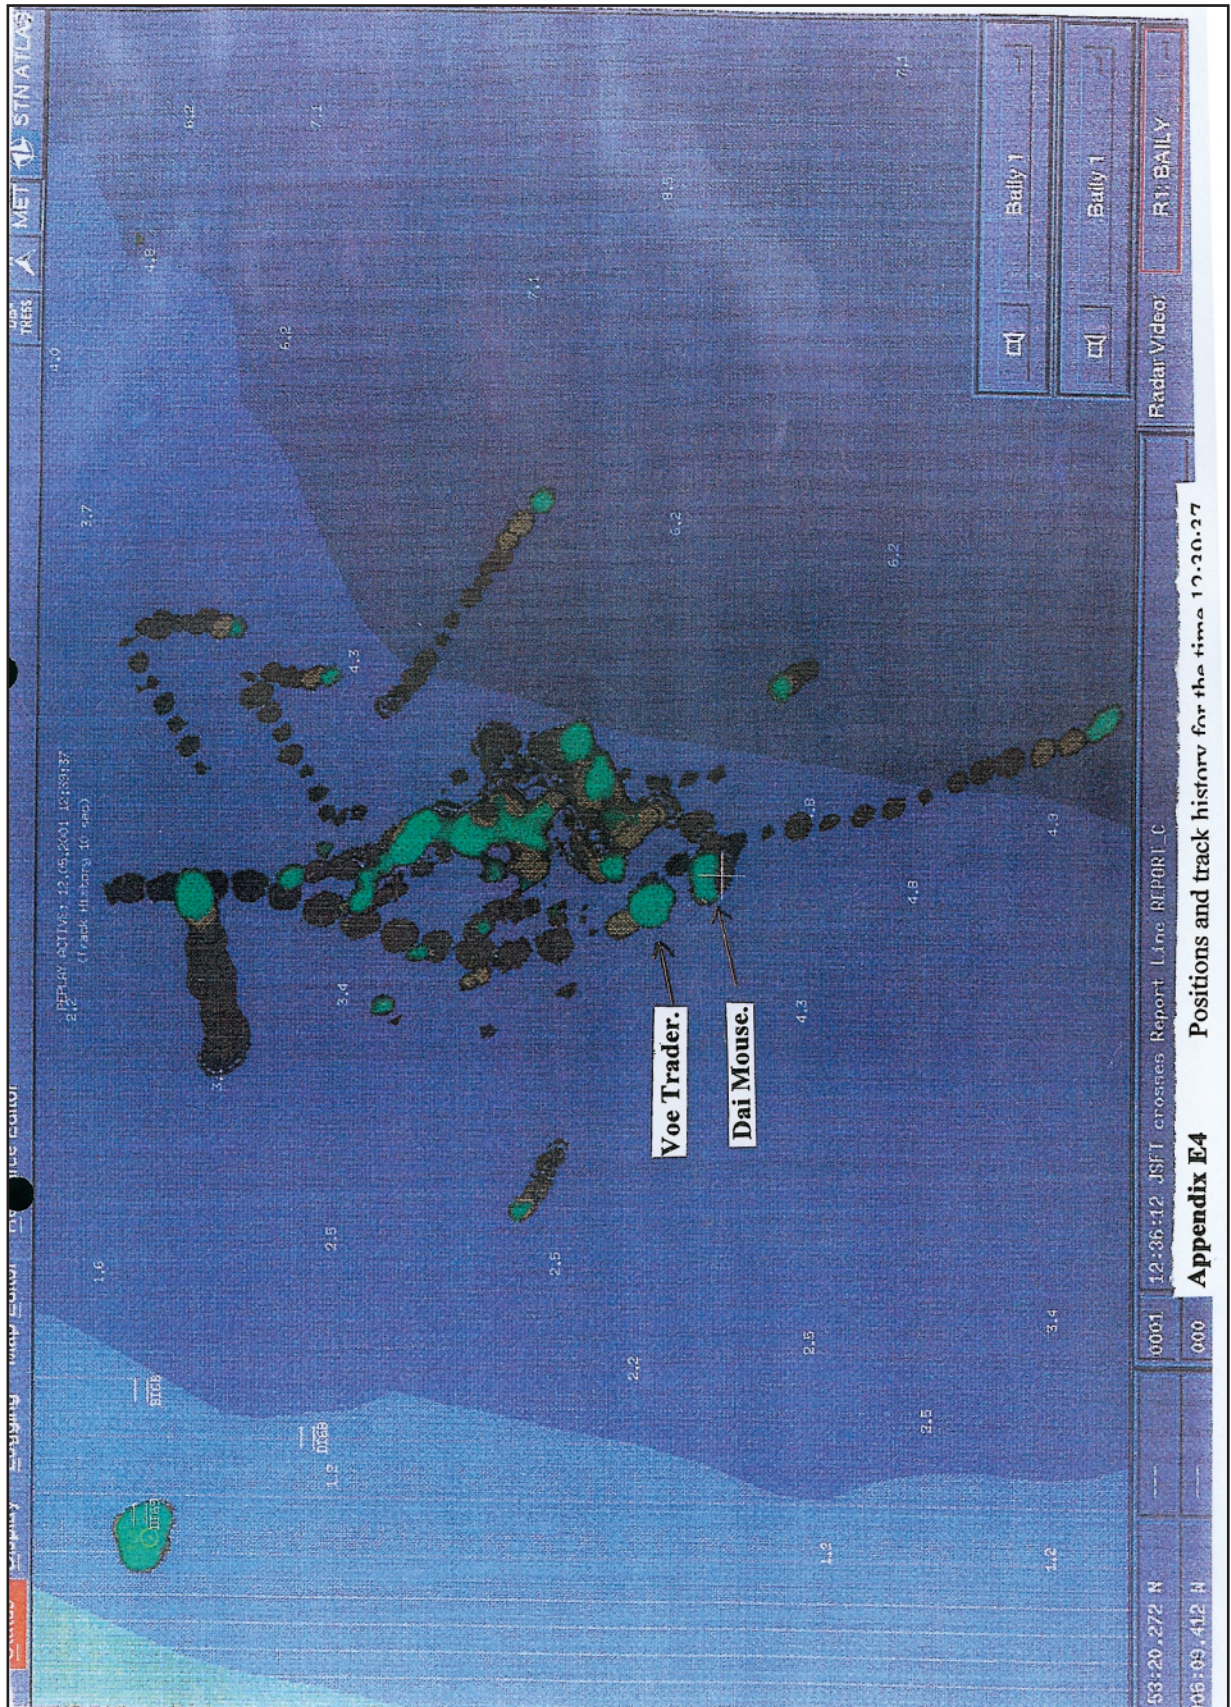
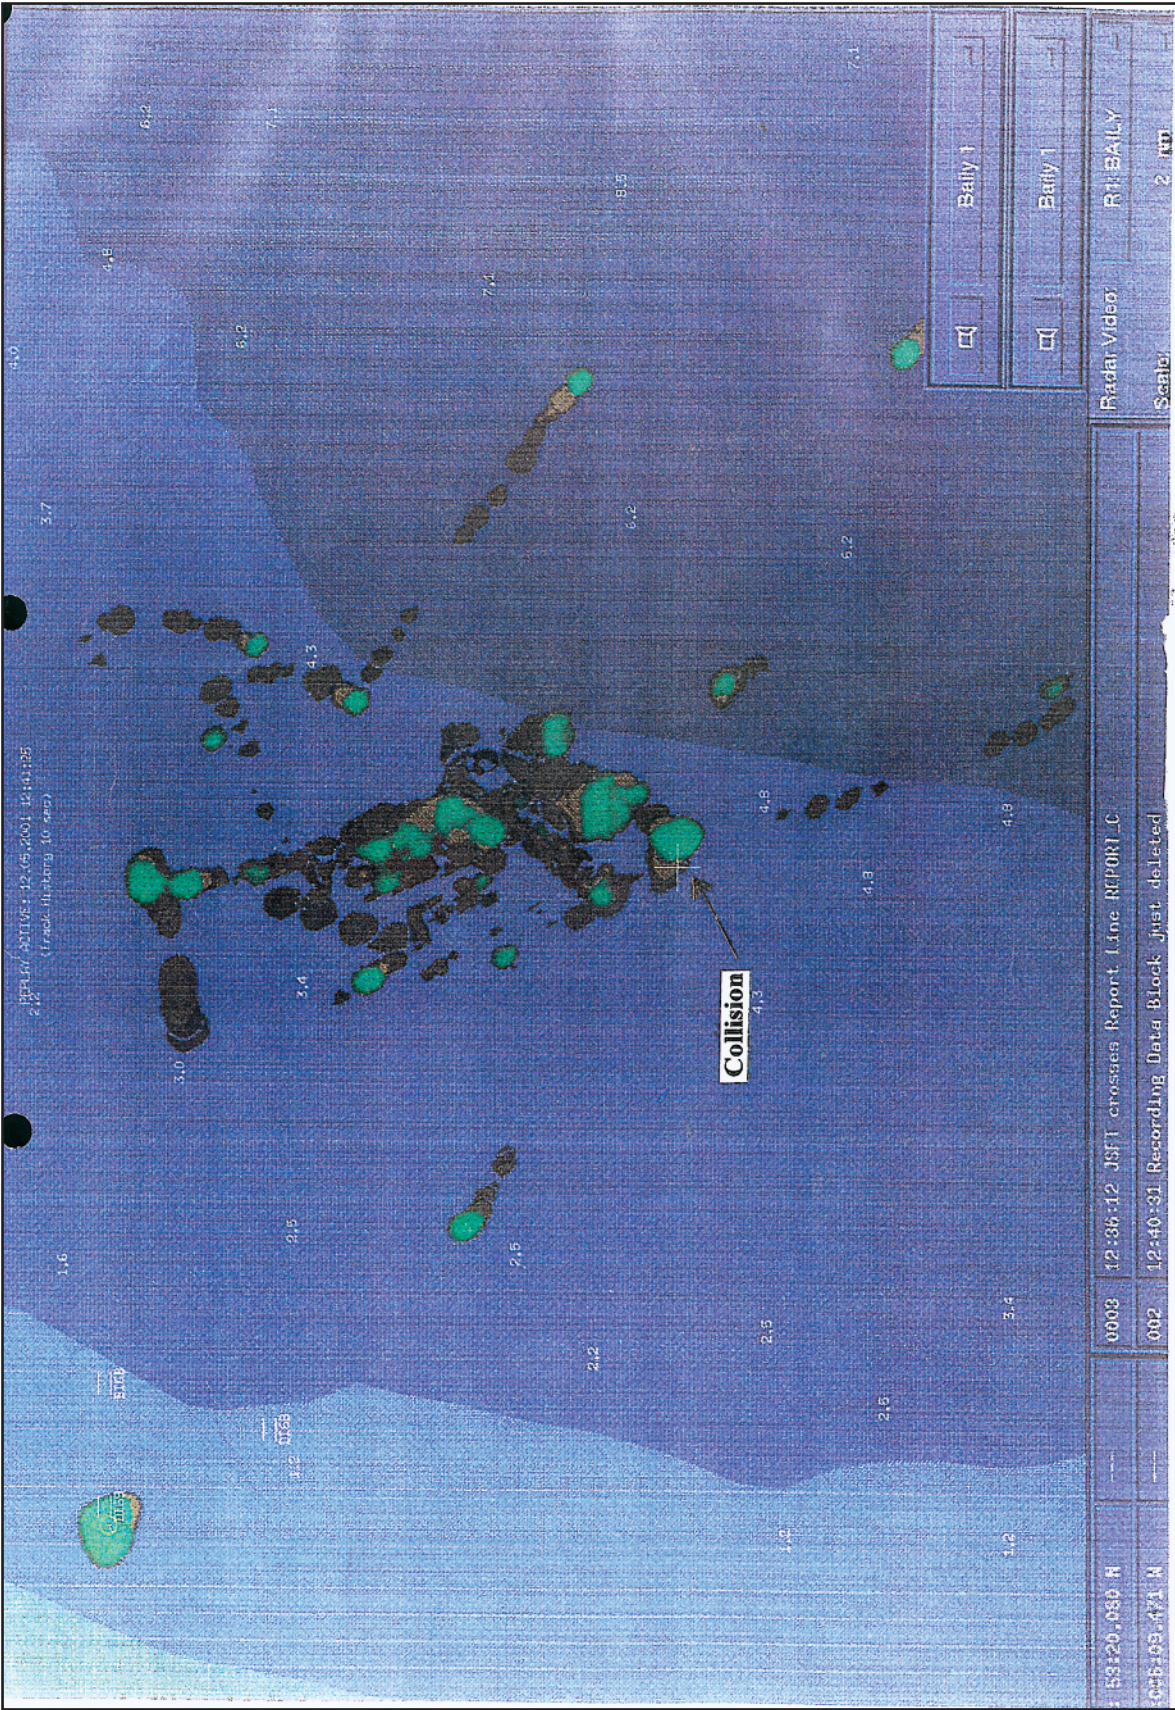
Dublin Bay Radar Recordings leading up to the collision.

- 6.3 For the period from 1234 to 1240 hours, the recordings show that the "Voe Trader", travelling on various courses in a mainly southerly direction, covered a distance of approximately 0.861 nautical miles. This gives a speed of 8.61 knots over the ground. Taking into account the tidal flow, as experienced by the yacht, this would indicate that the "Voe Trader" was proceeding at a speed of about 9.03 knots at the time of collision.

- 6.4 The radar recordings also reveal that the "Voe Trader" altered course to port in the immediate time leading up to impact. This is shown by radar recordings showing the track history of the "Voe Trader" as given in Appendix E. It would appear from witness statements that this alteration took place in order to avoid another committee boat that was ahead of the "Voe Trader" prior to the alteration to port.

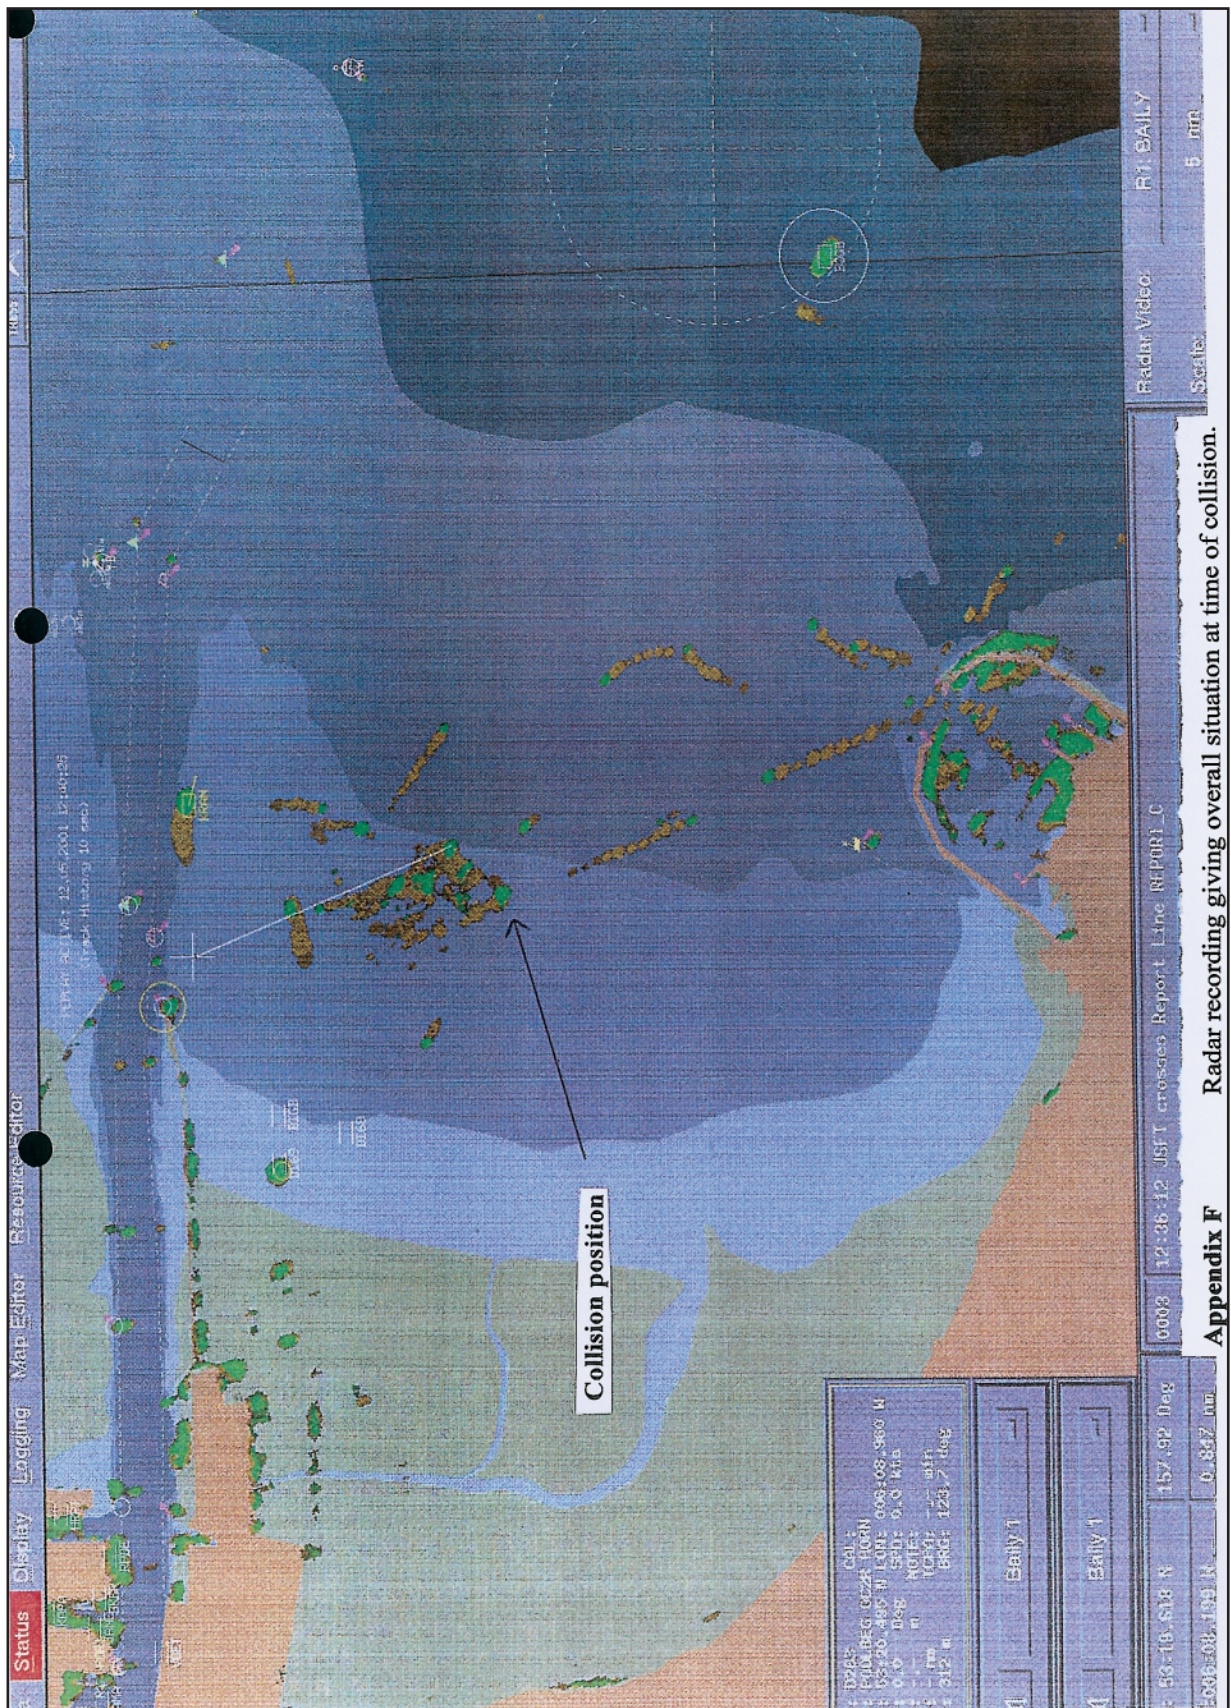
Dublin Bay Radar Recording giving the overall situation at the time of the collision.

- 6.5 The radar recording for the time 12:40:25, which is given in Appendix F, shows the vessel movements and concentrations in Dublin Bay at the time of the collision.

- 8.7 Rule 2 is given in Appendix G and it deals with the responsibility of vessels. In the circumstances of this case it is hard to understand why the "Voe Trader" did not navigate around the cluster of yachts as there was ample sea room to the east and west of the yachts, as illustrated by the radar recording given in Appendix F.
