**REPORT OF INVESTIGATION
INTO AN INCIDENT ON
PASSENGER BOAT
“FLYING HORSE”
OFF THE SKELLIG ISLANDS,
CO. KERRY
29th JUNE 2012**

**REPORT No. MCIB/220
(No.1 of 2014)**

Report MCIB/220 published by The Marine Casualty Investigation Board.
Printed 25th March 2014.

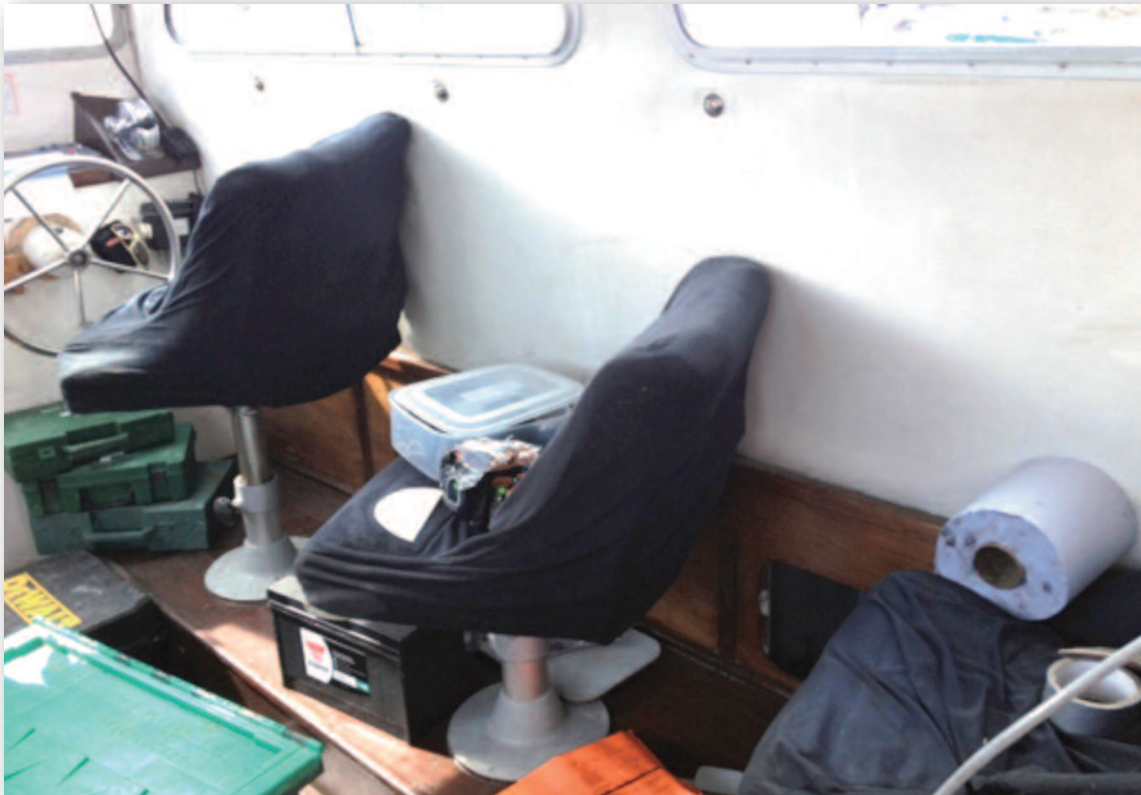
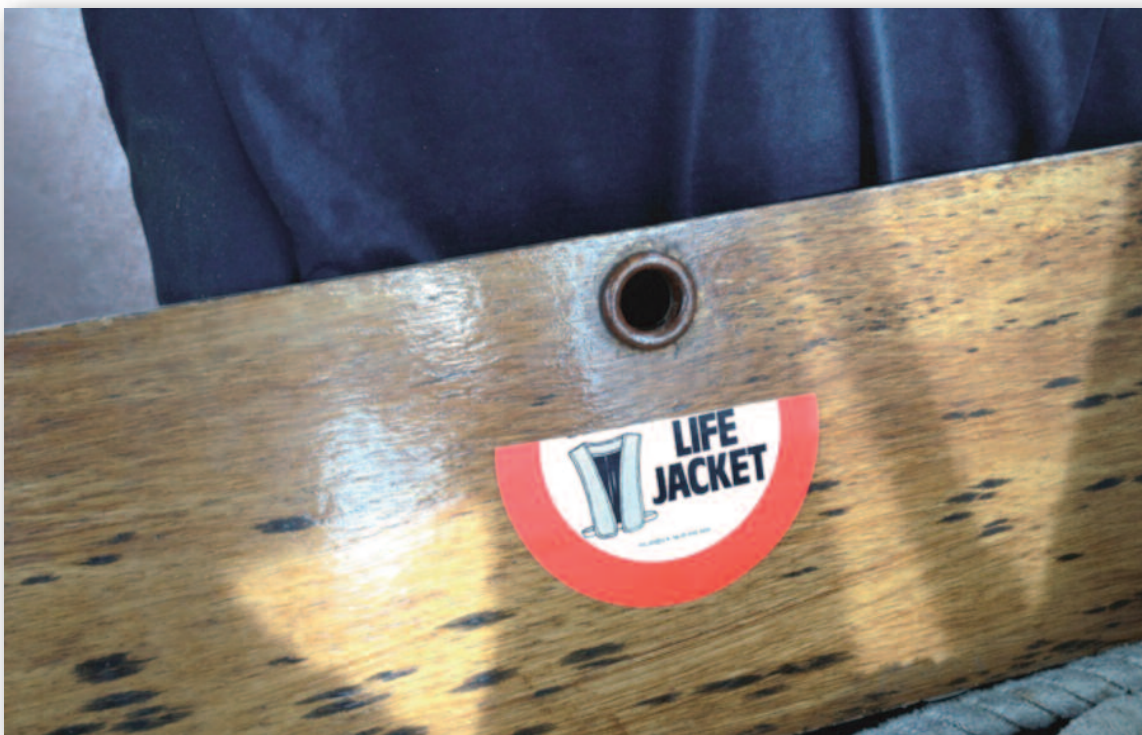
APPENDIX 7.2

- 3.2 Once on board the boat the owner's representative gave them a short safety briefing. He pointed out the location of the life jackets as part of the briefing (pointing to sides of the boat behind the seats). No instructions were given as to how to don the lifejackets. The owner's representative warned the passengers that the sea would be rough on the way out but what seemed rough to the passengers was normal to him and that it was absolutely safe (See Appendix 7.2 Photograph of life jackets position).

- 4.3 A short safety briefing was given by the owner’s representative prior to the craft departing Ballinskelligs. Part of the briefing pointed out the location of the lifejackets, namely in lockers on the boat’s sides under the seats. However, the briefing did not include a demonstration as to how to don a lifejacket. It is a condition of the boat’s licence, that safety instructions concerning signals, life-saving appliances, means of escape, etc. must be announced to the passengers before the commencement of any voyage.

- 4.4 There was an inadequate number of lifejackets on board for the passengers and crew being carried, at least three persons could not be provided with lifejackets, and there was also no child’s lifejacket provided. The child had to wear a lifejacket that was too large for her and could have been completely ineffective if it had become necessary to abandon the boat. The lifejackets were stowed in lockers at the sides of the boat under the seats. This would not be considered the most accessible place for the stowage of lifejackets. The markings indicating the position of the lifejackets were poor and sparse. It is a condition of the boat’s licence, that lifejackets be stowed in a readily accessible location for use in an emergency.

Cabin Seating Arrangement & Lifejacket Lockers.

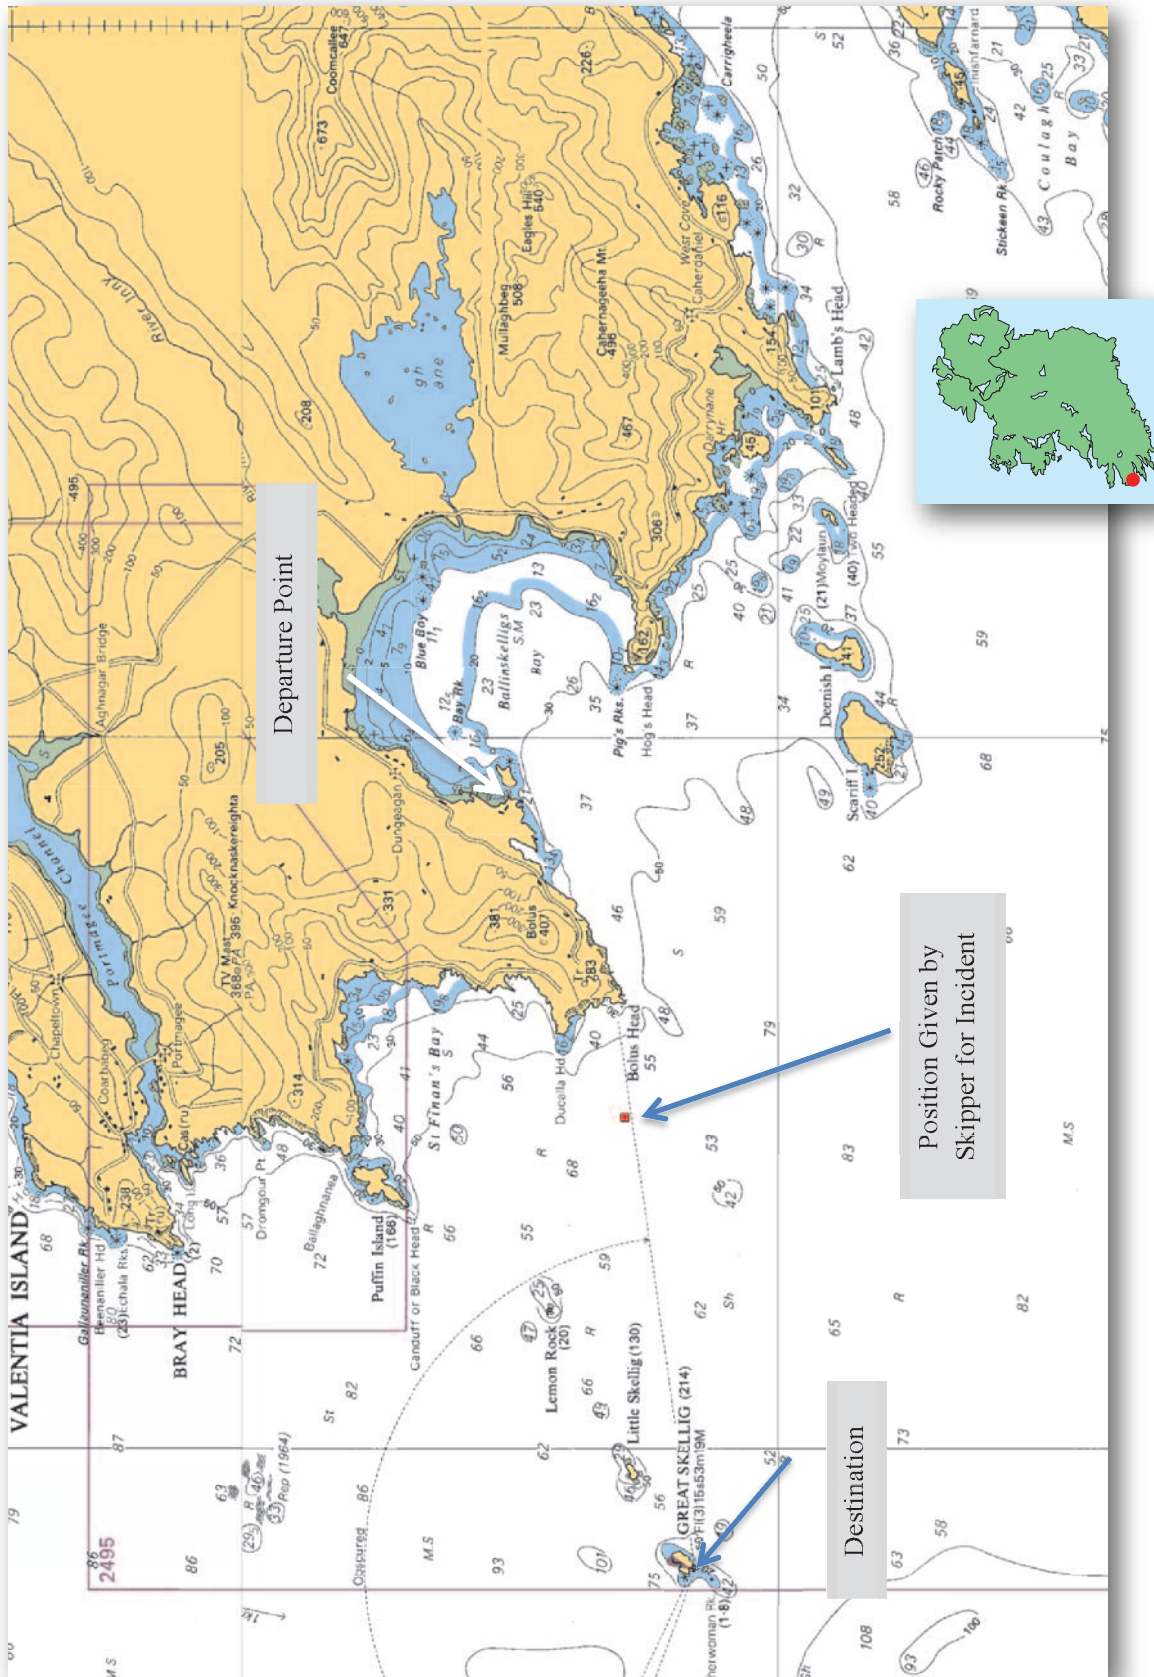
Appendix 7.3 Chartlet of area of incident.

- 3.4 The sea was rough on the way out with wave heights between 2 and 3 metres in height with some passengers feeling queasy and sick. Approximately 20 minutes into the trip when the boat had just cleared the end of the headland into open sea, the boat came off a big wave, when a loud bang was heard (See Appendix 7.3 Chartlet of area of incident).

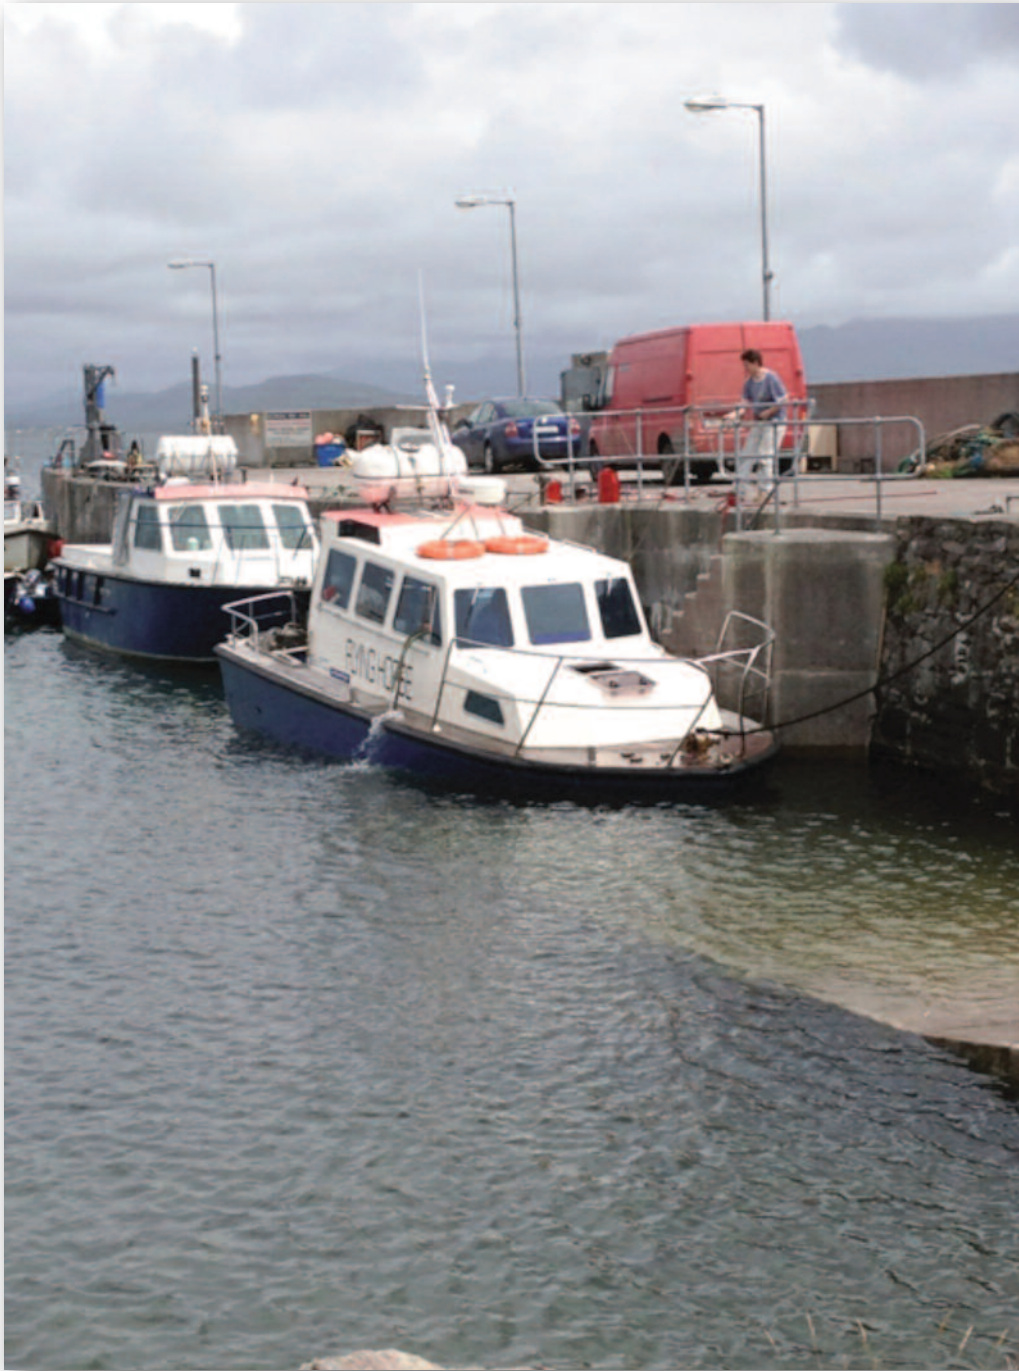
Photo 1: Flying Horse At Ballinskelligs Subsequent to Incident.

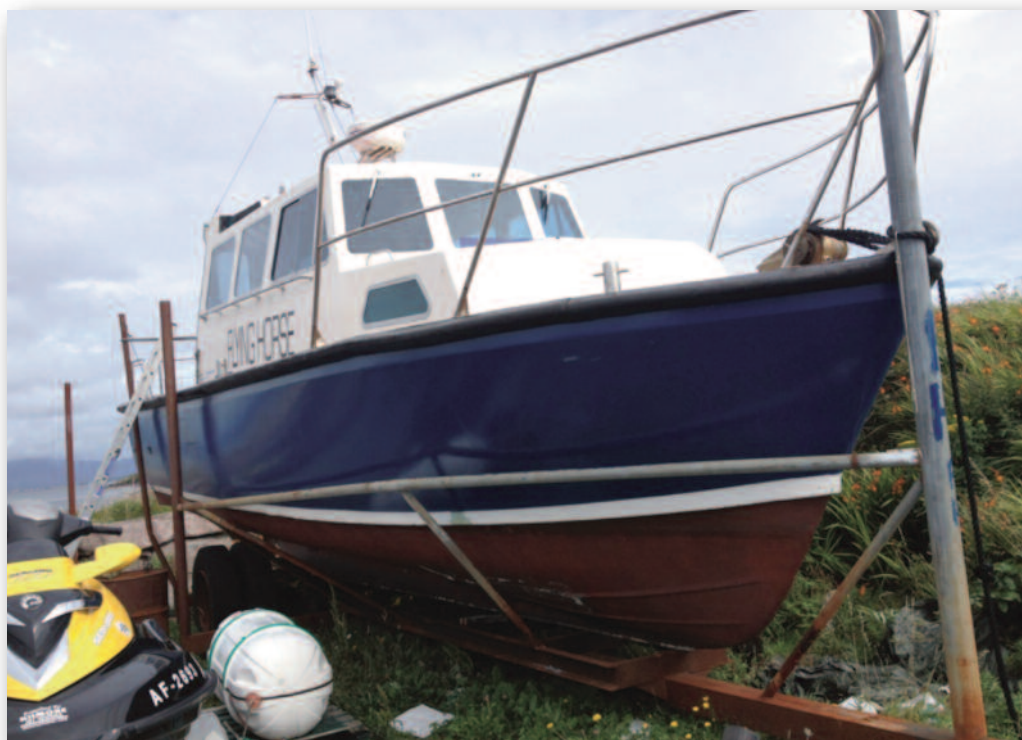
Photo 2: General View of Craft.

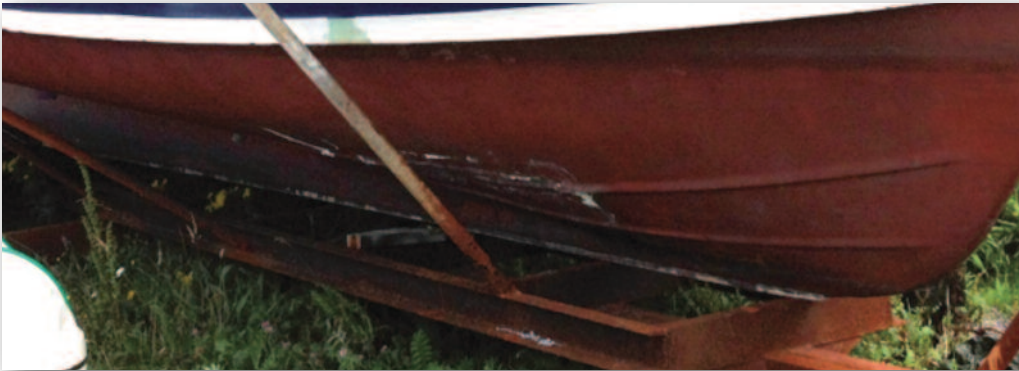
- 3.9 A subsequent examination of the craft showed that damages had been sustained on the starboard side over a length 500mm above keel over a length of 1000mm commencing 1400mm abaft of the stem (See Appendix 7.4 Photographs of damage sustained).

- 4.6 The damage was sustained on the starboard side of the craft and it coincided with the craft coming off a large wave. It was reported that floating logs were seen in the area of the incident. It cannot be determined if the structural damages to the boat were as a result of hitting a floating object or as a result of proceeding at an excessive speed in unsuitable weather conditions. There was no evidence to suggest that there were any structural deficiencies in the vessel prior to the incident.

Photo 3: General Area of Damage.

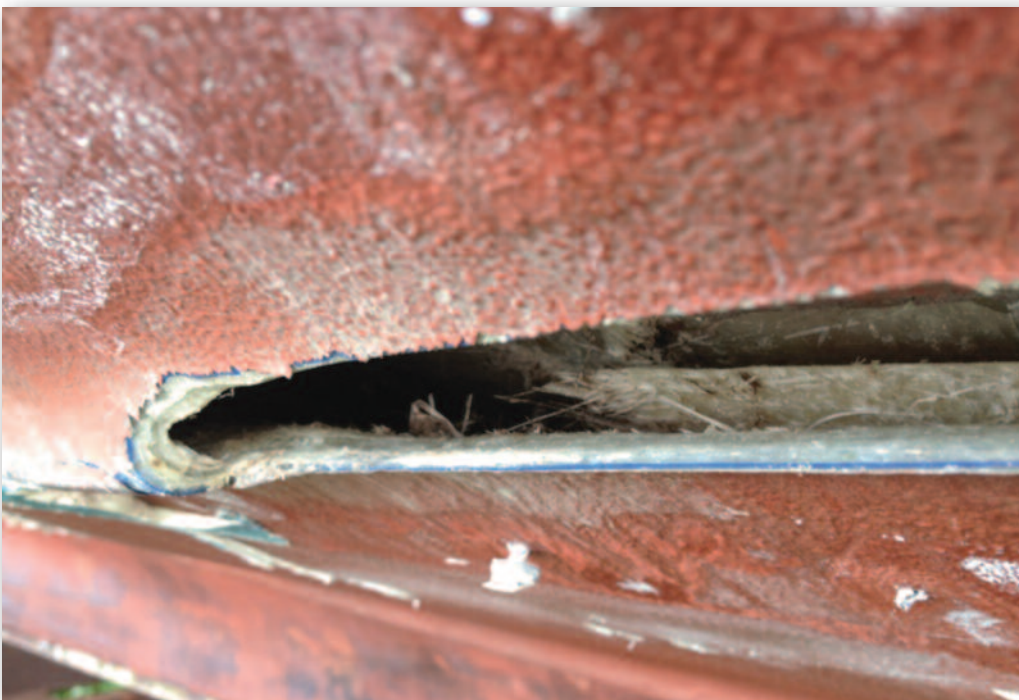
Photo 4: Close-up of Hull Damage.

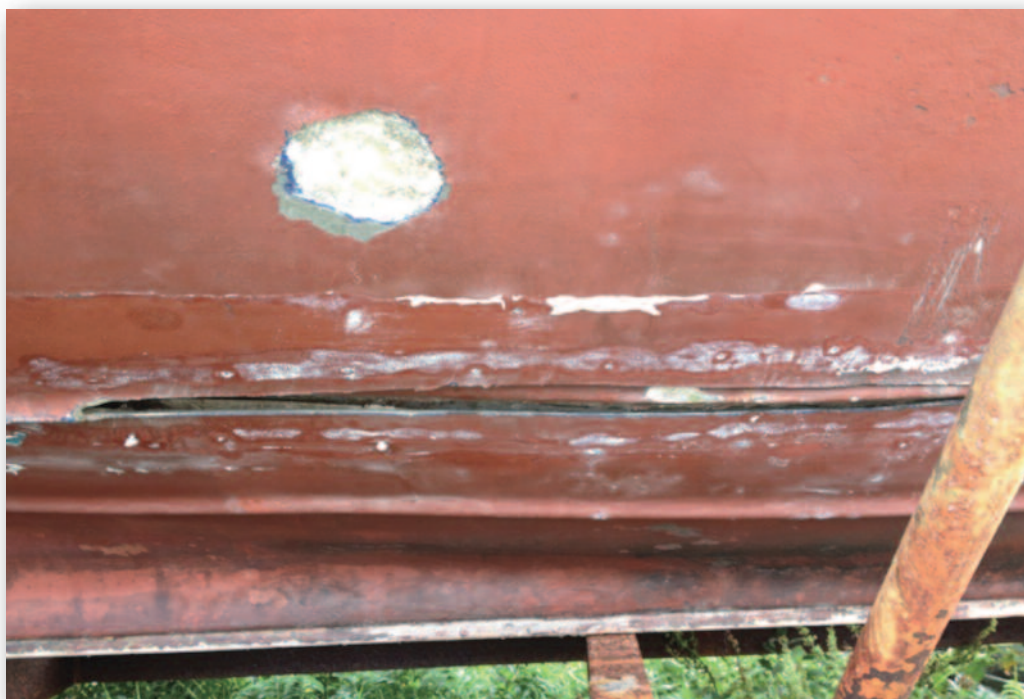
Photo 5: Close-up of Hull Damage.
