**REPORT INTO THE INCIDENT
OF THE COLLISION
BETWEEN A JET-SKI AND
A SPEEDBOAT IN
YOUGHAL, CO. CORK
ON 11TH AUGUST, 2003**

The Marine Casualty Investigation Board was established on the 25th March, 2003 under The Merchant Shipping (Investigation of Marine Casualties) Act 2000

Published by The Marine Casualty Investigation Board
31st May 2005

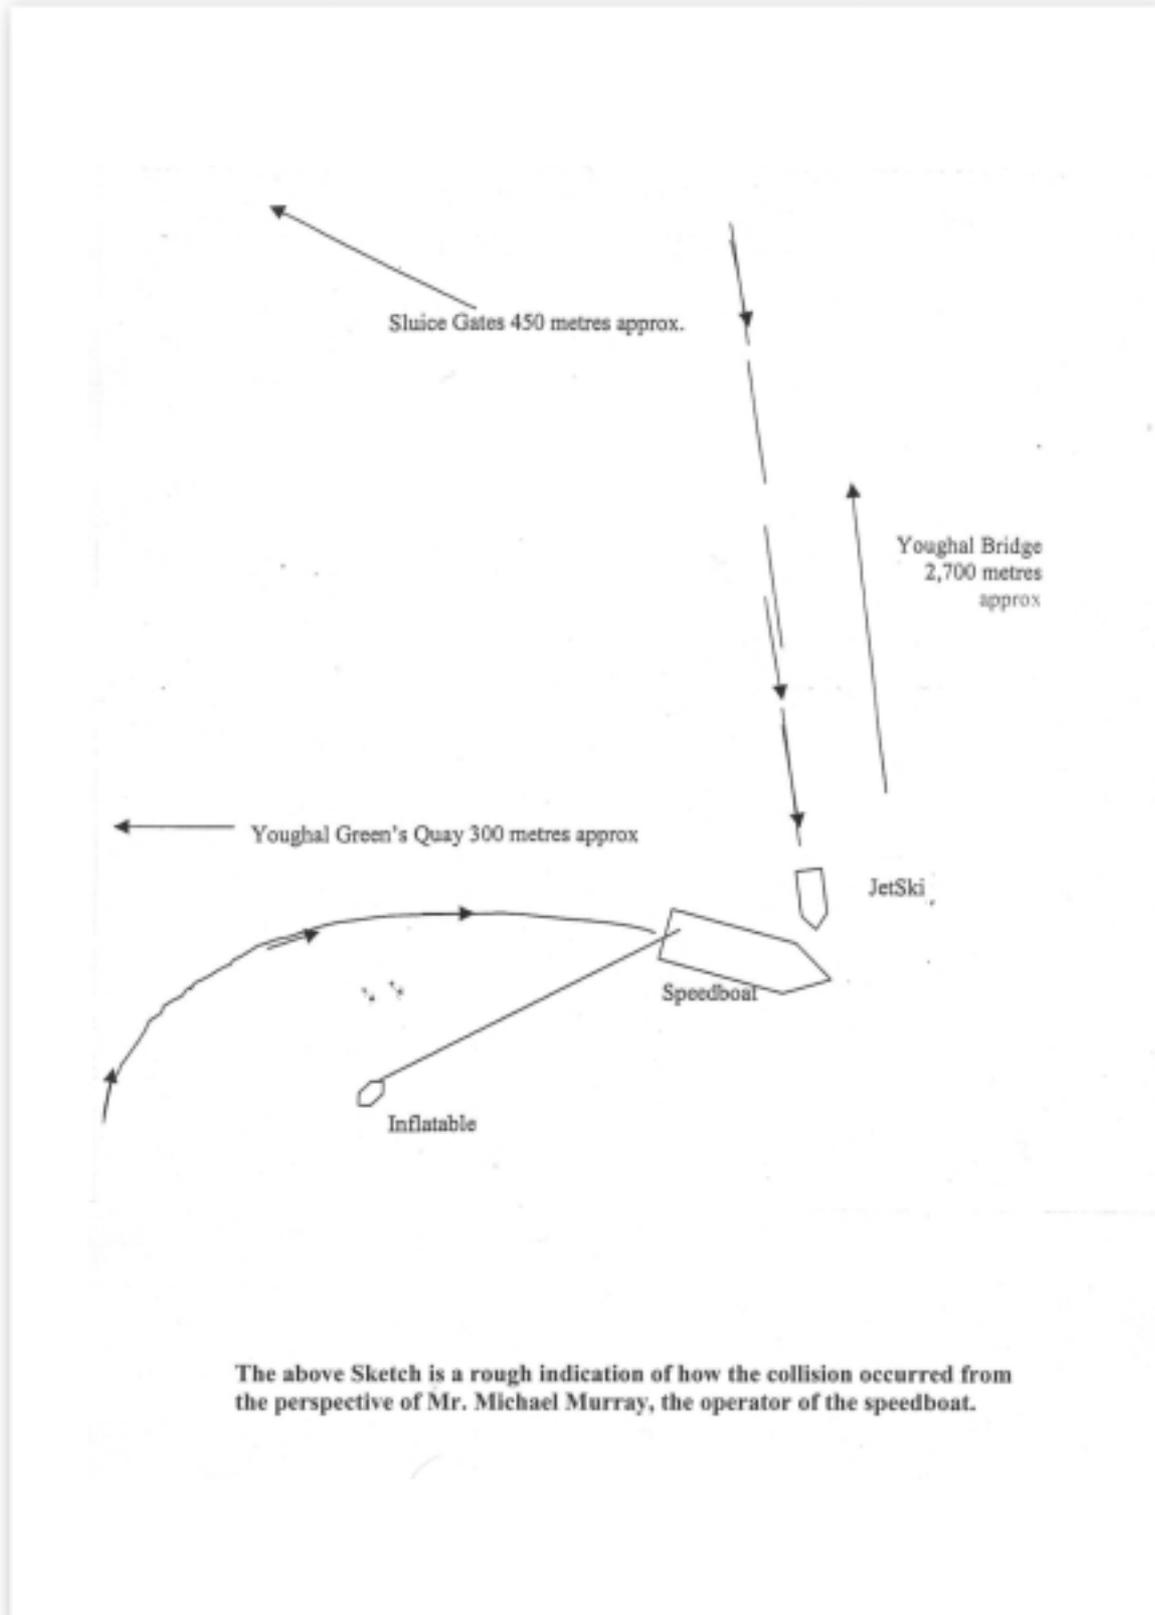
Sketch 1 - Possible Track of Vessels Prior to Impact.

- 4.2 According to Mr. Murray when the "doughnut" was launched he proceeded north up the harbour. He observed a Jet Ski about five hundred / six hundred yards away in the region of the sluice gates and about two hundred yards off Youghal shoreline. When he was adjacent to 'Youghal Carpets' he proceeded to turn to starboard to head out to sea and slowed down to about fifteen knots to make the turn. He had turned through about ninety degrees when he saw the Jet Ski coming towards him. He maintains that the Jet Ski was going flat out and thought that it would turn away at some stage but the Jet Ski didn't turn and collided with his boat. {Sketch 1 in Appendix 9.3 illustrate this version of events}.
- 4.3 The Jet Ski and speedboat collided at approximately 2025hrs. Mr. Daly, Mr. Murray and Mr. Pierce were thrown into the water.

The above Sketch is a rough indication of how the collision occurred from the perspective of Mr. Michael Murray, the operator of the speedboat.

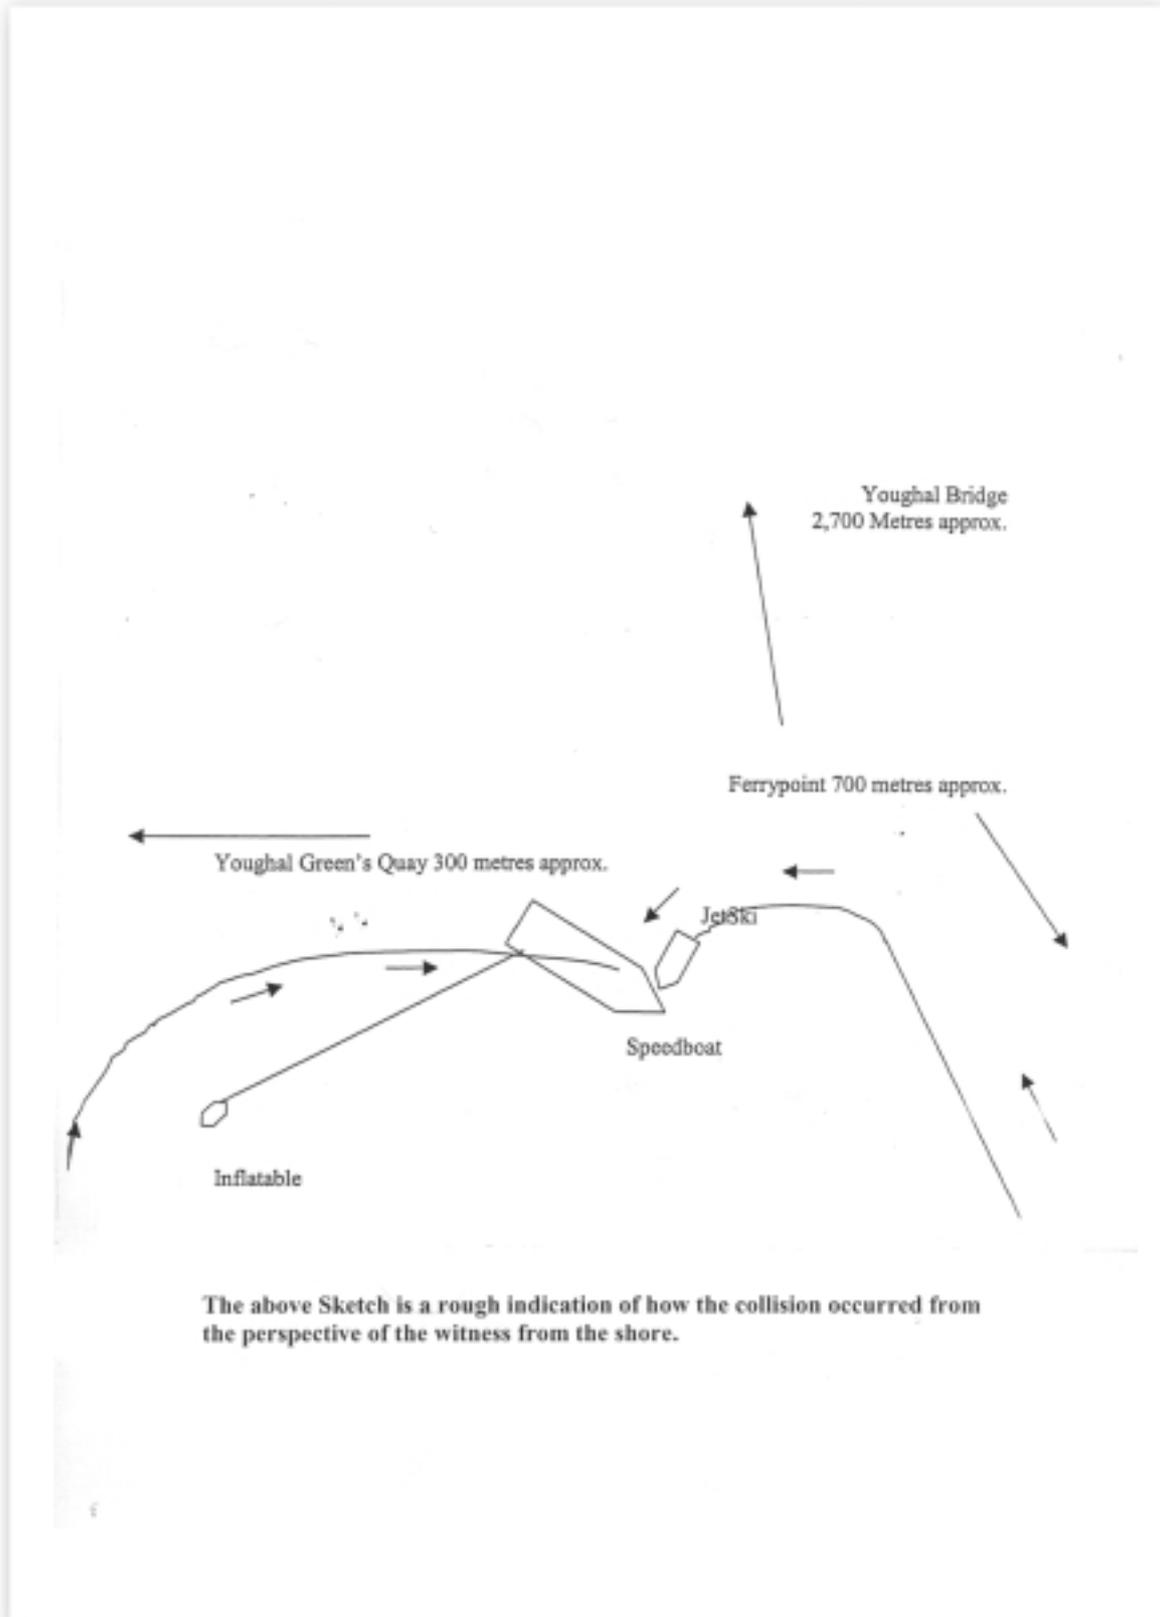
Sketch 2 - Possible Track of Vessels Prior to Impact.

4.1 A person was sitting on a bollard on the shore at Youghal watching the fishing activity on the shore. This person's attention was drawn to Mr. Murray's speedboat and the doughnut being towed behind. He heard shouts from the person on the doughnut, which he believed, were shouts of fun. He thought at first that the doughnut was a jet ski following the speedboat. He also noted a Jet Ski (Mr. Leahy's being driven by Mr. Daly) travelling in the same direction as the speedboat but further offshore. He observed this 'Jet Ski' and Mr. Murray's turn towards one another almost at the same time and observed them collide. There was a loud bang on impact. {Sketch 2 in Appendix 9.3 illustrates this version of events}.

- 7.2 It is clear from the vessel damage report (see Appendix 9.1) that the vessels were on converging courses when they collided. This clearly supports the version of events given by the witness on the shore (see Sketch 2 in Appendix 9.3). It is also considered that if the accident occurred as per Mr. Michael Murray's version of events, the damage to the vehicles would have been of a different configuration.

The above Sketch is a rough indication of how the collision occurred from the perspective of the witness from the shore.

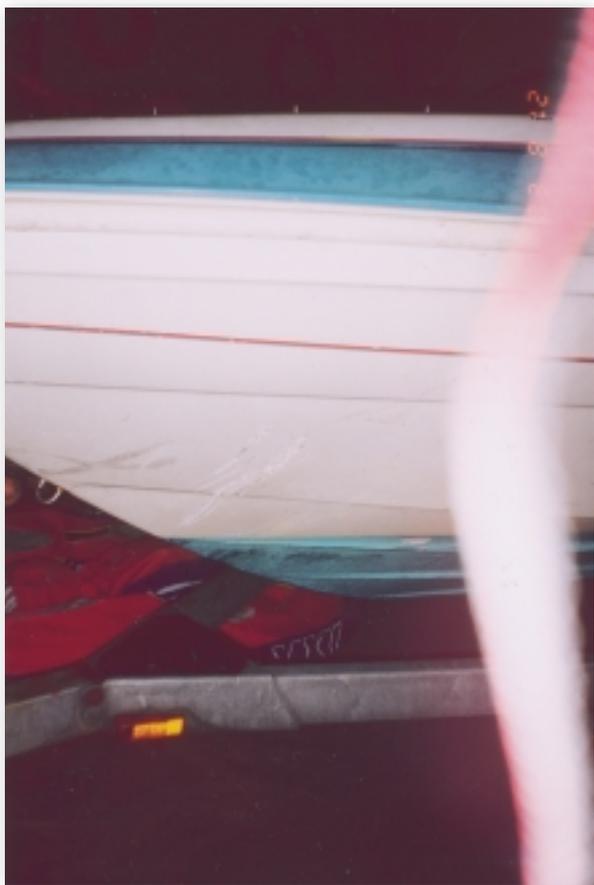
FIGURE 1
SCRATCHES TO PORT BOW
REGION

1. On the forward port side of the hull there were four deep scratches, the deepest of which would be approximately 3mm deep. These were located approximately 300mm aft of the stem at the height at which they are located. The scratches ranged in length from 130mm to 340mm and extended 120mm longitudinally. (Figure 1)
2. 500mm aft of these scratches there are some black scuff marks on the side of the hull. It is presumed that these were caused by the gunwale of the Jet Ski. (Figure 2)

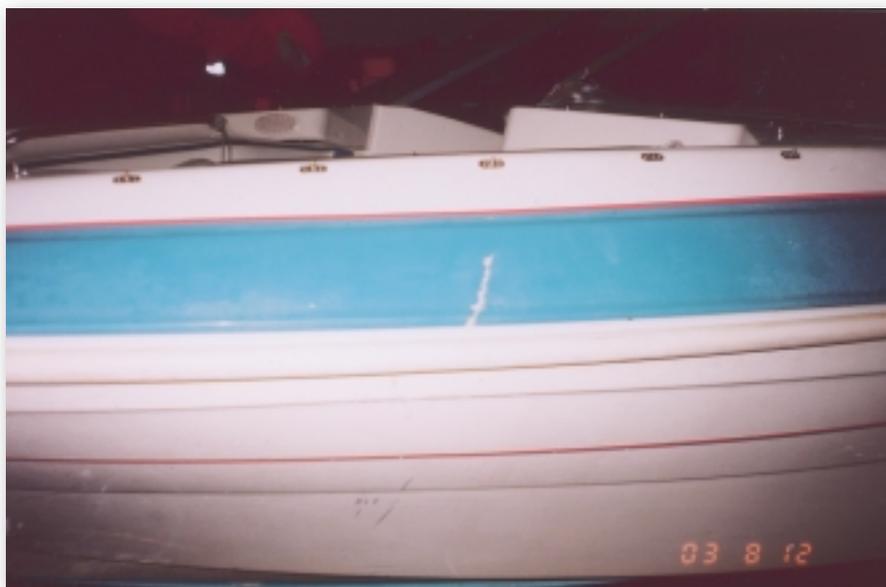
FIGURE 2
DAMAGE TO HULL & DECK
JOINT

3. Above these scuff marks there is damage to the hull to deck joint. Firstly the hull to deck joint has opened up over a length of approximately 800mm. In the region above the scuff marks there are two vertical cracks radiating out from the deck joint. On the deck side the crack is 80mm long and on the hull side it is 55mm long. At the lower end of the hull crack is a horizontal crack of approximately 100mm. (Figure 2)

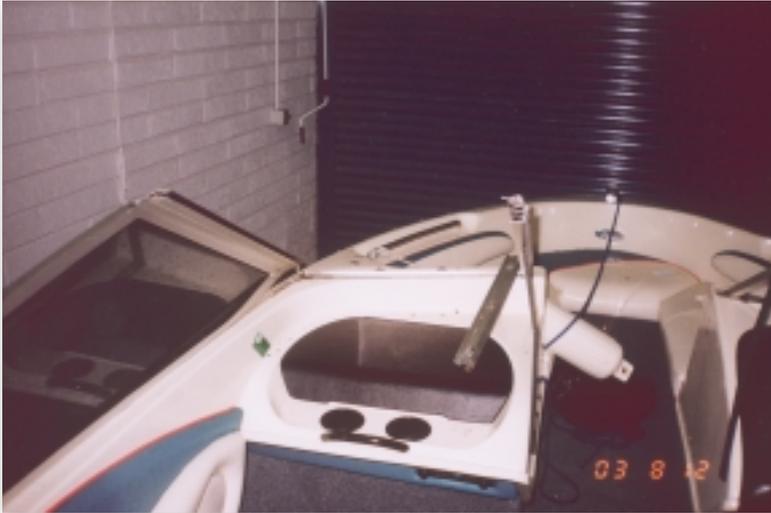
FIGURE 3
DAMAGE TO WINDSHIELD

5. The port side windshield sustained damage. This consisted of an aluminium frame structure with perspex or polycarbonate windows. The windshield consisted of three sections, port, starboard and a centre section that folded over to the port side to facilitate access to the vessels forward section. It would appear that the centre section was folded over to allow access to the forward section. The damage sustained to the windshield included the loss of both port and centre forward facing windshields, the loss of the top bar of the frame for both windows, loss of the unhinges side frame on the centre window and damage to the bottom frame on the centre window. Additionally there was damage sustained to the side windshield on the port side, with the bottom framework forward pulled out from the deck and bent outboard. (Figure 3)

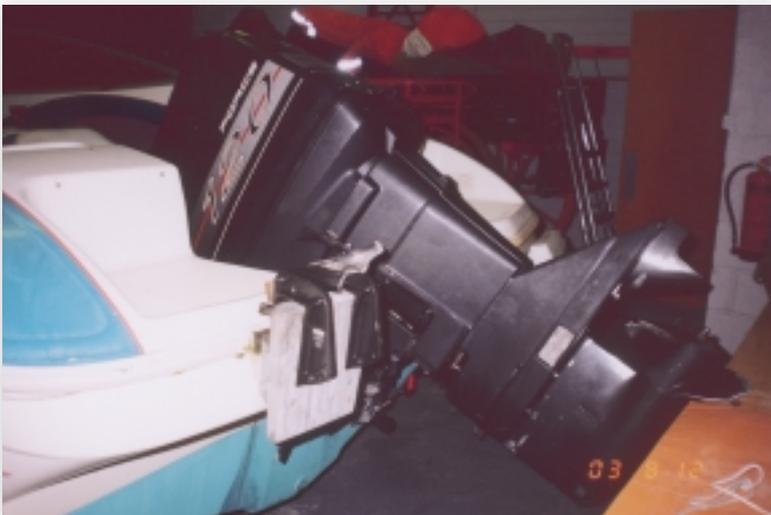
FIGURE 4
DAMAGE TO AUXILIARY &
MAINENGINE

6. It is apparent that the vessel carried an auxiliary outboard engine for emergency use. A bracket for this engine was located on the port side of the transom. However during the inspection the engine was missing and the bracket had been sheared. (Figure 4)

7. The propeller on the main engine was also damaged. This was a three blade propeller, diameter approximately 330mm. Two blades sustained damaged to their tips. The damage would appear to have been caused by striking some object. The intact blade length was 120mm, on the damaged blades the lengths were reduced to 100mm and 95mm. (Figure 4)

There was no apparent cause for the damage to the propeller of the main engine.

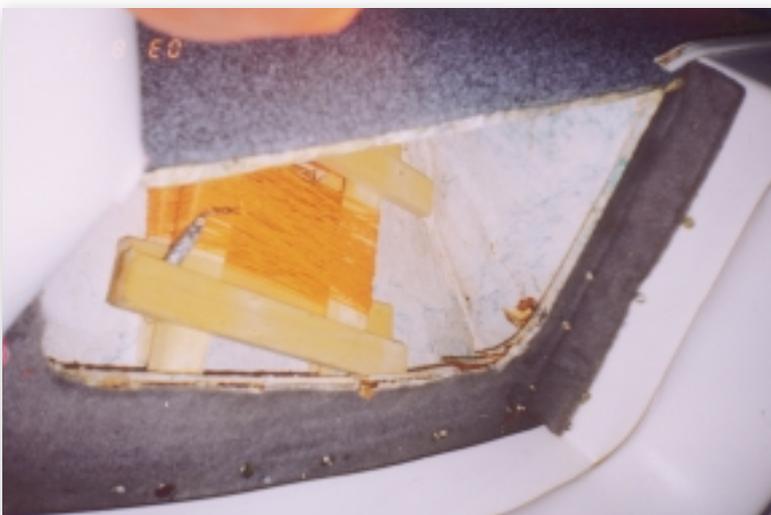
FIGURE 5
PLYWOOD DELAMINATION

8. I also observed some delamination to the plywood shelf on the forward port side, which forms the base for the forward V shaped seats. There was also a crack on the plywood bulkhead at the aft end of this structure. As this delamination on the plywood shelf is also evident on the starboard side

I would consider this to have existed prior to the collision. However the crack on the bulkhead may have been caused by the collision. (Figure 5)

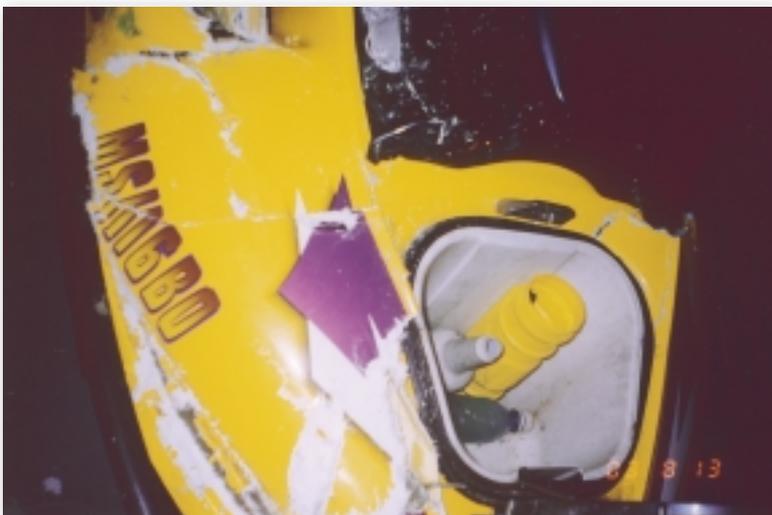
FIGURE 7
DAMAGE TO TOPSIDE
COWLING

- A. About 500mm aft of the bow the topside cowling of the Jet Ski is cracked from the starboard hull to topside joint across to the port side joint. (Figure 7)
- B. The cowling on the forward starboard side was extensively cracked. Additionally there was a crack on the hull chine extending aft for a length of approximately 1300mm, starting 200mm aft of the bow. (Figure 7 & 8)

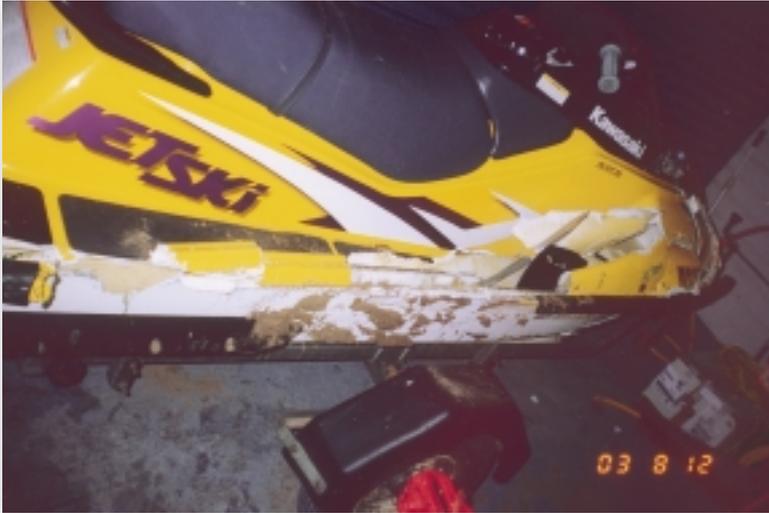
FIGURE 9
DAMAGE TO STARBOARD
SIDE TOPSIDE TO HULL
JOINT

- D. The throttle lever, which was located on the starboard side handlebars, was damaged.
- E. On the starboard side, the hull to topside joint was extensively damaged along the full length of the craft. There were traces of the powerboats turquoise antifouling along this region. Additionally the rubbing strake was damaged on the Jet Ski. (Figure 9)
- F. There was very little damage to the port side of the Jet Ski. Apart from the crack detailed in Item 1, there was one crack radiating aft and one small crack radiating into the hull. (Figure 10)

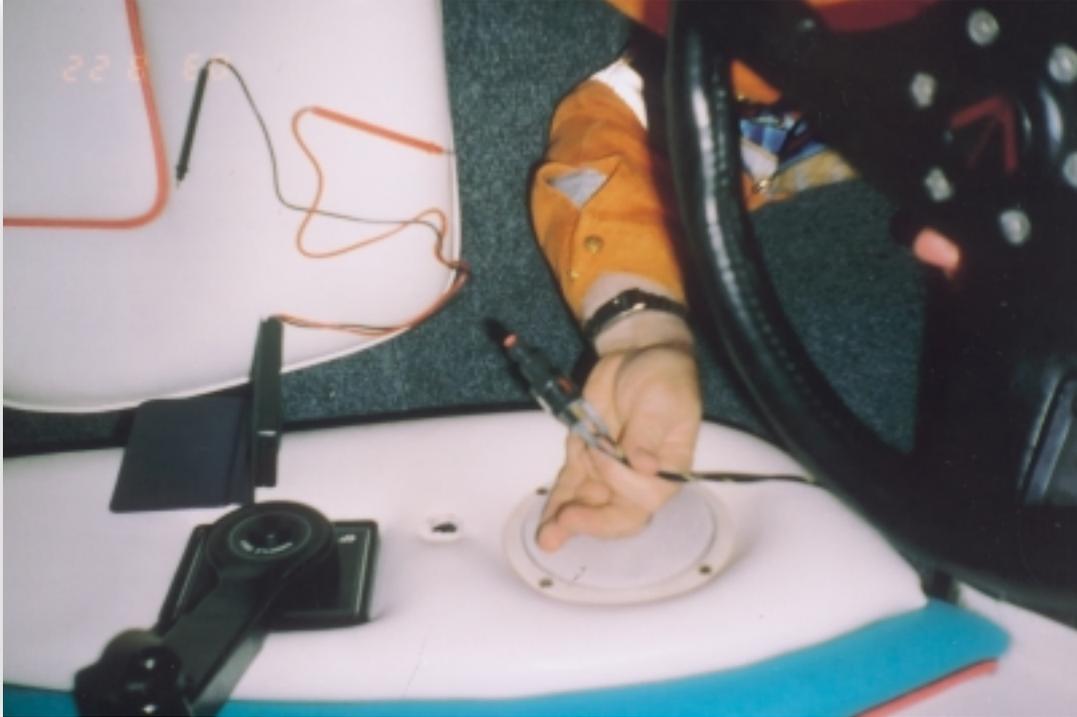
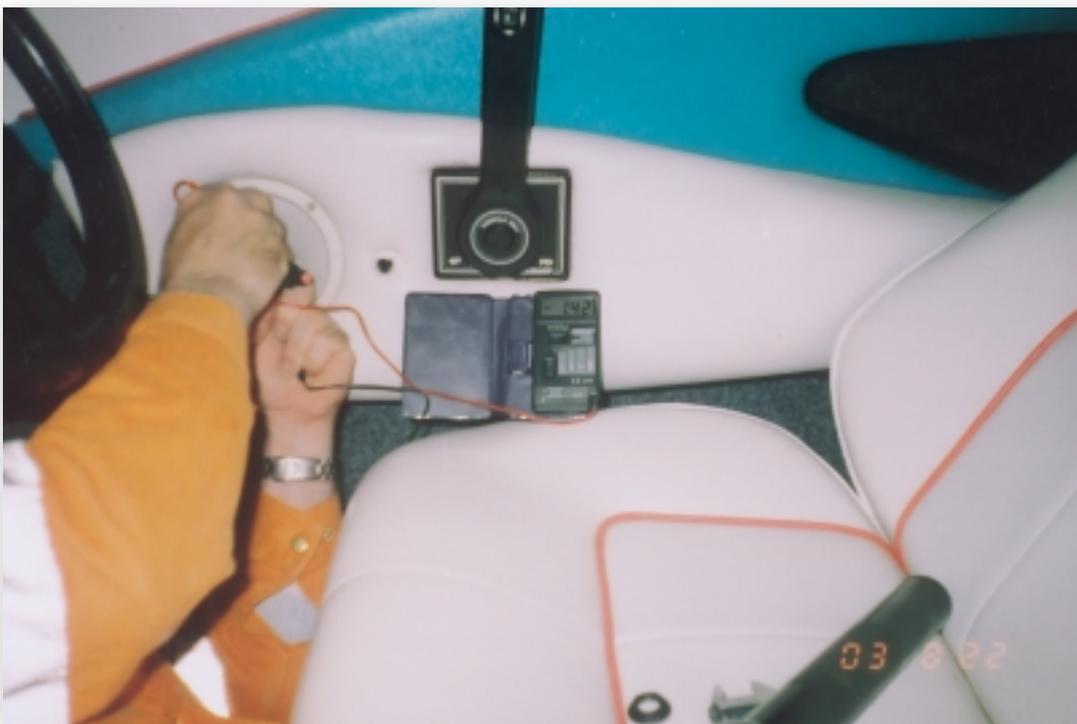
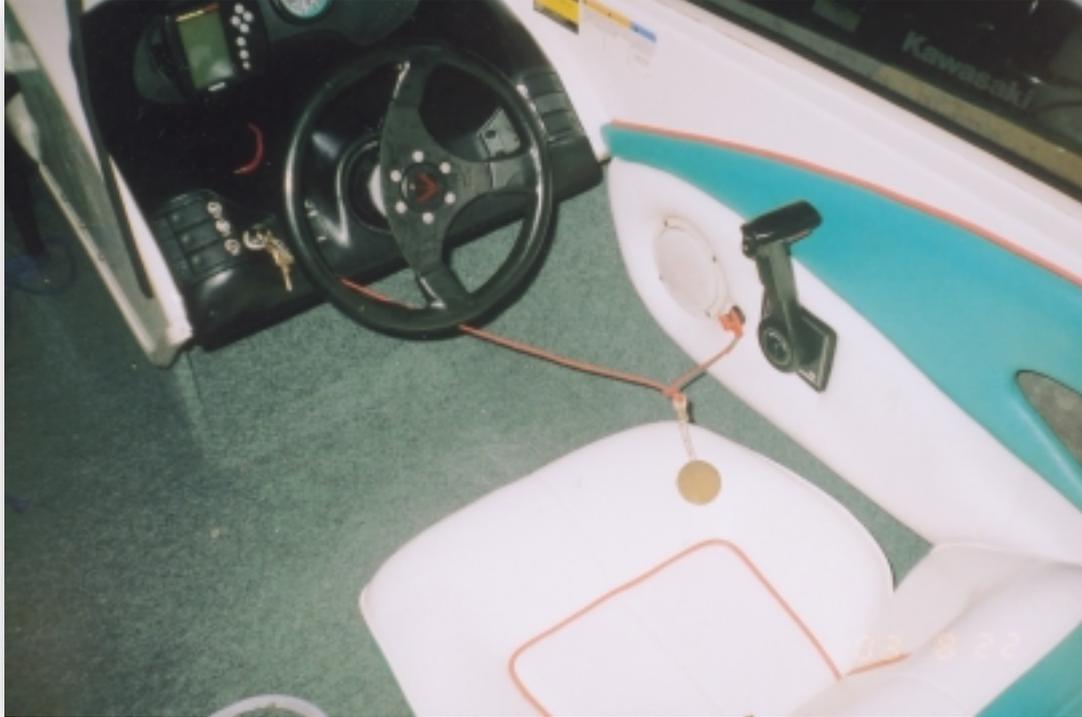
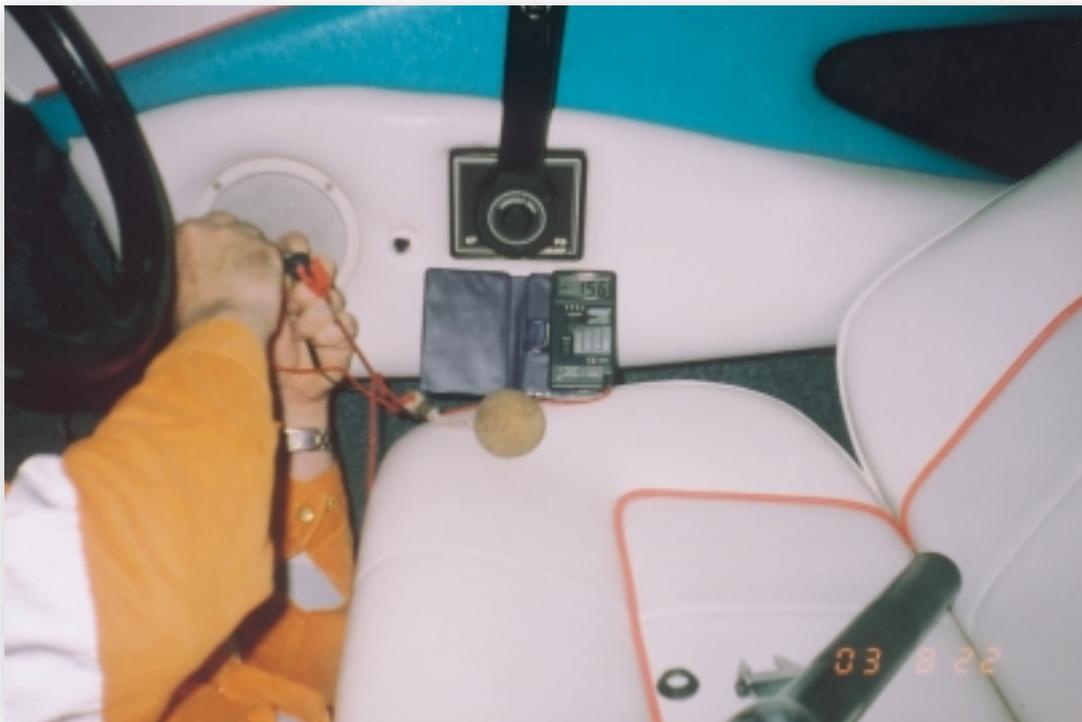
Emergency Stop Switch

- 6.5 The Emergency Stop switch in the speedboat is located outboard of the steering position in way of the radio speaker (see photos at Appendix 9.4). To operate in an emergency the Emergency Stop Cord with connecting switch should be attached to the operator of the boat. If the operator of the boat leaves or is forced from his position then the switch pulls from the Emergency Stop position and the engine cuts out. When the boat was inspected at Youghal during the investigation it was noted that the lanyard with the connection to the emergency stop position was attached to the ignition mechanism.

- 6.6 On inspection the Emergency Stop Mechanism in the speedboat was found to be faulty. However, Mr. Michael Murray stated that although he never specifically tested the Emergency Stop he noted that the engine would not start if the switch on the cord was not inserted into the Emergency Stop.

- 6.7 Mr. Michael Murray was standing up in the boat while steering. The Emergency Stop lanyard was not attached to his person.
- 6.8 Youghal Urban District Council was in the process of introducing Bye Laws, which will include provisions regulating the use of Jet Skis within its functional area. These Bye Laws were not in place at the time of the accident.

- 8.5 All owners and operators of leisure craft are recommended to follow maker's instructions and guidance, especially regarding safety features on board their leisure craft.
