**REPORT OF THE
INVESTIGATION INTO
THE COLLISION BETWEEN
THE FRENCH FISHING
VESSEL "ROHELLAN"
AND THE IRISH FISHING
VESSEL "OILEANN CLEIRE"
ON SATURDAY 15 MAY 1999.**

The Marine Casualty Investigation Board was established on the 5th, June 2002 under The Merchant Shipping (Investigation of Marine Casualties) Act 2000

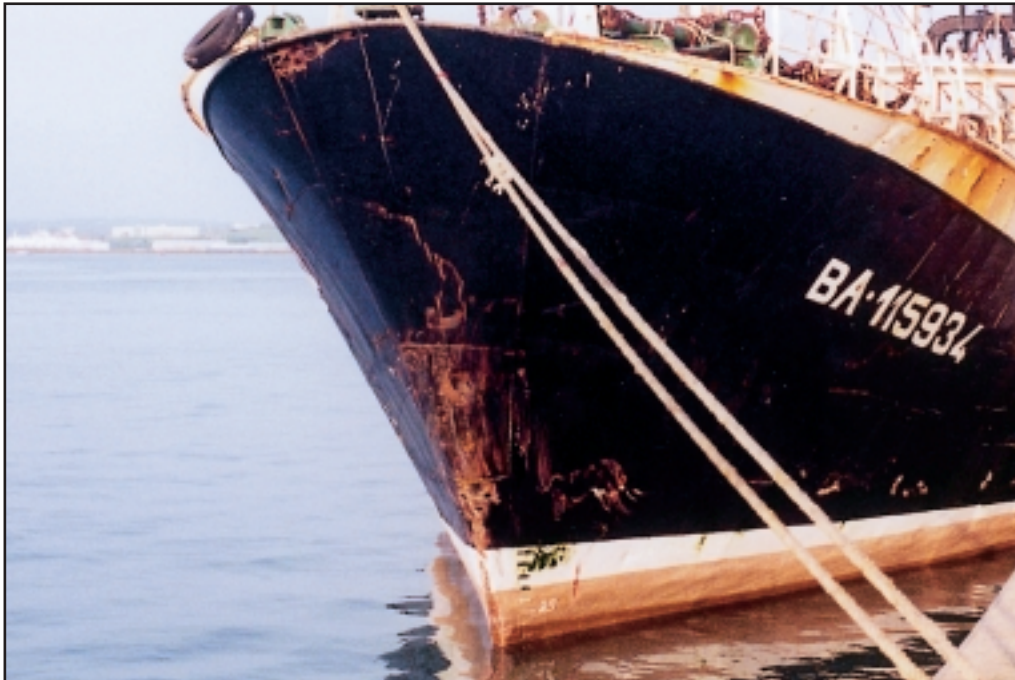
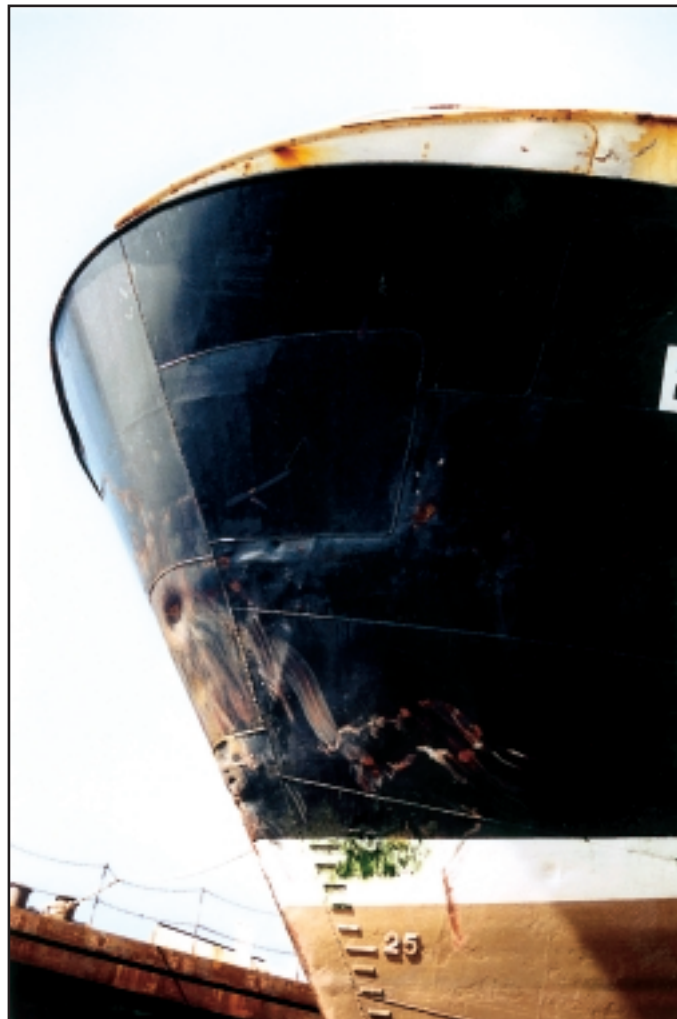
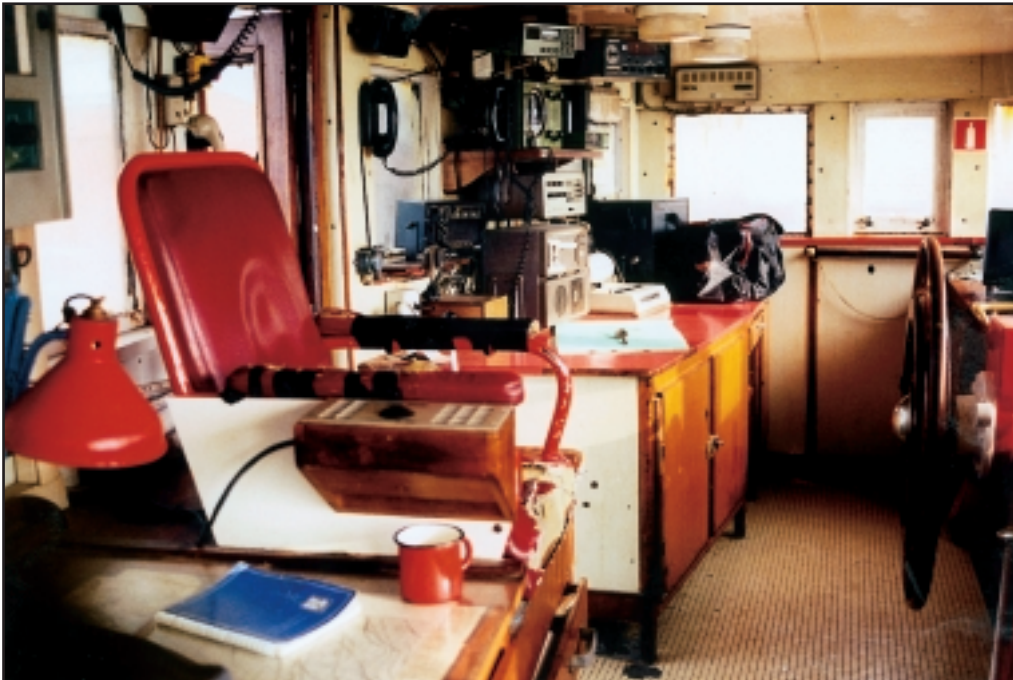
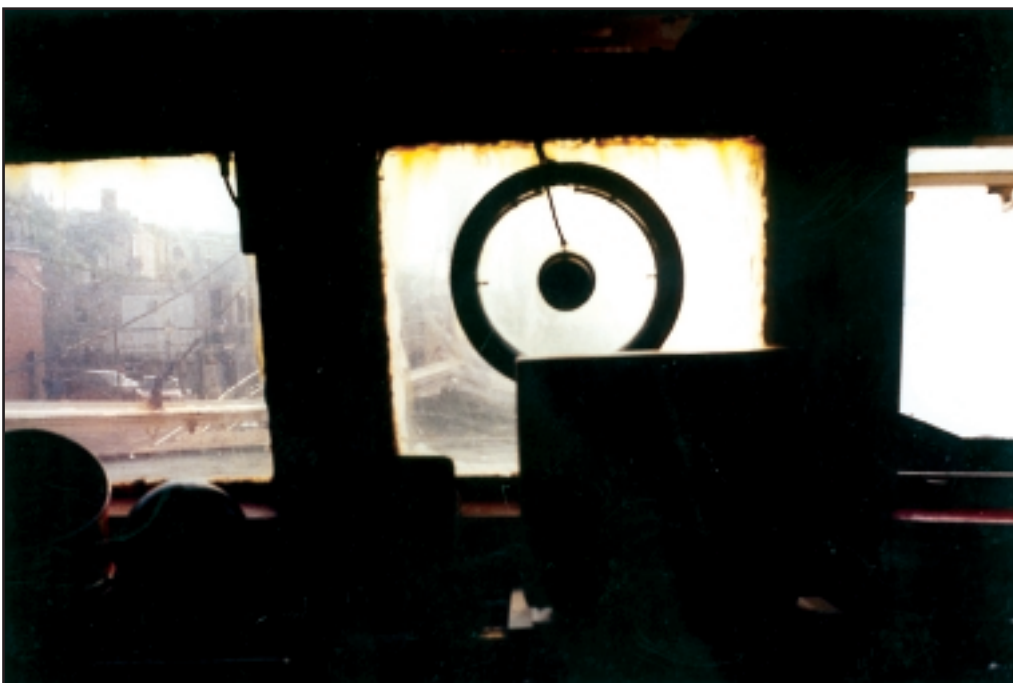
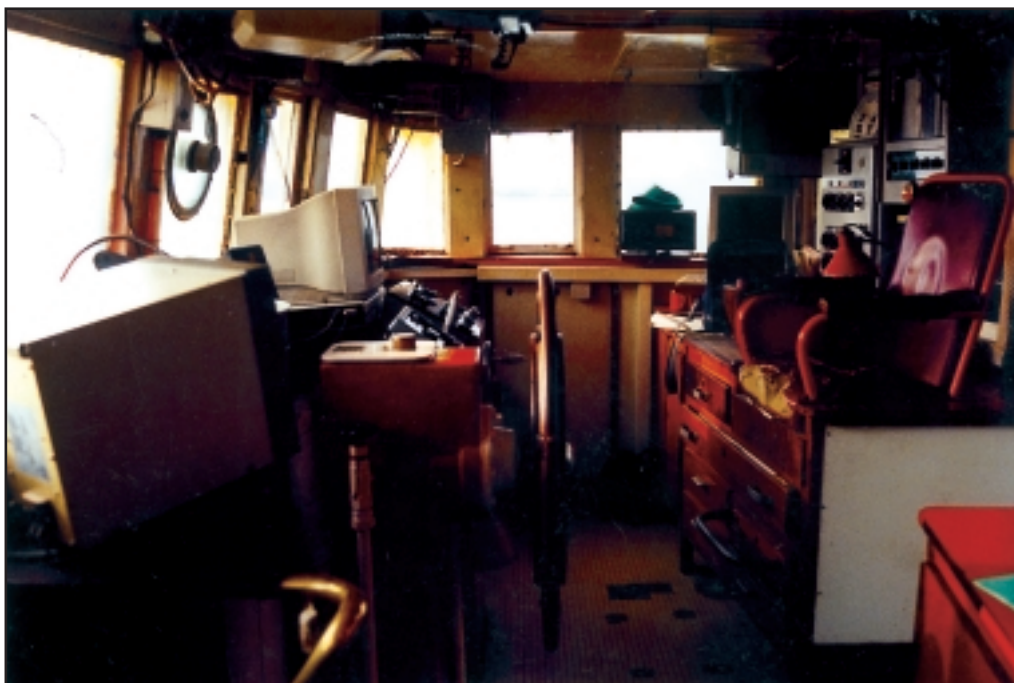
- 2.3.2 There was a pilot chair fitted close to the aft door. The wheelhouse window that was in front of the pilot chair had stain marks. A computer repeater screen sited in front of the line of vision further obstructed the line of visibility from the pilot chair. There is a mechanical clear view screen fitted to the window in line with the pilot chair.

- 4.1 The incident occurred at position 52.40.N and 011.46.W on Saturday, 15th May 1999 (See Appendices 8.2 and 8.3).
- 4.2 The bow of "Rohellan" struck the port stern of "Oileann Cleire" at full speed of 11 knots.

8.5 Photos of "Rohellan" showing damage on bow and views from wheelhouse.
