**REPORT INTO THE SINKING
OF THE IRISH FISHING VESSEL
"ST GERVASE" CLOSE TO
MIZEN HEAD, CO. CORK
ON 23 NOVEMBER 2000.**

The Marine Casualty Investigation Board was established on the 5th, June 2002 under The Merchant Shipping (Investigation of Marine Casualties) Act 2000

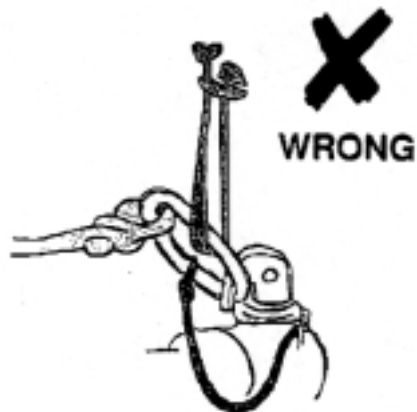
EXAMPLES OF INCORRECT METHODS OF CONNECTION

LIFERAFT WILL NOT RELEASE FROM CRADLE IF THE SHIP SINKS

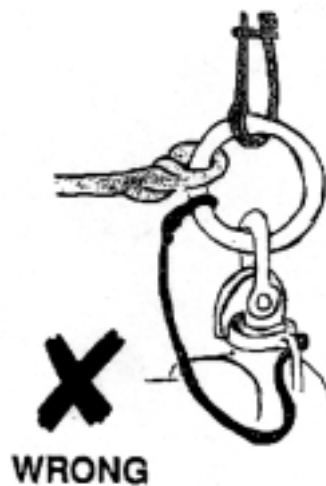
LIFERAFT WILL NOT RELEASE FROM CRADLE IF THE SHIP SINKS

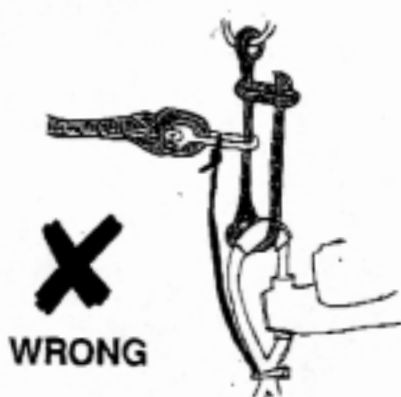
EXAMPLES OF INCORRECT METHODS OF CONNECTION

LIFERAFT WILL NOT RELEASE FROM CRADLE IF SHIP SINKS

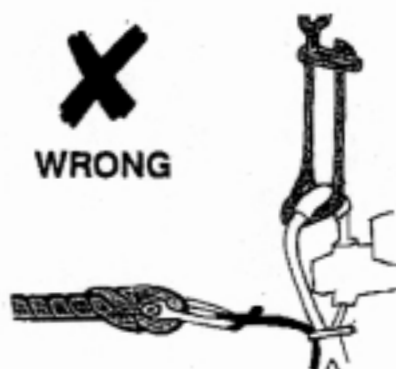
WILL WORK CORRECTLY ON AUTOMATIC RELEASE BUT THE LIFERAFT WILL ONLY BE SECURED BY THE WEAK LINK IF THROWN OVERBOARD - WEAK LINK MAY BREAK AND LIFERAFT WILL BE LOST
