**REPORT OF THE INVESTIGATION
INTO
AN INCIDENT INVOLVING
A RIB ON LOUGH REE,
ATHLONE,
CO. WESTMEATH
ON
14th JULY 2012**

**REPORT NO. MCIB/219
(No.5 OF 2014)**

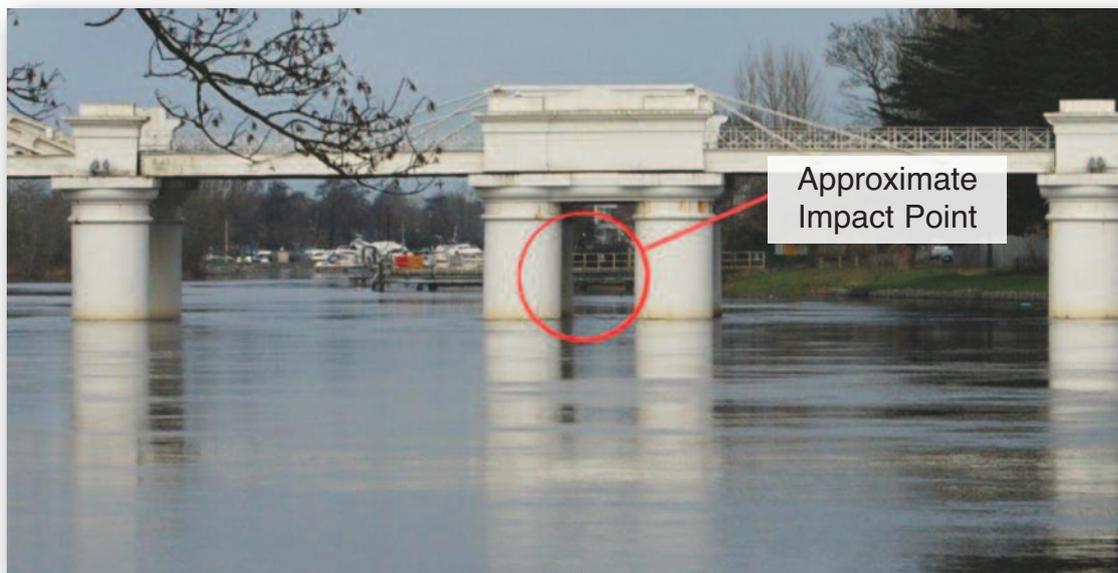
Appendix 7.3 Photograph of the Athlone Railway Bridge.

- 3.6 A very short time after their departure, the RIB struck one of the centre support pillars of the Athlone Railway Bridge. (See Appendix 7.3 Photograph of Athlone Railway Bridge).

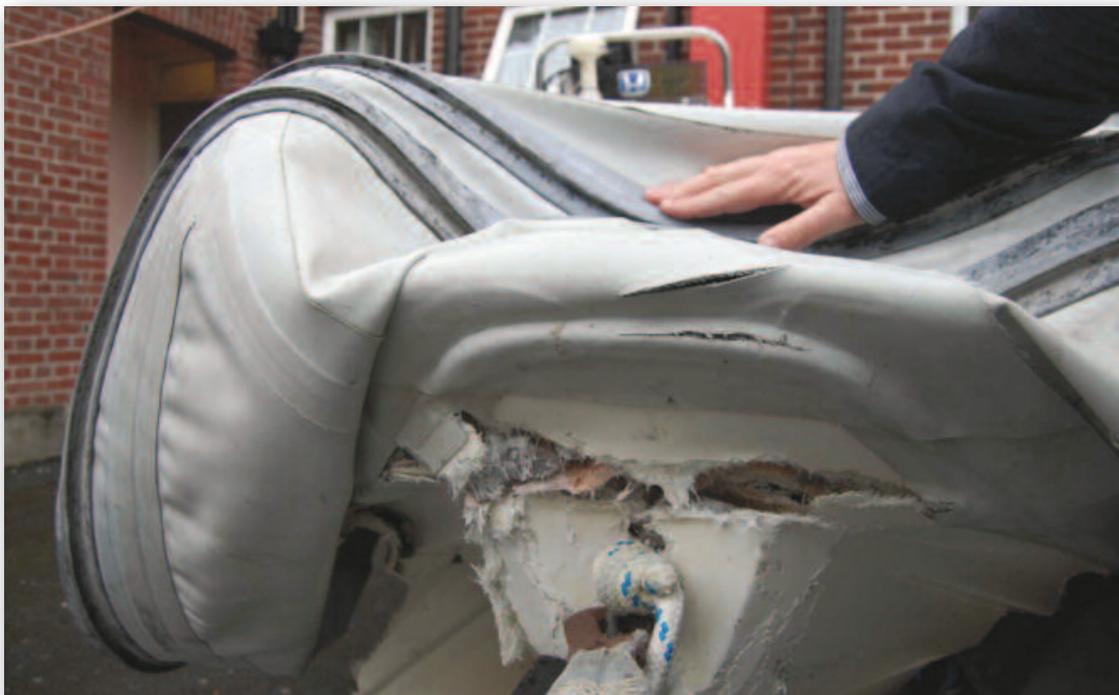
- 4.1 The RIB's sponson is a three-chamber arrangement and upon inspection the forward and port side chambers were deflated. Further investigation found the forward chamber was torn in at least 2 places. These were both on the underside of the tube at the bow. These tears were approximately 80 mm in length, which would have instantly deflated the forward chamber. (See Appendix 7.4 Photograph No. 1).

Photograph No. 1: Shows two of the tears that caused the forward chamber to deflate

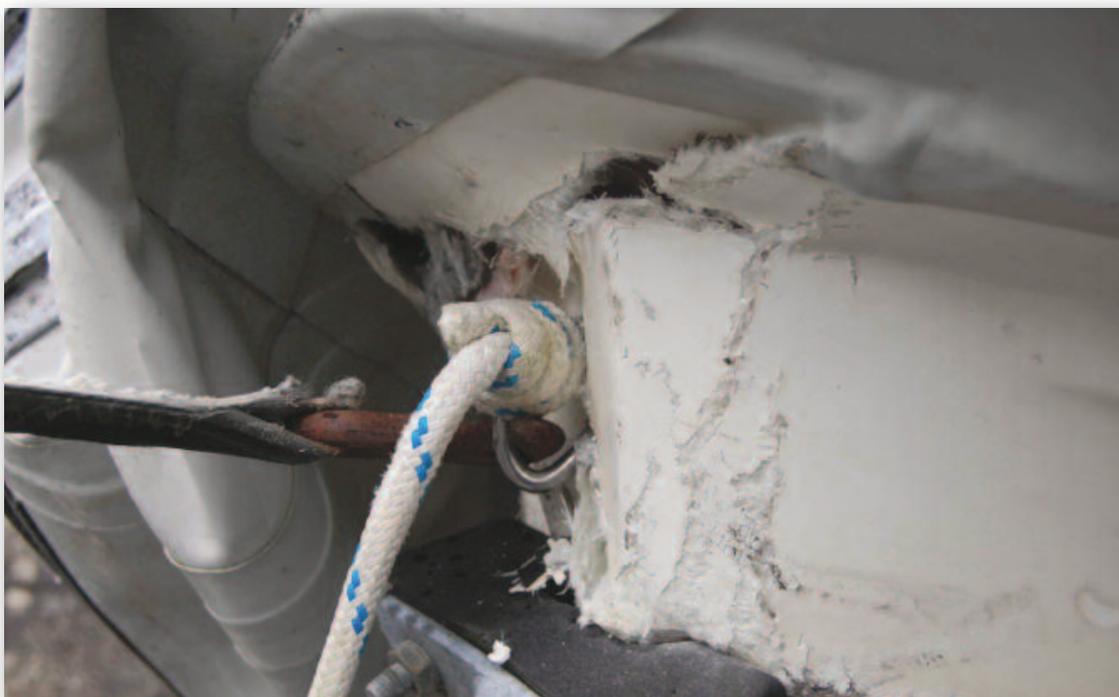
- 4.3 The hull failed in two positions. The first was on the bow stem just below the hull flange, where the sponson meets the GRP hull. The second was about 300 mm aft of the stem, where the chain locker starts. The forward damage was a result of the collision energy being transferred into the GRP hull in this area, causing total failure of the laminate. The painter ring (stainless steel U bolt on the bow of the boat) had been driven back and the glass surrounding had been crushed. About 100 mm aft of the bow tip, the hull laminate was split on both the port and starboard sides, running from stem to the top of the GRP hull. (See Appendix 7.4 Photograph No. 2).

Photograph No. 2: Shows the smashed glass on the stem N.B. the rope is attached to the painter ring

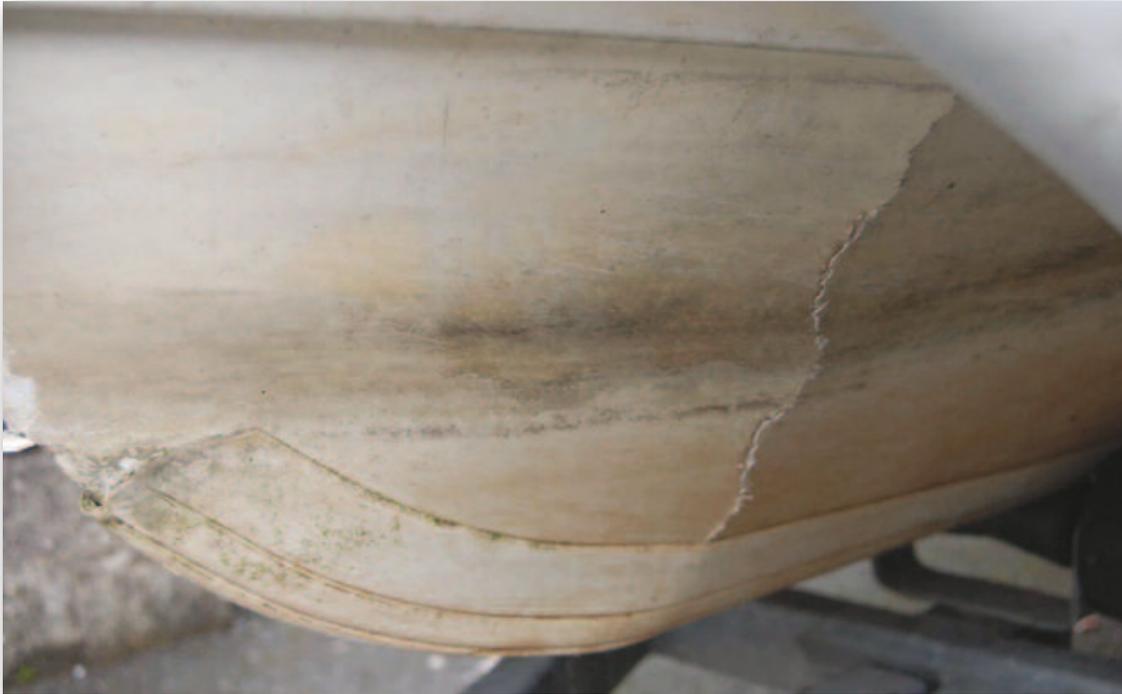
- 4.4 The second damaged area was about 300 mm aft, in this area the hull was split transversely from the keel to the sponson flange. This was caused by the collision energy travelling along the hull laminate until it met the transverse bulkhead that forms the forward part of the chain locker. At this point the bulkhead acted as a stress raiser, spreading the collision energy out board along the bulkhead causing the hull laminate to split on the port side and fold on the starboard side. (See Appendix 7.4 Photographs No. 3 and No. 4).

Photograph No. 3: Split in the hull laminate on the port side

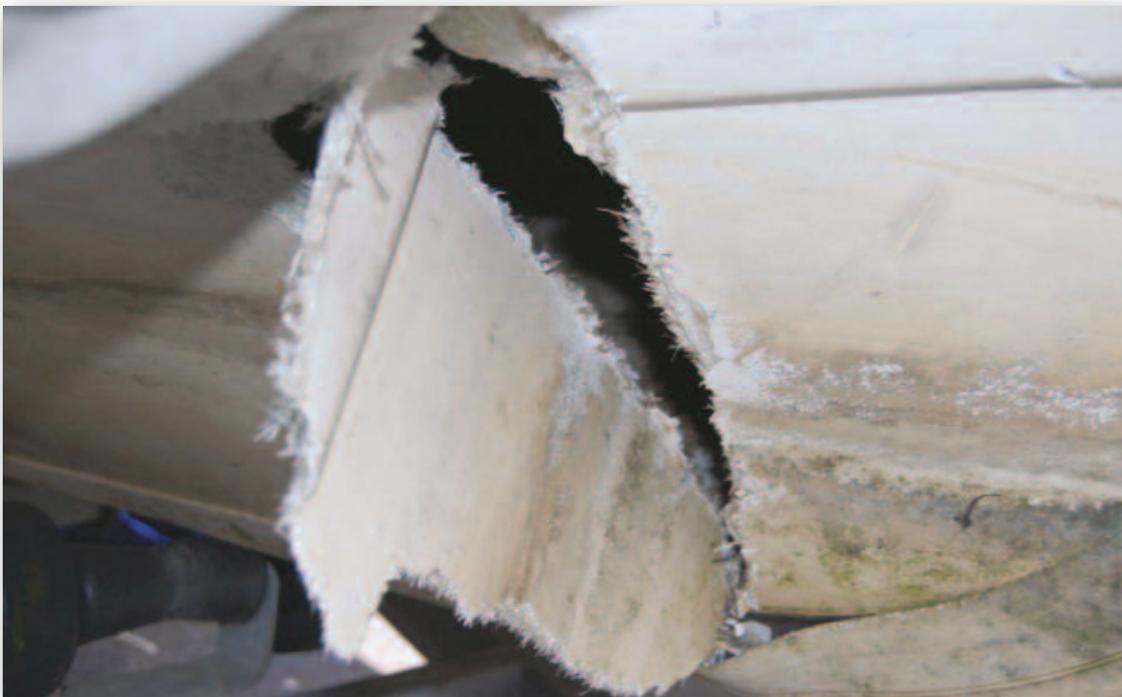
Photograph No. 4: Fold in the hull laminate on the starboard side

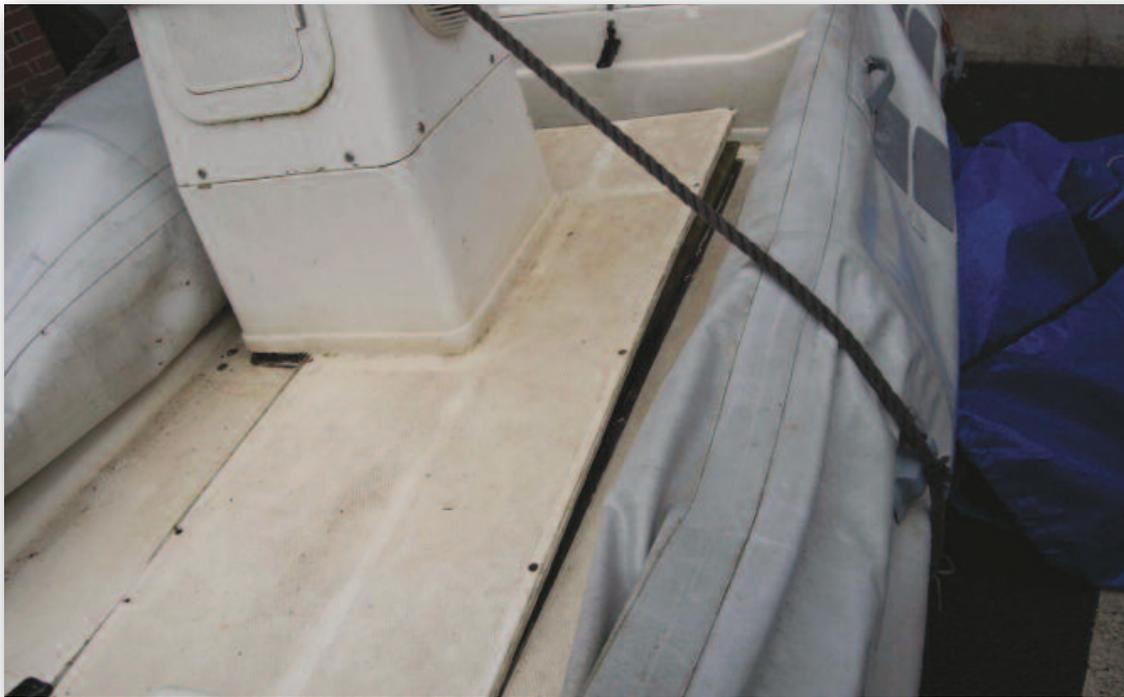
- 4.5 The centre console was fixed to a GRP deck plate that doubles up as a cover for the inboard fuel tank. This cover board was fixed to the rest of the deck by means of stainless steel screws. The aft side of the cover board had lifted and the stainless steel screws were pulled from the deck beams. This damage was most likely due to the force exerted on the console by the momentum of the helmsman. (See Appendix 7.4 Photograph No. 5).

Photograph No. 5: Console and the deck lifted to reveal the inboard fuel tank beneath
