**REPORT OF THE INVESTIGATION
INTO AN EXPLOSION AND FIRE
ON BOARD THE BOAT
'PEGASUS'
OFF ORANMORE STRAND,
CO GALWAY,
ON
9th APRIL 2016**

**REPORT NO. MCIB/256
(No.7 OF 2016)**

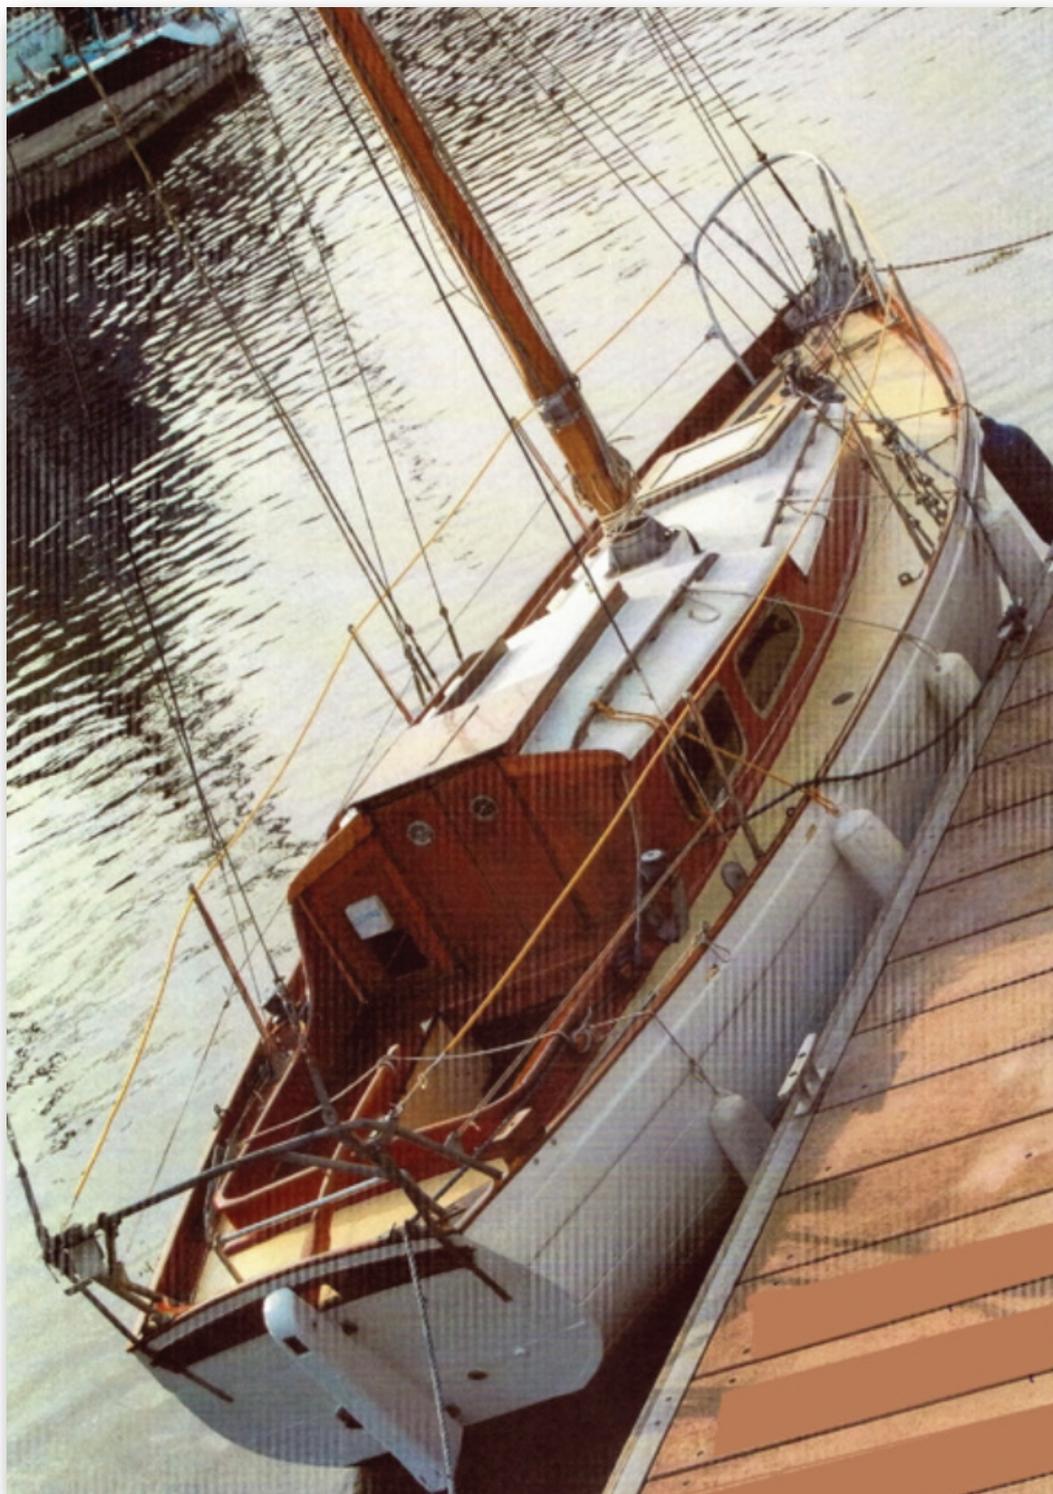
Photograph No.1 - 'Pegasus' before the explosion.

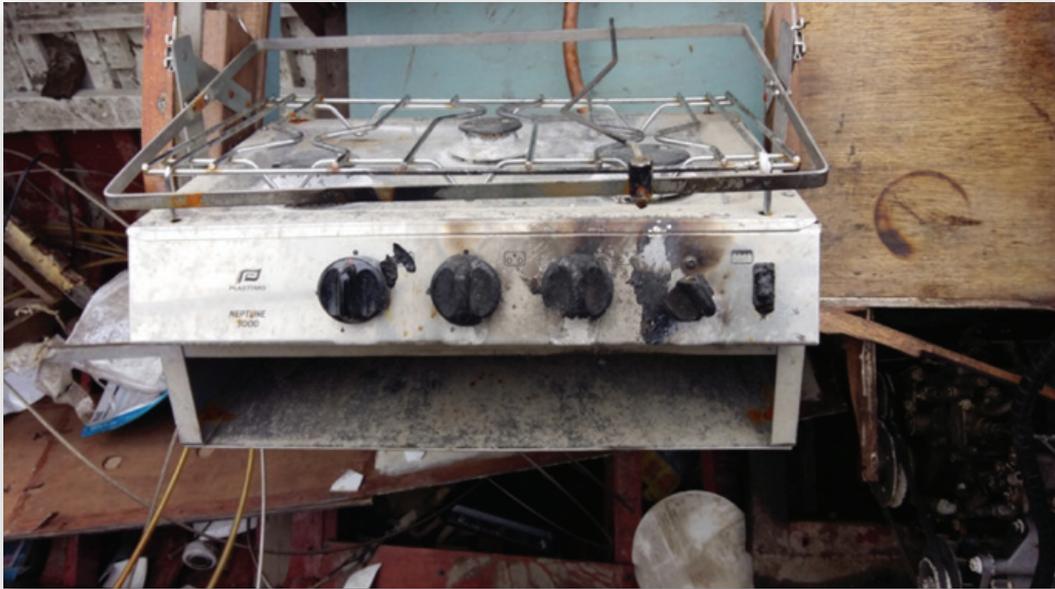
2.5 The vessel was bought by the current owner in 1992 and initially restored professionally in Askeaton, Co. Limerick. A new three burner gas cooker complete with grill was purchased and installed by the owner shortly before the incident (see Appendix 7.1 Photograph No. 2). The installation had been tested but not used.

Photograph No.2 - Cooker as installed in galley.

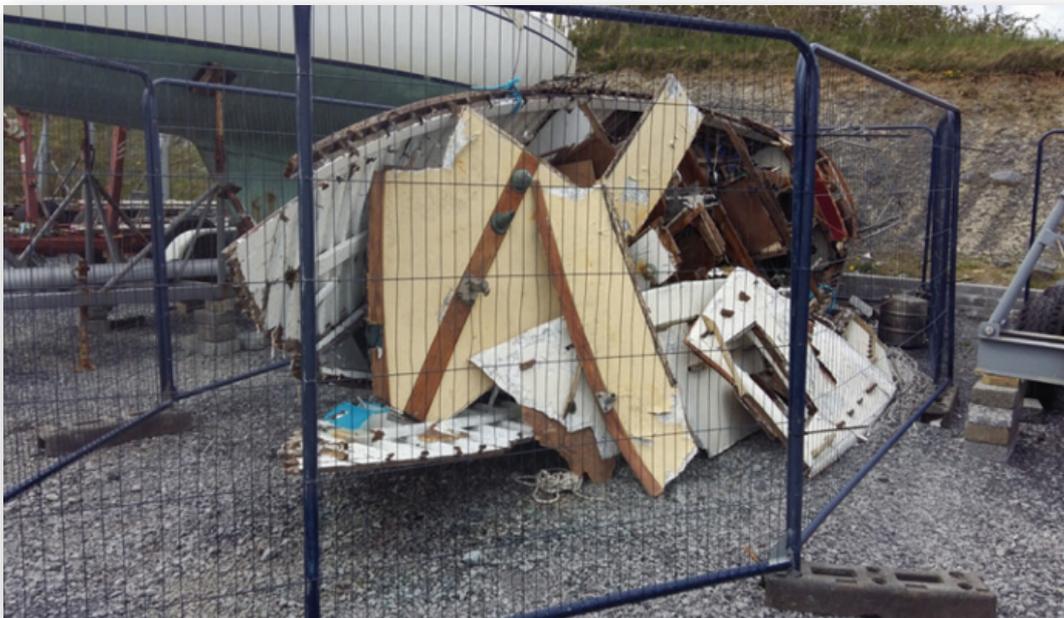
- 3.8 The deck had been blown off the boat, the bulkheads in the cabin had been dislodged and the bow split open by the force of the explosion.

Photograph No.3 --- following salvage.

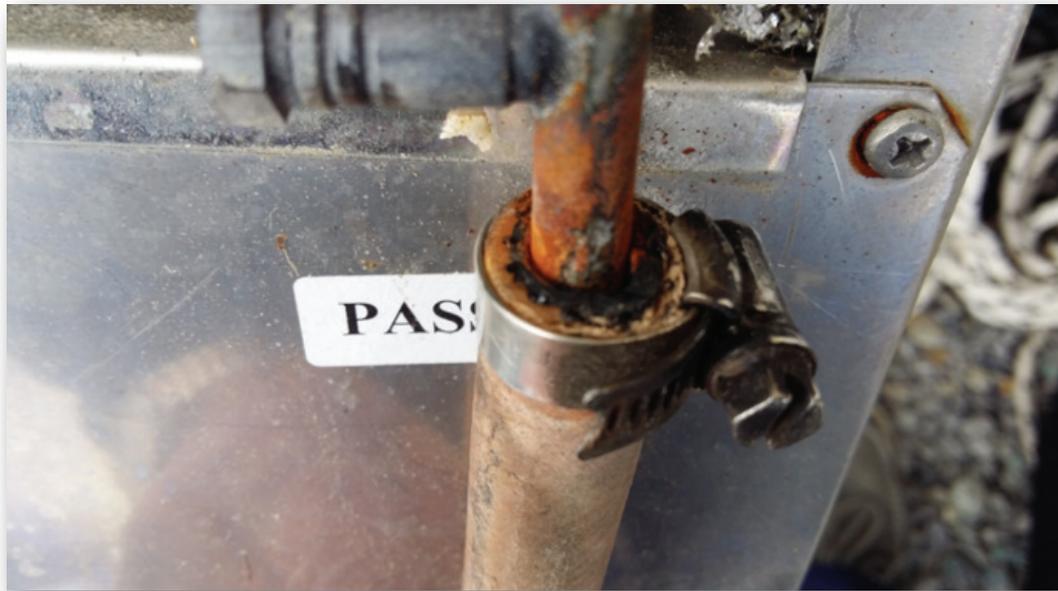
- 4.1 The gas cylinder in use at the time of the incident was a Campingaz type cylinder with a screw on regulator mounted on top. The regulator was equipped with an isolating valve. The cylinder and regulator could not be found following the incident. The owner had installed the new cooker in gimbals on the starboard side of the cabin in the galley area. The flexible hose was routed from the cockpit into the cabin and emerged outboard from the cooker. The hose was then fitted to the copper hose tail on the cooker and secured with a hose clamp (see Appendix 7.1 Photograph No. 4). No secondary isolating valve was fitted nor was a gas alarm.

Photograph No.4 - Gas hose refitted to cooker hose tail.

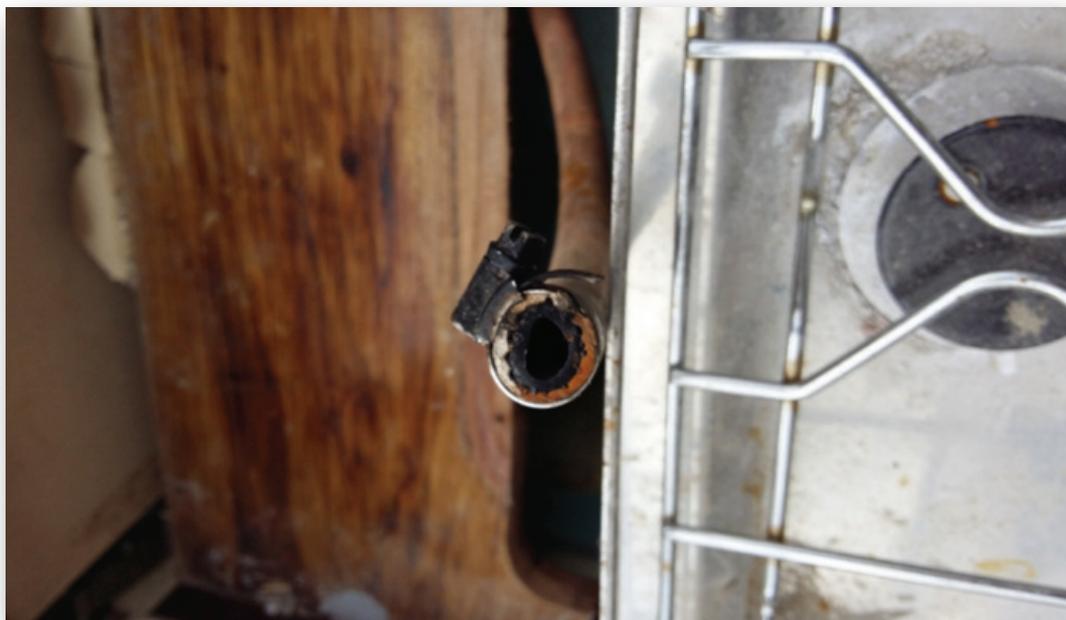
- 4.2 The flexible hose used for the gas installation was of an approved type however, the internal diameter was too large for the outside diameter of the cooker hose tail. The result of this was that, despite being clamped in place by the hose clamp, the hose was likely to have been loose and its shape distorted. The initial inspection of the gas installation following recovery of the vessel showed that the hose had become disconnected from the cooker hose tail. The end of the hose and the hose clamp were found to be distorted and also blackened and scorched (see Appendix 7.1 Photograph No. 5).

- 4.3 It was noted that there was a ball of blue flame. The nature of this would suggest that it is most likely caused by the ignition of gas which had collected in the bilges of the vessel as a result of the hose becoming loose at the connection to the cooker. As the valve was open at the cylinder this would have released gas for the period of the ten minutes that it was open.

- 5.1 As the explosion caused severe and extensive damage to the vessel, it is not possible to be certain of the layout of the gas cylinder, regulator and hose prior to the explosion, however; as the gas hose was detached from the cooker hose tail and blackened and scorched on inspection, it is most likely that it had become loose or partially detached before the incident took place. Thus, when the gas valve was turned on in the cockpit, it is most likely that gas was flowing freely into the grill area of the cooker and, as this gas is denser than air, overflowing onto the floor and then into the bilges. When the owner struck the match, the gas on the floor and in the bilge exploded and the gas flowing from the hose ignited forming a blue ball of flame.

Photograph No.5 - Gas hose cooker end as found, charred and distorted.

- 6.1 It is recommended that the Minister for Transport, Tourism and Sport draws attention to Marine Notice No 1 of 2002 - Use of liquefied petroleum gas (LPG) installations and systems on merchant vessels, fishing vessels, pleasure craft and other marine craft.
- 6.2 It is recommended that the Minister for Transport, Tourism and Sport should provide updated guidance on the fitting and usage of LPG installations in the Code of Practice for the Safe Operation of Recreational Craft. This is included as Action No. 16 in the Maritime Safety Strategy of the Department of Transport, Tourism and Sport.
