**REPORT OF THE INVESTIGATION
INTO A FATAL INCIDENT**

**ON
LOUGH CORRIB,
CO. GALWAY
ON
26th MAY 2016**

**REPORT NO. MCIB/259
(No.4 OF 2017)**

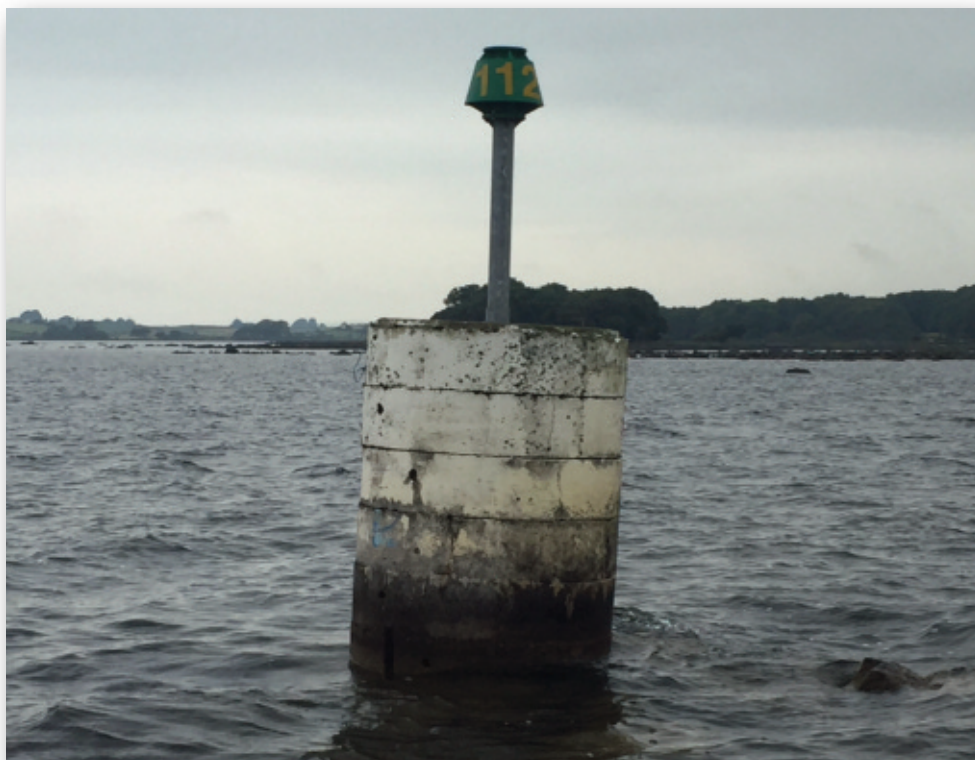
- 4.6.1 Marker No. 112 is a fixed navigation mark of cement structure built upon a rock base. It is not a floating structure anchored by a chain like that of a navigation buoy. Navigation mark No. 112 is referred to as a “Beacon” and more accurately an “Unlit Beacon”. This beacon and many others along this stretch of Lough Corrib have been fitted with topmarks to indicate that they are port and starboard lateral marks of a well-defined channel. As many of the navigation marks on Lough Corrib are beacons, it is not required that they are constructed in the conical or can shape of lateral buoys.

Photograph No. 1: Lough Corrib Navigation Marker No.112.

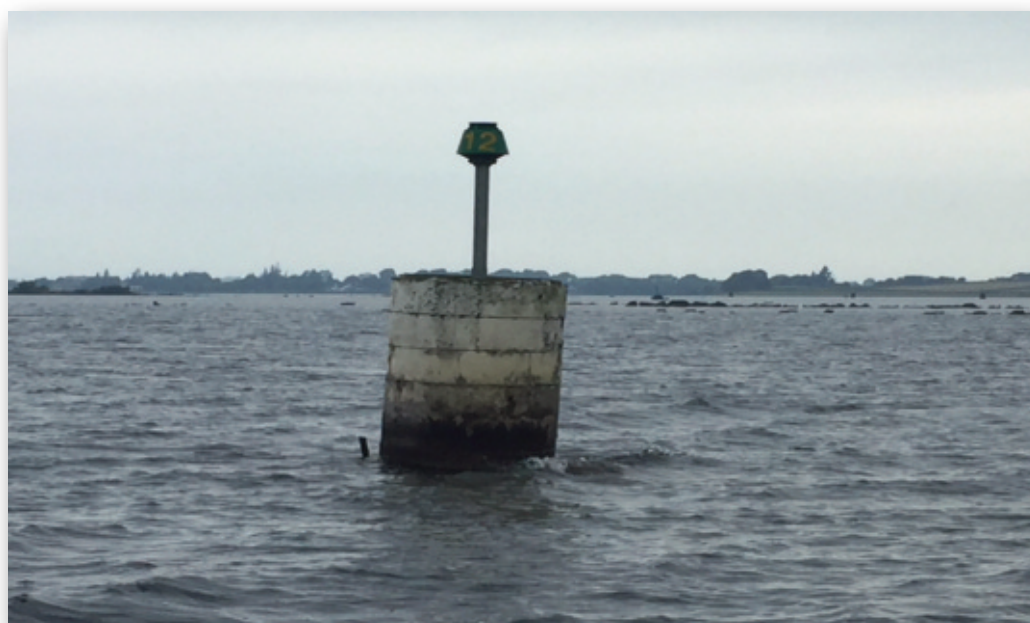
- 4.1.6 The vessel rode-up and over part of the underwater structure of the navigation mark and then continued back into the channel due to the vessel's momentum. A photograph of the navigation mark can be seen at Appendix 7.3 Photograph No. 1. As shown in Appendix 7.3 Photograph Nos. 4 and 5 the join between the gunwales and the stem in-way-of the breast hook is opened up. There is scarring damage to the keel and strakes on the starboard side indicating the vessels forward motion during the allision. These scars are likely to have been caused by the metal bar in Appendix 7.3 Photograph No. 2. Combining the issues of scarring on the hull with the momentum of the boat and the fact that the vessel was fitted with a four stroke 18 hp engine there is a likelihood that the vessel was not travelling at a safe speed. Rule 6 of the International Regulations for the Prevention of Collisions at Sea states that every vessel shall at all times proceed at a safe speed so as to take proper and effective action to avoid a collision. When determining a safe speed there are a number of factors to be taken into account, the first being the state of visibility.

Photograph No. 2: Marker No. 112 showing a partially underwater metal bar from a previous navigation marking.

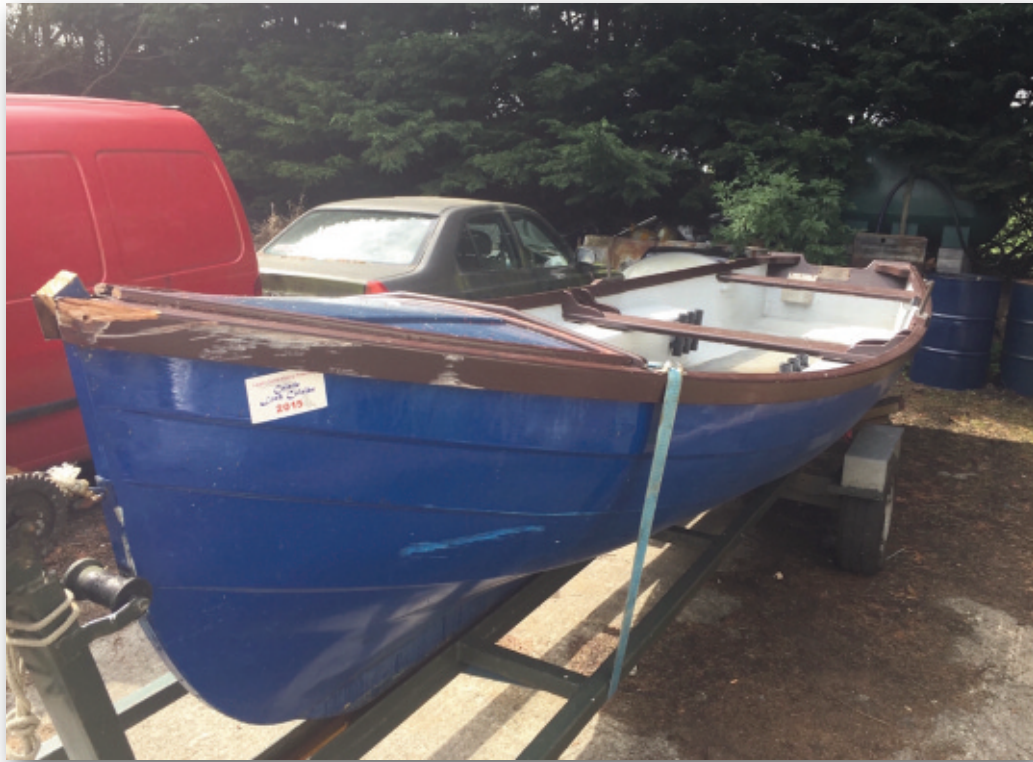
- The forward part of the vessel is damaged due to the allision (see Appendix 7.3 Photograph No. 3).
 - The timber stem and port side timber gunwales are scratched (see Appendix 7.3 Photograph No. 4).

Photograph No. 3: Damaged vessel, note damage to gunwales and stem.

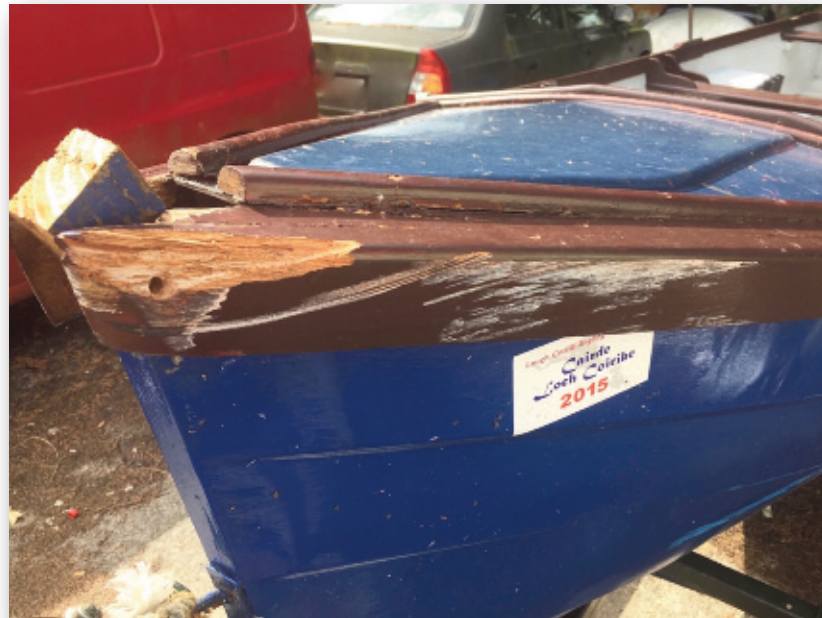
Photograph No. 4: Close-up view of damage to stem, port side gunwales and opening of join to breast hook/weather deck.

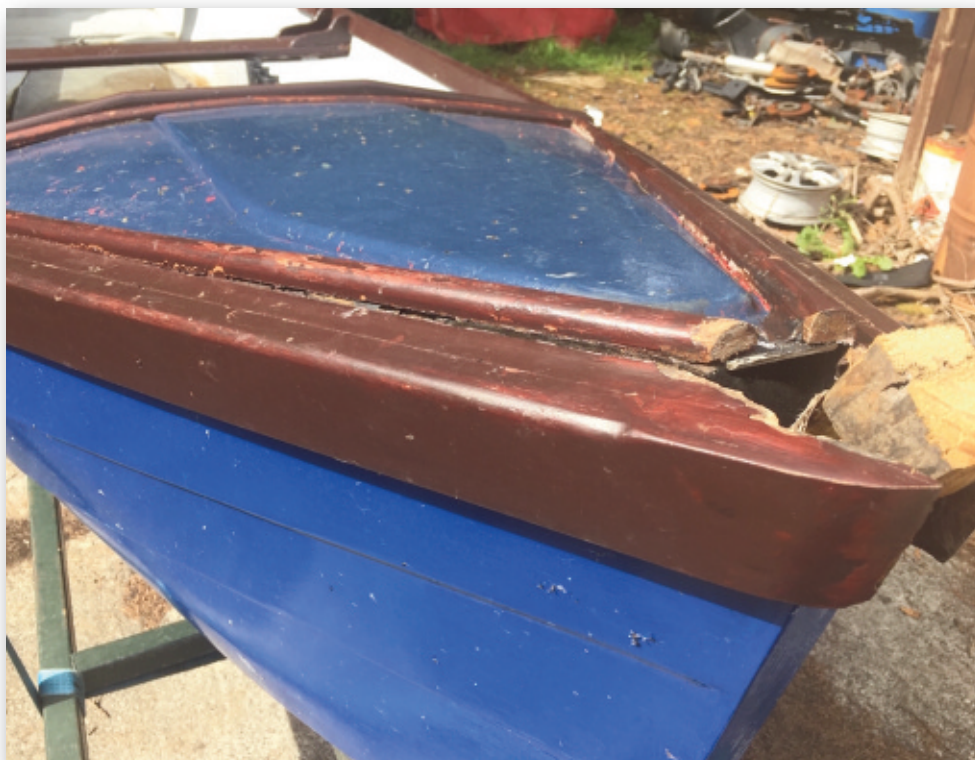
- The joins between the breast hook and the gunwales are opened up (see Appendix 7.3 Photograph No. 5).
 - The timber keel and the GRP garboard strake are scratched over a length of half a metre on the starboard side (see Appendix 7.3 Photograph No. 6).

Photograph No. 5: Opening up of breast hook/weather deck on starboard side.

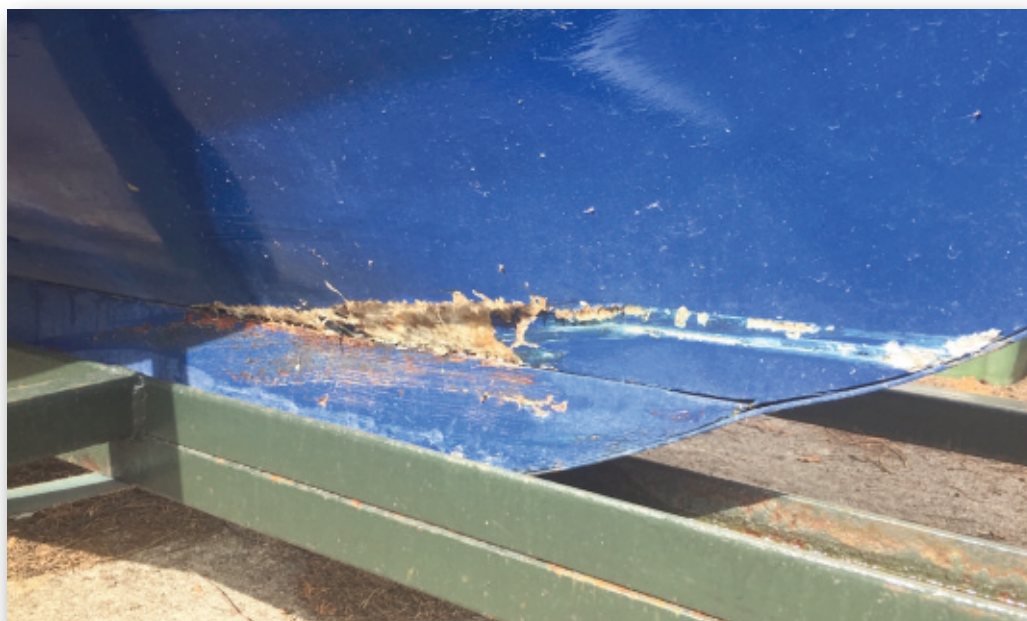
Photograph No.6: Damage to starboard side forward part of keel and garboard strake.

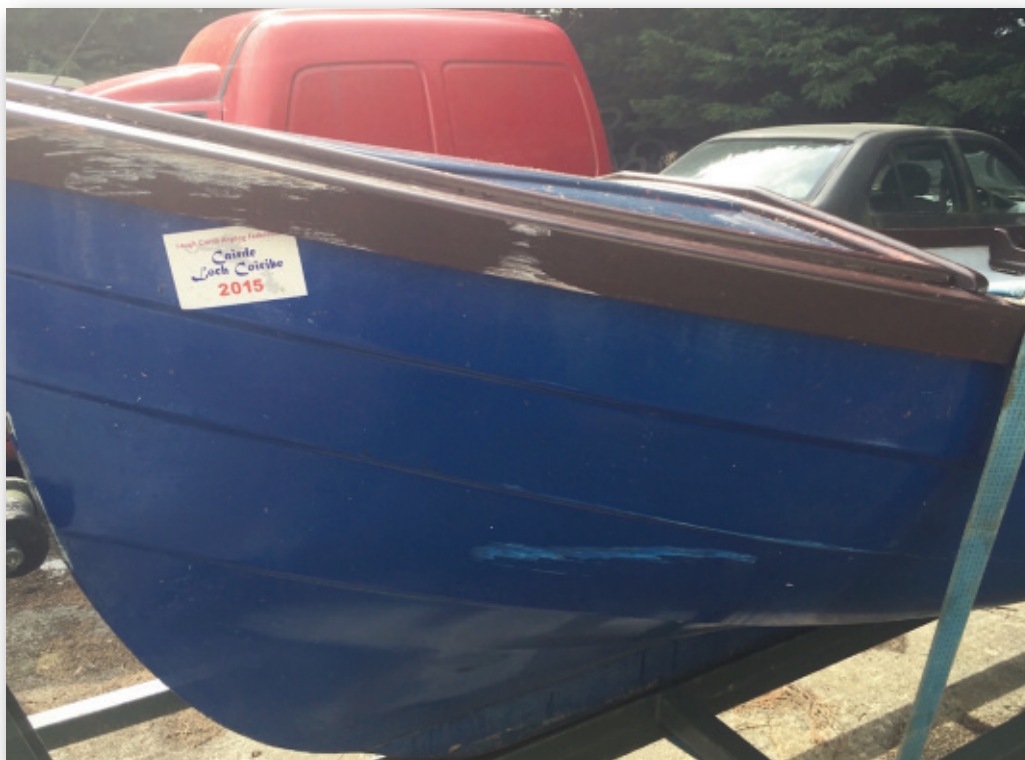
- One strake on the port side is lightly scratched at the fore part (see Appendix 7.3 Photograph No. 7).

Photograph No. 7: Scratches to port side gunwales and strake.

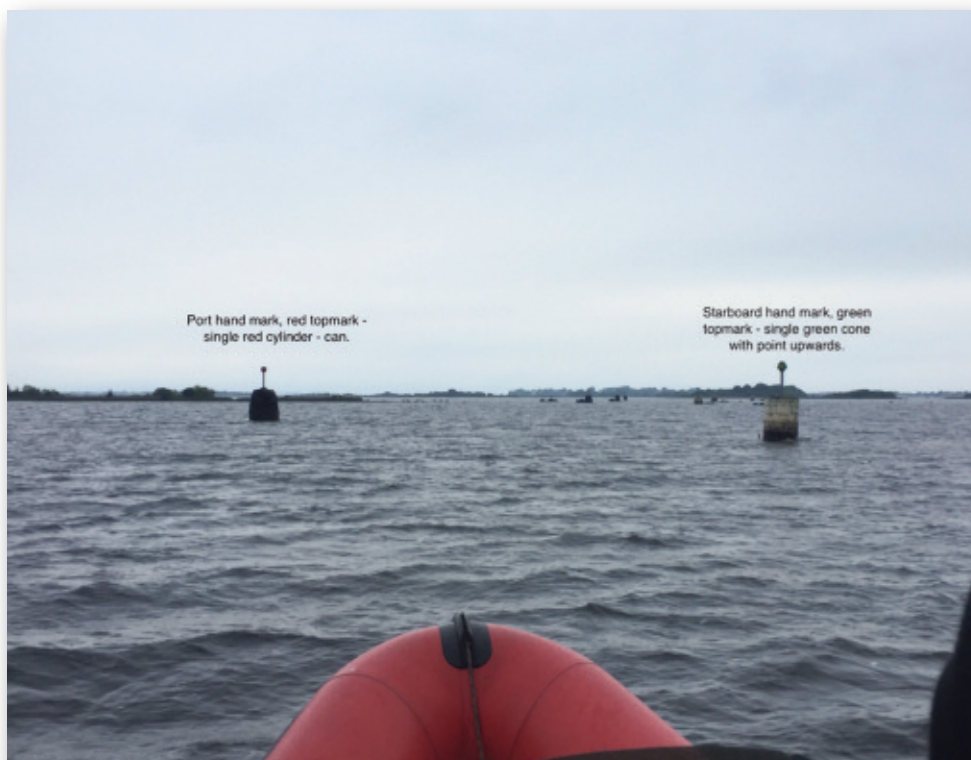
- 4.6.2 The view of the topmarks does not represent a clear “can” shape on the port side beacon and “cone” shape on the starboard hand beacon. Other beacons in this section of channel are fitted with the same type of topmarks. The fact that many Lough users are positioned low down in small boats and generally looking upwards towards topmarks that are silhouetted against the background sky make colour more difficult to identify. The topmark shapes are not in accordance with the IALA topmark shapes and are of a relatively small size. The starboard hand topmarks appear to be four-sided rather than a pure “cone” shape. The port hand topmarks appear to be seven sided polygons rather than a “cylinder” or “can” shape. Appendix 7.3 Photograph No. 8 is presented along with an extract of the IALA Guide.

- 5.7 The navigation beacon topmarks are of a relatively small size and the shapes can be misconstrued due to the present topmark fittings not being "conical" or "can" shaped. As the beacons are not coloured or shaped according to the IALA system it is important that the topmarks are an exact representation of the IALA system and of a suitable size so as to be clearly identifiable in shape.

Photograph No. 8: Navigation Marks 112 and 111 with topmarks silhouetted against the sky compared to IALA system topmarks below.

- 6.4 The Corrib Navigation Trustees should upgrade the topmarks fitted to the beacons in accordance with the IALA Region A system.
- 6.5 The Corrib Navigation Trustees should develop a single source of public user information in relation to navigation information on Lough Corrib. This will provide users of varying experience with the reassurance of acquiring the most up to date information available from an approved source.
