Marine Casualty Investigation Board
Bord Imscrúdú Taisní Muirí

**REPORT OF EMPTY VESSEL
FOUND OFF
TAWIN ISLAND,
GALWAY BAY
ON
7th SEPTEMBER 2016**

**REPORT NO. MCIB/265
(No.7 OF 2017)**

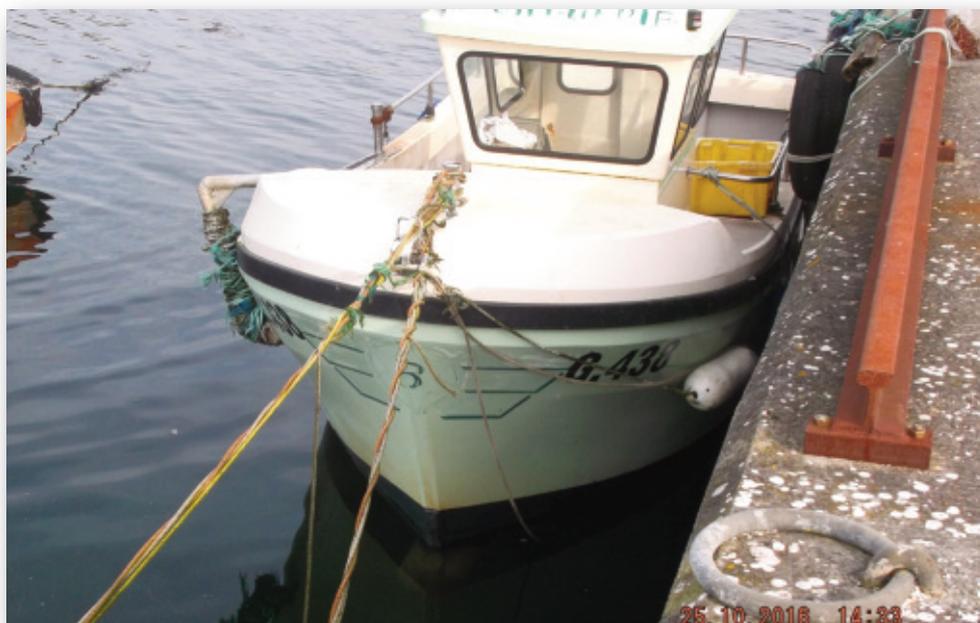
Photograph No. 1: View of vessel from front.

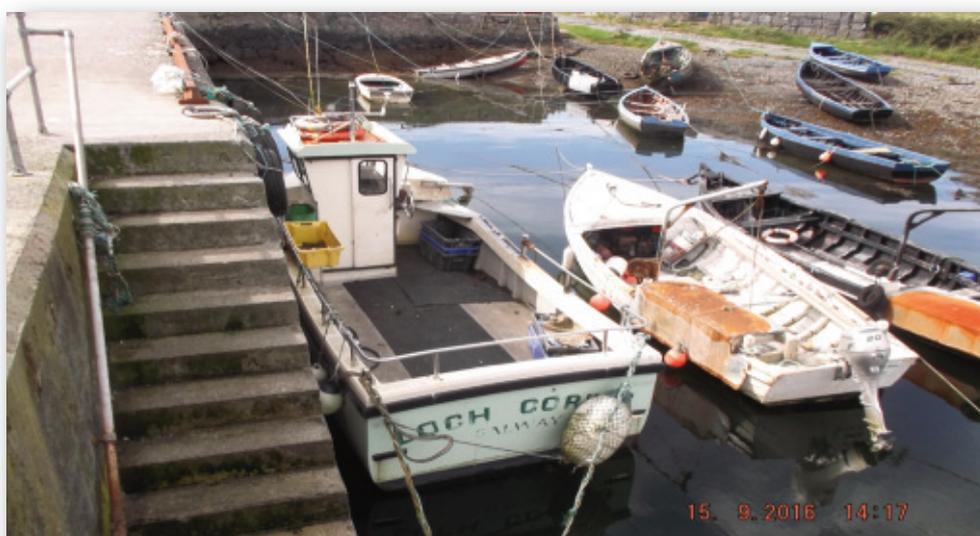
Photograph No. 2: View of vessel from aft.

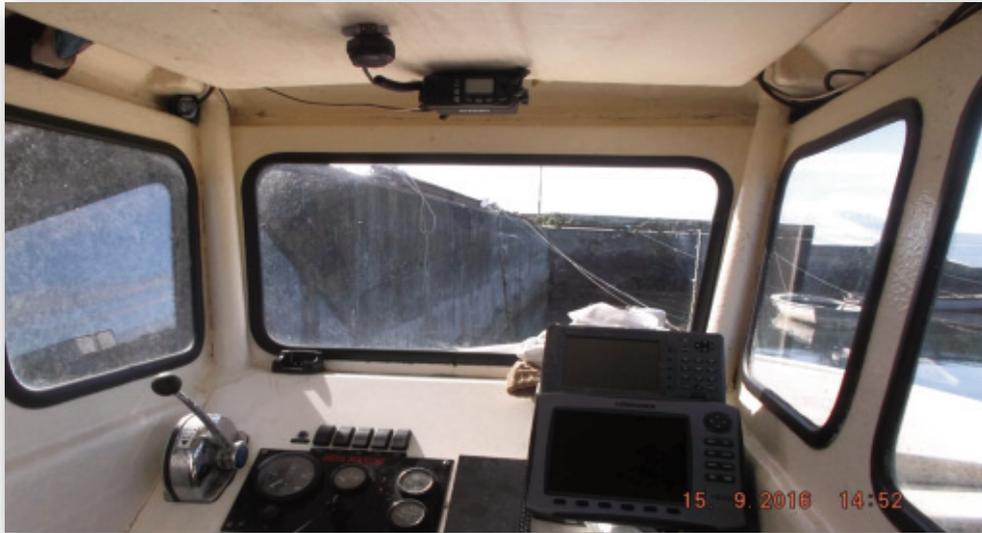
Photograph No. 3: Primary controls in wheelhouse.

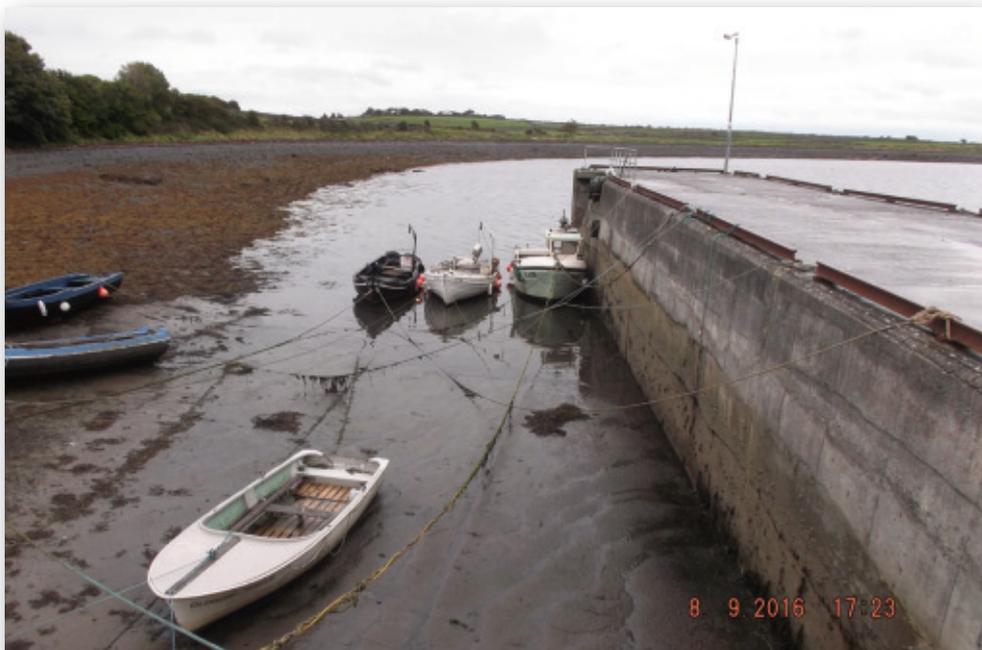
- 2.2 The vessel set out from a small pier at Ballinacourty, near Maree in Co. Galway at approximately 05.00 hrs on the morning of the 7th September 2016 (see Appendix 7.2 Photograph No. 4). There was only one person on-board the

Photograph No. 4: Pier at Ballinacourty.

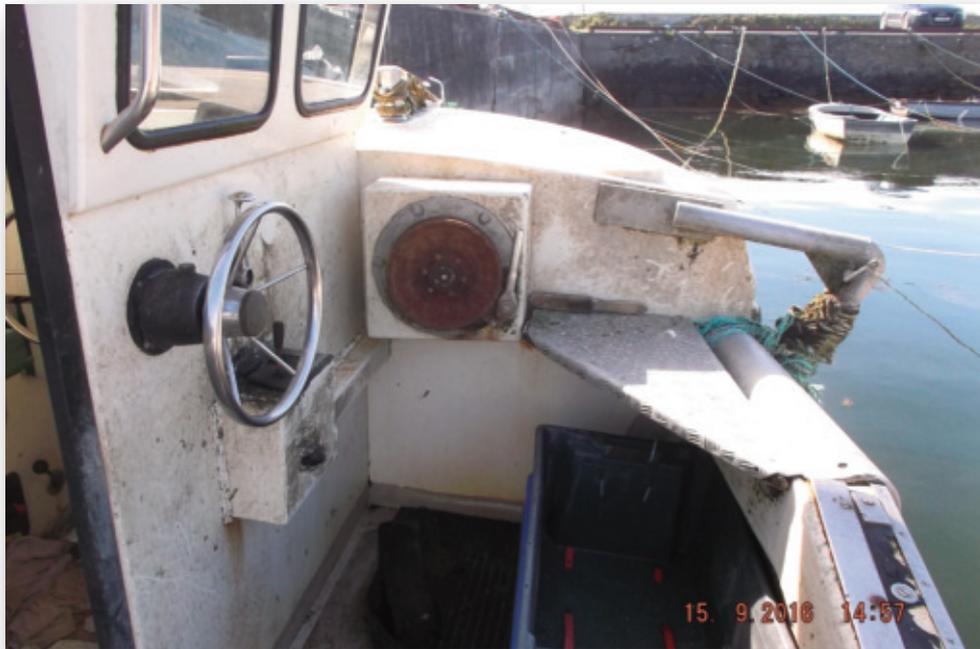
Photograph No. 5: Secondary controls beside pot hauling system.

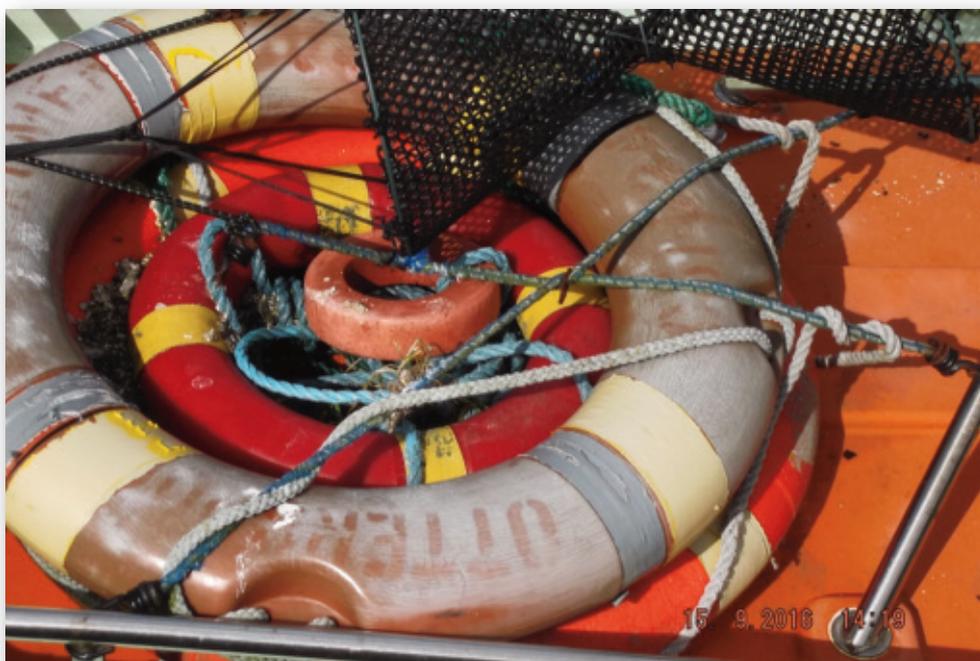
- 4.5 Although not incident related, it was noted that the two lifebuoys were carried on top of the wheelhouse structure. Both were secured by bungee cords which would make their release difficult. The uppermost lifebuoy was faded and had lost its high visibility qualities. The outline of lettering on the sides indicated the lifebuoy came from another vessel. The third life-ring did not comply with the statutory requirements.

Photograph No. 6: Lifebuoys on wheelhouse
