**REPORT OF THE INVESTIGATION
INTO A FATAL INCIDENT AT
MALIN BEG HEAD,
CO DONEGAL
ON
9th JULY, 2017**

**REPORT NO. MCIB/274
(No.1 OF 2019)**

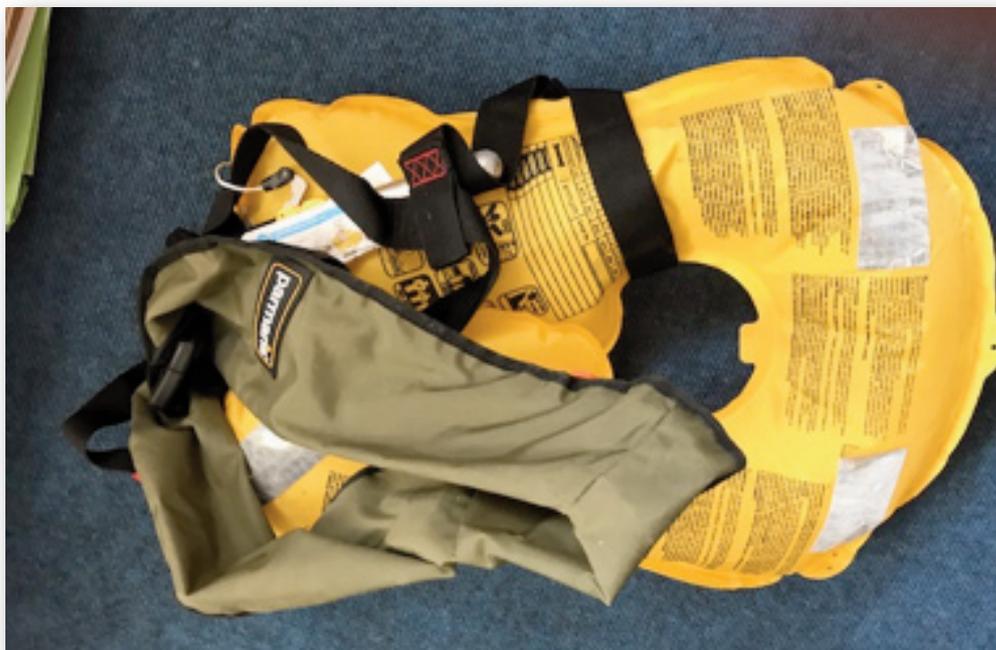
- Two Personal Flotation Devices (PFD), one recovered with one of the casualties and the second recovered from the debris field (see Appendix 7.1 Photograph No. 1).
- One Inflatable Dan Buoy.
- One Compass.
- One Cobra Marine D.S.C VHF without its hand held microphone.
- One GPS mounting bracket. No GPS was found.
- One Paddle.
- One Boat Hook.

- 4.10 Both casualties had CO2 canister inflated PFDs and were seen wearing them shortly after they departed Teelin Pier. However, only the first Casualty was wearing one, the second Casualty was recovered from the sea without a PFD. This second PFD was subsequently located in the debris field.

Photograph No. 1: PFD recovered in debris field.

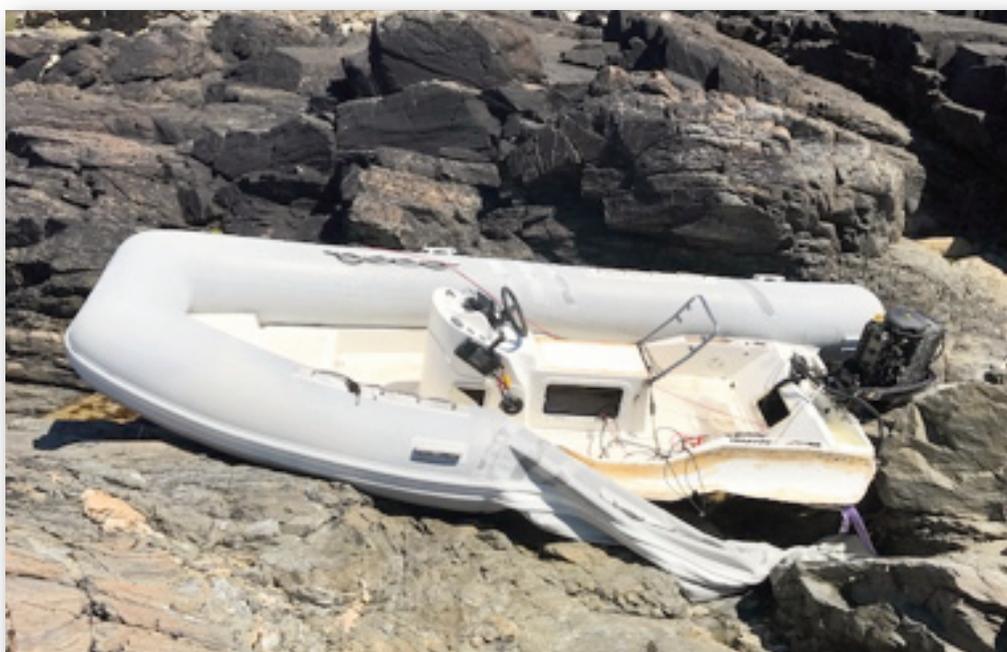
2.2.3 The vessel was found high and dry on the rocks at the approximate High Water mark at the north western foot of Malin Beg Head (see Appendix 7.1 Photograph No. 2).

- 5.3 The severity of the damage to the vessel and the spread of the debris suggest the vessel came hard ashore in large breaking waves. The height above the sea where it came to rest suggests it came ashore before High Water.

Photograph No. 2: Vessel as found after the incident.

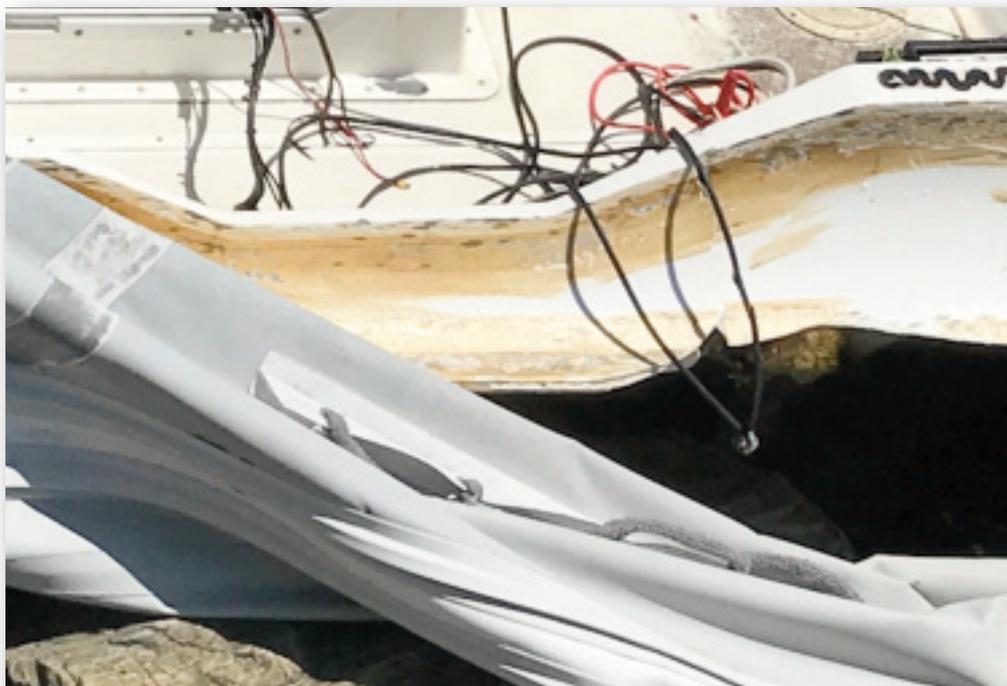
- a) The aft port tube was punctured and torn away from the rigid hull (see Appendix 7.1 Photograph No. 3).

Photograph No. 3: Aft port tube torn away from hull.

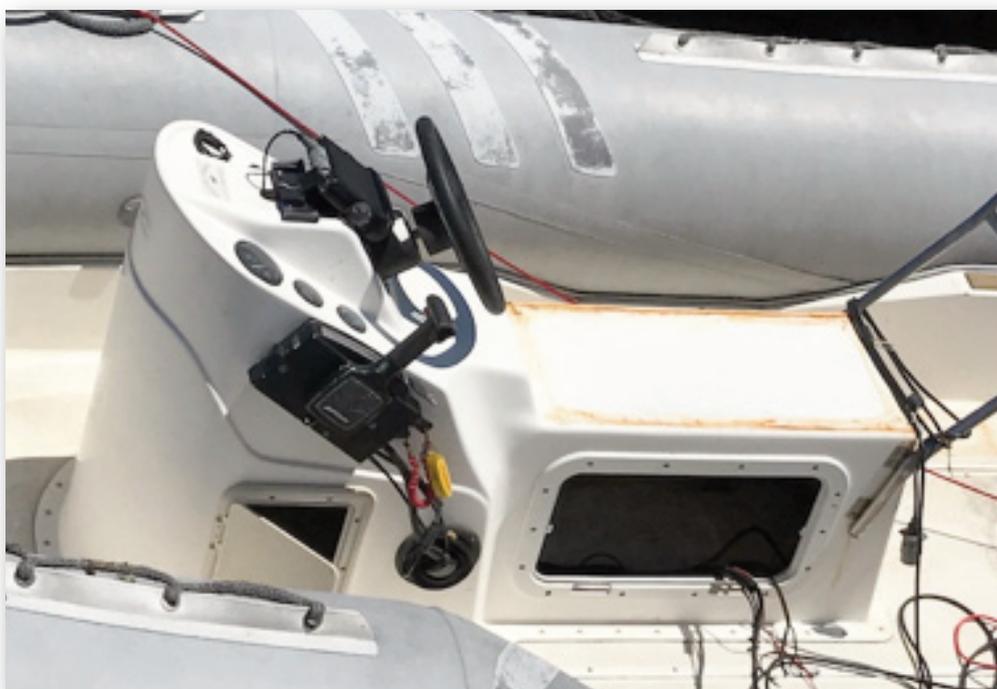
- b) The batteries and battery covers on the centre console were broken away (see Appendix 7.1 Photograph No. 4).
- c) The outboard engine cover was torn off and found approximately 15 m away from the boat (see Appendix 7.1 Photograph No. 5).

Photograph No. 4: Battery cover in console broken out.

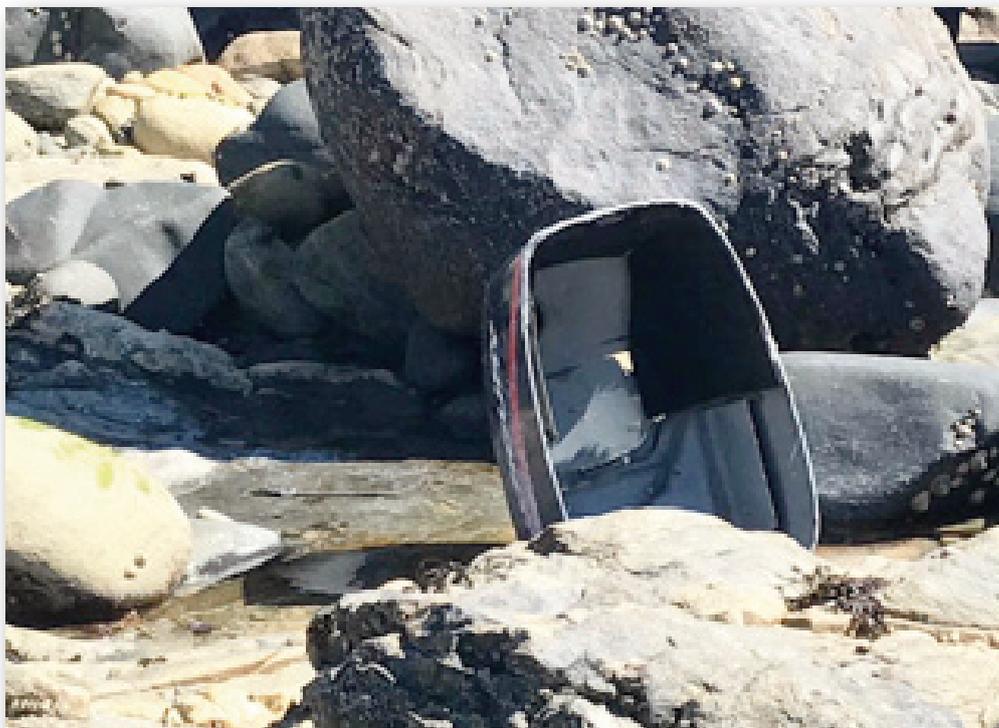
Photograph No. 5: Engine cover in debris field.

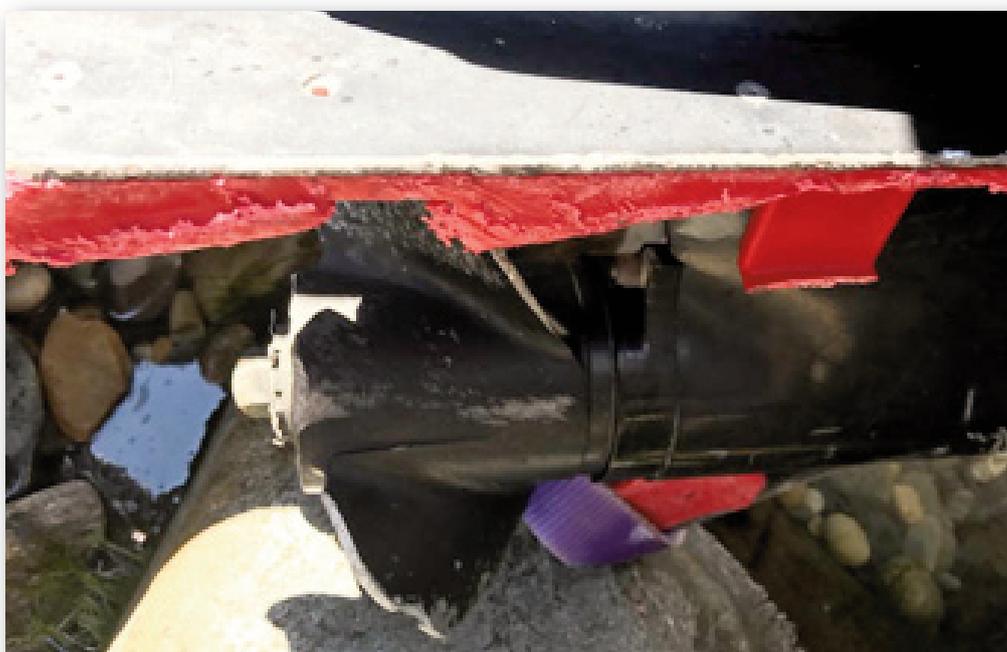
- d) The propeller guard and propeller were destroyed with the propeller blades broken (see Appendix 7.1 Photograph No. 6).
- e) The A-Frame was broken away from the vessel and was not found.

Photograph No. 6: Propeller blades damage.

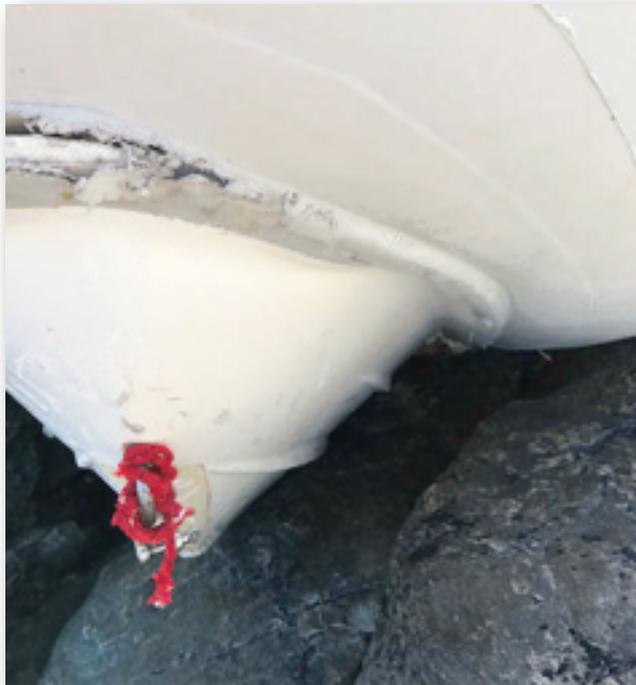
- f) The vessel's rigid hull was found to be heavily scuffed and to have holes (see Appendix 7.1 Photograph No. 7).
- g) The Very High Frequency (VHF) hand held microphone was missing, as was the jack plug on the end of the cable (see Appendix 7.1 Photograph No. 8).

Photograph No. 7: Rigid hull damage.

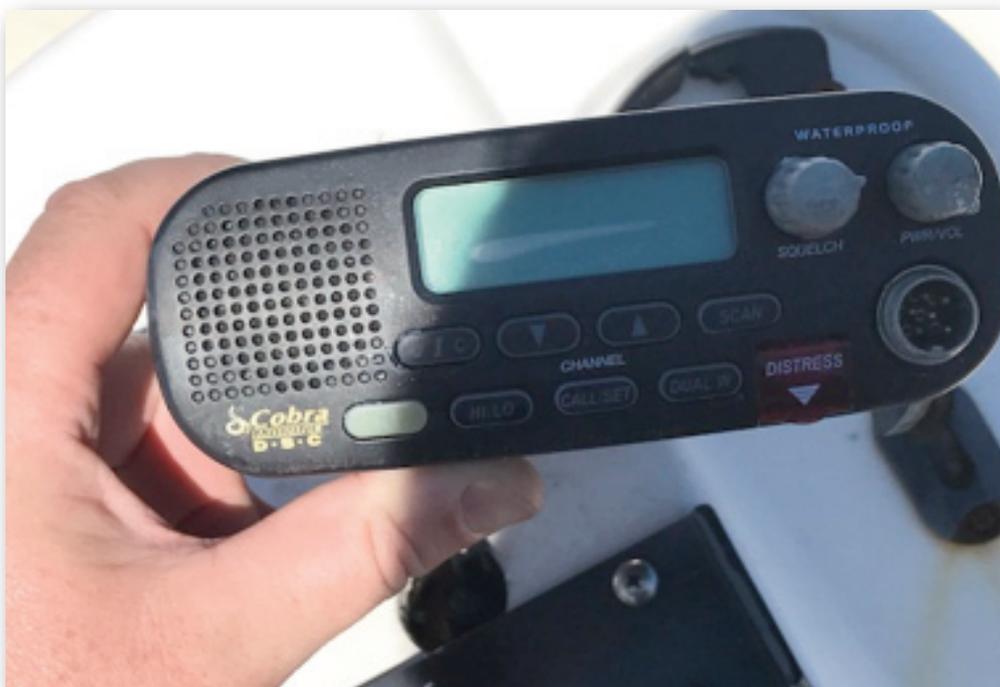
- 4.11 The RIB was equipped with a VHF radio which was damaged when found. It is not known if it was functioning correctly at the time of launching. No Mayday call appears to have been made. The use of mobile phones is not recommended as a communication method at sea. Mobile phone coverage was poor in the area.

Photograph No. 8: VHF without hand held microphone.

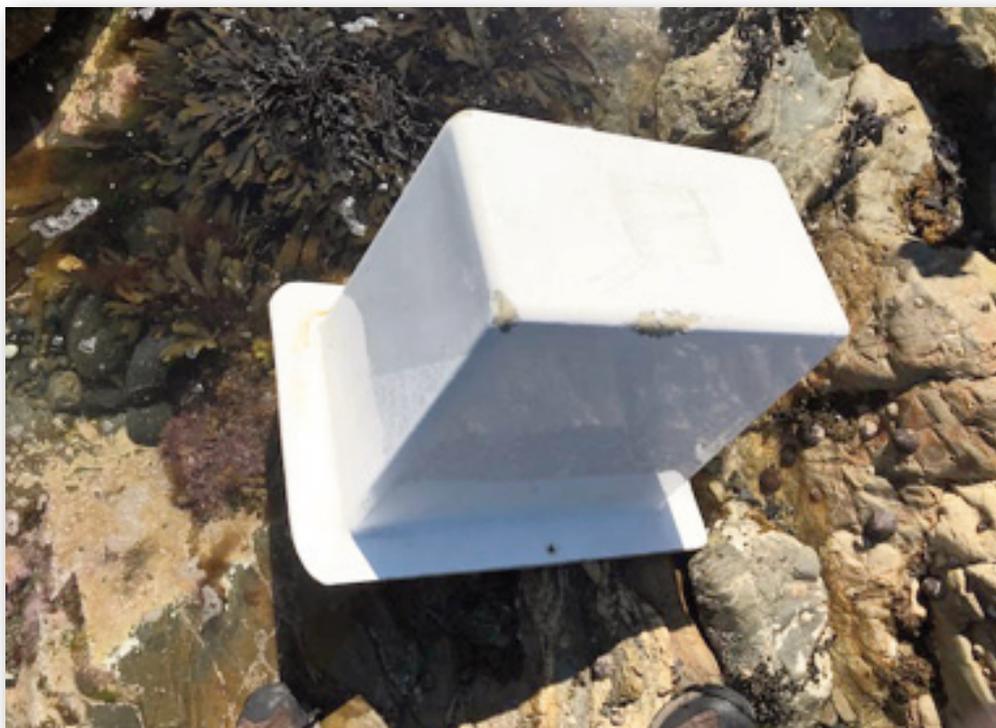
- h) The vessel's second, centre seat and seat cushions had broken away from the boat and were found within a 150 m radius of the boat (see Appendix 7.1 Photograph No. 9).

Photograph No. 9: Extra centre seat found in debris field.

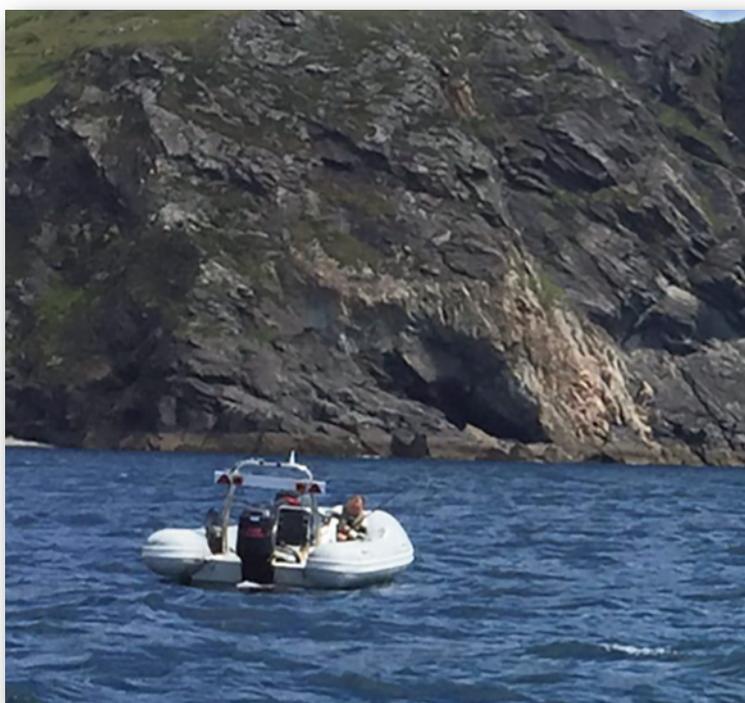
- 3.4 At 12.40 hrs a boatman, who had seen the men launch the RIB at Teelin Pier, sighted the two men fishing from their boat using fishing rods and reels. The outboard engine was idling and both men were wearing PFDs. They did not appear to him to be in distress at this stage. The plastic trailer board for road use while towing the boat was still attached to the boat's A Frame (See Appendix 7.1 Photograph No. 10).

- 4.4 As noted in paragraph No. 3.4, the RIB was launched with the trailer board still attached to the vessel’s A Frame fitted to the stern. The five core cable and plug which connects to the towing vehicle can be seen in Appendix 7.1 Photograph No. 4 coiled around the back of the seat frame attached to the rear of the centre console. This would have presented an additional trip hazard within the boat.

- 5.4 From the photograph evidence taken by the boatman (see Appendix 7.1 Photograph No. 10) it would appear that the men were wearing their PFDs during the day. However, only one of the men had his PFD on when he was recovered. This suggests his entry to the water was involuntary rather than planned.

Photograph No. 10: Photo of the men fishing.
