**REPORT INTO THE  
FIRE AND LOSS  
OF  
MFV SUZANNE II  
EAST OF ARKLOW  
ON  
2nd MAY 2019**

**REPORT NO. MCIB/291  
(No.1 OF 2020)**

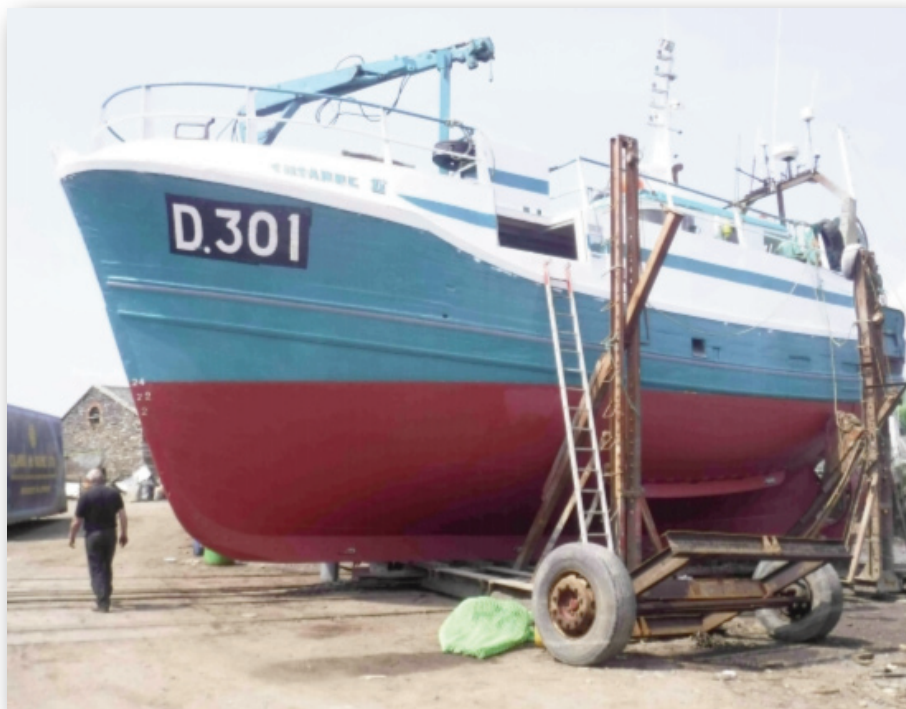
Photograph No. 1 - Vessel at survey.

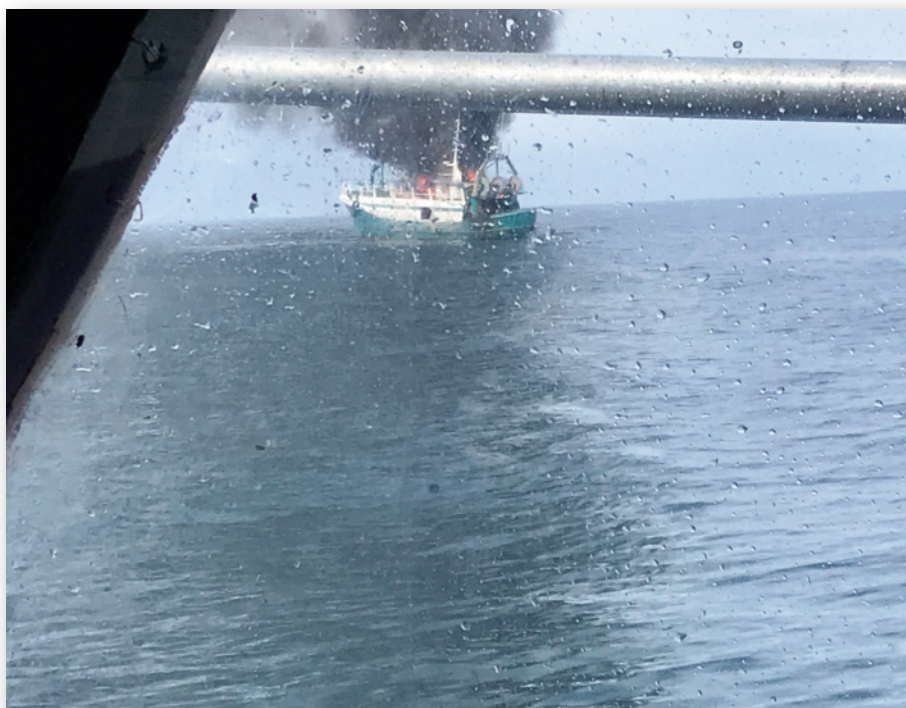
- 5.1 The source of the fire is unknown. It started in the engine room and rapidly got out of control. Once the fire was well established it engulfed the vessel and being of timber construction it continued to fuel the fire until the entire vessel was ablaze (see Appendix 7.1 Photographs No. 2, 3 & 4).

Photograph No. 2 - Vessel on fire, as first seen by angling vessel, approximate time 15.04 hrs.

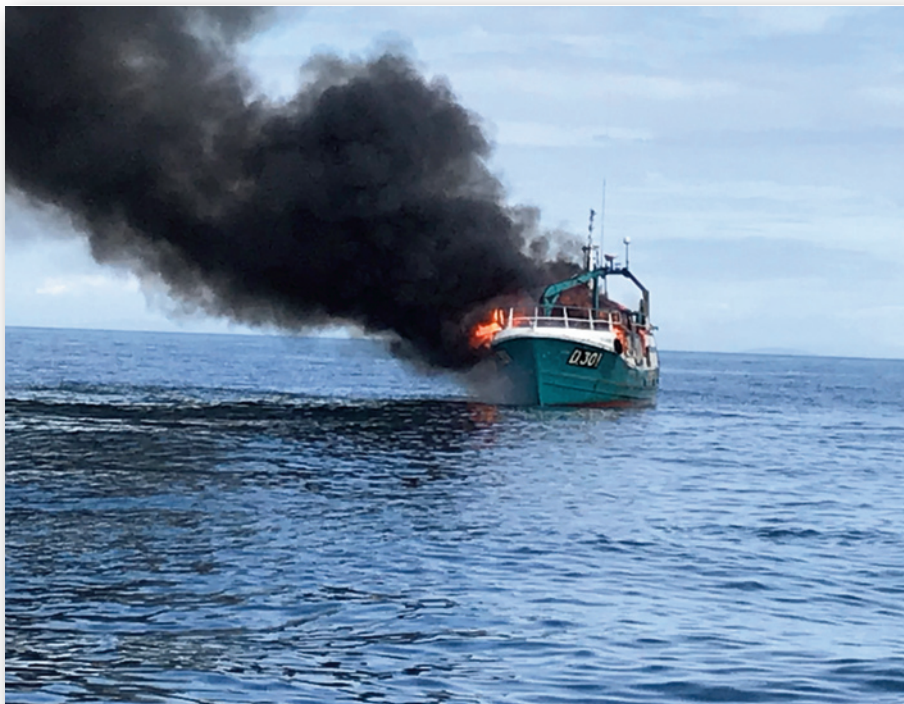
- 4.17 From arriving on-scene the tug with fire fighting capabilities continued to fight the fire but failed to get it under control or extinguish it. The photographs in Appendix 7.1 clearly show that by the time the tug arrived the entire vessel was engulfed in flames.

Photograph No. 3 - Fire continues.

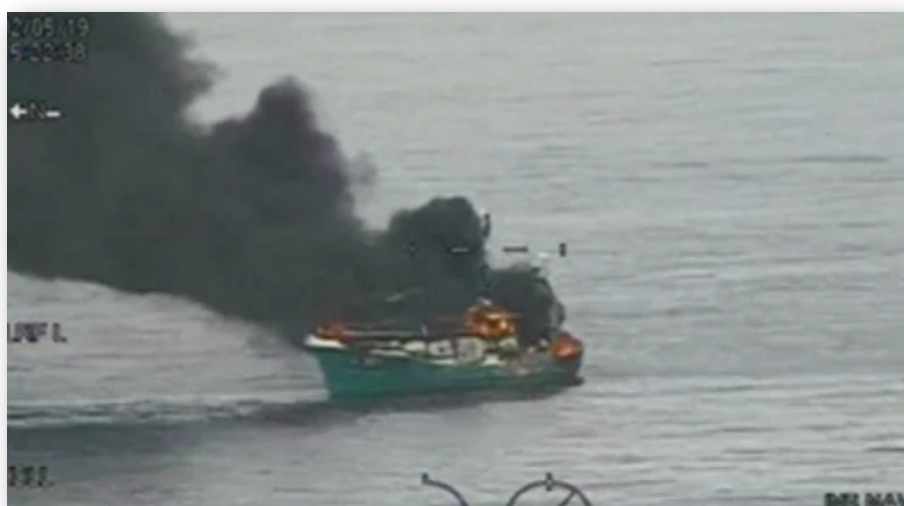
Photograph No. 4 - Vessel as seen by rescue helicopter at approximately 15.21 hrs.
