**REPORT OF THE INVESTIGATION
INTO AN INCIDENT ON
LOUGH REE, HODSON BAY,
ATHLONE, CO. ROSCOMMON
ON
20th MARCH 2014**

**REPORT NO. MCIB/237
(No.8 OF 2015)**

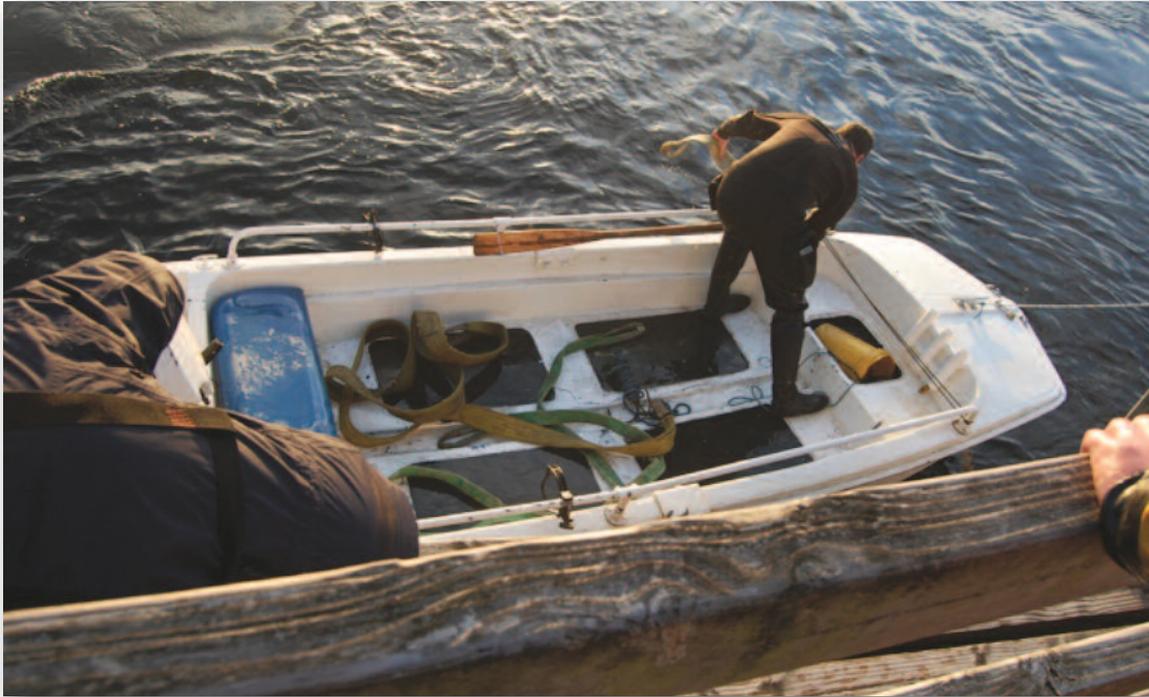
- 4.3 Boat B was recovered from the lake on Tuesday 1st April 2014. After it reached the surface, the vessel was bailed and re-floated. The boat was then towed to Athlone Sailing Club where it was craned out and brought by flatbed truck to Garda storage in Athlone (See Appendix 7.4 Photograph Nos.1 & 2).

Photograph No. 1 - Boat afloat after it was recovered from the lake

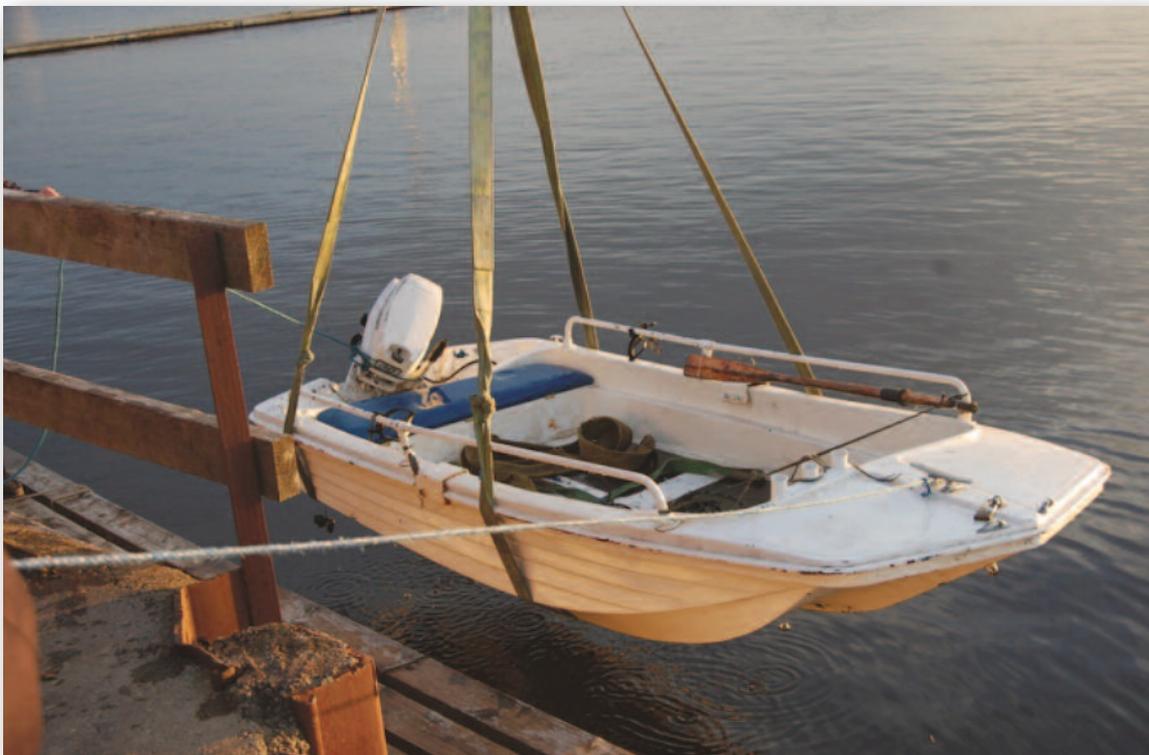
Photograph No. 2 - Boat being lifted out of water after it was recovered

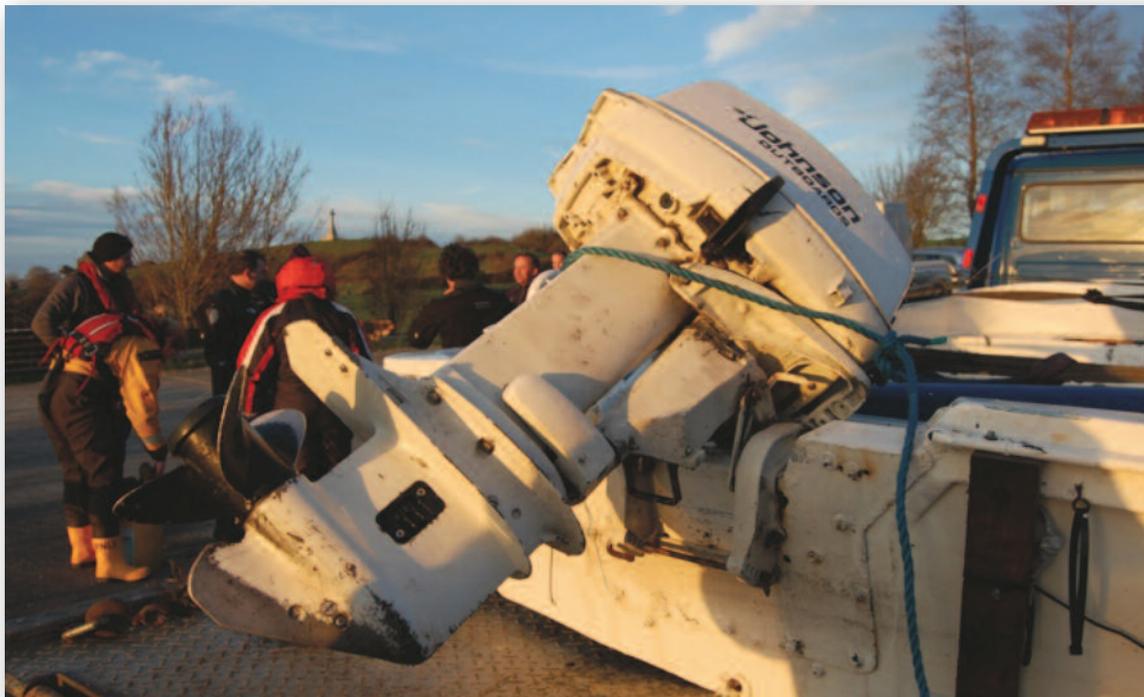
- 4.4 The hull was found to have no significant damage that could explain the vessel sinking.
- 4.5 The drain hole in the transom was fitted with a bung, which appeared to make a good seal. The bung was removed to allow the boat to drain fully (See Appendix 7.4 Photograph No.3).

Photograph No. 3 - Transom of the boat draining water after the bung was removed

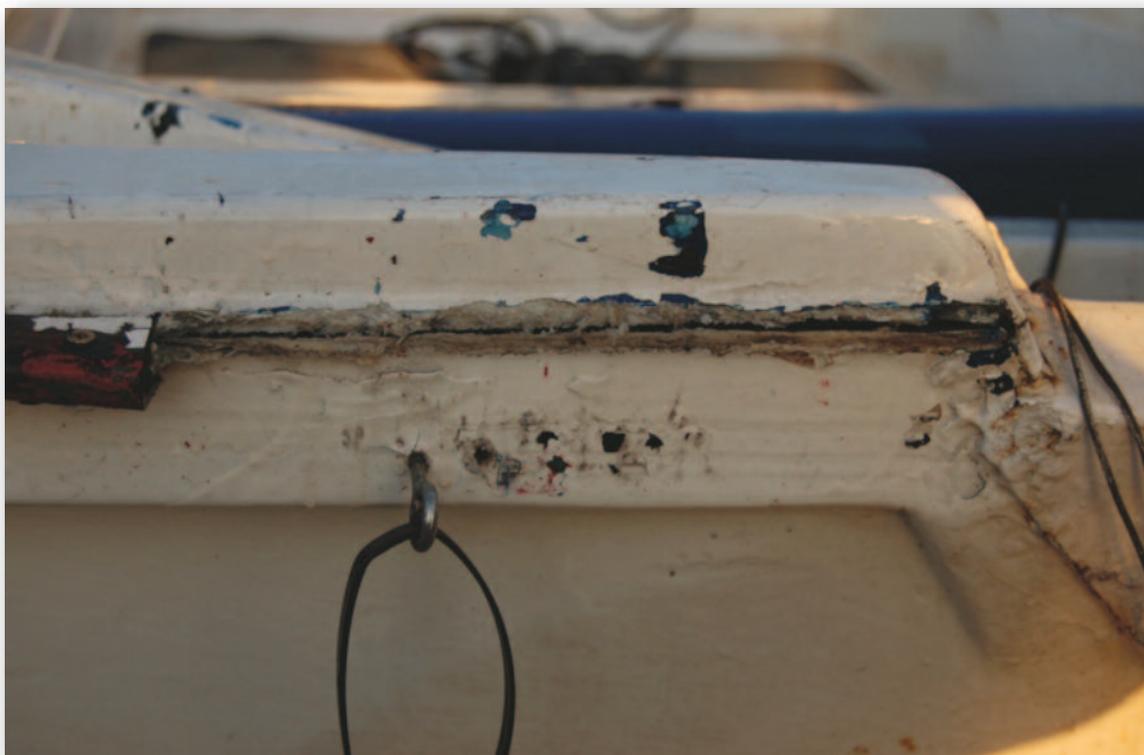
- 4.7 The floor (sole) of the boat was found to be weak and it deflected under weight of foot.
- 4.8 The hull deck joint was found to be in poor condition (See Appendix 7.4 Photograph No.4).

Photograph No. 4 - Showing the damage to the hull deck joint

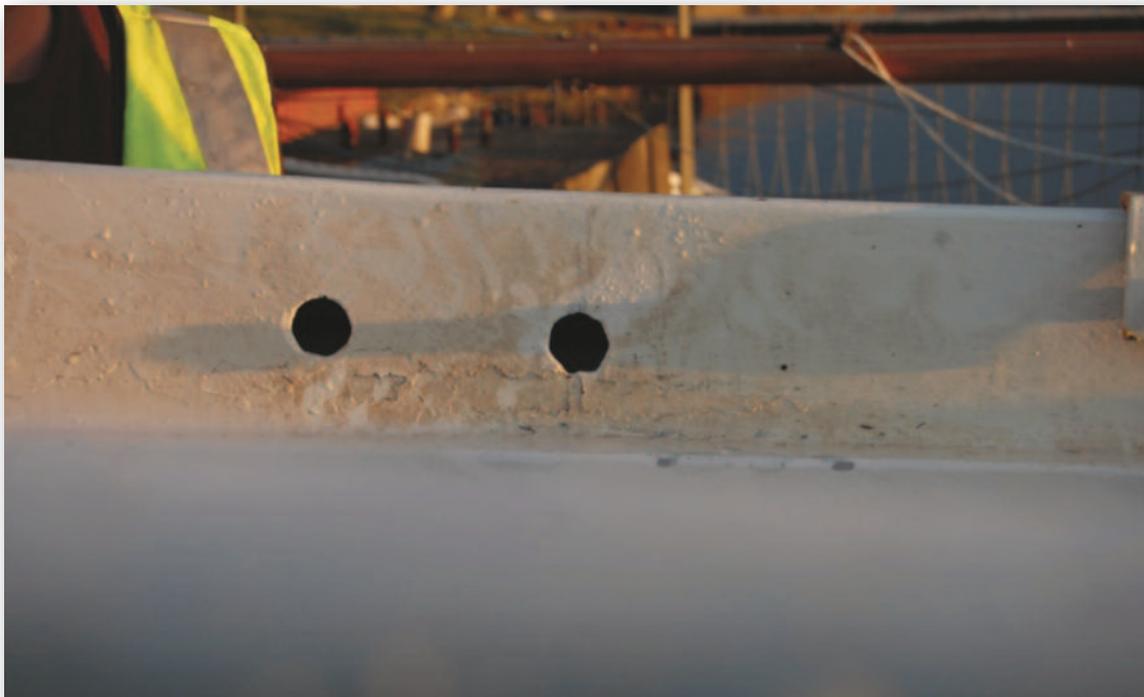
- 4.9 Several large drill holes were found on the inside of the gunwale (See Appendix 7.4 Photograph No.5). The transom was found to have been previously damaged and poorly repaired. It had several holes in it, possibly as a result of fitting different types of outboard brackets over the lifetime of the vessel. The lowest of these holes was found to be approximately 240 mm below the gunwale height (See Appendix 7.4 Photograph No. 6).

Photograph No. 5 - Picture showing holes cut in the inside of the gunwale

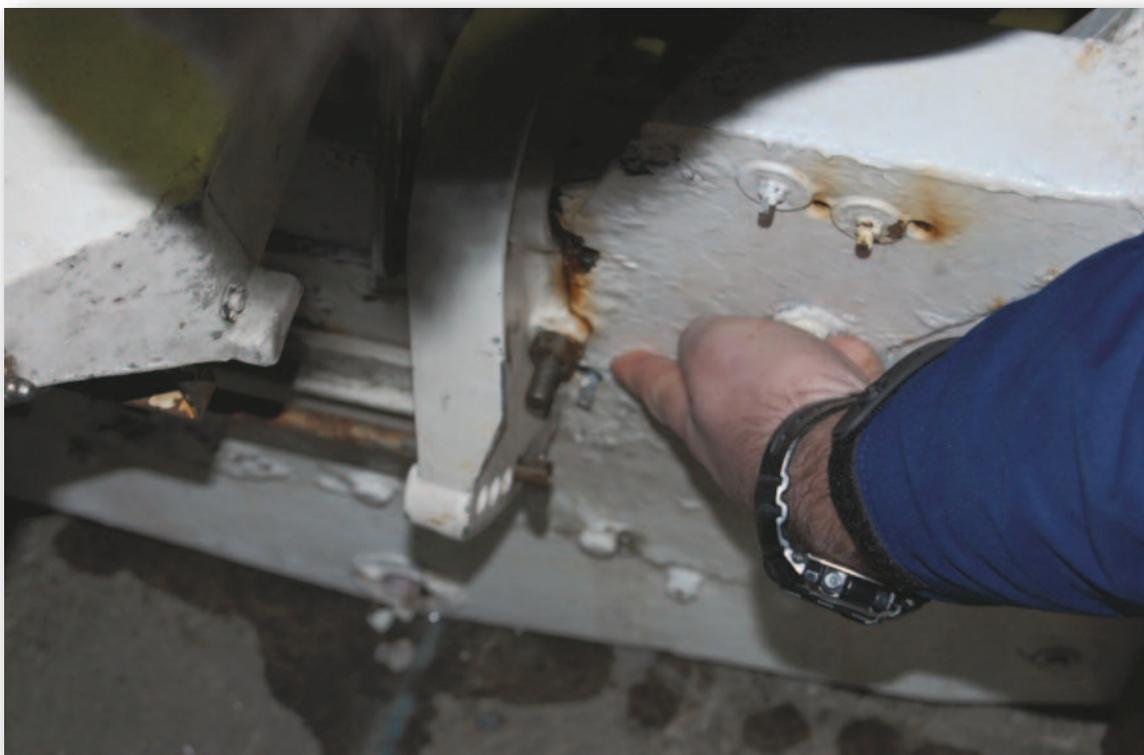
- 5.4 The holes found in the transom were approximately 240 mm below the gunwale, therefore they were 50 mm below water level at the time of the second departure. It is estimated that the holes were letting two to three litres of water into the boat every minute.

- 5.6 It is probable that the rate of flooding would have increased the longer the boat was in the water as the flooding was causing the vessel to lose freeboard and in turn, immerse more holes.

Photograph No. 6 - Transom with holes in the gunwale possibly from previous outboard motor brackets

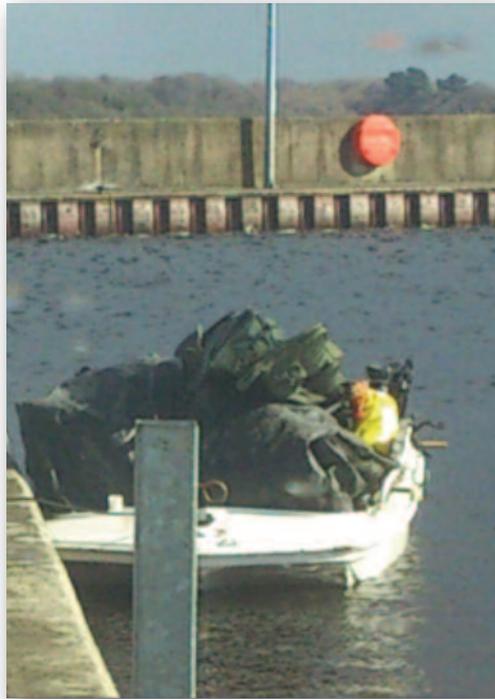
- 4.10 The photographs taken by the local man who later called the RNLI, showed that the vessel had a departure draft amidships of approximately 340 mm when departing from Hodson Bay for the second time (See Appendix 7.4 Photograph Nos.7 & 8).

- 5.1 Using the photographs of boat B departing Hodson Bay on the second trip towards the campsite, it was possible to roughly estimate that the vessel had a departure freeboard of 190 mm (See Appendix 7.4 Photograph Nos.7 & 8).

- 5.2 As the vessel depth is 530 mm, the departure draught of boat B was approximately 340 mm that would suggest the vessel had a departure displacement of approximately 1,500 kg (See Appendix 7.4 Photograph Nos.7 & 8).

Photograph No. 7 - Boat shortly before departure

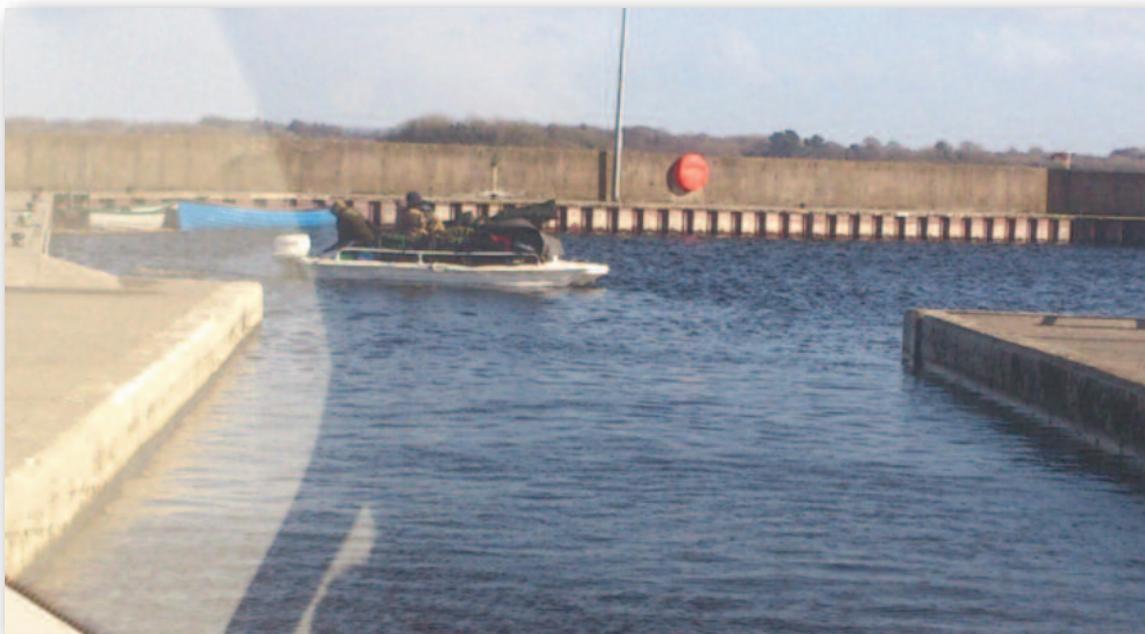
Photograph No. 8 - Boat departing Hodson Bay harbour
