**REPORT OF THE INVESTIGATION
INTO
A FATAL INCIDENT INVOLVING
“MFV OUR JENNA”
HORN HEAD,
CO. DONEGAL
ON
16th JUNE 2015**

**REPORT NO. MCIB/245
(No.1 OF 2016)**

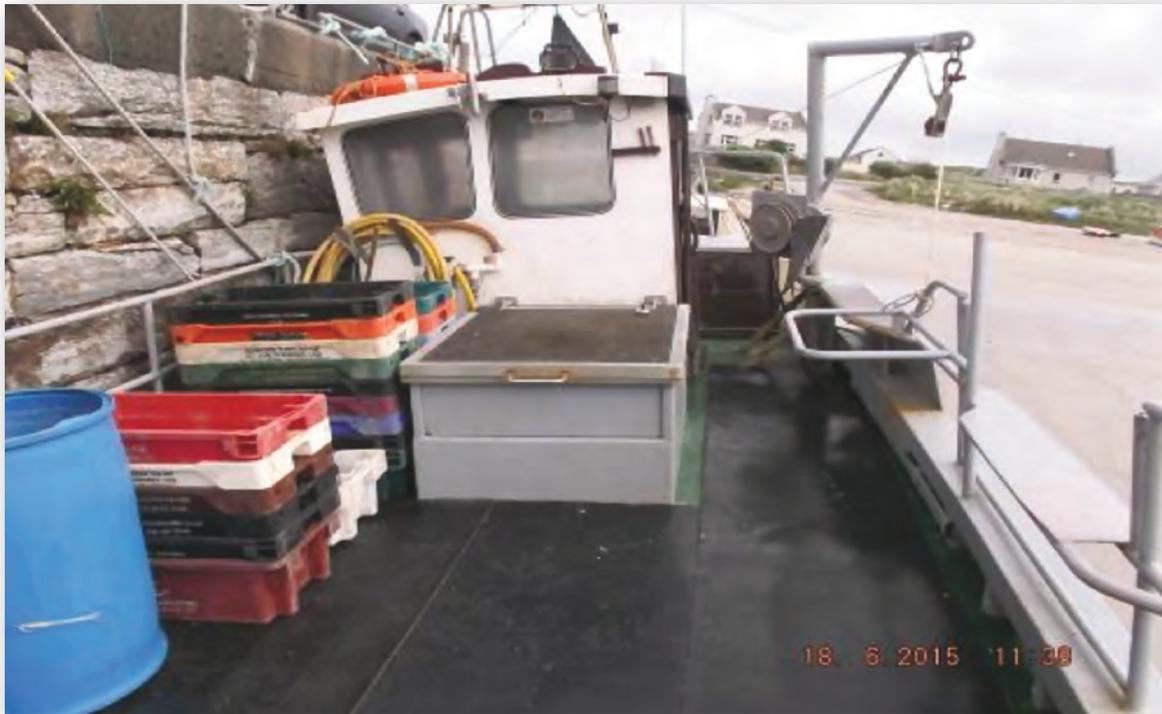
3.7.2 As he approached the location, the Skipper looked back on this occasion and could not see the Crewmember due to the crazed perspex windows.

- 5.2 There was no direct witness to the incident. There are two possible areas where the Crewmember could have fallen overboard either:
- The opening in the starboard side rails where the pots were recovered (see Appendix 7.1 Photograph No. 1), or,

Photograph No. 1 - View from aft shows offset wheelhouse and pot hauler davit. Engine and fish hold hatch is immediately aft of the wheelhouse. Both aft windows are crazed from u/v light

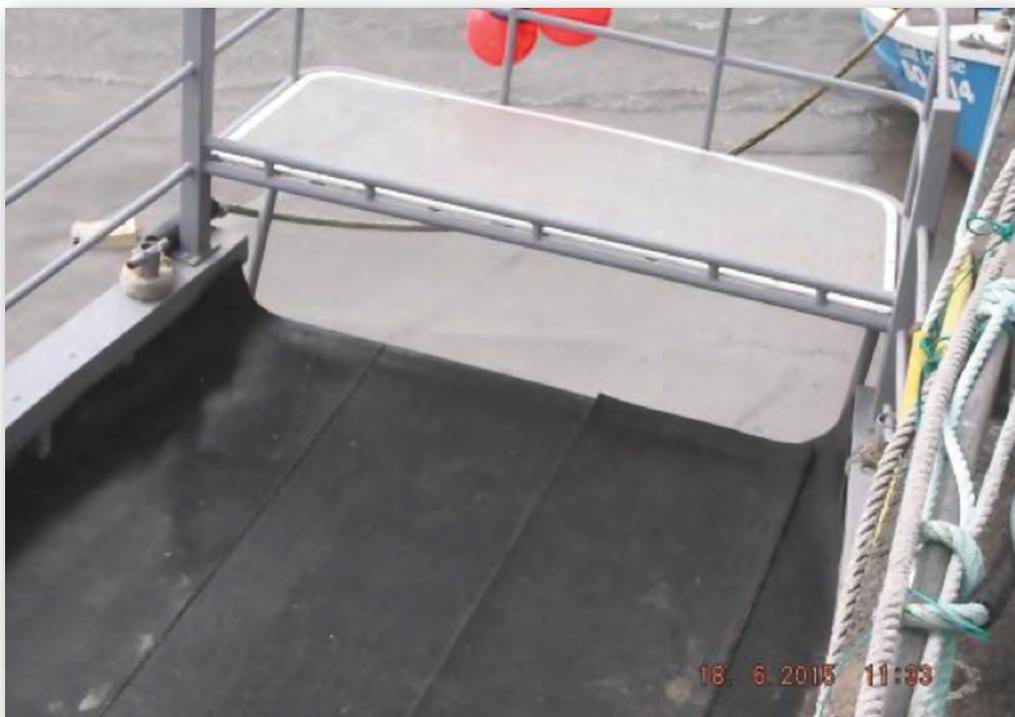
- 4.3 The Document of Compliance issued in 2013 was incorrect in describing the vessel as an open boat.
- 4.4 The rubber laid on the deck was designed for a conveyor belt. This material does not have the same anti-slip properties as dedicated marine grade matting. Conveyor belt rubber is noted to become slippery when wet and therefore would not conform to Section 6.1.4 of the Code of Practice.

- 5.4 The rubber used on the deck did not conform to the Code of Practice and conveyor belt rubber is known to become slippery when wet. The deck would therefore not have the anti - slip properties required for safety. It is considered the rubber laid on deck did not conform to Section 6 of the Code of Practice.

Photograph No. 2 - View of opening of transom and the conveyor belt rubber used on deck

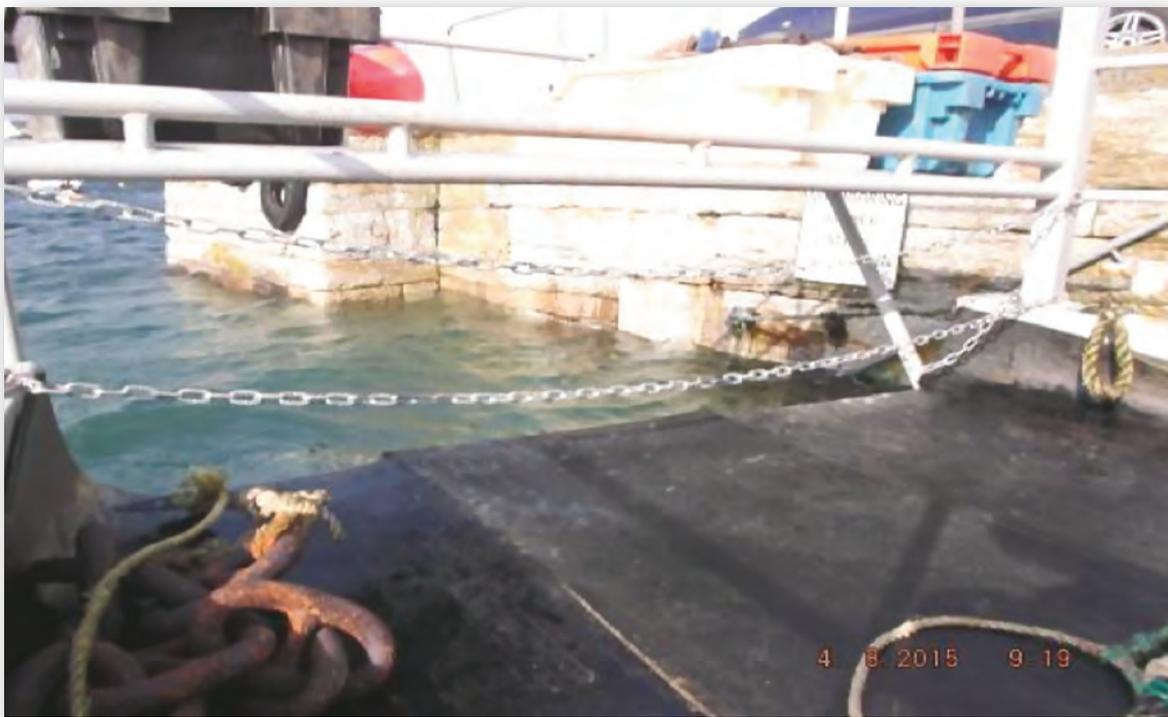
- 3.4 In early 2015, a modification to the transom bulwark was carried out at a local boatyard. This involved cutting away the section of bulwark that stretched across the transom. There was an unprotected opening left of 2,337 mm x 609 mm across the aft end of the working deck (see Appendix 7.1 Photograph No. 3).

- The opening across the stern area (see Appendix 7.1 Photograph No. 3).
- 5.3 In altering the construction of the vessel and removing the transom bulwark, the owners created a large opening at the aft end of the working deck, through which a person could easily fall. Bulwarks are put in place for safety reasons and the implications of their removal should be carefully considered. It is considered that the modification did not conform to Section 6 of the Code of Practice, under which the vessel operated and perhaps rendered the Document of Compliance for the vessel invalid.

Photograph No. 3 - Stern area from deck level showing removed bulwark

1. The Document of Compliance was withdrawn as it incorrectly described the type of vessel.
2. Two lengths of chain have been attached to the side rails and span the opening aft.
3. A new portable section of side guard rail has been fabricated and inserted in way of the pot landing point on the starboard side.
4. A new Code of Practice inspection has been carried out and a new Document of Compliance issued for the vessel.

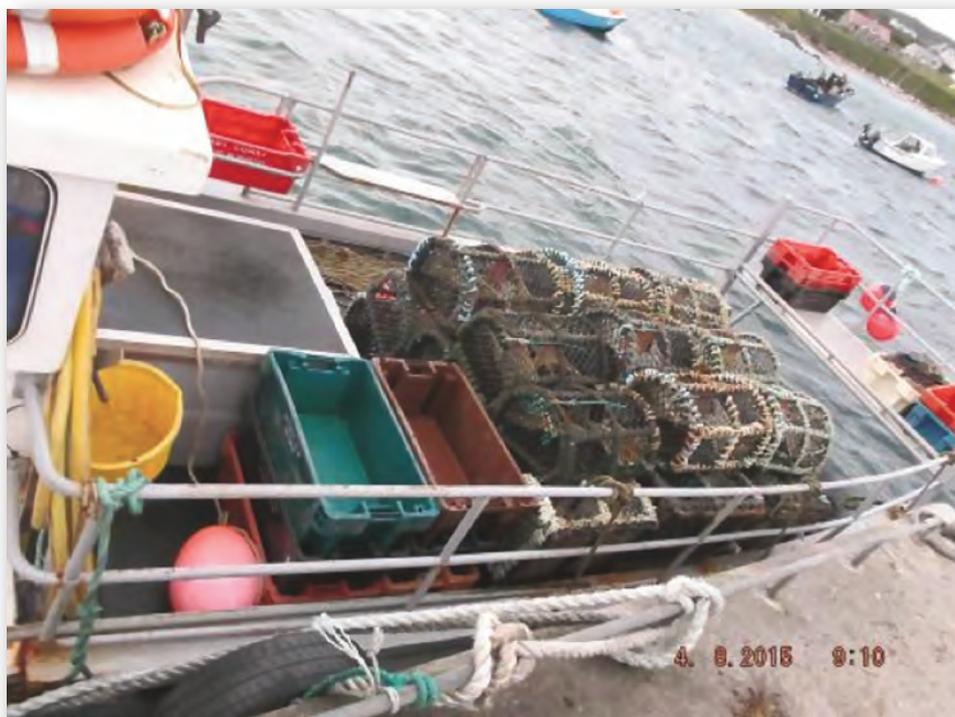
- 3.6.1 As the string of pots was recovered the pots were placed in a cradle at the starboard side rails (see Appendix 7.1 Photograph Nos. 4 & 5). The pots were emptied and then baited. They were then set out on deck. The string contained 40 pots and was of 10 mm Powerflex rope (approximately six full coils of rope were used to make the string). The riser element at each end was fitted with a buoy bearing the vessel's fishing number and was approximately 60 fathoms in length. At the 60 fathom end, a small section of anchor chain was attached, with a weight of 25 kg. The pots were attached to the line using toggles set through loops in the line and spaced at 15 fathoms (see Appendix 7.1 Photograph No. 6). The line was flaked on deck on the starboard side.

Photograph No. 4 - Vessel with pots set up for shooting string

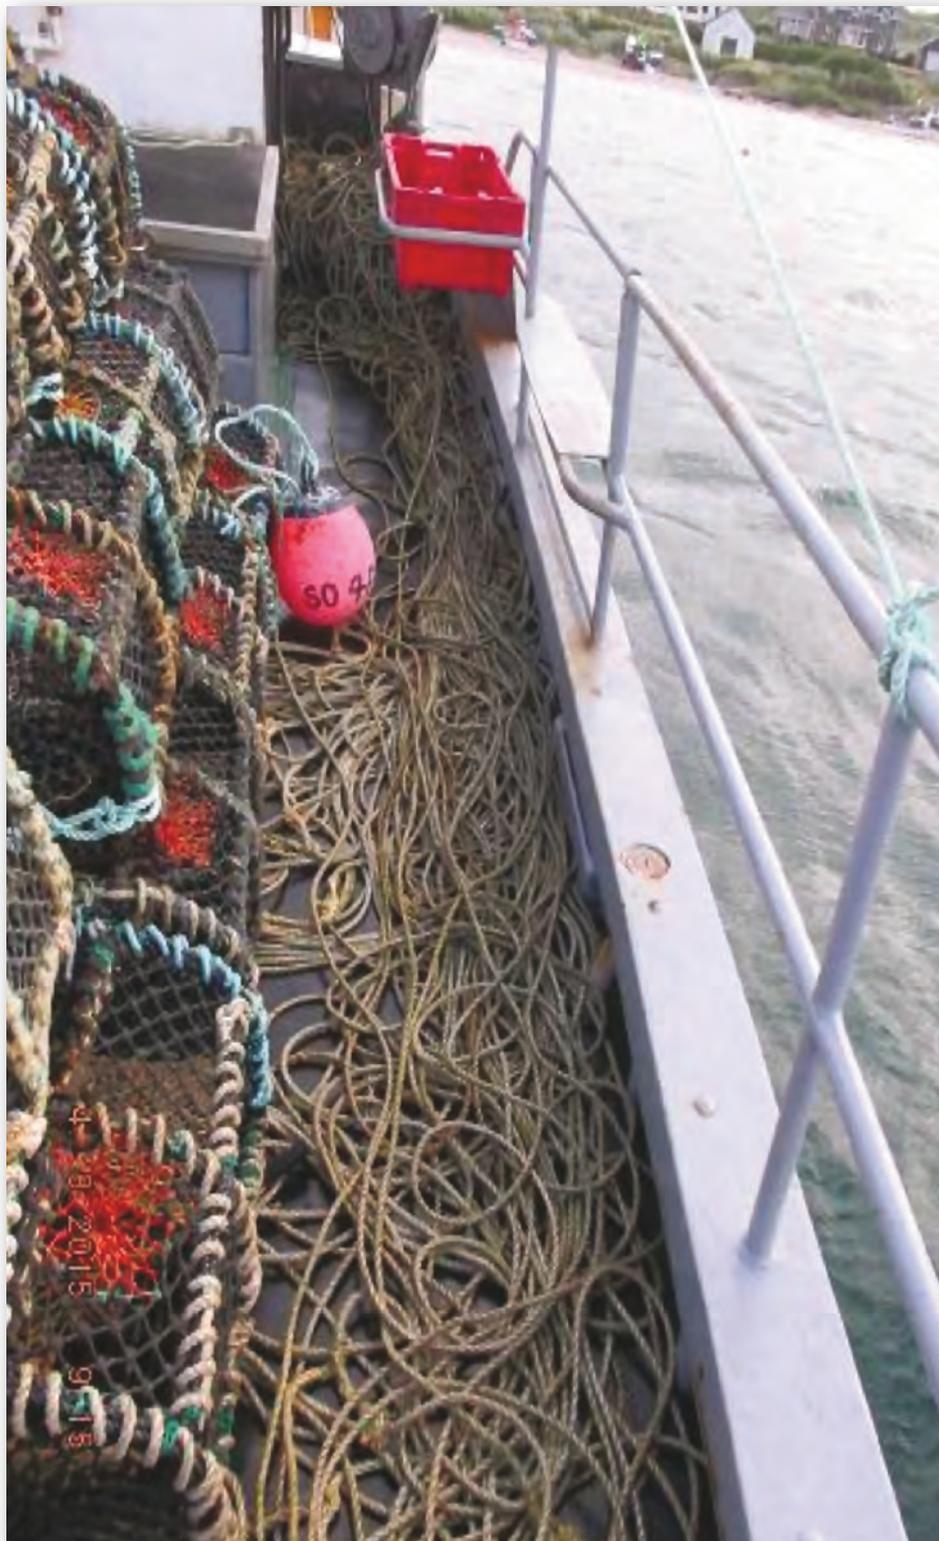
Photograph No. 5 - View along starboard side, fish box in cradle for catch and new top section of rail in place at opening for landing pots

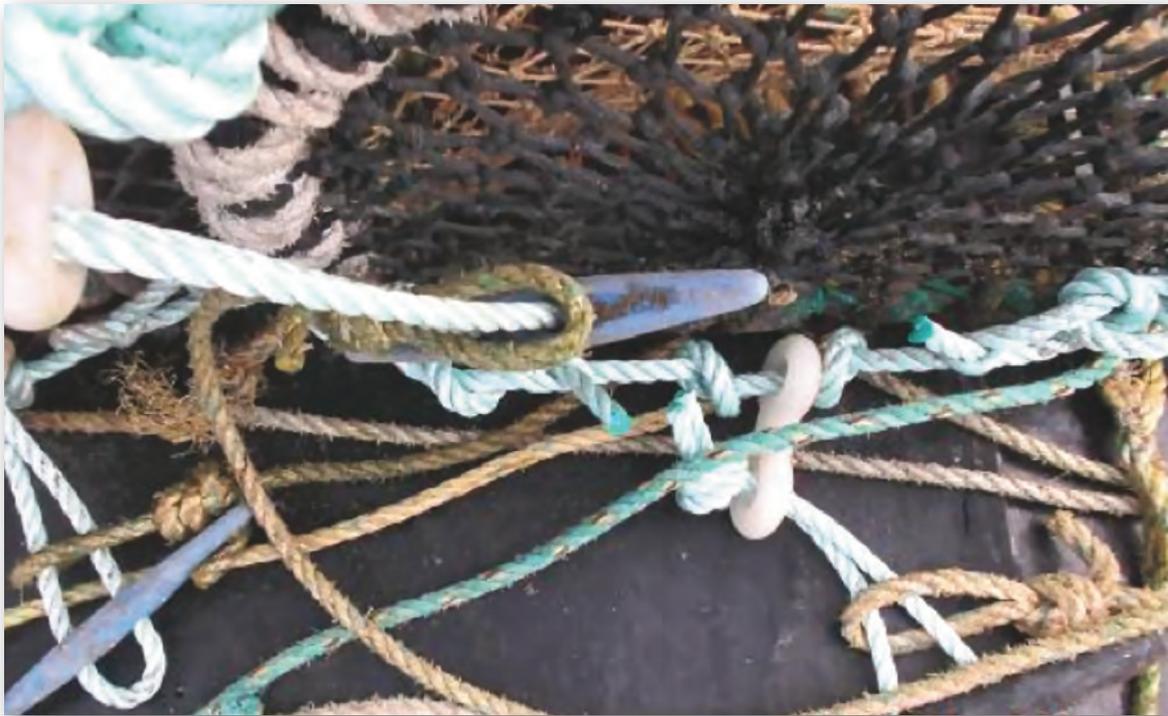
Photograph No. 6 - Toggle on pot set through loop in string

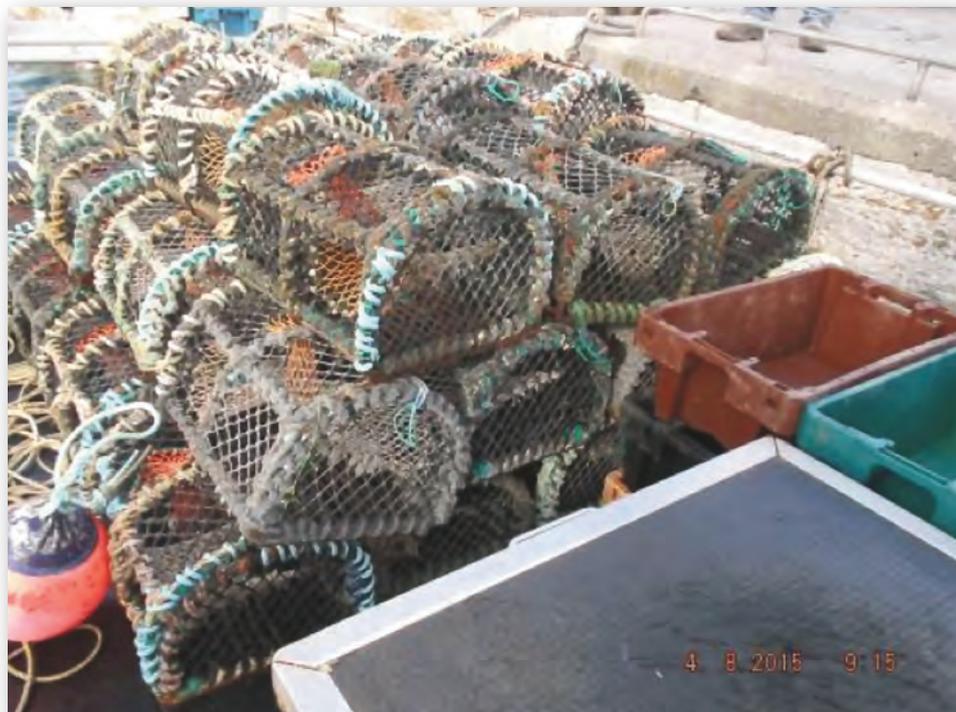
- 3.6.2 The arrangement was viewed on the deck of the vessel on the 4th August 2015. It was noted that with the main rope element flaked out on deck the only clear deck space was between the stern and the aftermost row of pots and there was a small area immediately aft of the engine access hatch (see Appendix 7.1 Photograph No. 7).

Photograph No. 7 - Space between front of pots and engine hatch where casualty was last seen

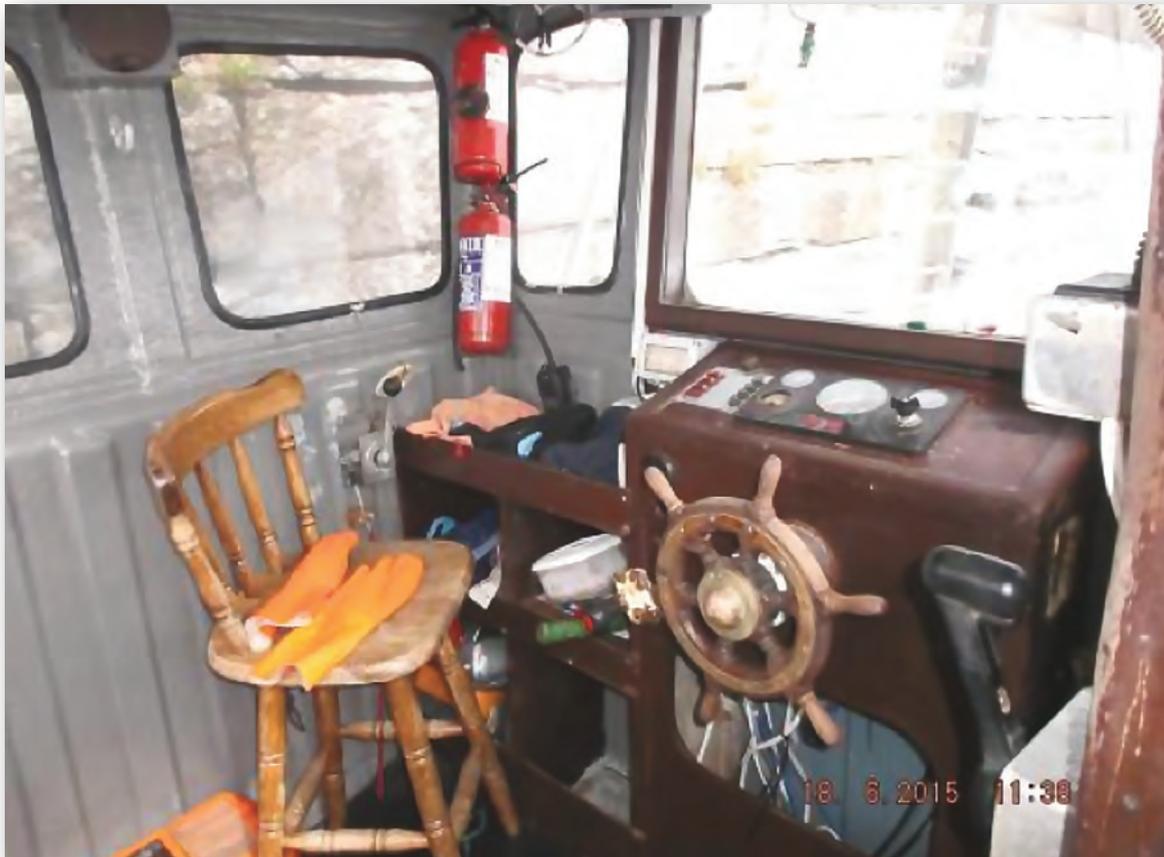
3.6.4 As the vessel approached the position, the Skipper brought the “Morse” type lever to the neutral position. He also ensured the power to the pot hauler was disengaged. The throttle lever was on the starboard side of the wheelhouse. On the port side of the wheelhouse there was a lever for engaging or disengaging the hydraulic pump for the pot hauler. The hauler was controlled by a lever on the unit. A joystick control was fitted on the starboard side (inside) of the wheelhouse to enable the Skipper to control rudder movements whilst operating the pot hauler (see Appendix 7.1 Photograph No. 8).

Photograph No. 8 - Inside wheelhouse. Engine throttle lever on right and hydraulic pump control on left beside chair
