**REPORT OF THE
INVESTIGATION INTO
THE FATAL INCIDENT ON-BOARD
'FV OILEÁN AN ÓIR'
AT THE PORT OF KILLYBEGS,
CO. DONEGAL
ON
24th AUGUST 2015**

**REPORT NO. MCIB/246
(No. OF 2016)**

Report MCIB/246 published by The Marine Casualty Investigation Board.
Printed 23rd August 2016.

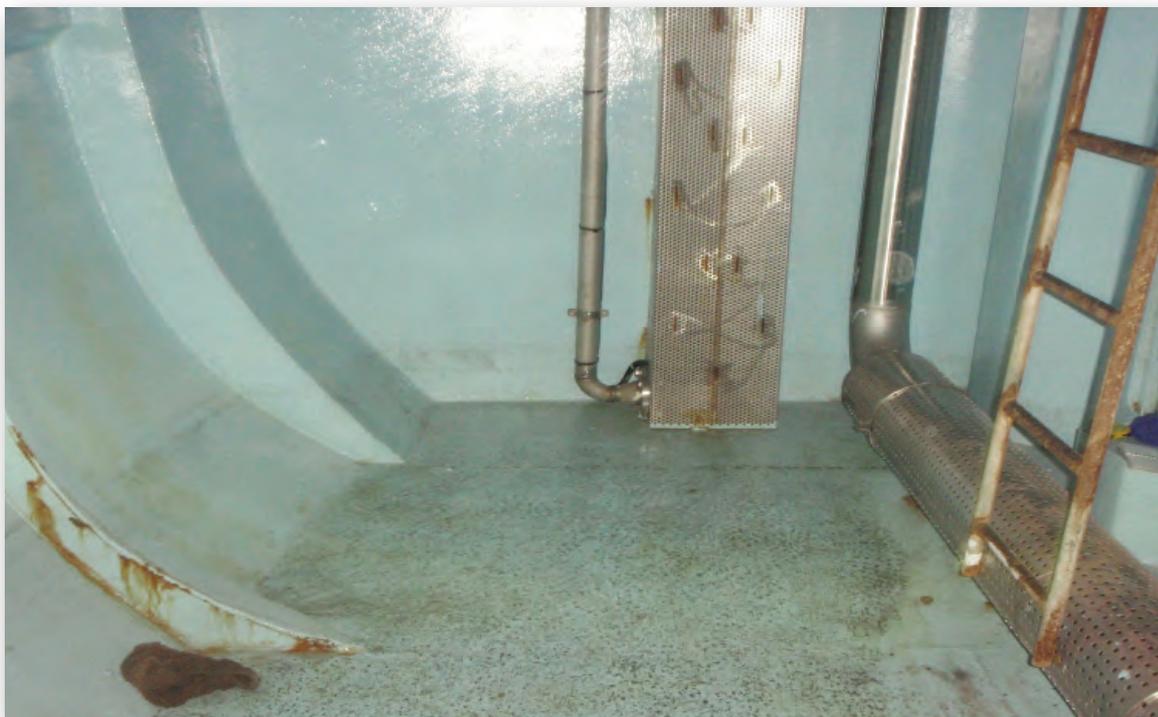
Photograph No. 2: Port Side Refrigerated Sea Water Tank.

The Port Side Refrigerated Sea Water Tank:
See Appendix 7.1: Photograph Nos. 2, 3 & 4.

Depth of scum mark on tank: 0.21 m forward 0.55 m aft.

Calculated volume of water that was pumped into the tank based on scum marks on tank sides: 4.3 m³.

- 3.3.5. Calculations, from scum marks on the tank sides described earlier, indicate that Crewmembers 1 and 2 stopped pumping water into the port side RSW tank at about 4.3 m³ volume, when it was noted that the water in the port tank was dirty.

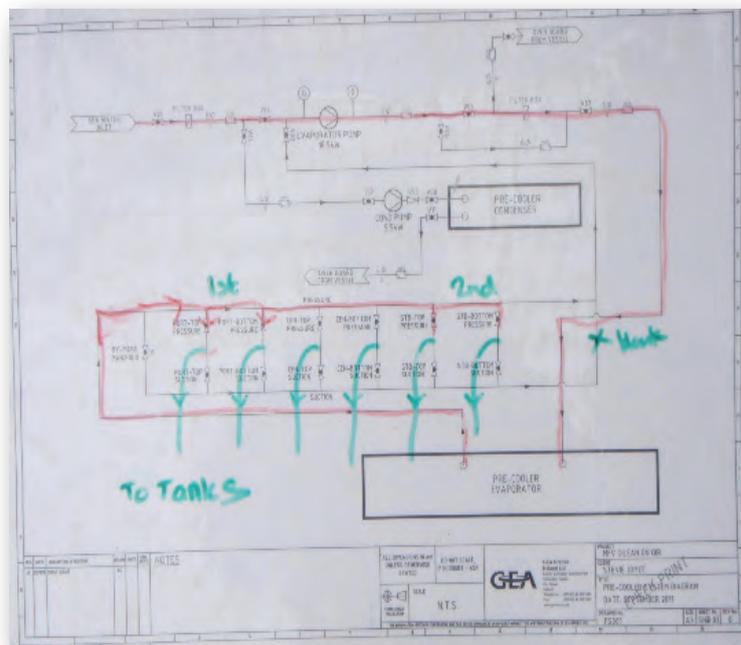
Photograph No. 5: Refrigerated Sea Water System.

The RSW piping system is stainless steel grade 316. The piping from the seawater inlet valve chest to the Pre-cooler Evaporator Pump is 200mm nominal bore. The remainder of the refrigerated system piping is 150mm nominal bore.

On the 6th November 2015 the piping was measured at Rossaveal Harbour and the following volumes were calculated. All volumes are approximate (See Appendix 7.1 Photograph No. 5).

Section A: From the sea water inlet valve chest and filter to the Pre-cooler Evaporator Pump, 190 l.

Section B: From the Pre-cooler Evaporator Pump to the valve before the filter on the main deck, 271 l.

Section C: From the valve before the filter on the main deck to the pre-cooler heat exchanger and the distribution manifolds, 574 l.

Section D: The circulating pipe work from the distribution manifolds to the suction side of the Pre-cooler Evaporator Pump, 447 l.

The total approximate volume 1,482 - litres \approx 1.5-mtr³ (1.5-tonnes).

- 3.4.2. Water samples from the RSW system and the harbour were taken for analysis. Among the samples, three were taken as set out below (See Appendix 7.1: Photograph No. 5):

- 3.4.9. The results are as follows:
- Samples generally less than 10-µg/ltr.
 - Filter on main deck 870-µg/ltr.
 - Circulating line (sample taken by MCIB) 2,200-µg/ltr.

4.2. The most salient finding in regard to the source of the contamination was the high level of toxicity found when the water contained in the circulating line that was released to the atmosphere on the 4th September 2015 as described above. The reason being that when Crewmembers 1 and 2 set up the RSW system to pump water into the port and starboard side RSW tanks there would have been no necessity for them to open the valve on the circulation line adjacent to the suction of the evaporator pump or the suction valves on the manifold. The circulating line is only brought into service at a later stage in the process as described in Section 3.2 above. Thus there would have been no movement of fluid in the circulating line pipework (See Factual Information, pipework Section D) in the period leading up to the incident and it would have contained the same residual water (447 l) after the incident as it had contained before the incident. This water would have been of the same age as the dormant water that existed in the RSW system (See Factual Information, pipework Section C) which was pushed ahead of and displaced by the sea water that was pumped through the RSW system and into the tanks. Thus it follows that there is a direct correlation in the levels of contamination between the quality of the water in pipe Section C and pipe Section D.

- 5.3. The source of lethal levels of hydrogen sulphide (H_2S) and elevated levels of ammonia (NH_3) was the dormant water that existed in the RSW system Section C.

- 6.1. It is recommended that the Minister for Transport, Tourism and Sport issue a Marine Notice warning crews on fishing vessels of the hazards associated with toxic gas generation and retention in RSW systems and that a notice highlighting these dangers be displayed on vessels fitted with RSW systems. It is recommended that the Marine Notice may include details on enclosed space entry techniques, raising awareness of calibrated atmospheric monitoring systems, either permanent or hand held and rescue techniques.
- 6.2. It is recommended that the Minister for Transport, Tourism and Sport considers mechanisms to address the safety in respect of design, construction and operation of RSW systems and the generation of toxic gases as in this case.

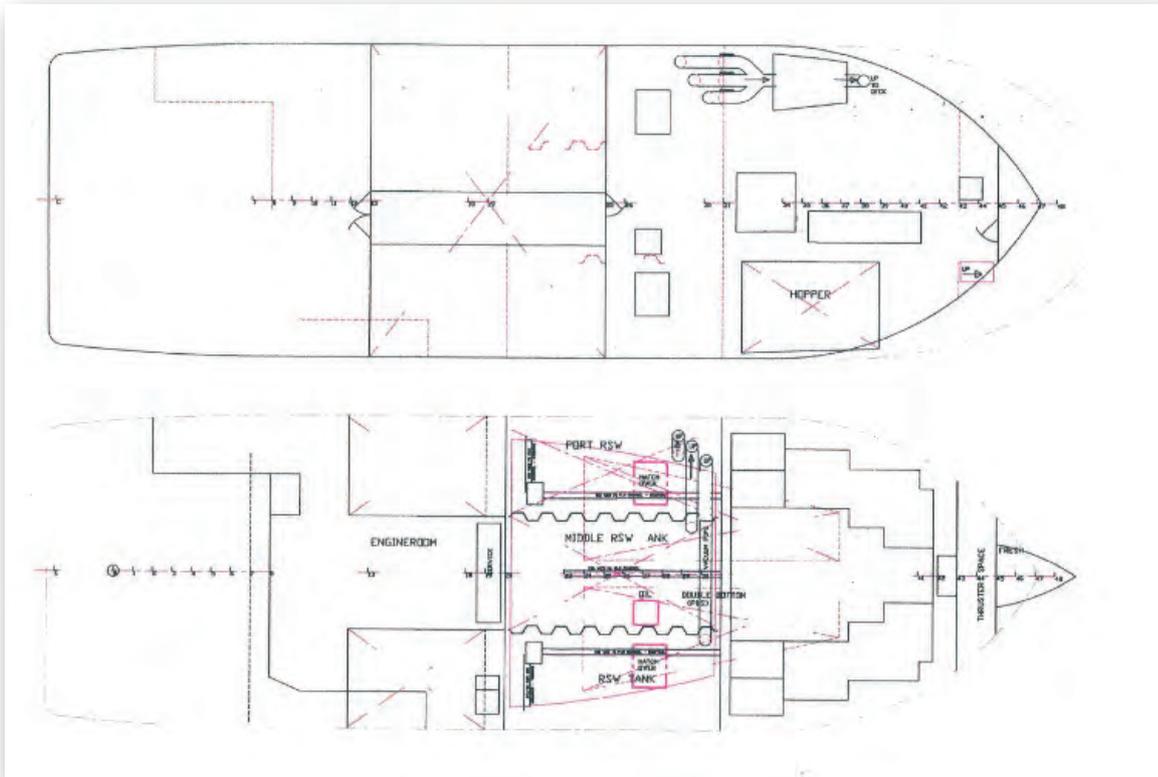
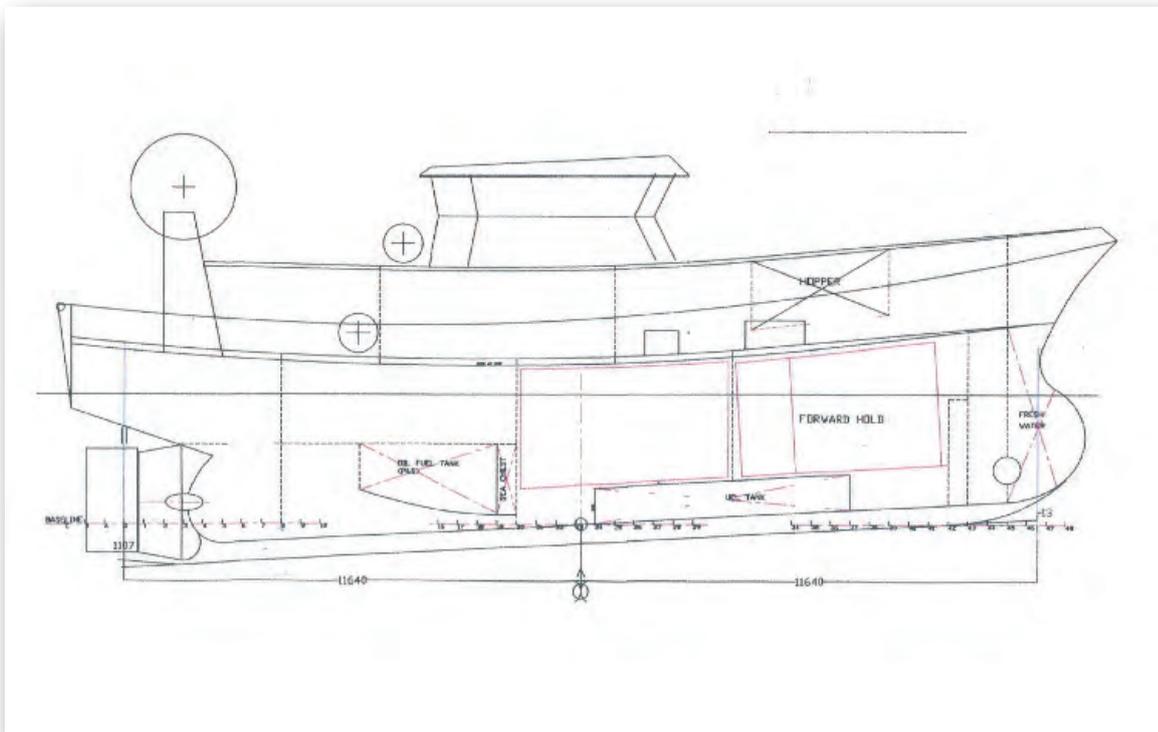
Appendix 7.2 Drawings of Vessel 'FV Oileán an Óir'.

- 3.1.6. Not shown on the drawing of the RSW system at Appendix 7.2, is an off-take connection on the seawater supply pipe located after the pipe rises through the main deck and before the filter box on the main deck. A spigot attached to the off-take valve provides the facility for the attachment of a hose. The off-take gives the flexibility to use the pre-cooler evaporator pump for general purposes.
