**REPORT OF INVESTIGATION INTO
AN INCIDENT INVOLVING THE
CAPSIZED NAB 21 DORY,
'JILLIAN'
OFF SALTEE ISLANDS,
KILMORE QUAY,
CO. WEXFORD
ON
29th AUGUST 2015**

**REPORT NO. MCIB/247
(No.2 OF 2016)**

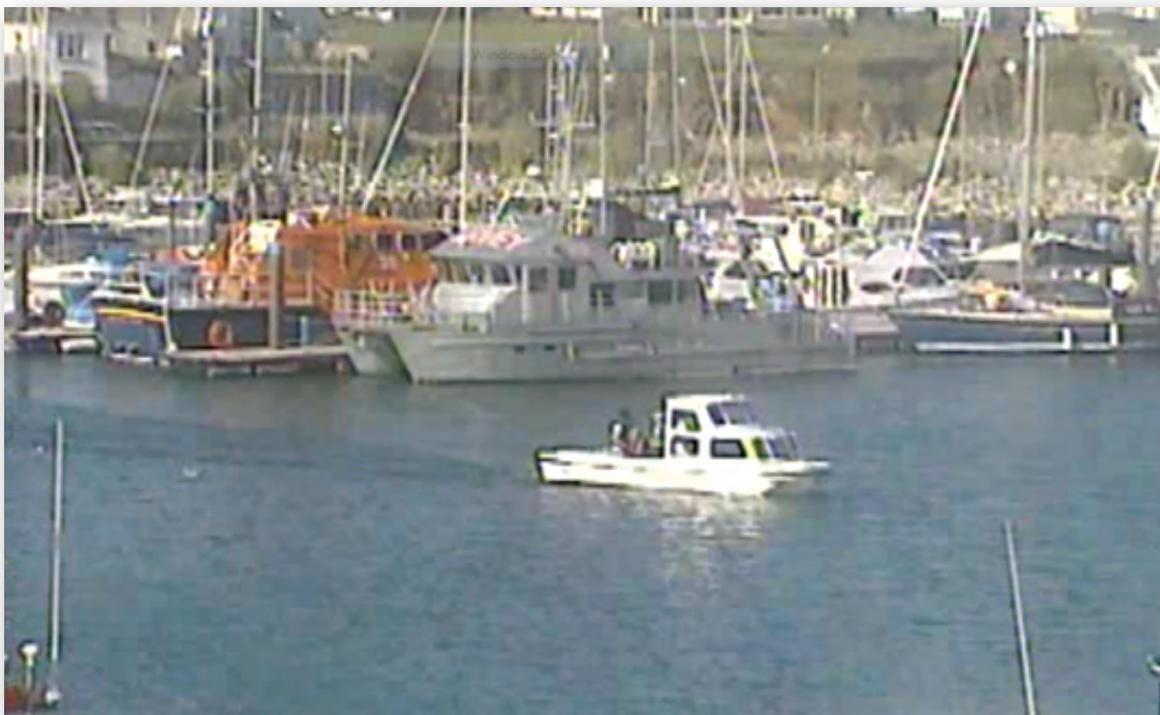
- 3.1.4 Kilmore Quay harbour is covered by CCTV cameras and footage of the vessel leaving the harbour shows that the vessel appeared to be low in the water (See Appendix 7.3 Photographs 1 and 2).

- 4.1 The CCTV footage from the harbour shows the vessel as sitting quite low in the water, therefore it is considered likely that with ten people on-board the vessel was overloaded (see photographs 1 and 2 in Appendix 7.3).

Photograph 1 - CCTV still photograph of “Jillian” before picking up final passengers.

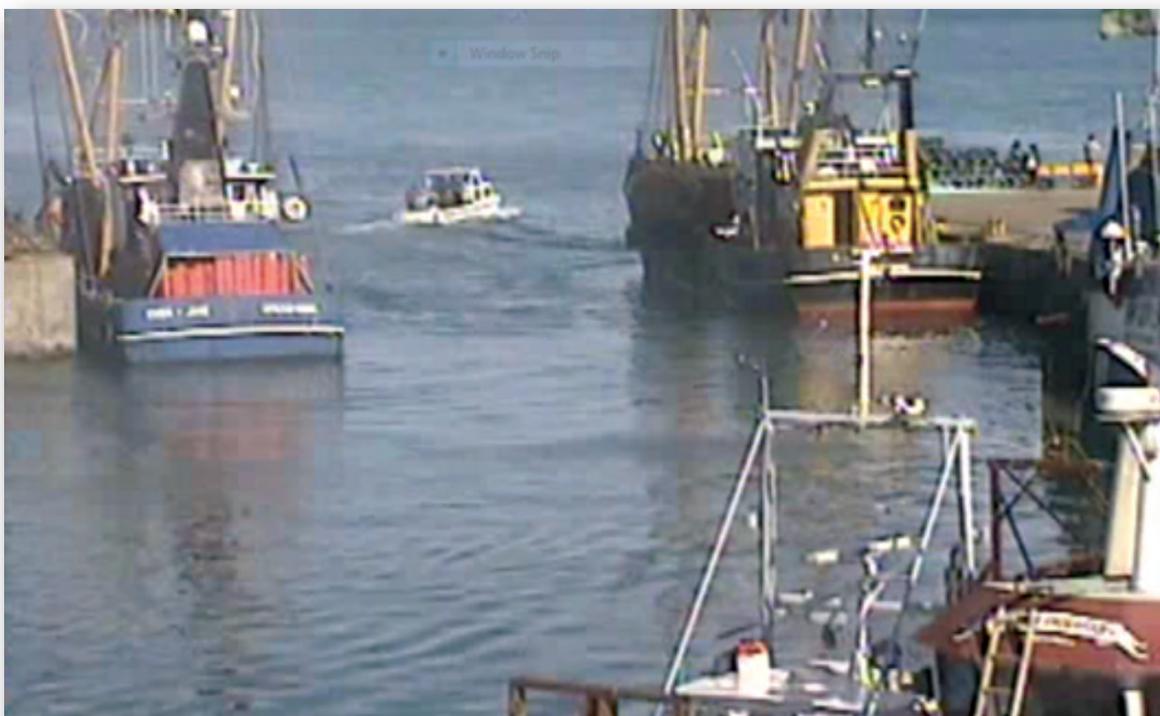
Photograph 2 - CCTV still photograph of “Jillian” leaving the harbour with 10 people on-board.

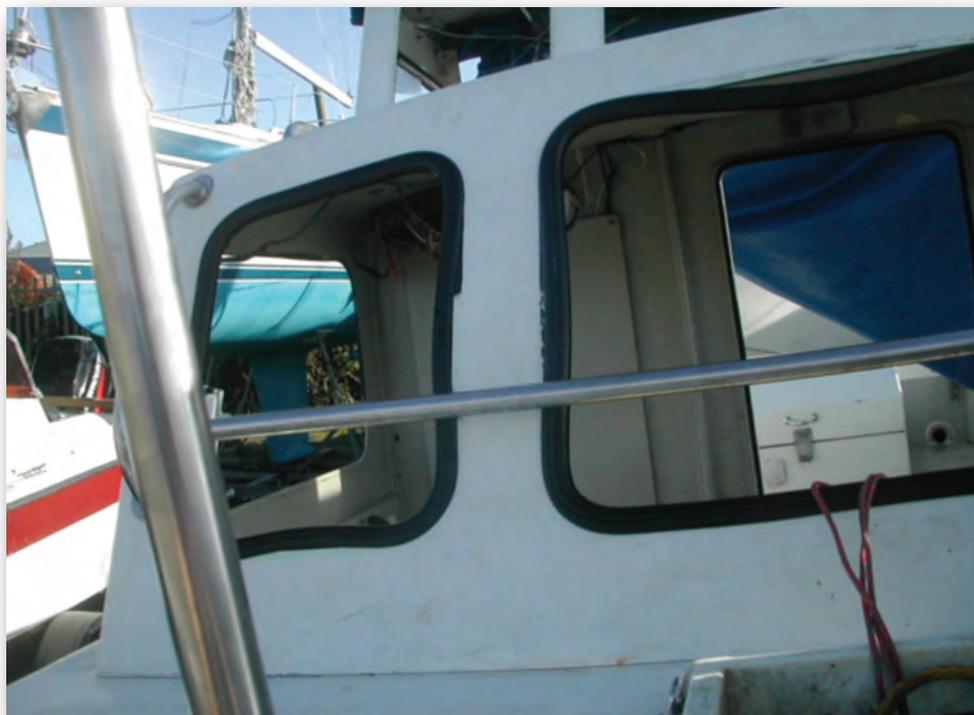
- 3.2.1 At 18.50 hrs, as the “*Jillian*” proceeded between the islands, witnesses stated that a wall of water thrown up by the flow of water through the gap came over the bow. With the additional weight of the two persons on the foredeck, the bow was lower in the water than it should have been. This allowed the waves to crash into the front of the cabin/wheelhouse, forcing the Perspex windows from their frames and allowing a significant quantity of water to enter the cabin, flooding it instantly (See Appendix 7.3 Photograph 3).

- 4.2 The seas between Little and Great Saltees are known to be rough at certain stages of the tide, causing a short and sharp chop. This combined with the positioning of two crew forward of the cabin, caused the bow to settle very low and contributed to the waves breaking over the bow and knocking out the perspex windows.

- 4.4 The perspex windows at the front and sides of the cabin and wheelhouse were held in place with a PVC bead. This was an original feature, however, it seems that on later versions of this type of boat the perspex windows were through bolted to the cabin/wheelhouse.

Photograph 3 - Damage to forward facing windows suffered by “*Jillian*” during the incident.

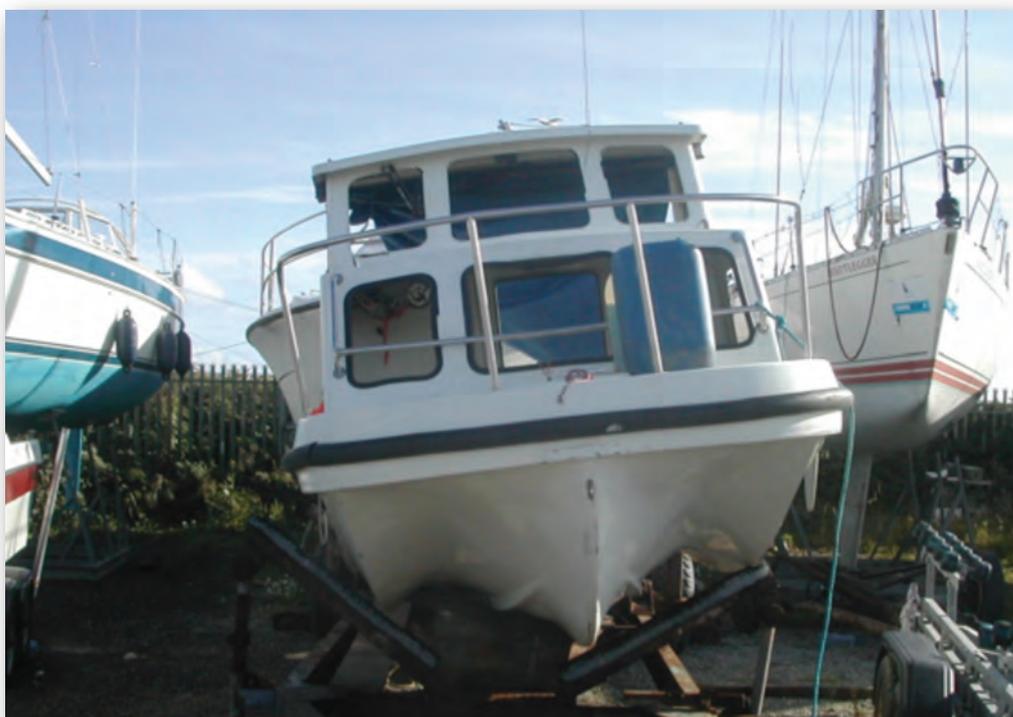
- 3.3.13 The “*Jillian*” was later recovered and brought ashore (See Appendix 7.3 Photograph No.4).

Photograph 4 - “*Jillian*” ashore following recovery.
