**REPORT OF INVESTIGATION  
INTO LOSS OF THE  
FV "AMY JANE"  
13 MILES NORTH OF  
MALIN HEAD, CO. DONEGAL  
ON  
7th OCTOBER 2011**

**REPORT No. MCIB/207  
(No.11 of 2012)**

Report MCIB/207 published by The Marine Casualty Investigation Board  
Printed 30th October 2012.

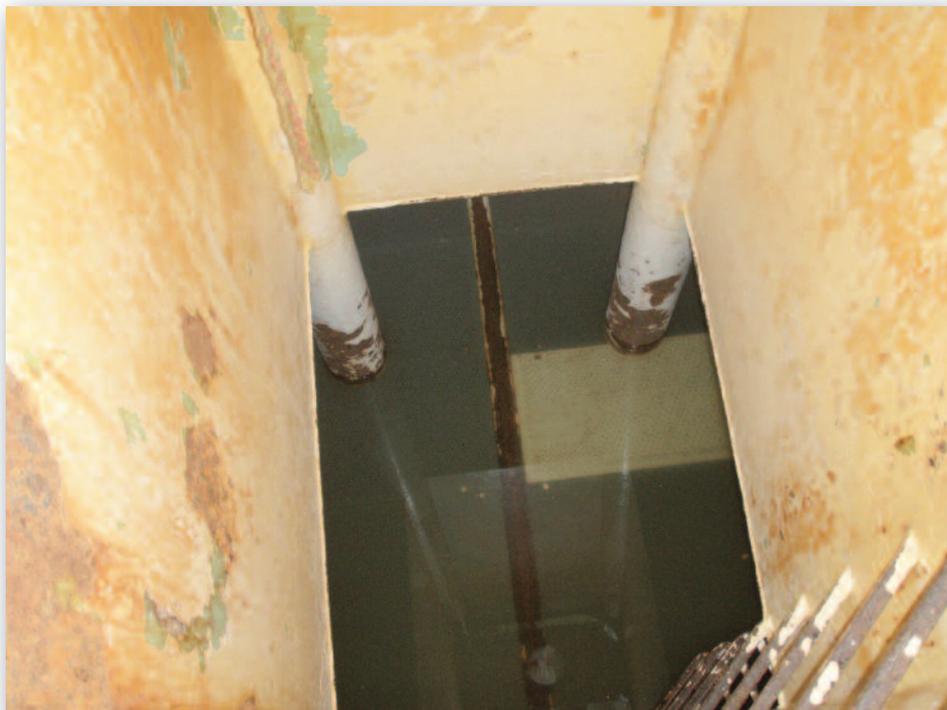
The Vivier system was known to have a corrosive environment. Anodes had been fitted inside the tank to combat corrosion of the welds, and pipe work had been replaced. Routine thickness readings of the tank top, trunking and pipe work were not taken. It is possible that the tank top or trunking to the main deck ruptured - see Photos 1 and 2, Appendix 6.2.

Vivier tank trunking.

- 5.1 That the regulations for fishing vessels SI (2007) 640 should be changed to include a requirement for bilge alarms in compartments such as holds and stores which extend below the waterline.
- 5.2 Consideration should be given to when next updating the survey guidelines to include requirements for the Vivier systems, if fitted.

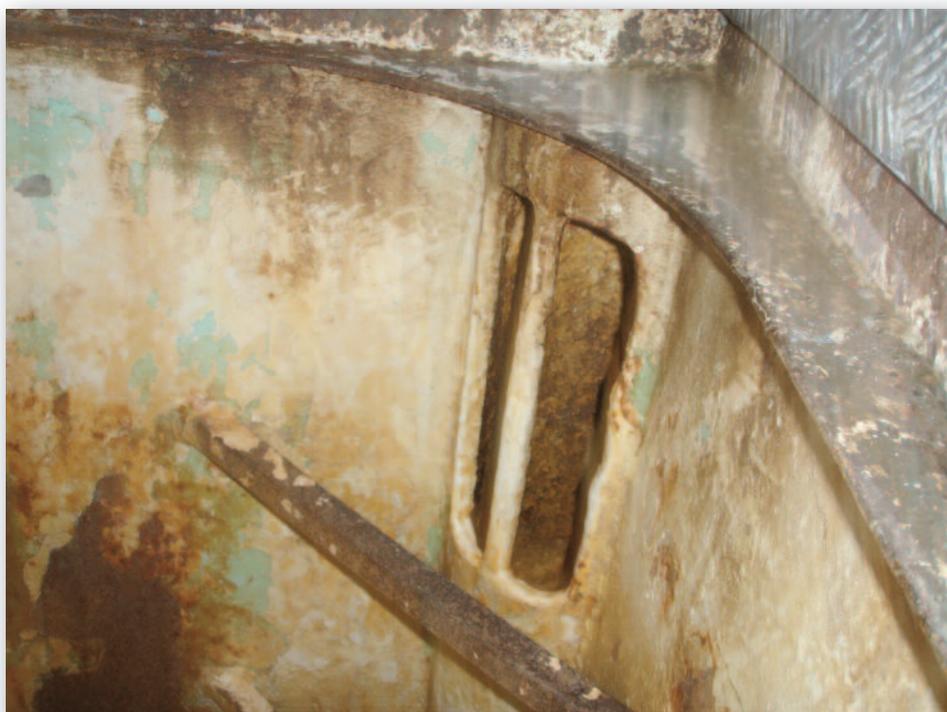
Top of Vivier tank, edge of bait store visible.

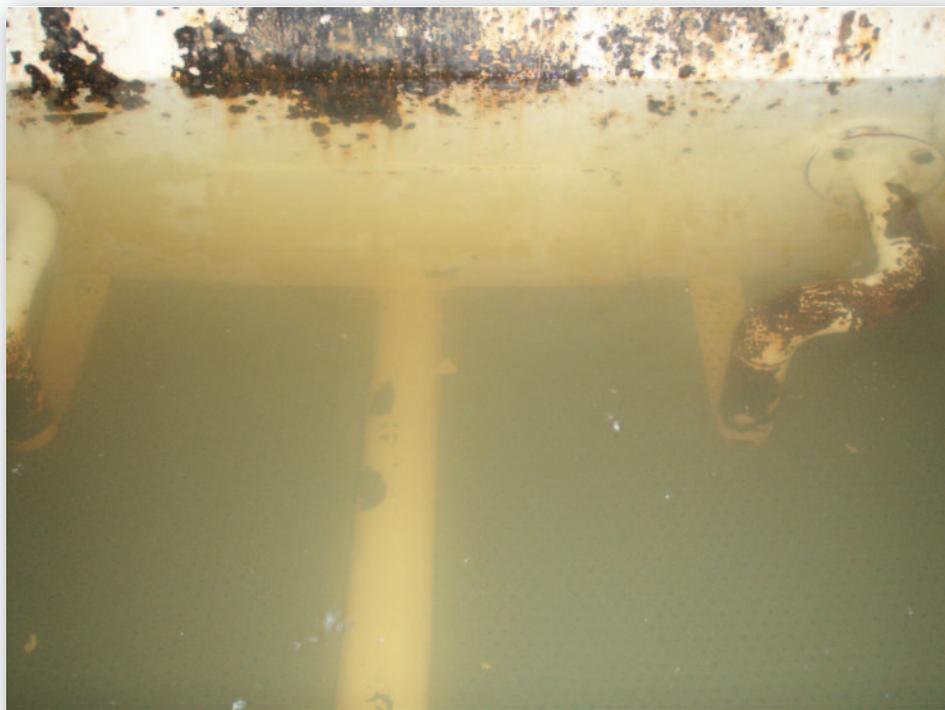
The bilge line was within the Vivier tank and subject to the same corrosive

environment. Failure of the line would result in water backfilling through the line into the pot store as there were no non return valves on the suctions - see Photo 3, Appendix 6.2.

Pipework within tank.
