**REPORT OF INVESTIGATION
INTO THE GROUNDING OF
“ARKLOW RAIDER”
AT
RIVER BOYNE ENTRANCE
16th NOVEMBER 2010**

**REPORT No. MCIB/195
(No.8 of 2012)**

Report MCIB/195 published by The Marine Casualty Investigation Board
Published 17th September 2012.

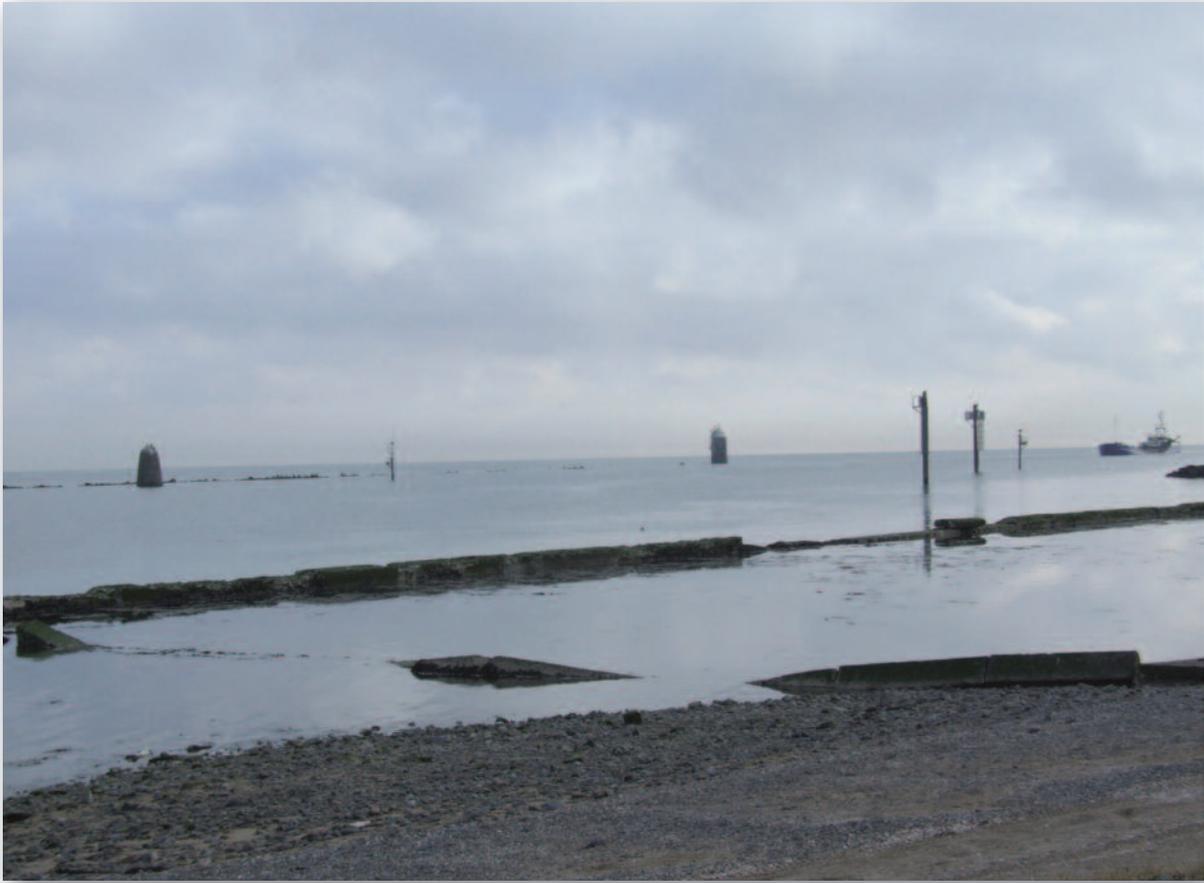
Appendix 8.2 Training wall inside Aleria Light submerged.

the training wall extends to eastward between the Tower Light and the Lyons Light. In certain tidal conditions this training wall is submerged to a depth of 0.7 metres. On the northern side the training wall commences just to eastward of the Bluff Light. Again, this extends to eastward and can be submerged to a depth between 0.1 to 0.7 metres, dependent on tidal conditions.

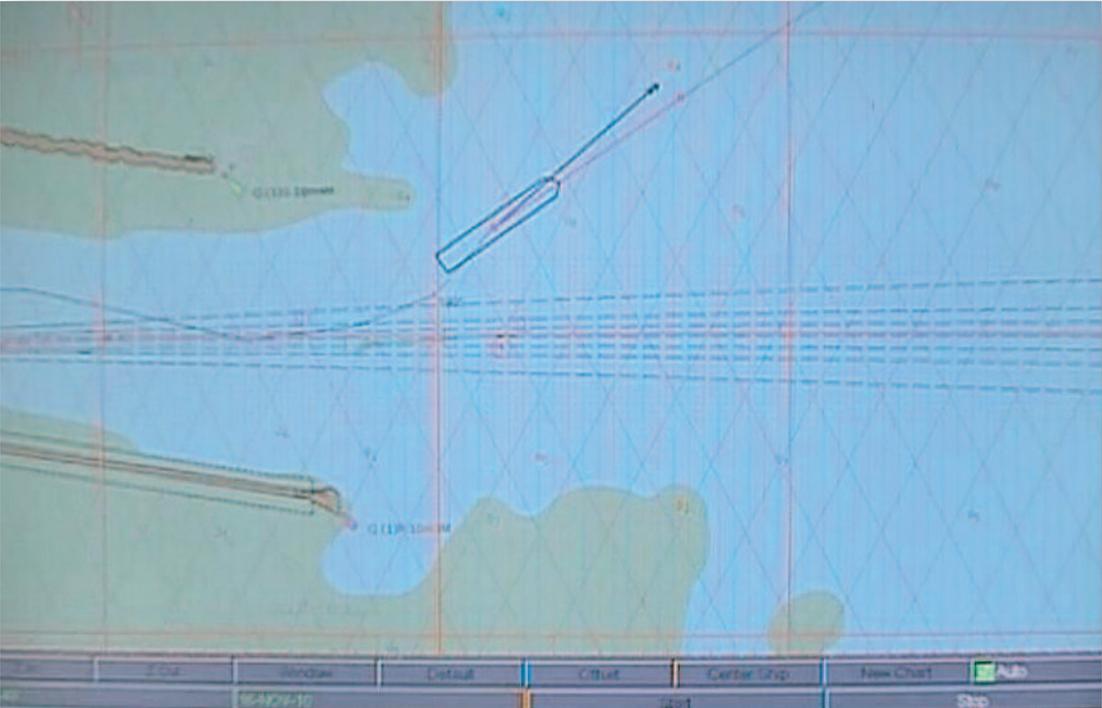
Photo 1

- 6.13 The Vessel Traffic Management System (VTMS) operated by the Port was preserved. However, it relied on AIS transmissions rather than GPS data and therefore the image produced tended to jump on the display. However, there was sufficient data to indicate the speed of the vessel and the time of the grounding was confirmed enabling the investigator to draw a conclusion with respect to the cause of loss.

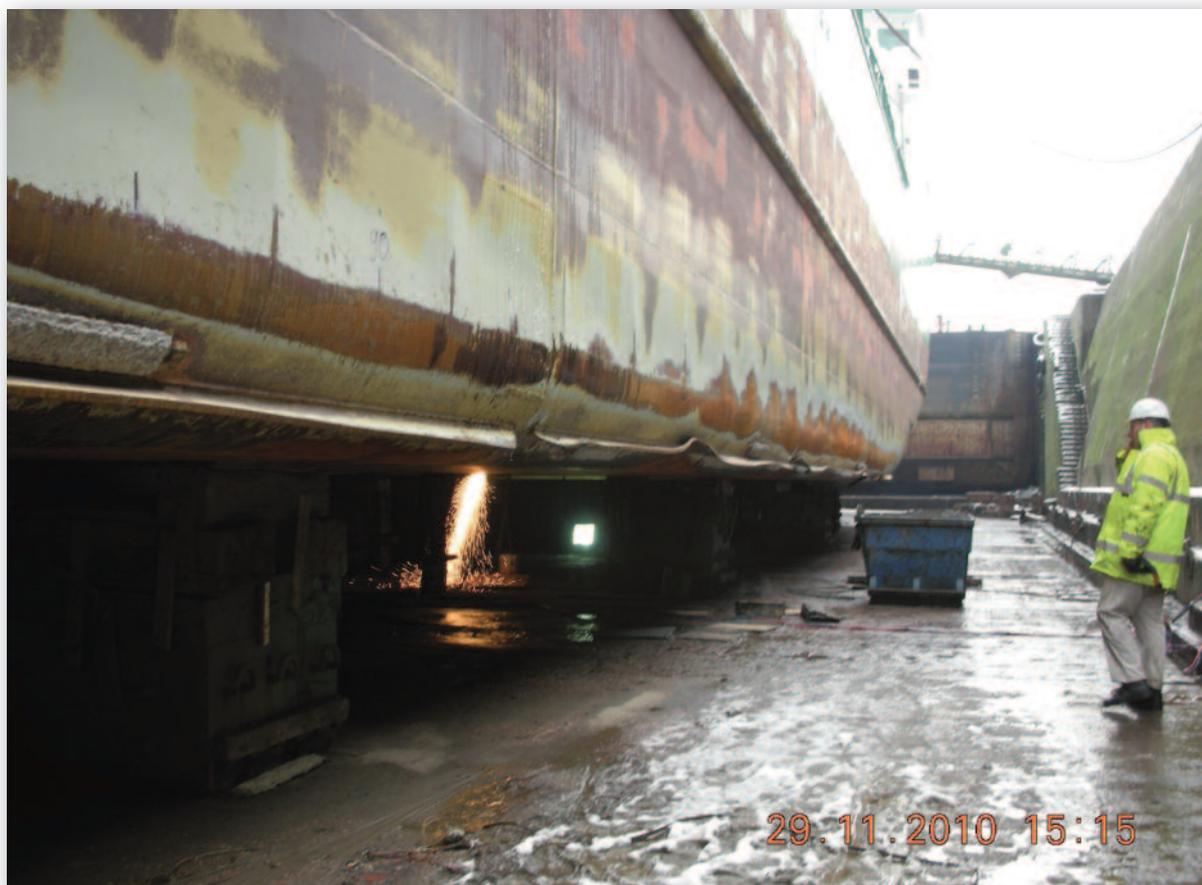
Appendix 8.5 Damage to port bilge keel.

- 6.17 The vessel suffered damage to the port bilge keel as shown in Appendix 8.5.

Most likely, the damage to the bilge keels would be as a result of the heave and pitch motion of the vessel immediately after the grounding north of the navigation channel caused in the immediate deterioration of the weather. This motion of the vessel is referred to in the Pilots and Harbourmasters reports. The vessel would have remained in motion until settling fully on the bottom with the ebb tide. This vessel motion would have been repeated on the following flood tide until the weather moderated.

If the ships bilge keel made contact with the seabed as you suggest, the impact would have been obvious to everyone on board, yet nobody felt anything. Any damage to the bilge keel would surely be caused after the grounding as the vessel was subjected to a severe pounding for a 24 hour period in a force 9 gale.

There was evidence of severe upward damage of a type associated with vessels lying aground on uneven hard stony ground, unsupported forward and aft. No tearing of the bilge keels from the hull as a result of bottom contact damage at 4 or 5 knots was apparent. Photographic evidence, including the one attached to the Draft Report, Appendix 8.3, shows upward damage to bilge keels of a type associated with lying on hard, uneven or stony ground. Undoubtedly there will be photographic evidence from other sources to back this up.
