**REPORT OF THE
INVESTIGATION INTO THE
FIRE AND SUBSEQUENT
DEATH OF ONE MEMBER
OF THE CREW ON THE
"ARKLOW VENTURE"
AT IRWELL PARK WHARF,
ECCLES, ENGLAND ON
TUESDAY JUNE 3RD 1997.**

The Marine Casualty Investigation Board was established on the 23rd, May 2002 under The Merchant Shipping (Investigation of Marine Casualties) Act 2000

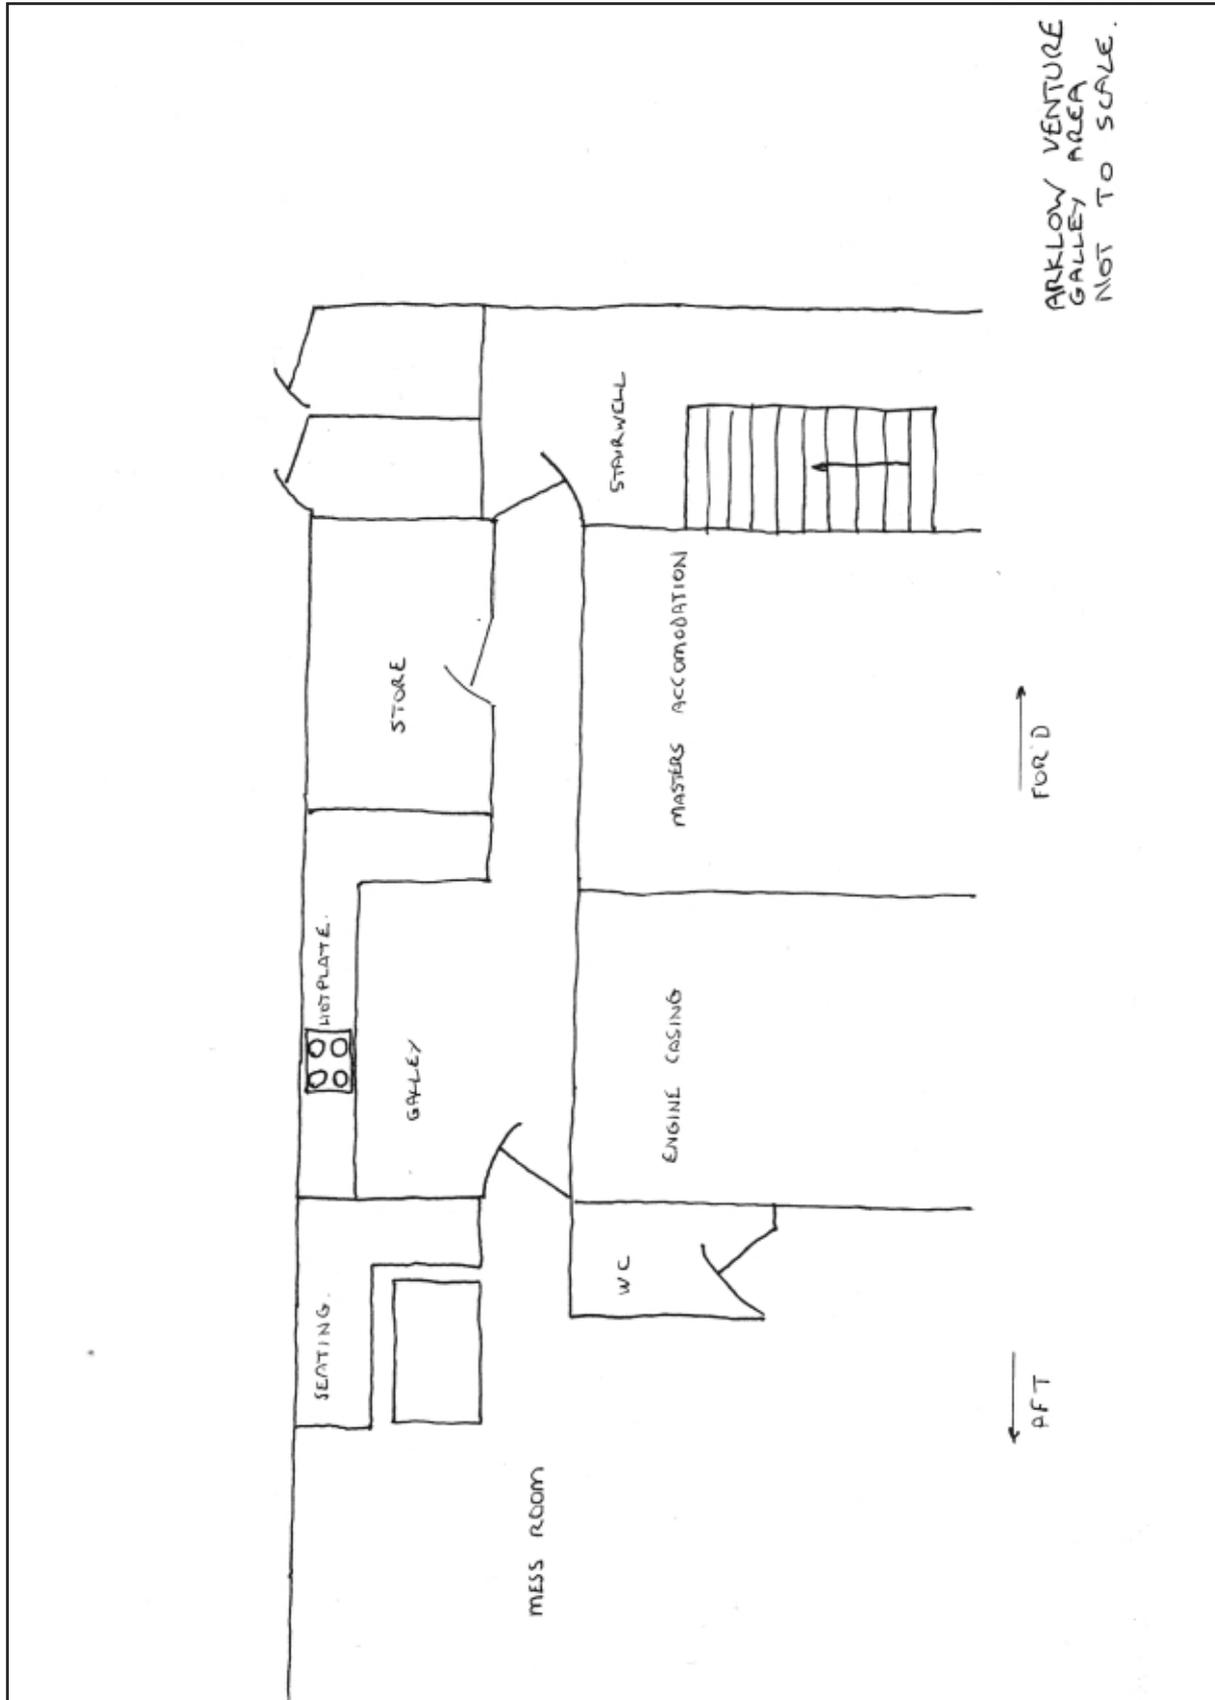
8.1 General plan of vessel in galley area

- 6.4 The doors at the forward and aft end of the galley being left open could have resulted in this incident being considerably more serious, the door if left closed would have prevented the fire and smoke from spreading to other parts of the ship if the fire had been of greater intensity or longer duration. The closed door leading from the forward stairwell to the bridge appears to have been effective in preventing smoke spreading to the bridge.

- 7.6 Fire doors should never be secured in the open position unless such securing involves a mechanism which will ensure that the door will close in the event of fire e.g. by remotely released magnetic devices or fusible links which will melt in a fire situation. Fixed hooks or similar devices must not be used.

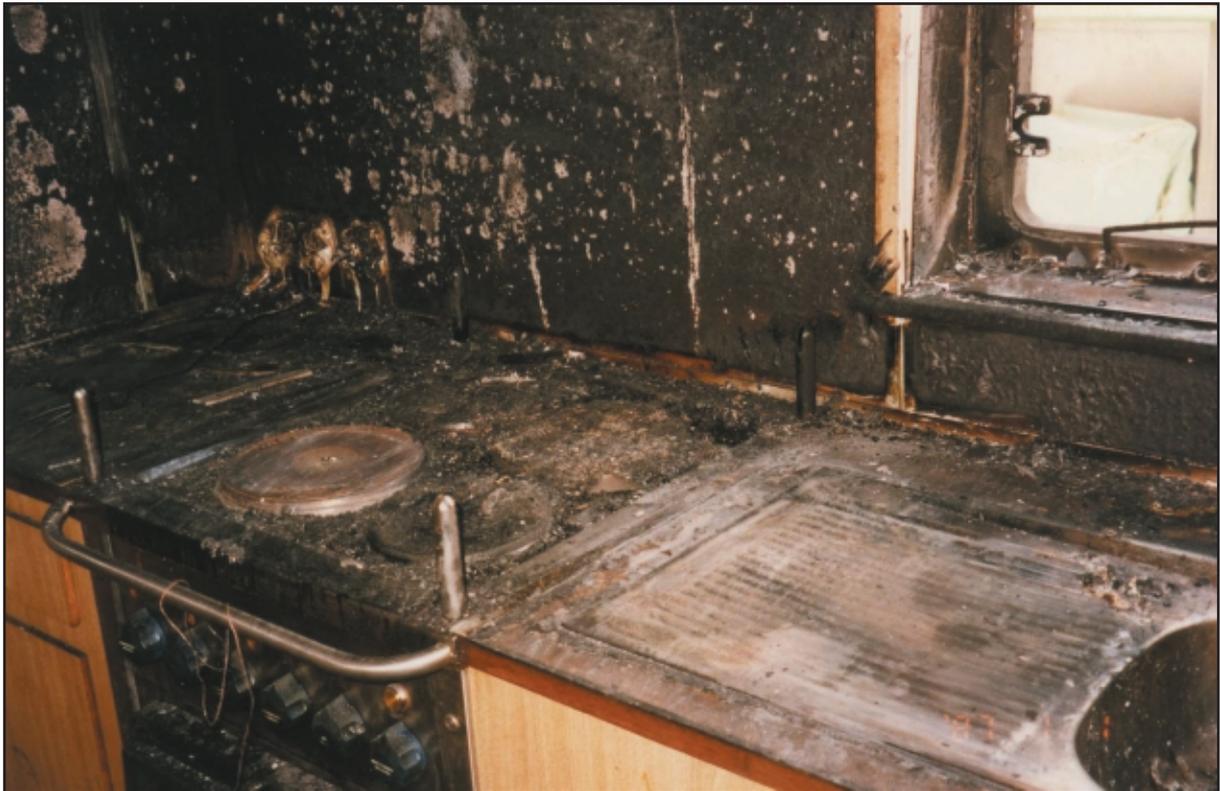
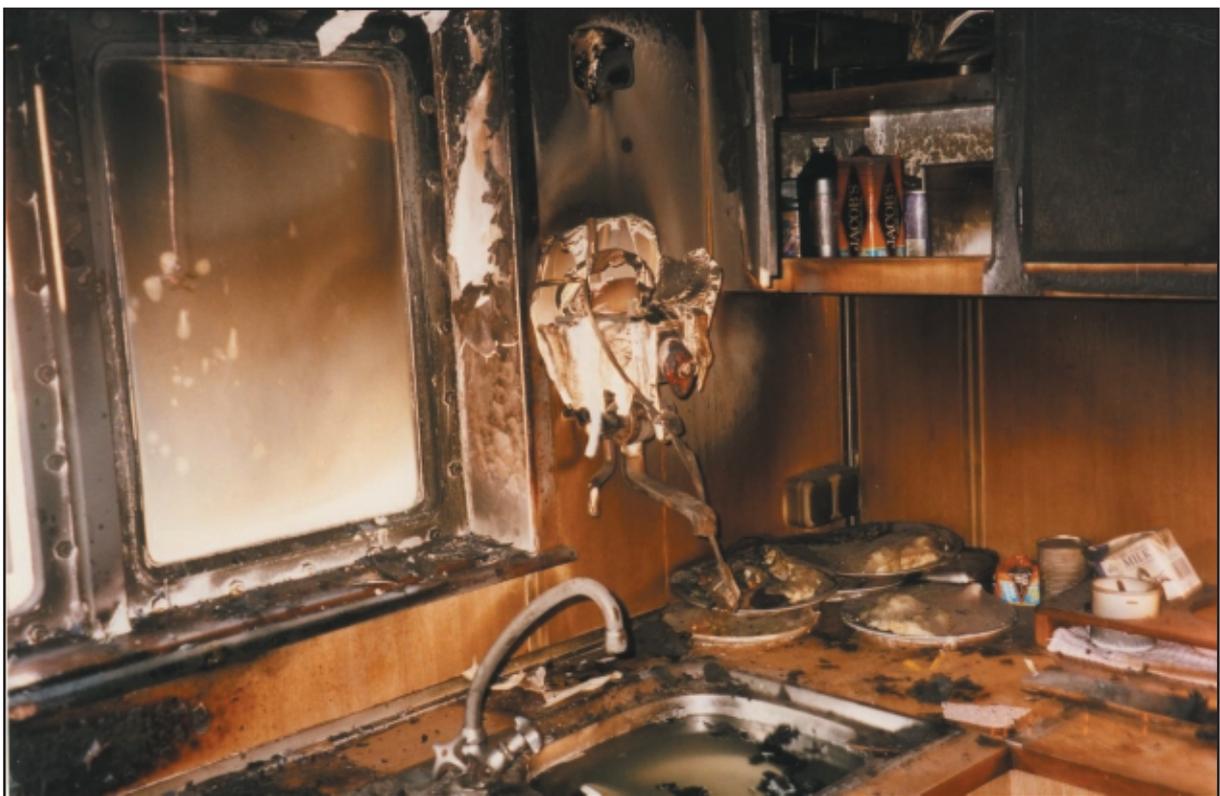
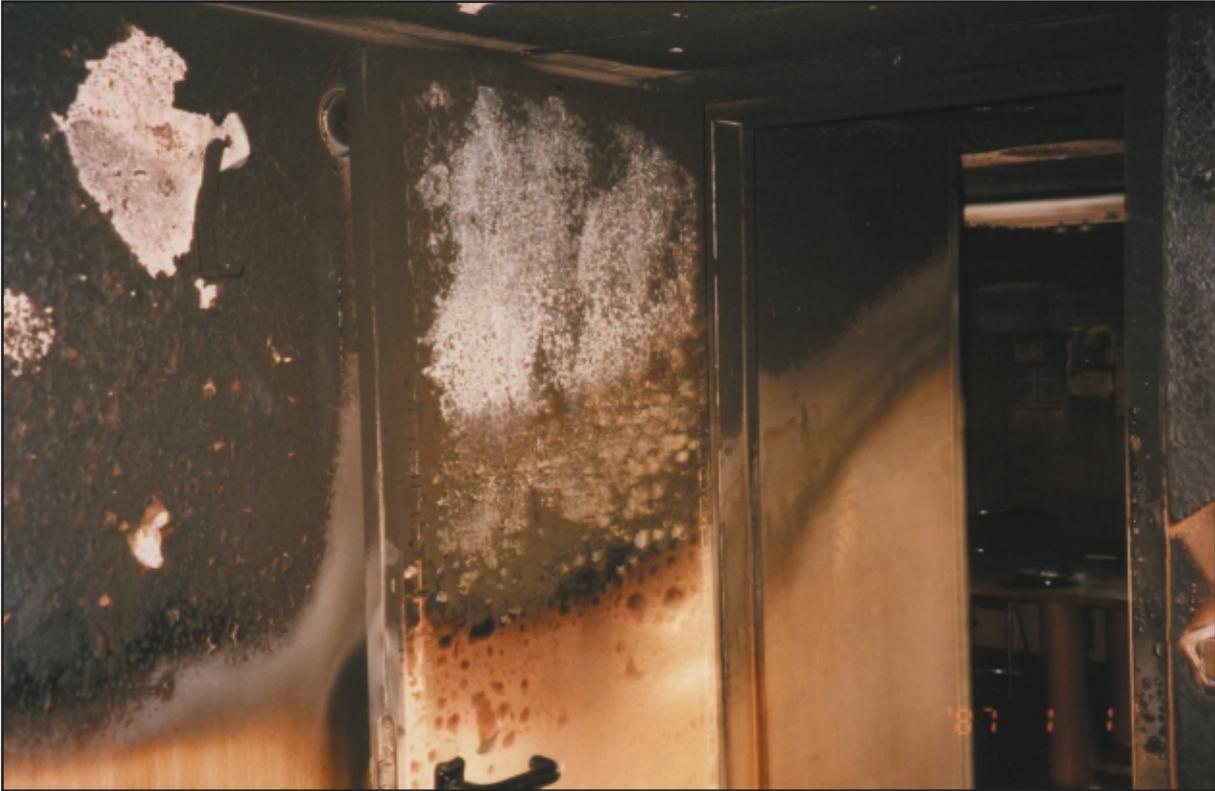
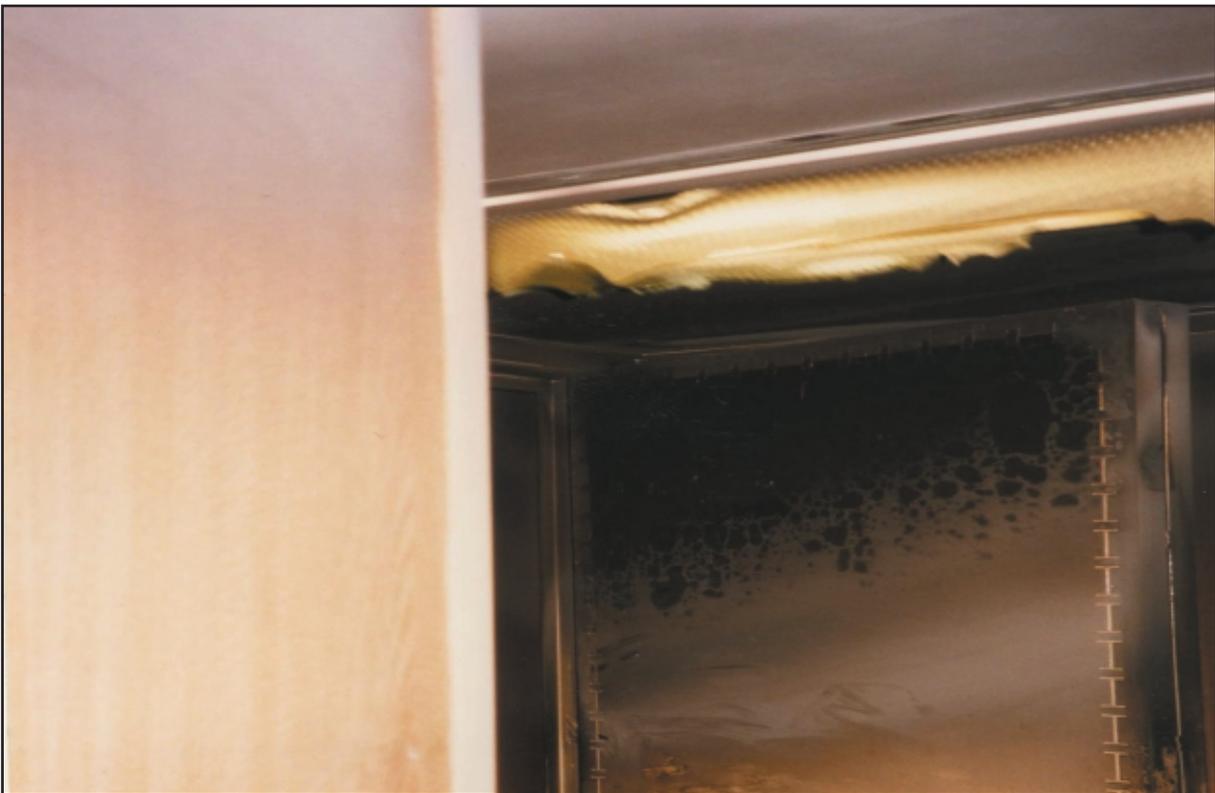
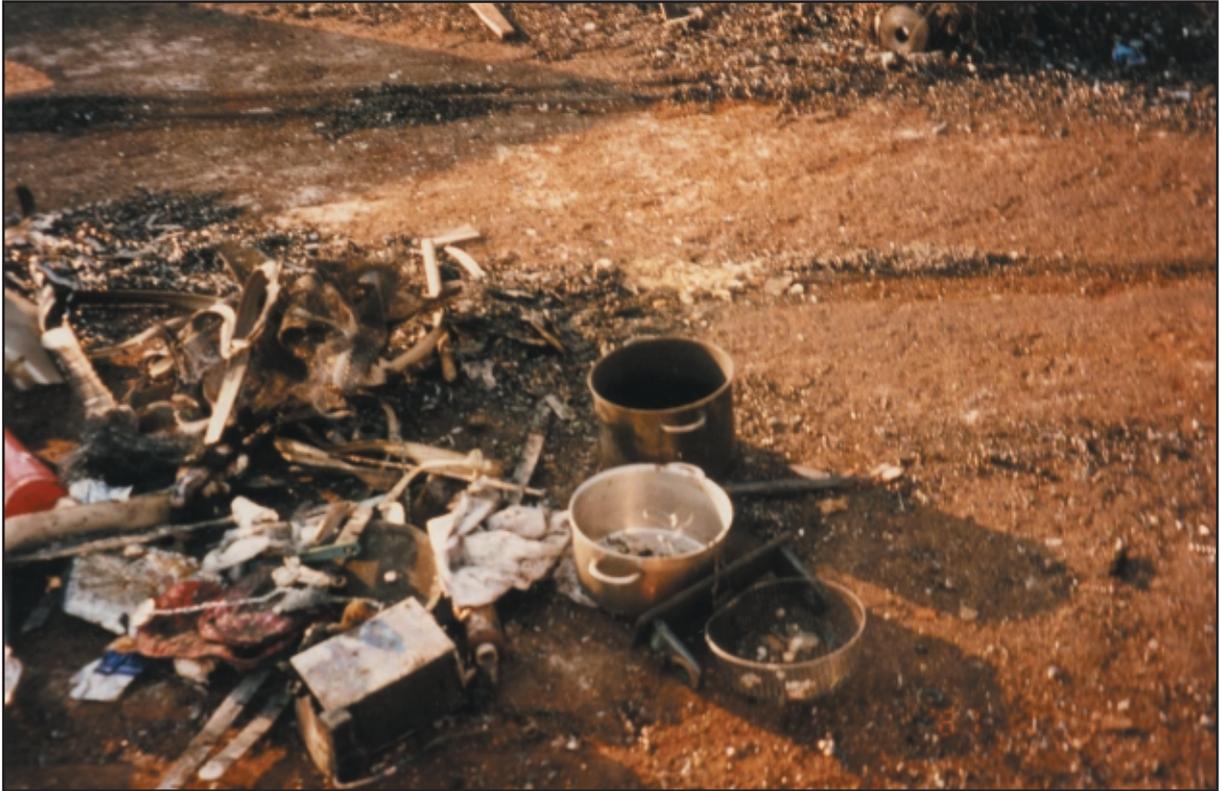
8.2: Photographs

- 5.1 Examination of the vessel following the fire revealed smoke and fire damage to the galley, a small amount of fire damage in the adjoining mess room aft of the galley, and further smoke damage in the mess room and forward stair well leading up to the navigation bridge. (See photographs at Appendix 8.2). The forward and aft doors to the galley appear to have been open at the time of the fire. A fire door at the top of the forward stairwell appears to have been closed and effective in preventing any smoke damage occurring on the bridge.

- 5.2 The fire brigade removed some loose items to the wharf from the galley following the fire. Examination of these items revealed the pot that appears to have been used for deep fat frying of the chips to be a simple open aluminum cooking pot.

- 6.7 The fire was caused by an open chip pan becoming overheated and igniting.

- 7.1 The following recommendations are made in order to prevent a recurrence of this type of accident:
- 7.1 Open chip pans or similar open utensils containing cooking fats or oils should never be used on board ship. Shipping companies should issue internal instructions to all their ships and seagoing personnel banning the use of such cooking utensils and methods, under any circumstances.

- 7.2 Cooking, which involves quantities of oil or fat, should only be carried out using proper deep-fat fryers, which comply with marine specifications. Such units must be fitted with dual thermostatic devices, which will ensure isolation of the electrical supply in the event of failure of the normal regulating thermostat. Such deep-fat fryers must be secured in position to prevent movement in rough weather conditions.
