**REPORT INTO THE INCIDENT
ON BOARD THE
"ATLANTIC DAWN"
ON 12 OCTOBER, 2002
RESULTING IN THE DEATH
OF ONE CREWMEMBER**

The Marine Casualty Investigation Board was established on the 5th, June 2002 under The Merchant Shipping (Investigation of Marine Casualties) Act 2000

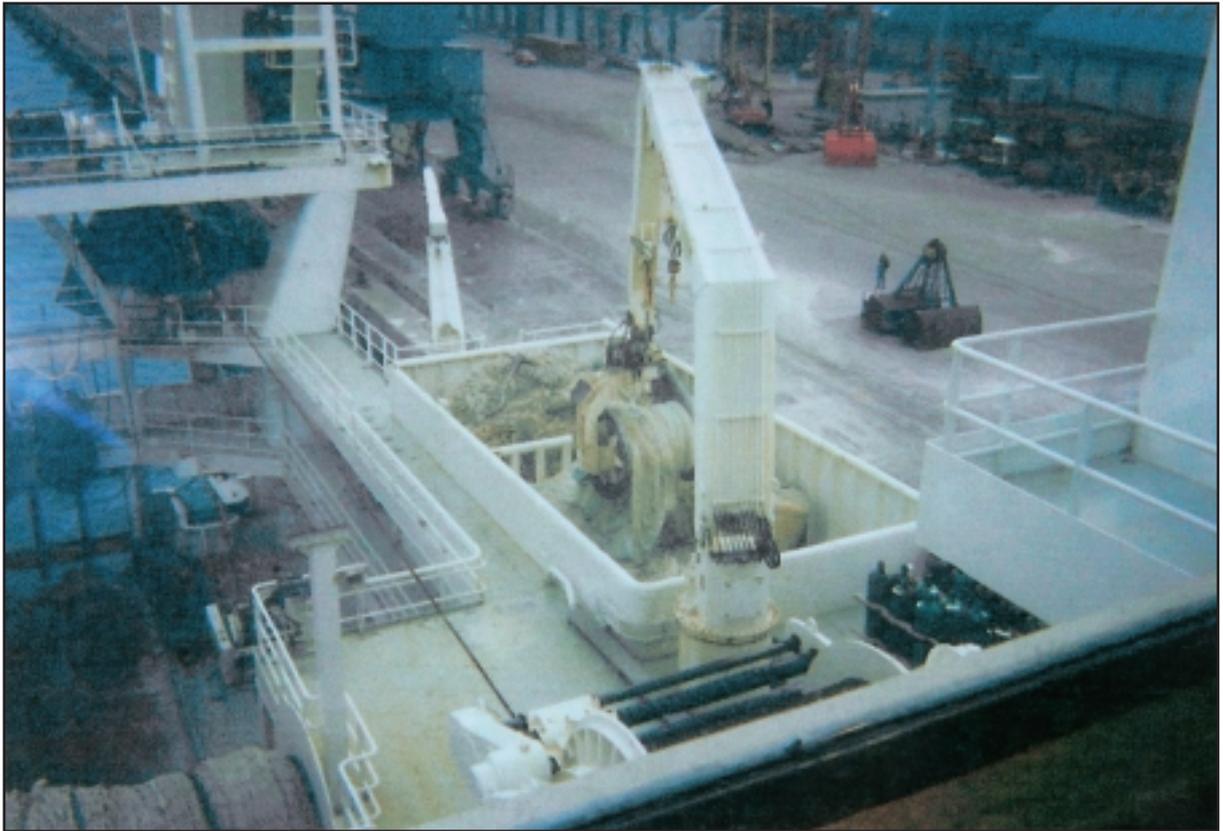
MFV "Atlantic Dawn" looking aft from wheelhouse window
Towards net moving crane on port side.

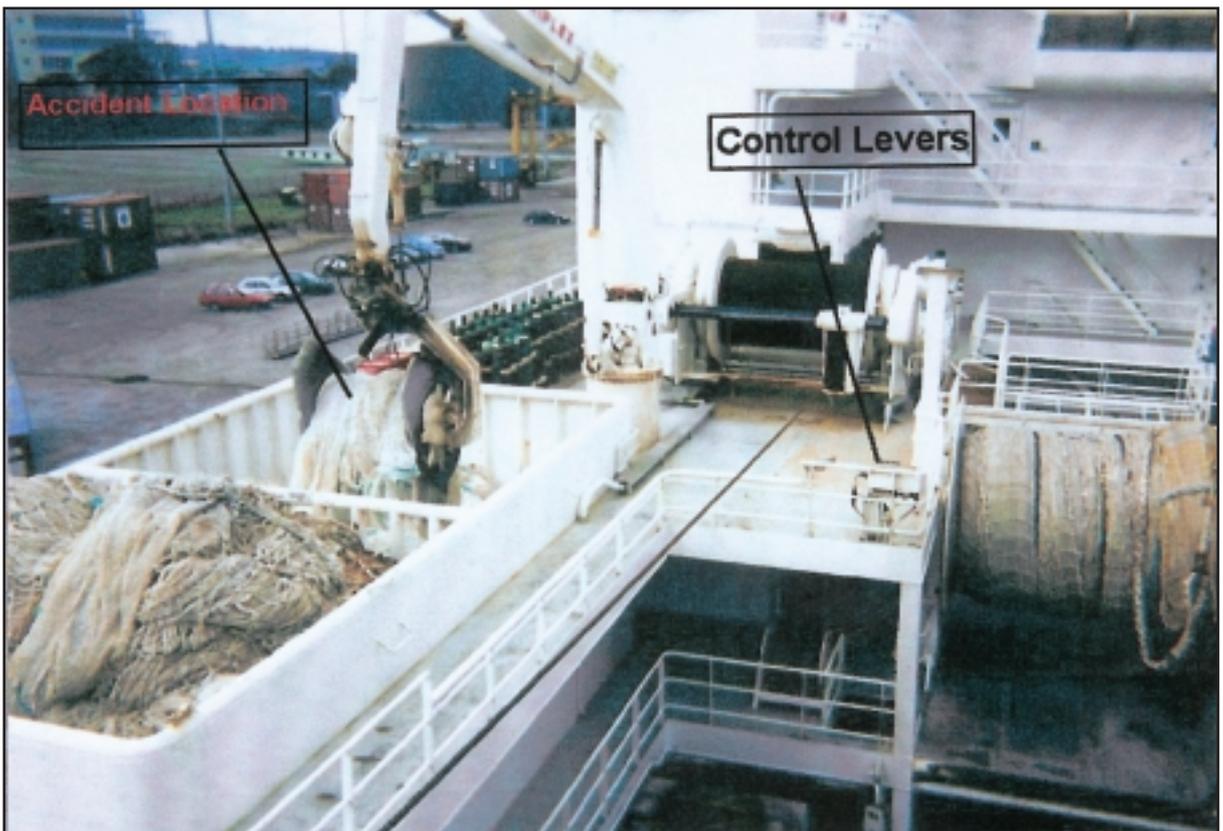
MFV "Atlantic Dawn" looking aft towards net bin on port side.

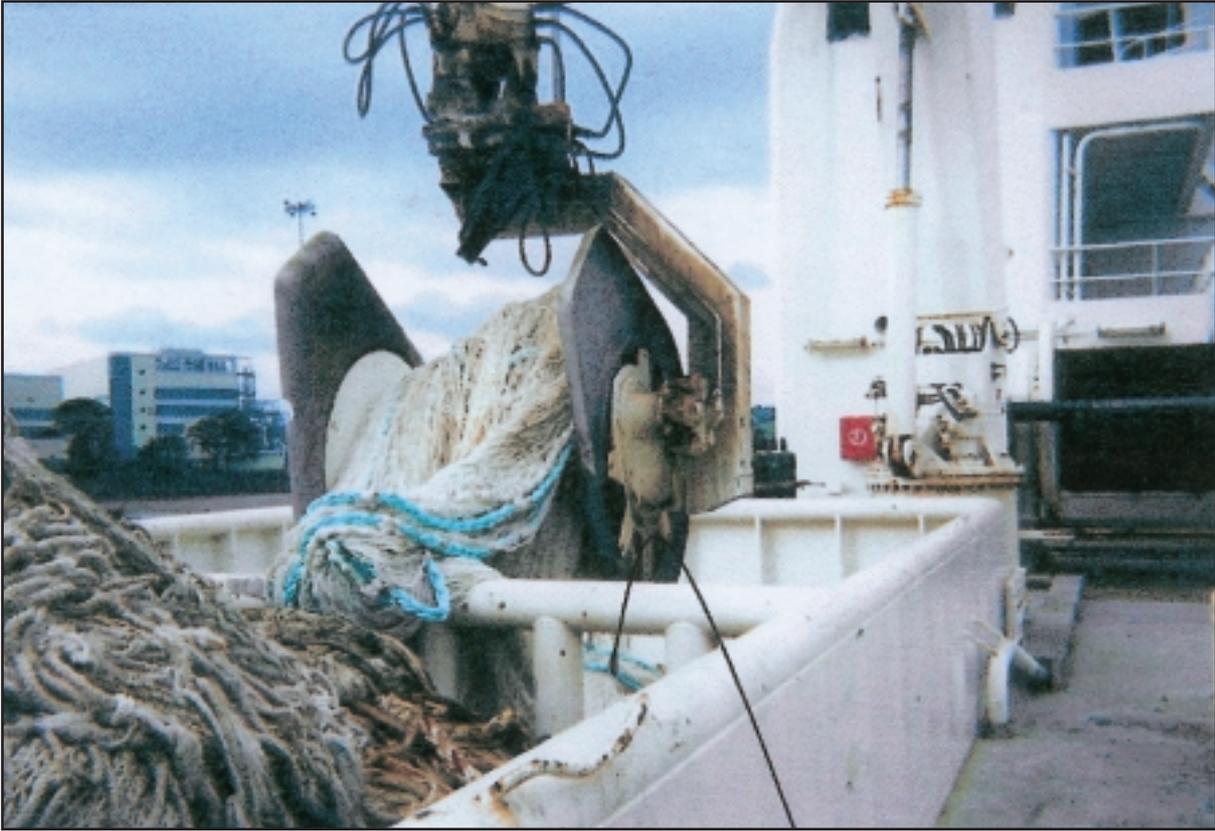
- 4.4 Michael McGuinness was an experienced fisherman. It would appear that when pulling the net through and over the roller Michael McGuinness got snagged in the net and the rope became wrapped around the roller. Michael McGuinness was unable to free himself and suffered fatal injuries when coming into contact with the power block and net bin

Mr. McGuinness may have been standing in the forward section of the bin feeding the net onto the roller, immediately prior to the accident.
