**REPORT OF
INVESTIGATION INTO
THE CAPSIZE OF THE
“BARBARA MARY”
AT KILKEE BAY, CO. CLARE
ON
18th SEPTEMBER 2008**

REPORT No. MCIB/163

Report MCIB/163 published by The Marine Casualty Investigation Board
3rd December 2009

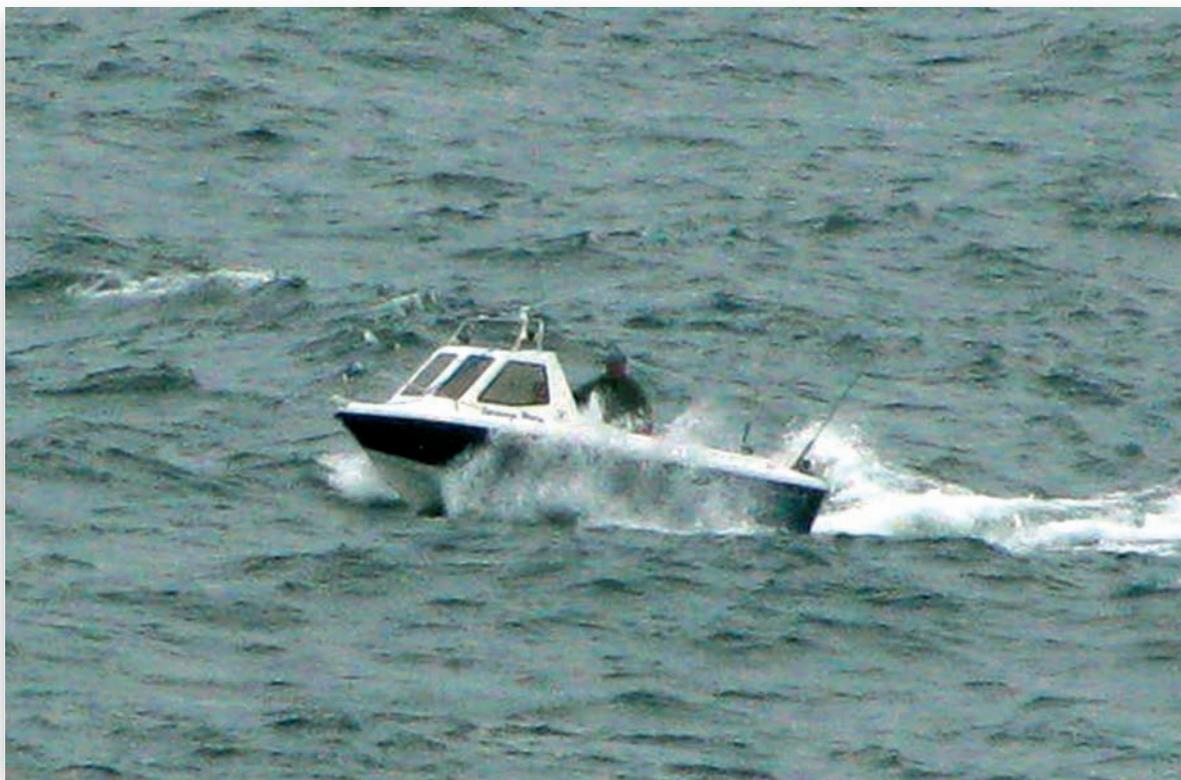
- 4.1 As the vessel passed to the north of the Pinnacles she encountered a sudden large increase in swell height on her beam and capsized.

Fig. 1 - Vessel moments before it capsized

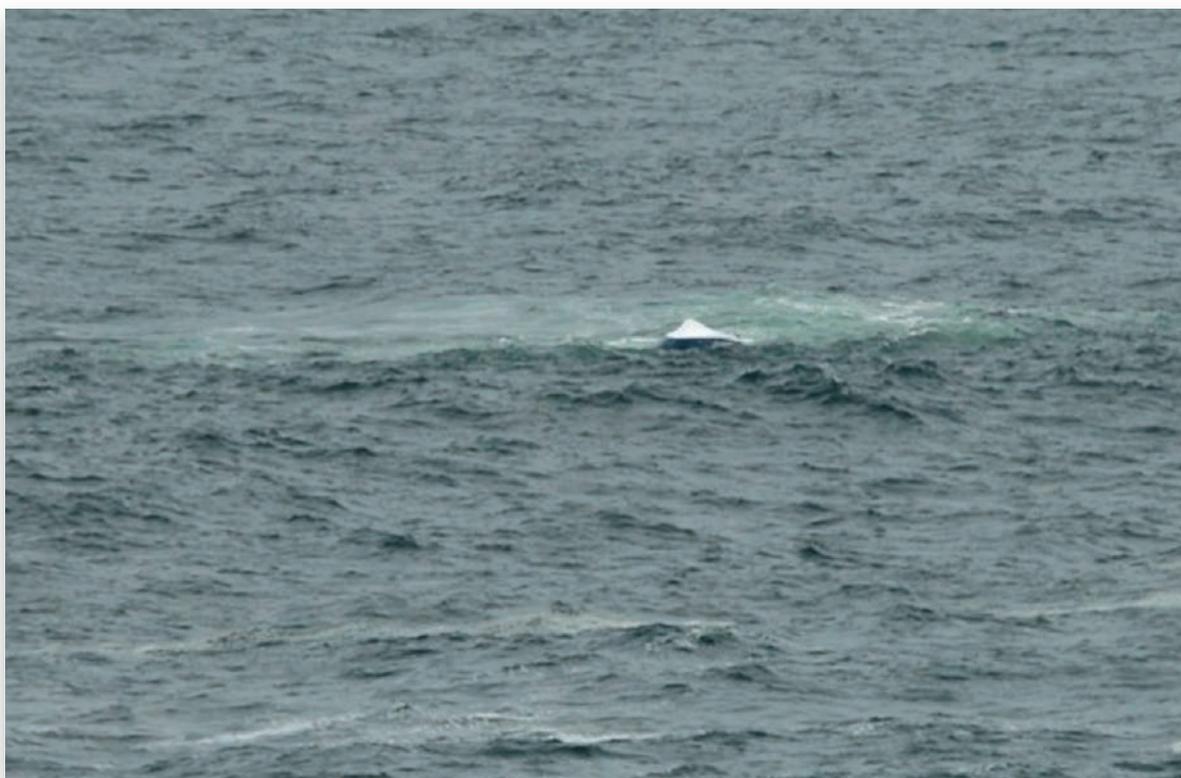
- 4.2 Mr. Brown was trapped inside the hull of the vessel when his PFD inflated while Mr. McSweeney was either flung clear or dragged to the bottom.

Fig. 2 - Upturned hull of vessel

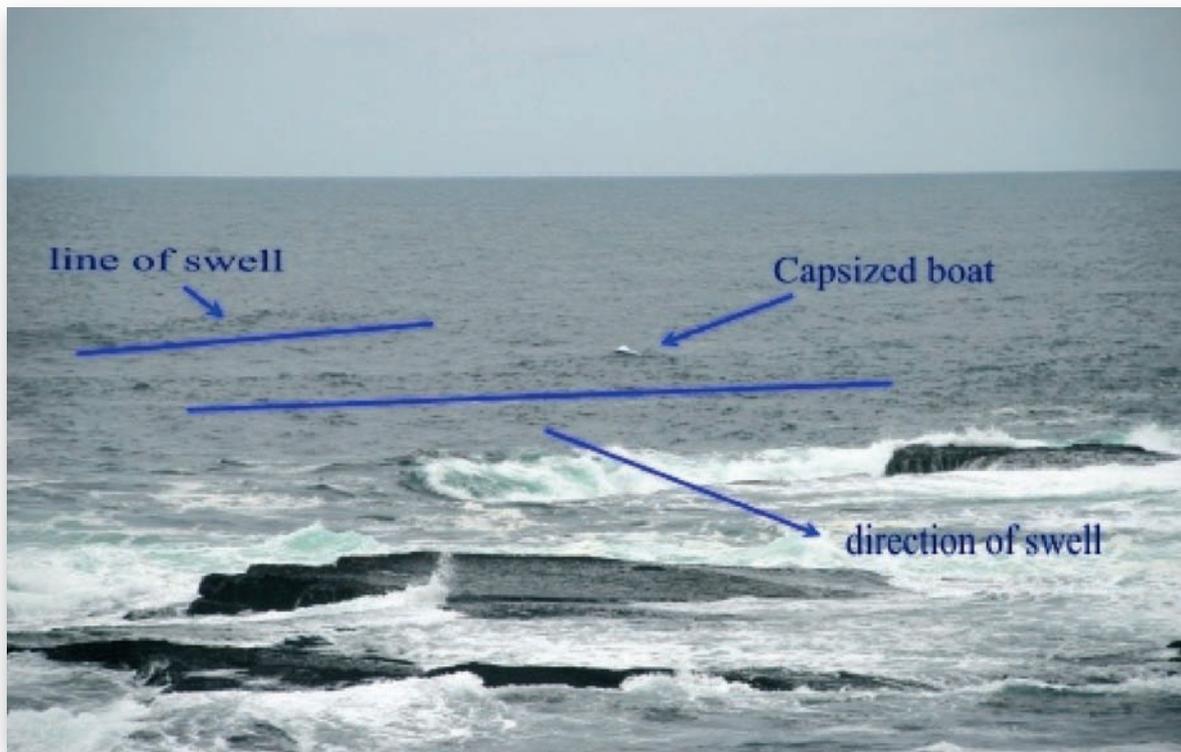
Mariners familiar with the area are aware of this sudden increase in swell height, which is in the vicinity of a sea mount just offshore to the north of the Pinnacles.

Photograph 3 shows some indication of larger waves still forming and photograph 4 shows a reduction in wave energy.

Figure 3 Swell and breaking waves

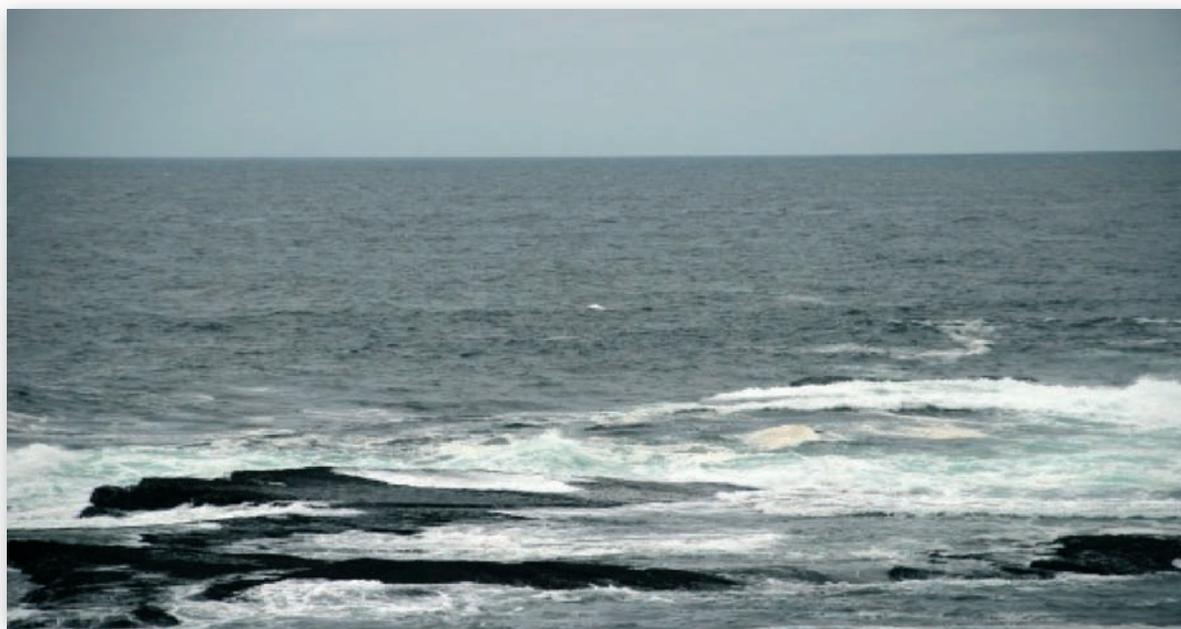
Figure 4 Swell diminishing
