**REPORT INTO THE
CASUALTY AND LOSS OF LIFE
AT BLACKROCK, CO. CORK
ON 18TH AUGUST, 2003.**

The Marine Casualty Investigation Board was established on the 23rd, May 2002 under The Merchant Shipping (Investigation of Marine Casualties) Act 2000

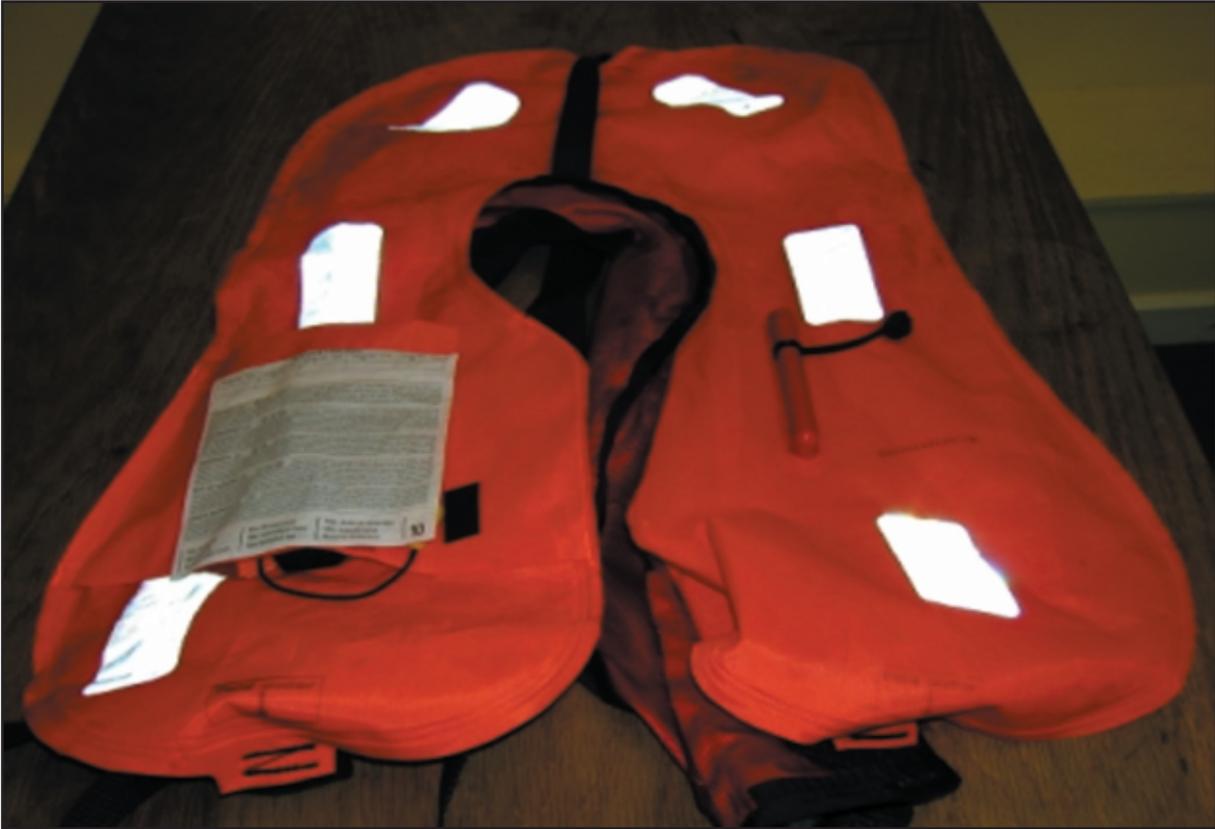
- 5.4 On inspection of the lifejacket at the Garda station, Blackrock, Cork on the 19th August 2003 it was noted that the lifejacket had not fully inflated and that the left side inflation chamber was still contained within its outer enclosure. The lifejacket inflation gas cylinder is fitted to the right side of the inflation chamber and the cylinder showed evidence of having been activated. The right side of the inflation chamber to which the cylinder was attached had inflated to some degree. On further examination it was noted that the non-return valve fitted to the mouthpiece (on left side of jacket), was stuck in an open position. If the valve was in that condition when the inflation cord was pulled it would have the effect of releasing the inflation gas to atmosphere as fast as it was entering the chamber and hence the reason for one side of the inflation chamber not inflating. The non-return valve had not operated correctly and this is borne out by the fact that water was found to be inside the lifejacket. If the jacket had inflated to the extent that a positive pressure was contained within it, then water would not have entered the chamber.

- 5.5 The lifejacket was taken to Midleton Marine, which is a licensed lifejacket servicing station, where it was examined by Mr. Gordon Reeves in the presence of Garda Mark O'Mahony and this investigator. It was confirmed by Mr. Reeves that the spring operated non-return valve was not operating correctly insofar that it was stuck in an open position. During the inspection of the non-return valve it appeared to pop back into its correct working position and it was decided then to test the jacket by fitting a new 33gram gas inflation cylinder and to inflate the lifejacket. The jacket inflated fully in less than 10 seconds and the non-return valve held the pressure. The non-return valve was then depressed manually to time how long it would take for the jacket to deflate. That took approximately 8 seconds.

FRONT VIEW SHOWING INFLATION/TOP UP MOUTHPIECE
BACK OF JACKET SHOWING STRAPS AND CLIP

- 7.1 That the manufacturer be informed immediately of this incident in order that further investigation be carried out as to the effectiveness or otherwise of the non-return valves fitted to this type of lifejacket.

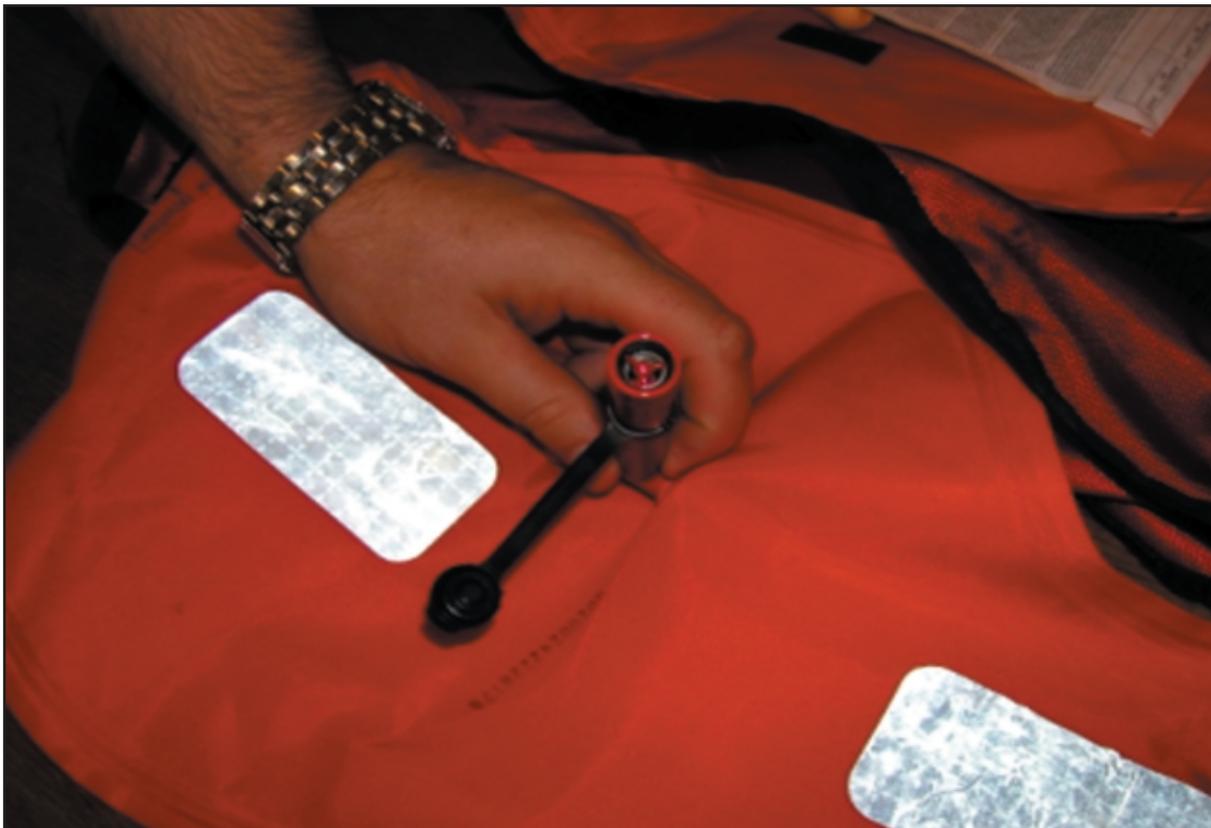
CLOSE UP OF INFLATION/TOP UP MOUTHPIECE.
TYPE OF LIFEJACKET

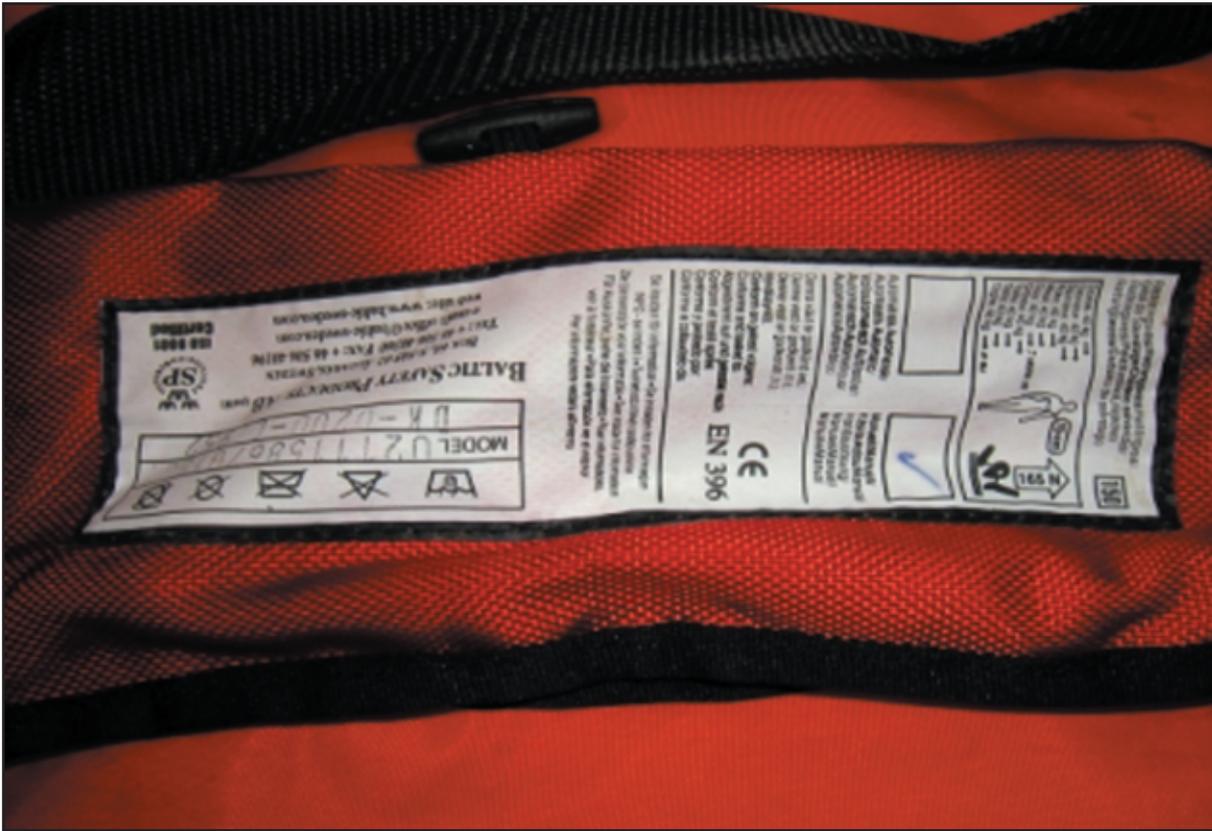
SPECIFICATION LABEL
CO2 INFLATION CYLINDER AND RELEASE CORD. ALSO WHISTLE
