**DRAFT REPORT OF THE  
SINKING OF A  
BLACK WOODEN CURRAGH  
OFF GALWAY BAY  
ON 28th DECEMBER 2006**

**REPORT No. MCIB/133**

Report MCIB/133 published by The Marine Casualty Investigation Board  
5th December 2008

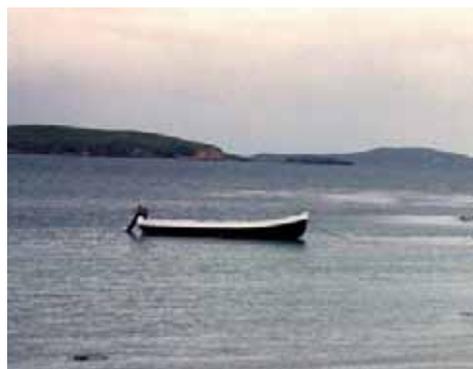
### 2.1 Description of vessel

The vessel was defined as a 6 oar wooden Curragh. The build construction of the vessel is carvel built with  $\frac{3}{4}$  inch larch planking. The vessel had sawed oak frames. The hull was caulked with a tar film cover. The colour of the 'Curragh' was white at the gunwhales with a black hull.
