**REPORT OF THE
INVESTIGATION INTO AN
INCIDENT
INVOLVING THE GROUNDING
OF THE OIL TANKER
“BRO TRAVELLER”
ON 17th SEPTEMBER 2005**

REPORT No. MCIB/117

Report MCIB/117 published by The Marine Casualty Investigation Board
18th November 2008

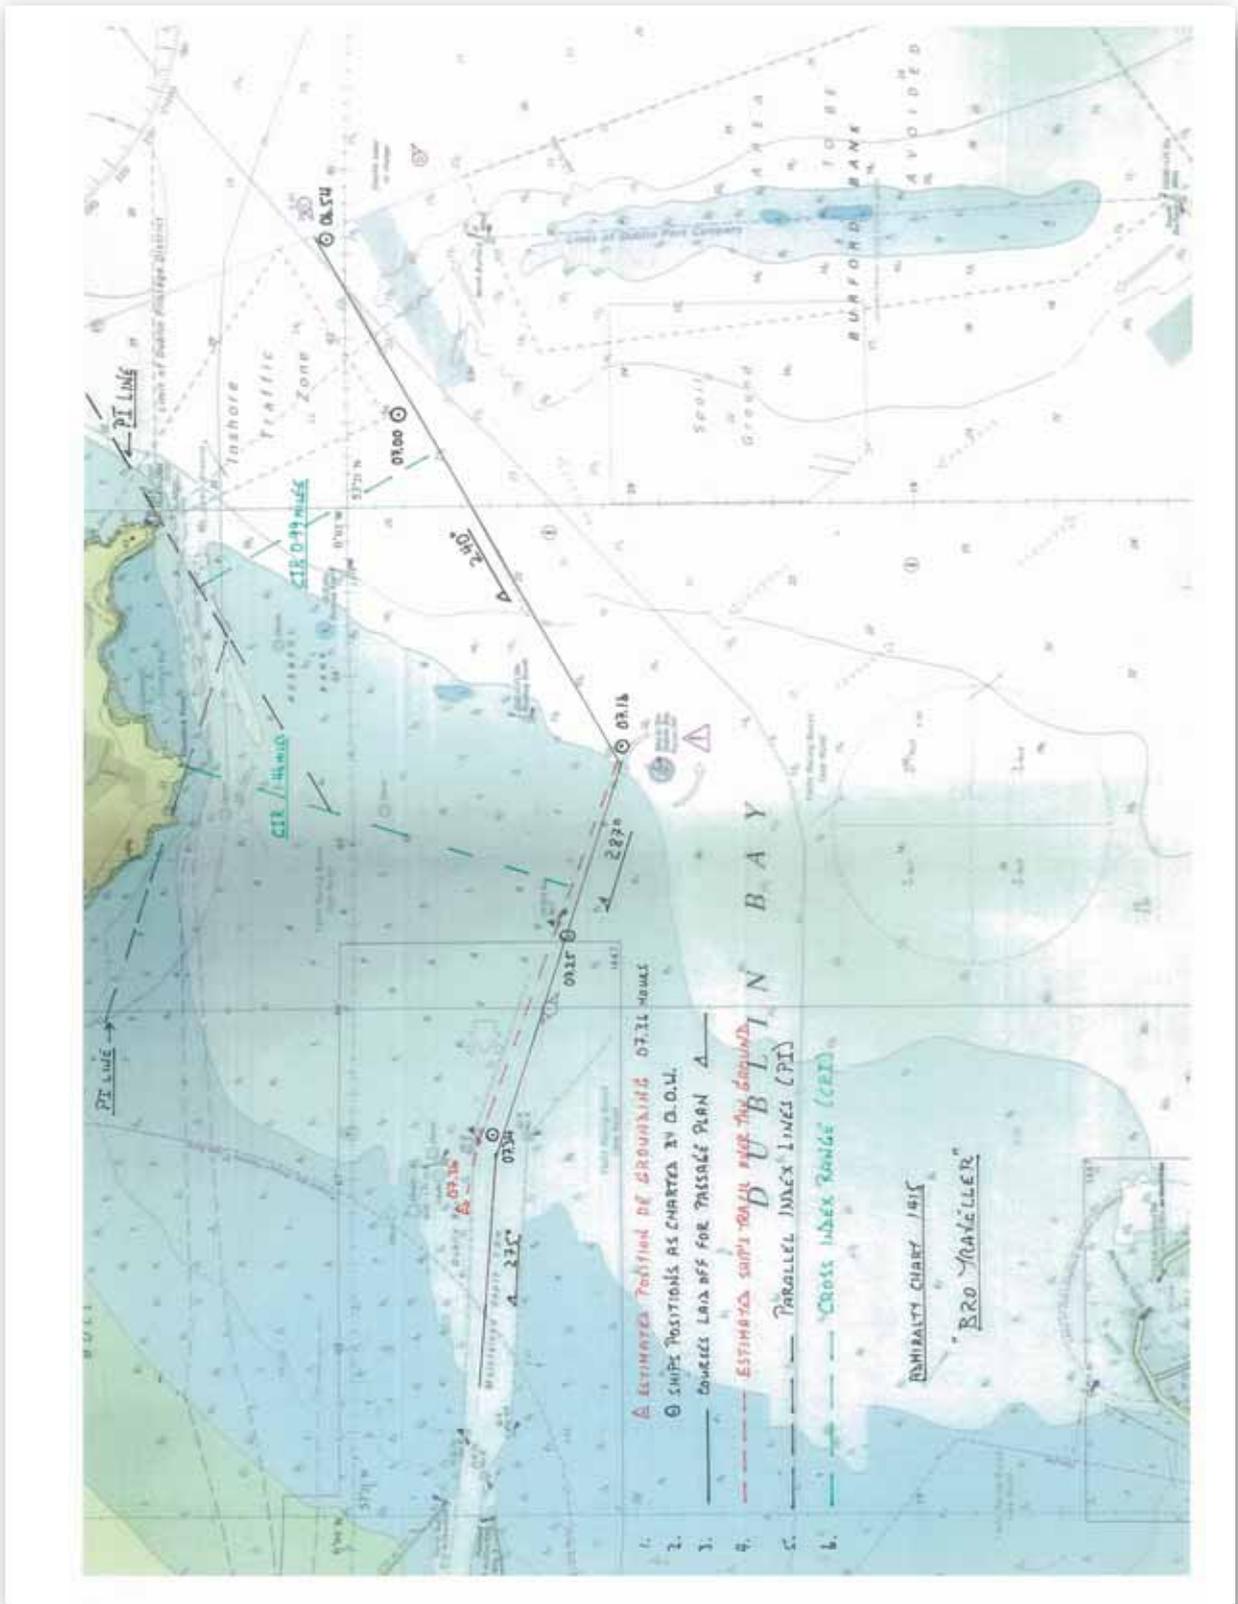
Appendix 8.1 Abstract from AC 1415

At 07.36 hours the “Bro Traveller” grounded forward with a gentle shudder and stopped remaining well afloat aft in a Global Positioning System (GPS) position Latitude 53020.61’ North Longitude 006007.19’ West and observed position 2.78 cables west of No. 3 buoy and 0.3 cables north of the pecked line between No. 3 and No. 5 buoys on chart datum 63 metres. At the time of grounding the pilot was on the helm at the console of the wheelhouse with the master standing to the right of the pilot. The third mate declared that he was at the chart table transferring the position obtained at 07.34 hours on to a large-scale chart. The ship was aground heading in a westerly direction lying parallel to the dotted lines joining No. 3 and No. 5 buoys.

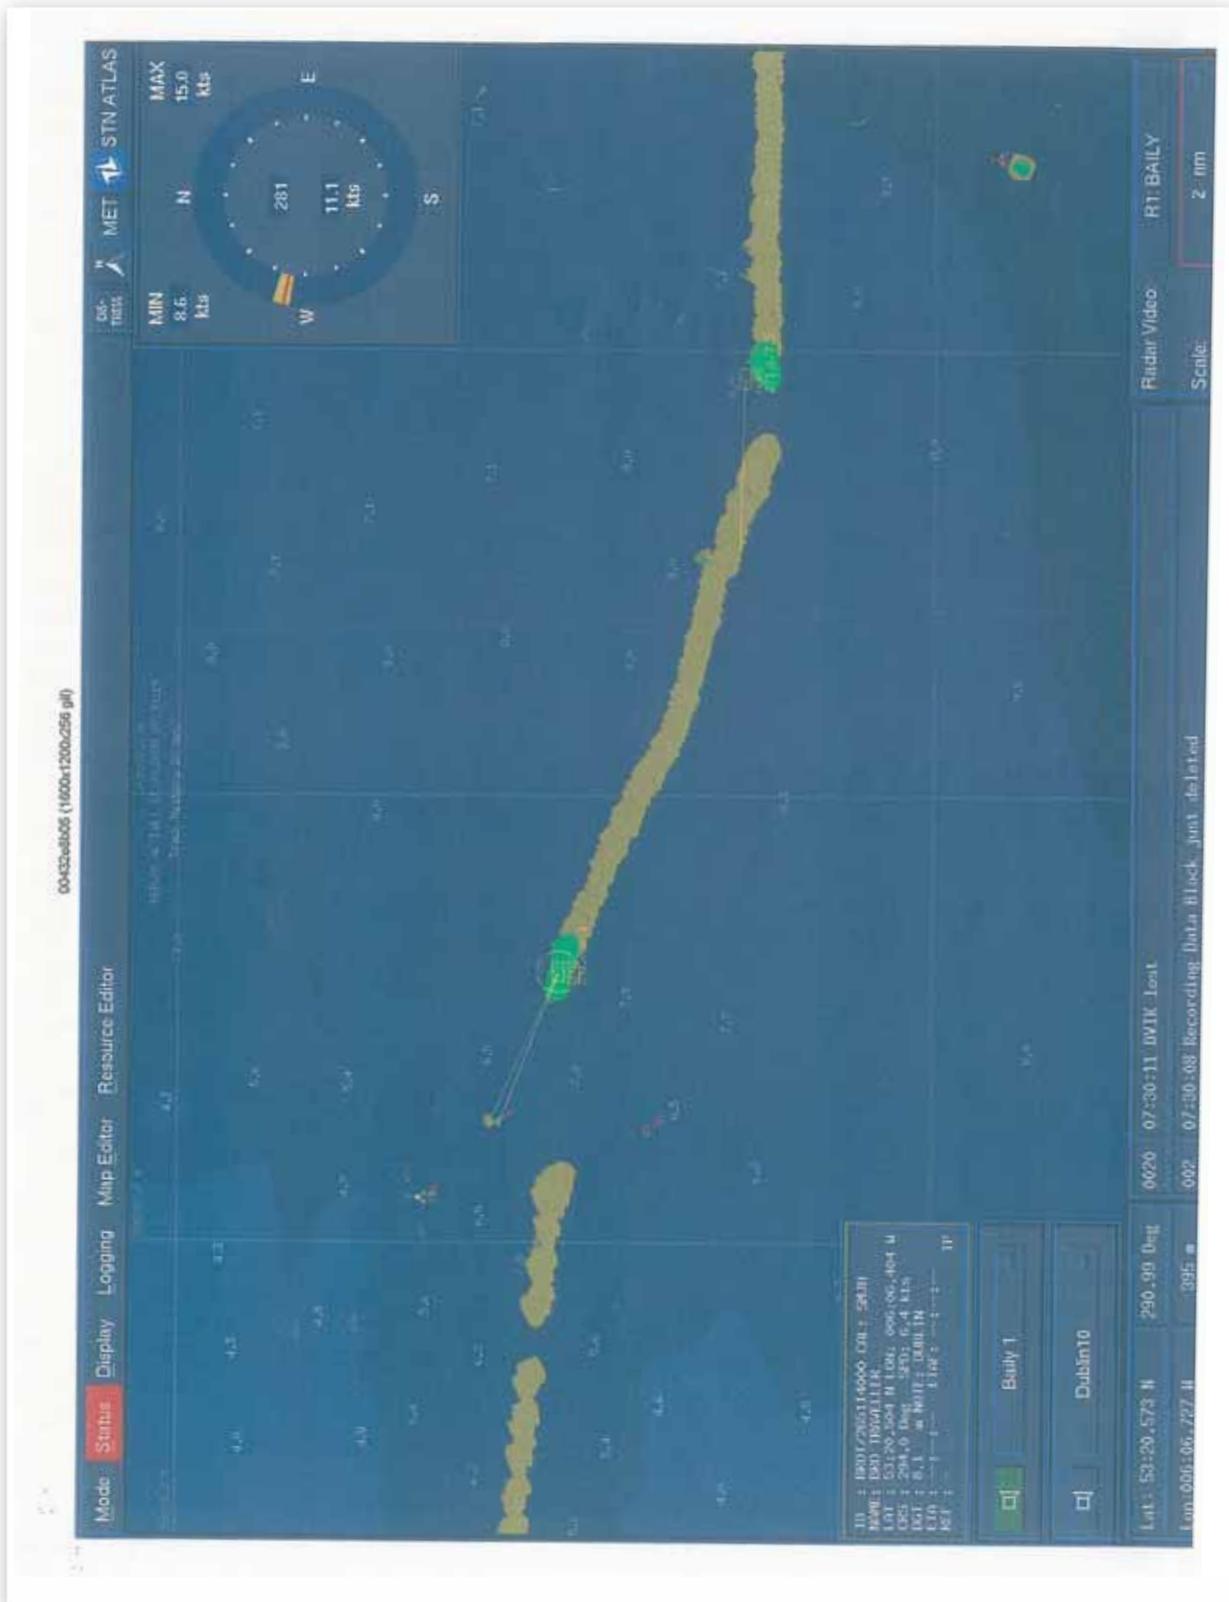
Appendix 8.5 (2) Port Radio VTS Radar Video

Observation of the VTS Radar should have indicated that the “Bro Traveller” was well to the north of the normal inwards course line particularly as there was no outward traffic. It should have been noted sooner that the “Bro Traveller” was aground.
