**REPORT INTO
THE GROUNDING OF
"CARRIE OF CAMARET"
(ALIAS "CABIN FEVER I")
AT TORY ISLAND,
CO. DONEGAL
ON 13TH JUNE 2003**

Published by The Marine Casualty Investigation Board
15th March 2005

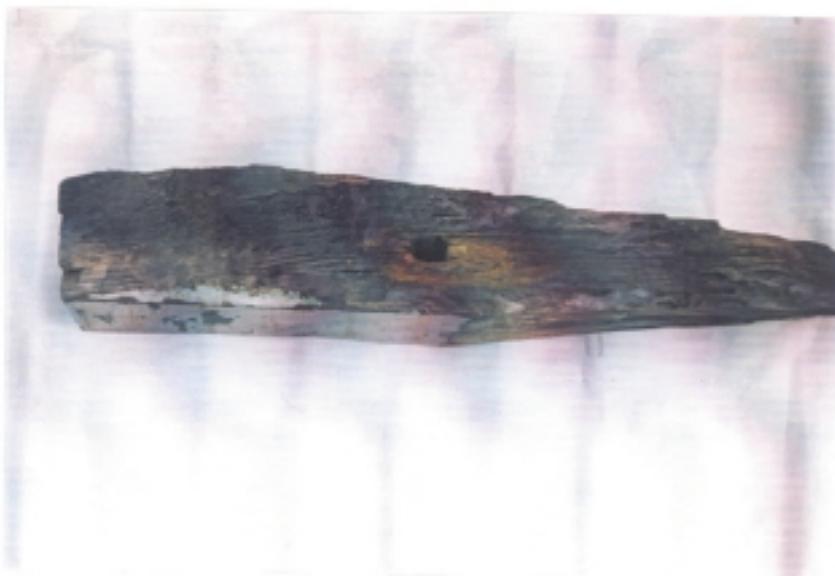
"Soft rot" caused by the action of micro-fungi, is normally found in wood which stays at a very high moisture content – a typical environment being cooling towers. In this case, it seems to occur on the surface between the frames and the planking. The surface erosion is typical of soft rot and the effect on strength in this case is negligible.

Figure 1, Frame 1. Surface soft rot to left of hole. Insect attack at extreme right.

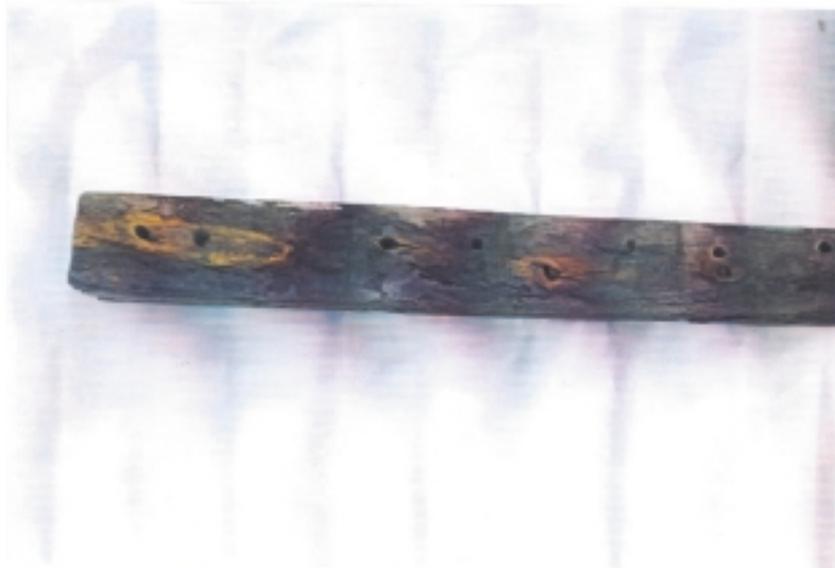
Two frame sections, said to have come from near the turn of the bilge, were received. Section 1. was approx. 800mm long and 150x100mm in section, tapering. Grey paint was present on two faces. Erosion, some 2-3mm deep was present on one unpainted face. A microscopical examination indicated that this was most probably due to the action of "soft rot" fungi. Below the eroded surface the wood was hard and sound. An area of sapwood (220x15x10mm) was present at one end. This had been attacked by terrestrial insects in the past and was soft. There was considerable rust staining on the wood at the position of some fastenings, with some localised softening of the wood at these points. Other than at the areas noted above, the wood was sound and hard.

Figure 2, Frame 1. Erosion and softening of wood at fastenings.

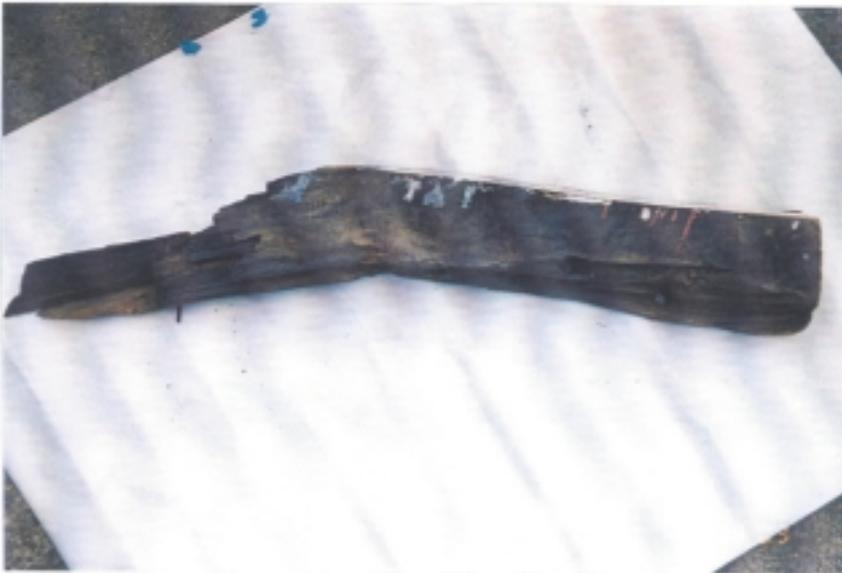
Section 2. was approx. 950x150x100mm, with a slight curve at mid-length. White and blue-grey paint was present on two sides. See Fig. 2. The grain was generally parallel to the two arms, indicating that it was cut from a grown section. The section was split along its length, with stains indicating that some of this splitting was present for a considerable time. Very localised erosion was present at one point on one unpainted face, indicative of soft rot. This did not penetrate more than 2-3mm. Localised softening of the wood was present at the position of some fastenings.

Figure 3. Frame 2. Grain running along axis of arms.

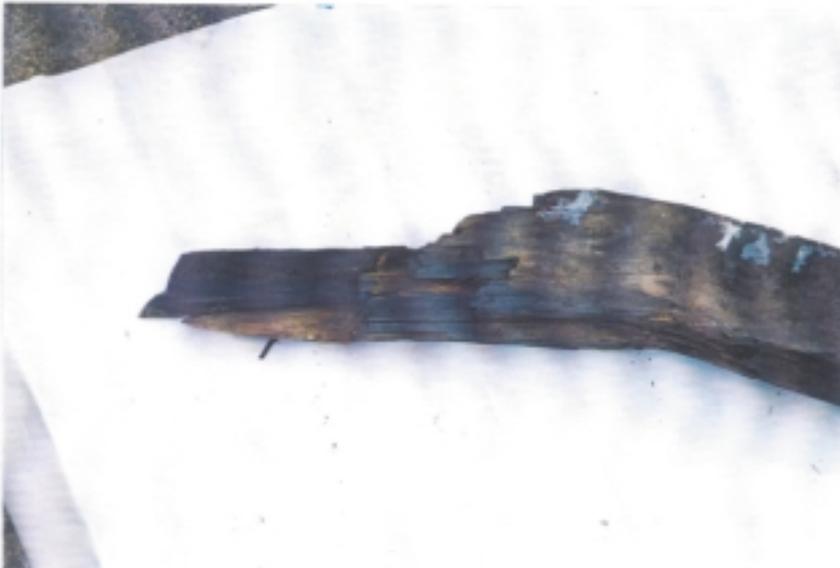
Figure 4. Frame 2. Rust on pre-existing splits, black surfaces freshly broken.

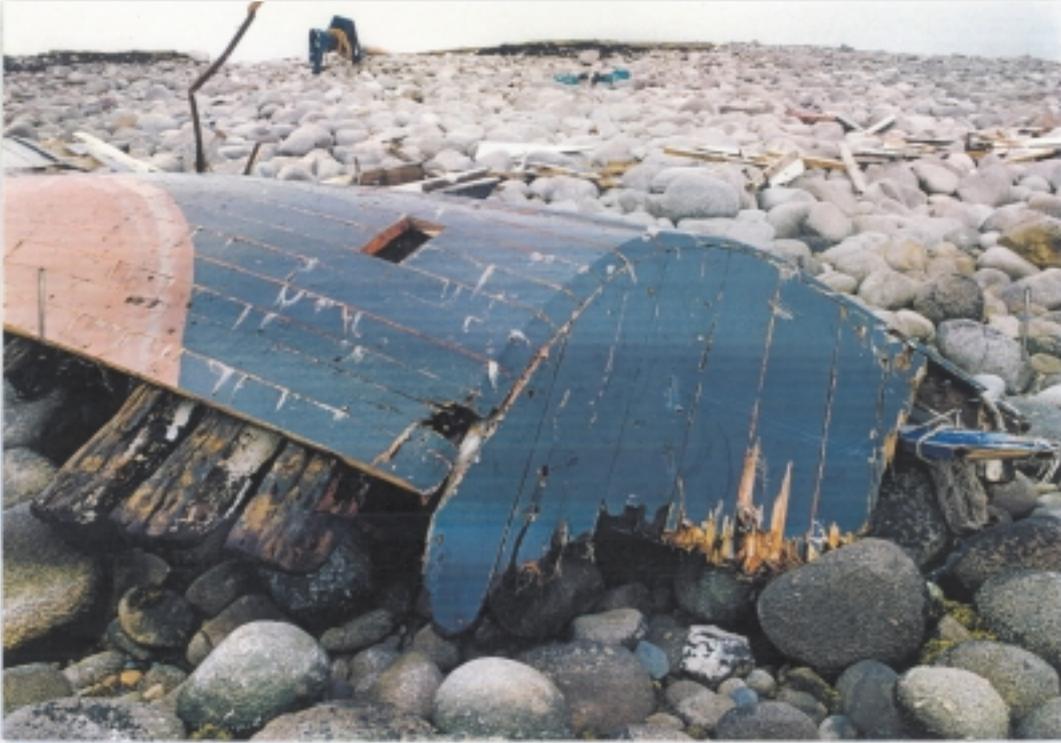
- 9.12 Photographs.
 - 9.12.1 Appears to show end of frames where they are butted against the keel. No fracture of frames.
 - 9.12.2 End of frames rounded and abraded, fastenings pulled out.

- 10.1 Appears to show end of frames where they are butted against the keel.
No fracture of frames.

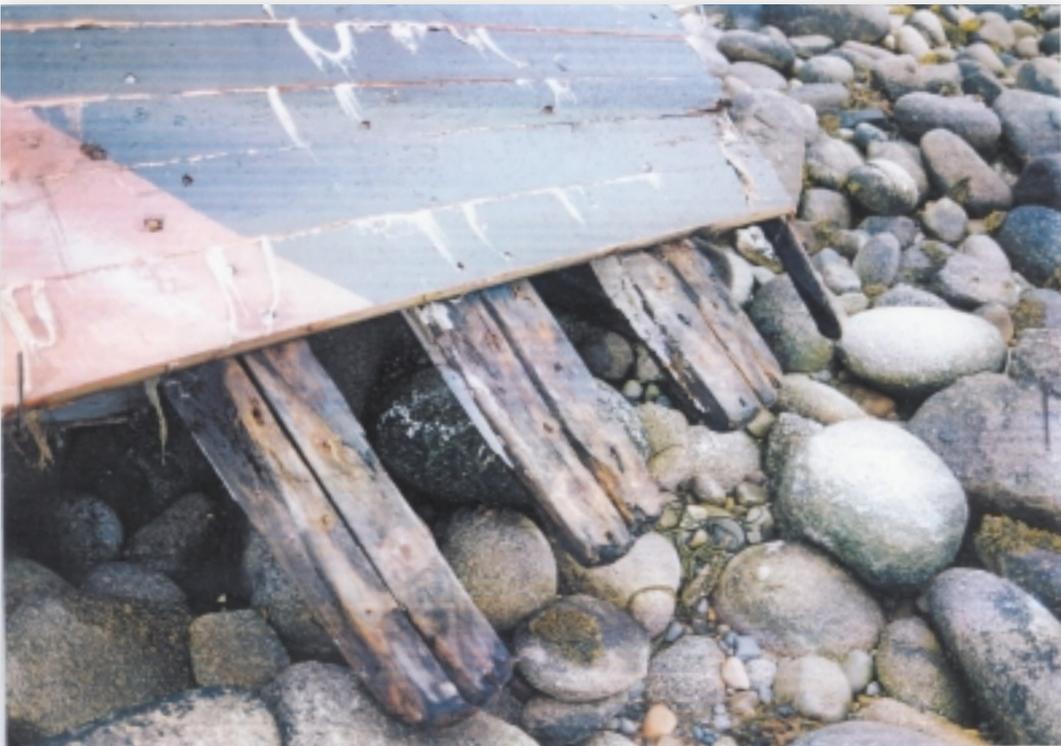
- 10.2 End of frames rounded and abraded, fastenings pulled out.

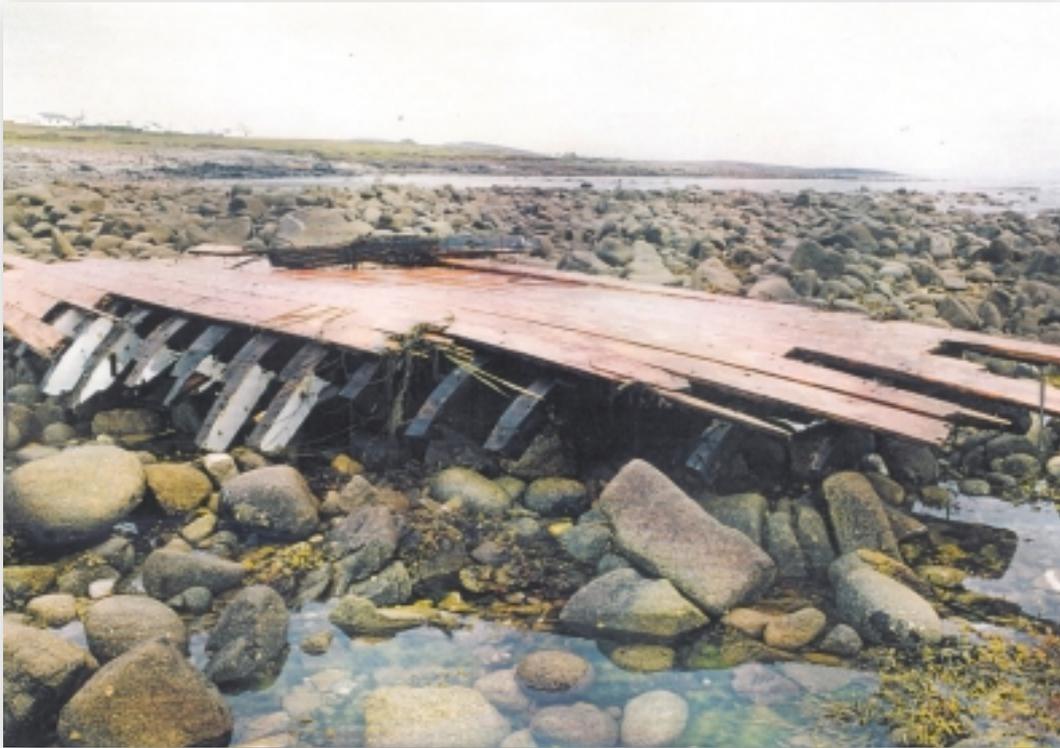
10.3 Most ribs intact - joints parted.

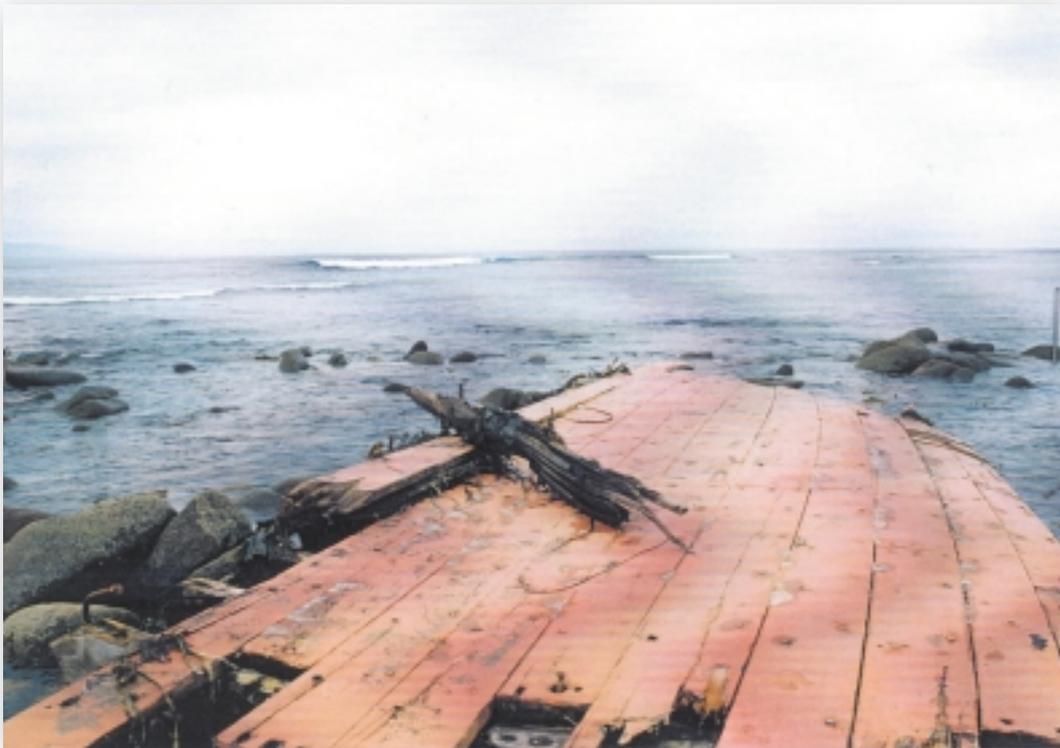
10.4 Fastenings pulled through and out of planking.

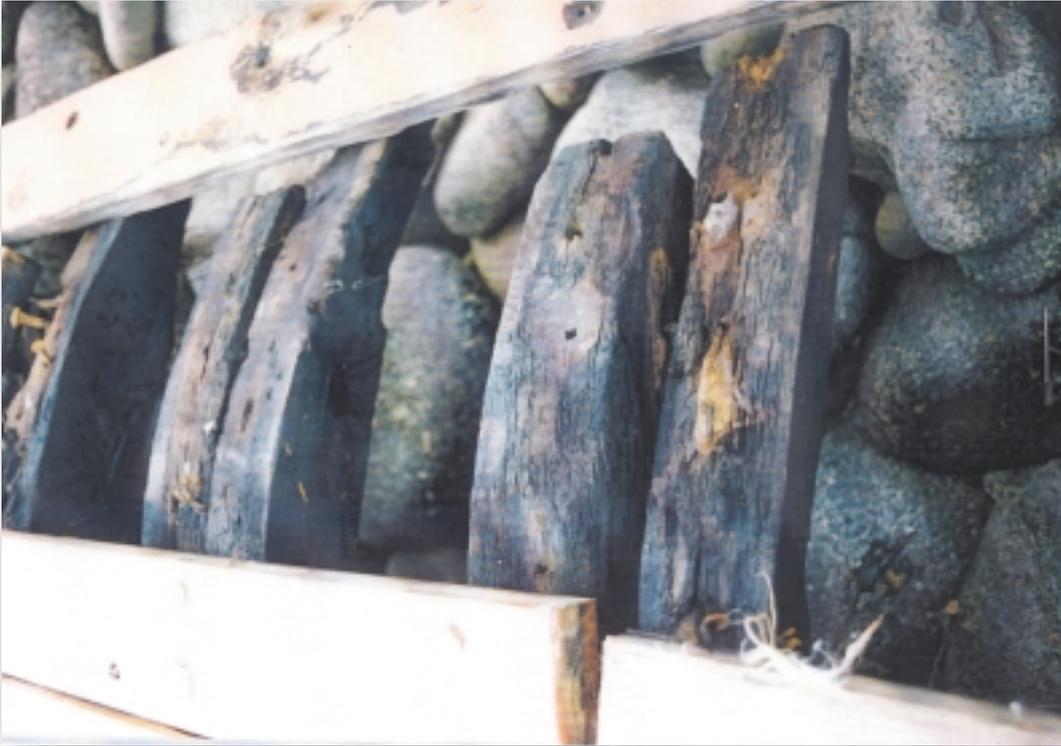
10.5 Wood soft at some fastenings. Possible decay in one frame. Butt joint in plank.

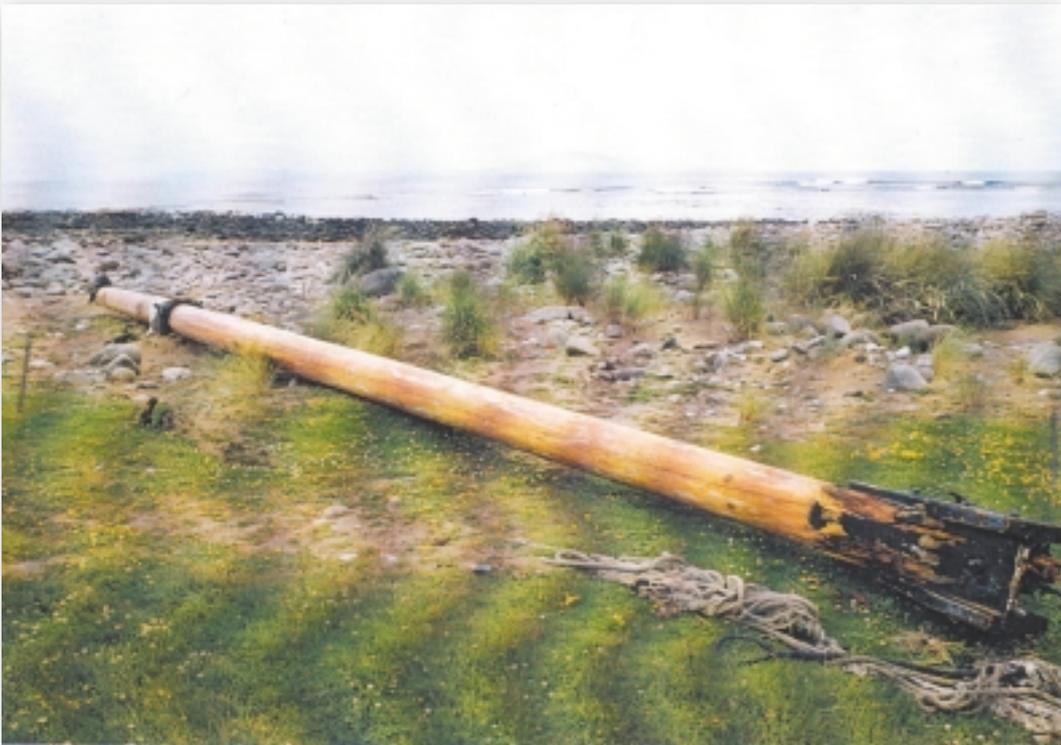
10.6 Apparent decay at base of mast.

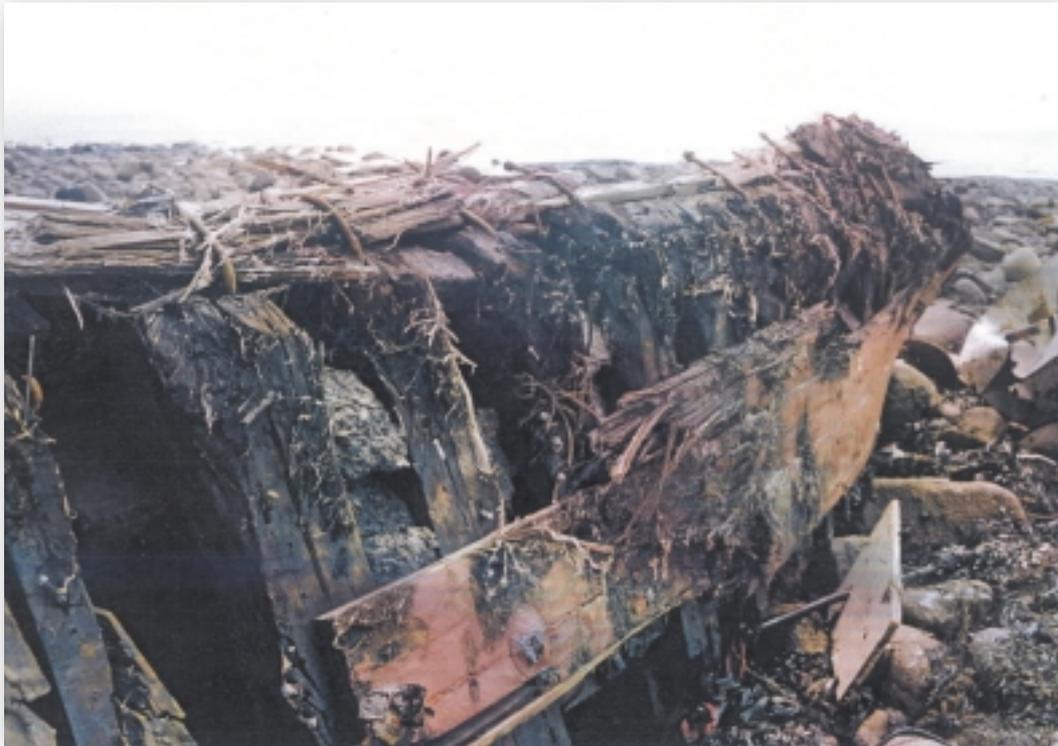
- 10.7 Fastenings pulled through. Considerable abrasion evident, not suggestive of decay.

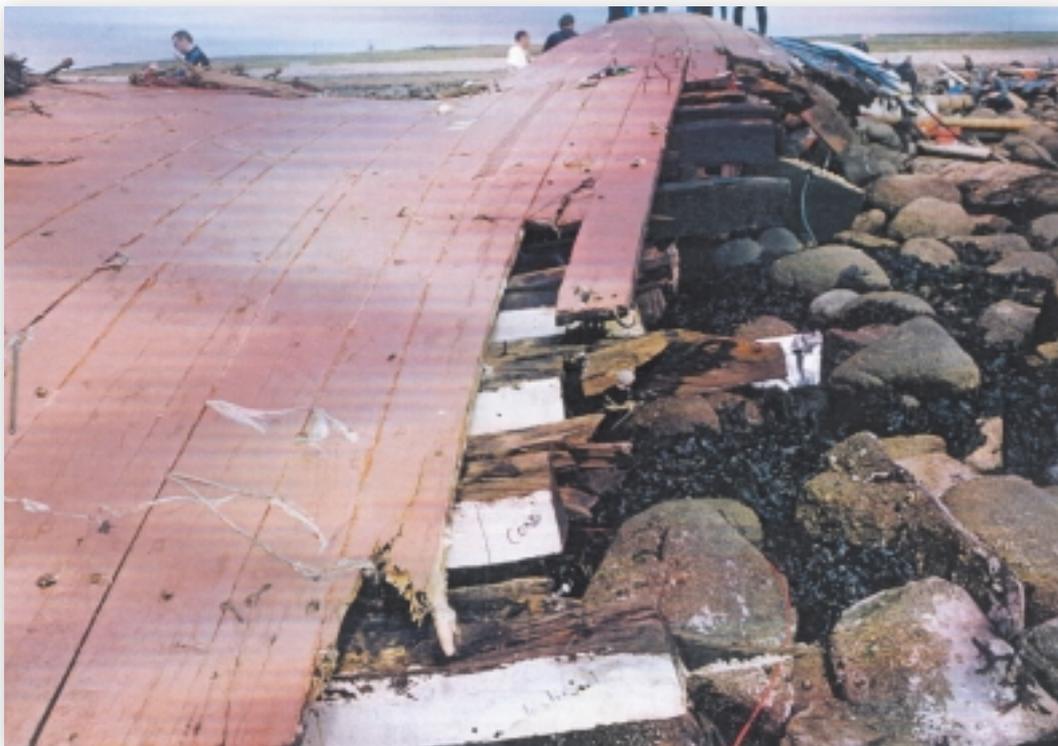
- 10.8 Splintery fractures typical of sound wood.
