**REPORT INTO  
THE INCIDENT INVOLVING  
THE M.F.V. "CAROLE DENISE"  
ON 21ST OCTOBER 2001.**

**The Marine Casualty Investigation Board was established on the 23<sup>rd</sup>, May 2002 under The Merchant Shipping (Investigation of Marine Casualties) Act 2000**

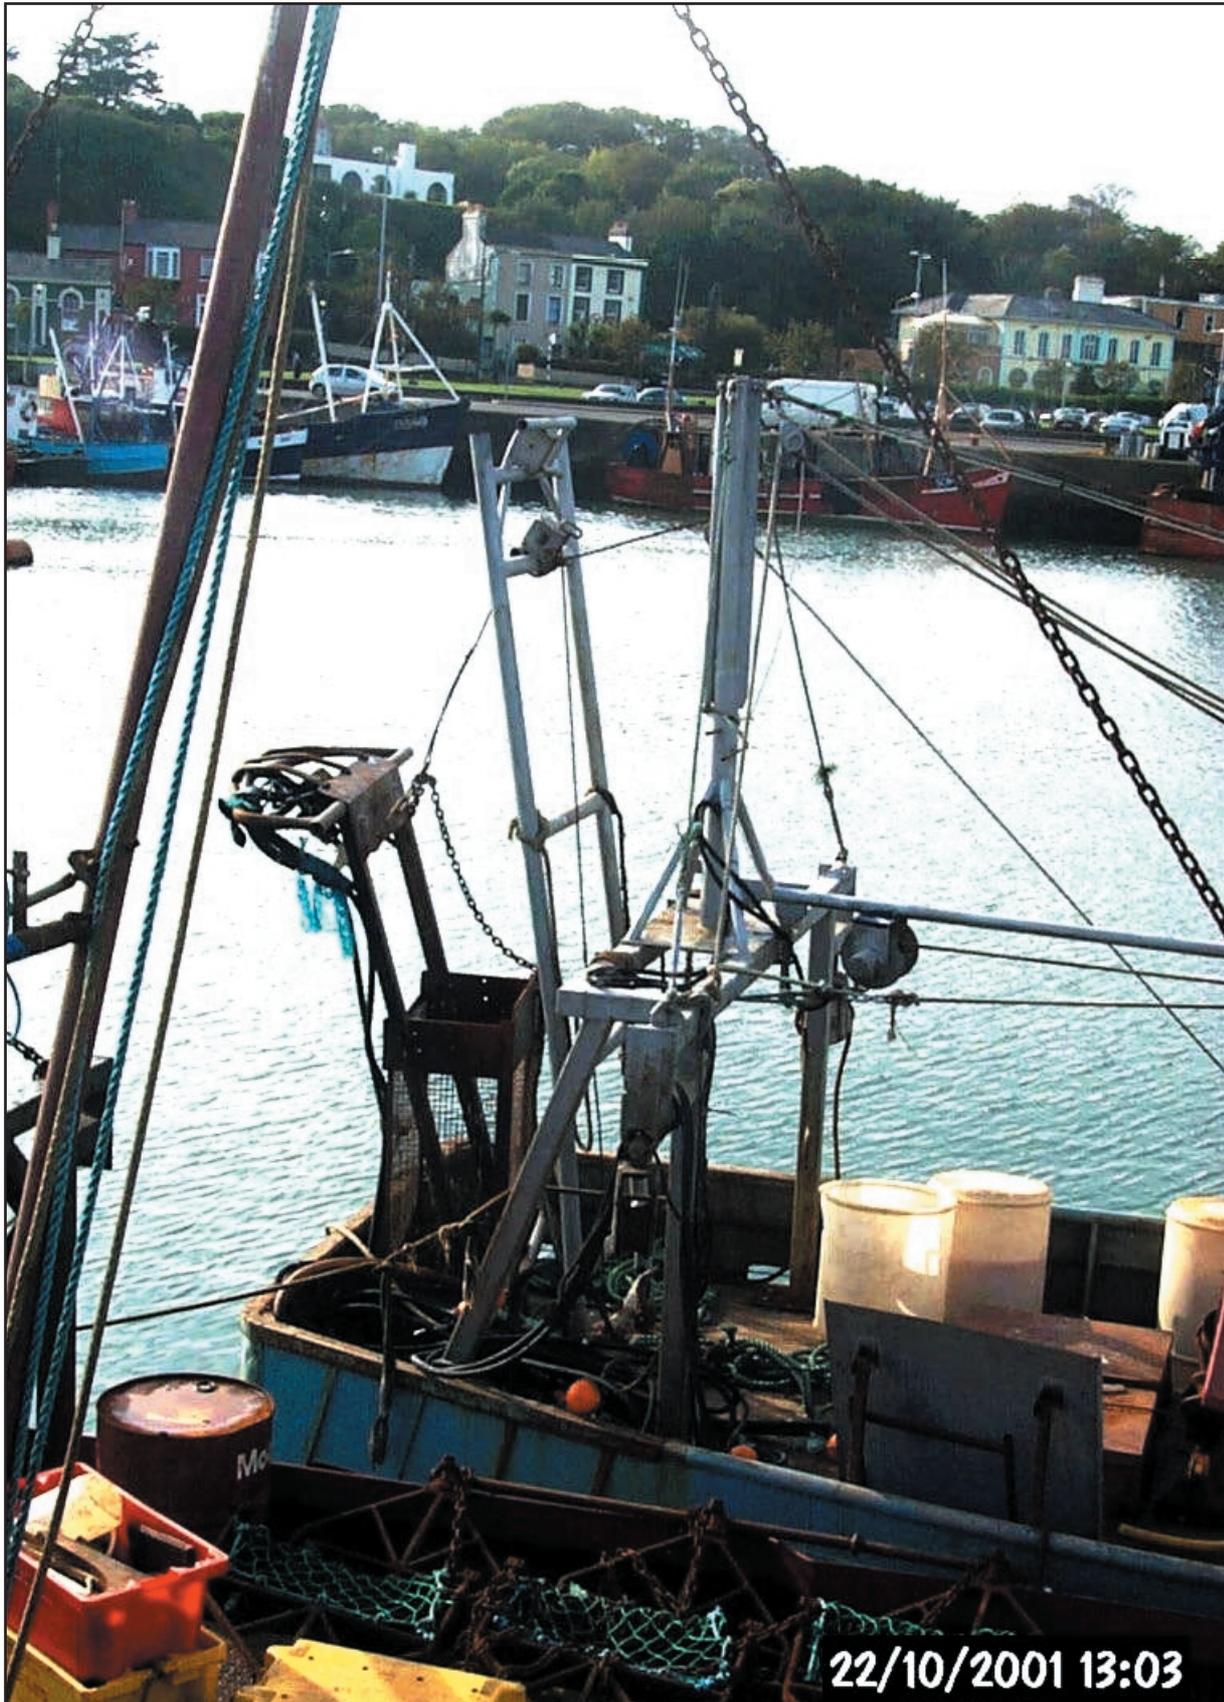
- The securing of the wire block to the derrick king post by welding its shackle directly to the post (photo 5).
- The welding of lifting gear chain links directly to the dredge structure (photo 6)
- The use of a winch unit which can only be used to pull in under hydraulic control - slacking out could only be done by de-clutching the winch and controlling its speed solely by the band brake.
- When being deployed, the dredge required manual manoeuvring over the transom gunwale putting the crewmember doing this job in a hazardous position immediately under the lifting jib.
- Following construction, there appears to have been no formal testing carried out to prove the rig was adequate and safe for its intended purpose.

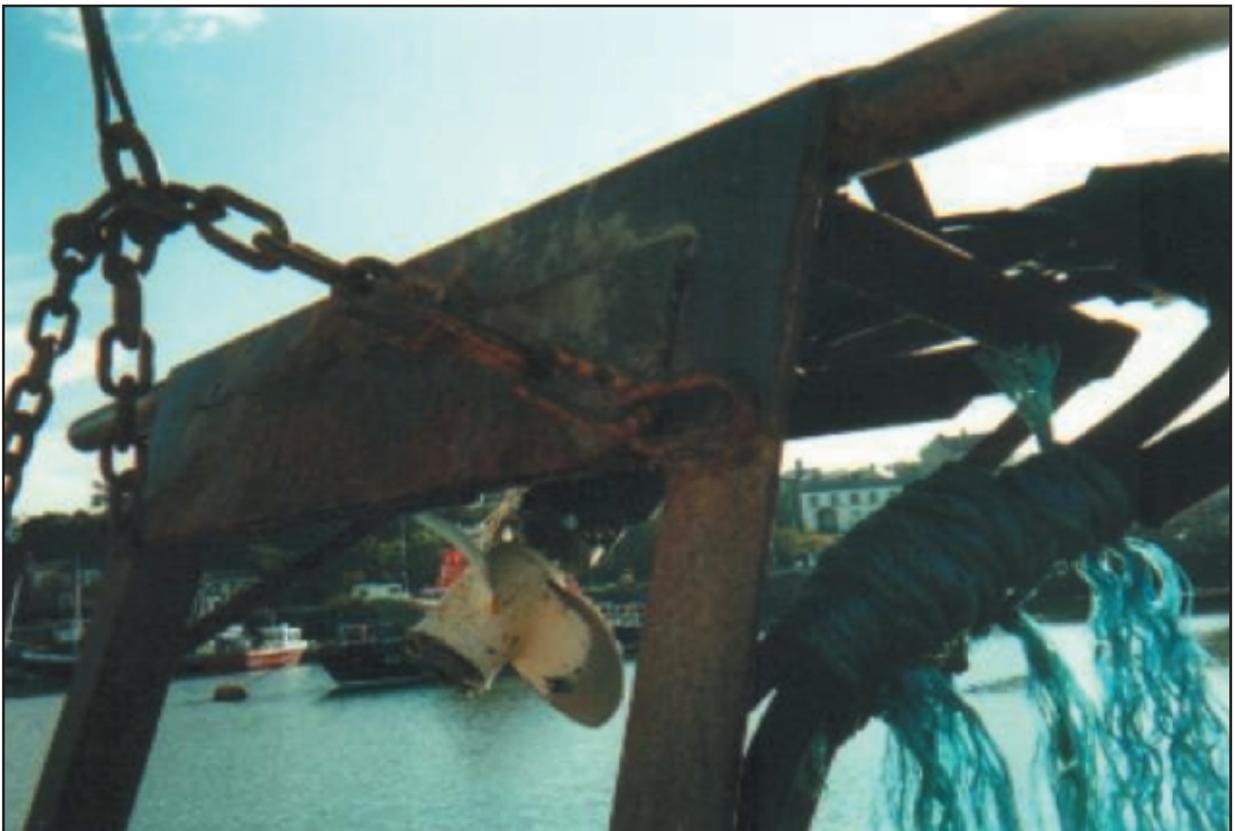
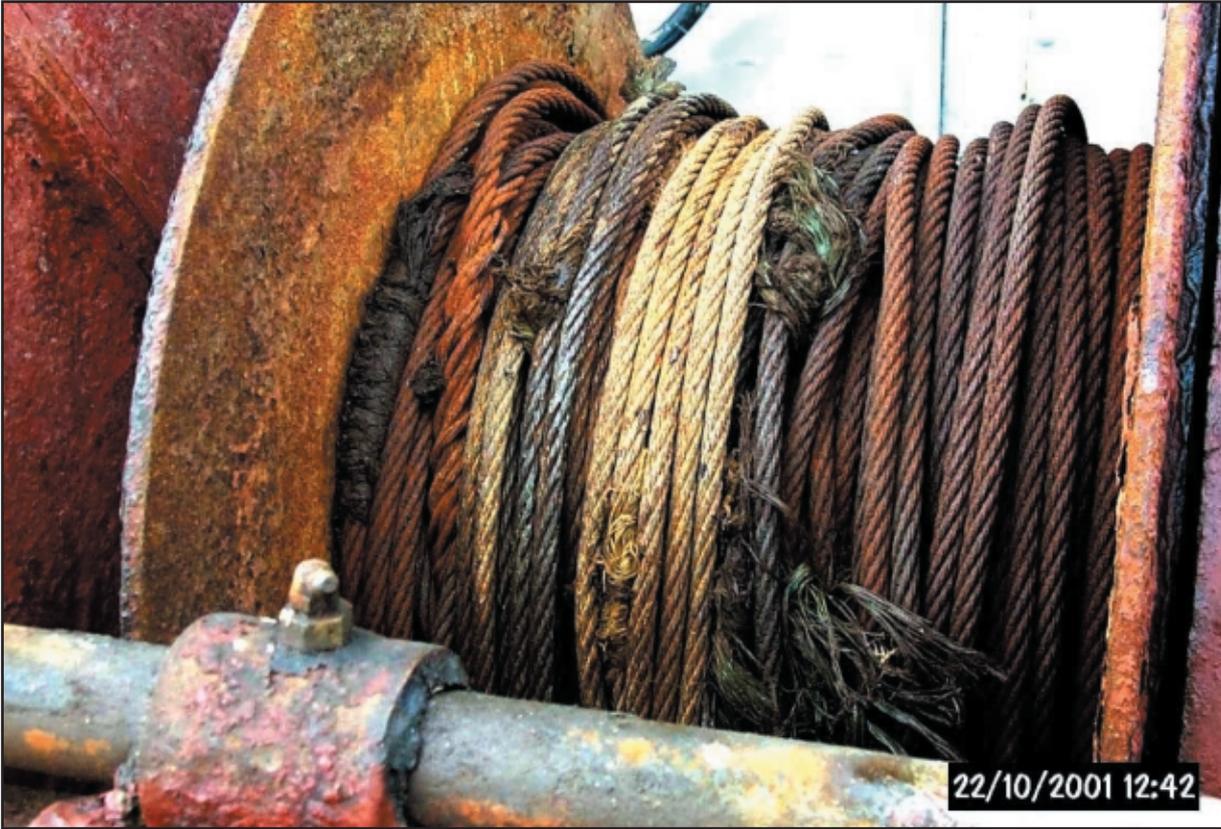
The equipment was generally in a poor state of maintenance (photos 7&8). There was considerable rusting and wastage of surfaces particularly on the winch unit. Its brake bands had sufficient friction material but the brake drums and bands were contaminated with dirt, rust and a grease-like substance, and were therefore rendered much less effective. The brake applying mechanism for the luffing winch drum (for the jib) was found to be inoperable. The screw threads on both its brake band nut and the brake-tightening rod were badly worn and damaged.

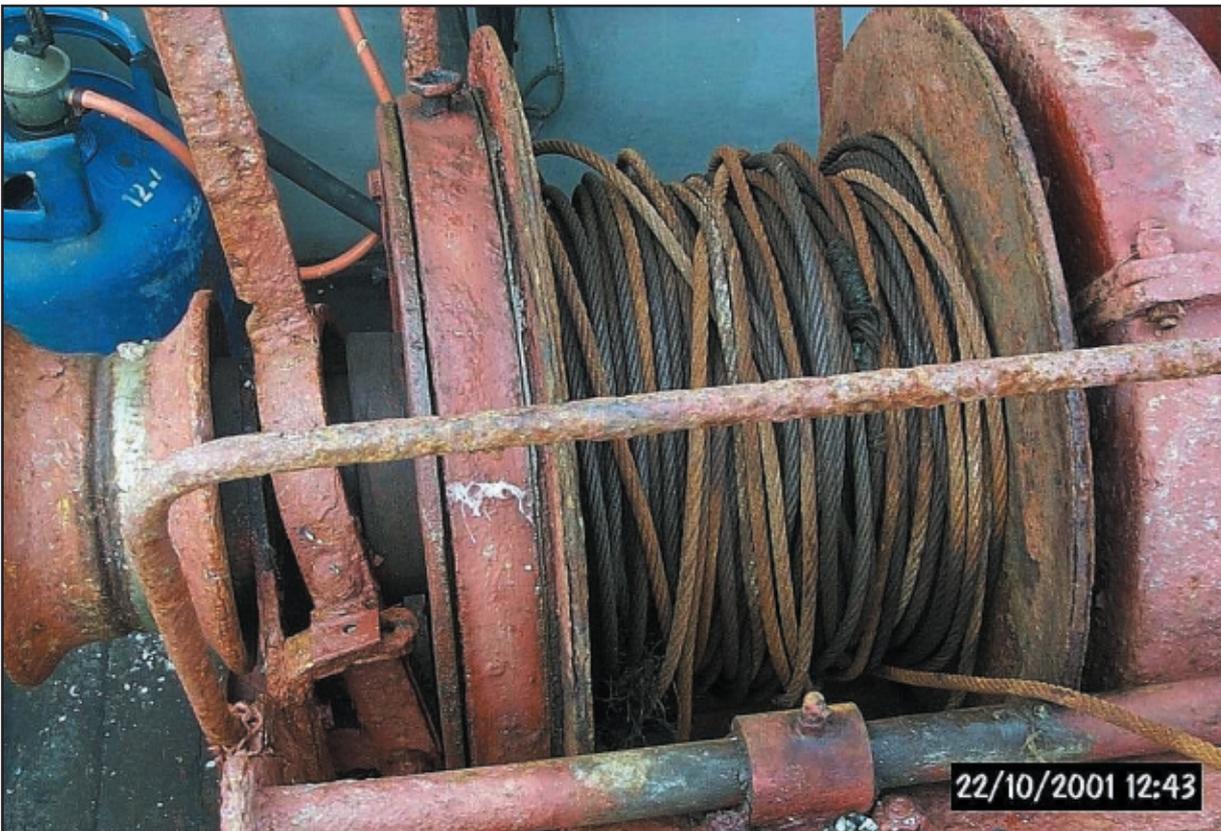
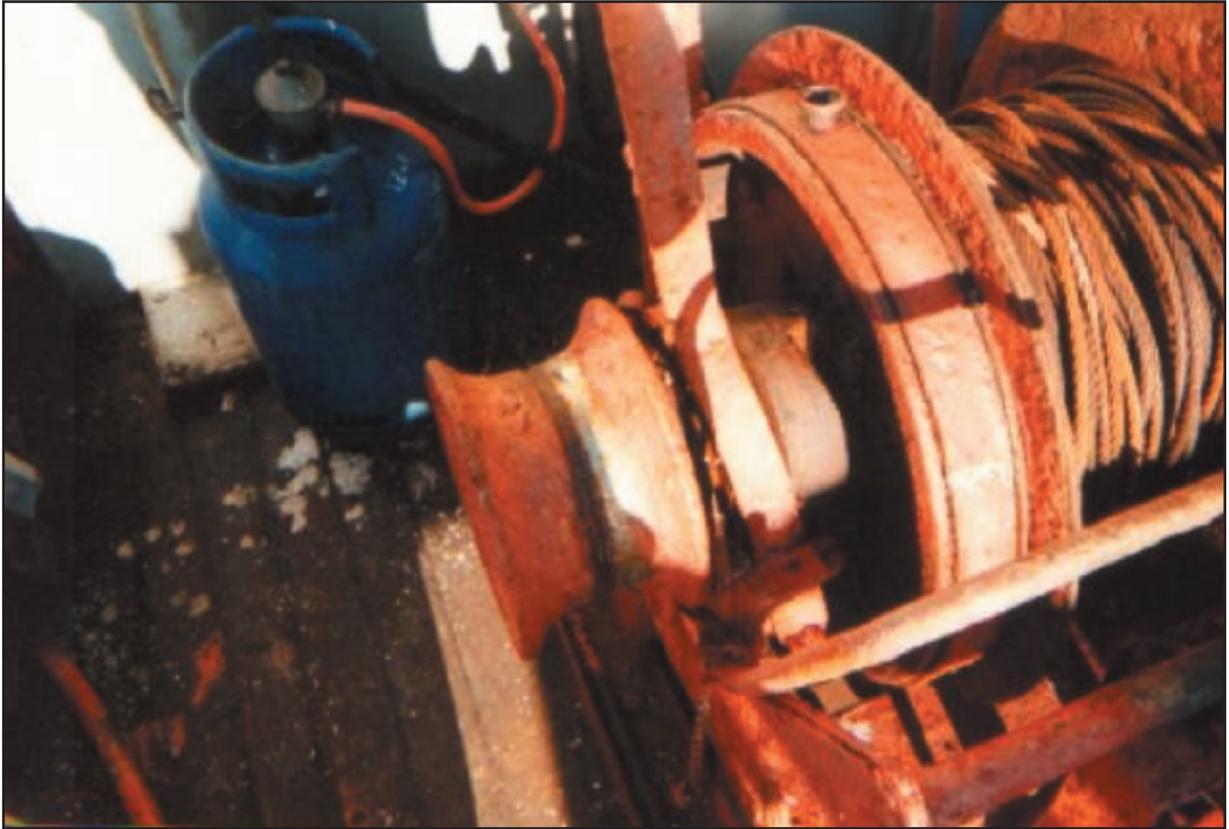
- Poor lay up of the wire on the winch drums resulting in slack loops and possible binding of cable (photos 9&10).
- Incorrect or poor rigging of wire (outside of guides).
- Joins in wire again leading to poor lay up on the drums.
- Deterioration and stranding of the wire.
- Clutch engagement retaining pins not fitting into their holes (painted over).
