**REPORT INTO FATAL INCIDENT
ONBOARD THE
MV “CEOL NA FARRAIGE”
ON
1st JULY 2012**

**REPORT No. MCIB/218
(No.6 of 2013)**

Report MCIB/218 published by The Marine Casualty Investigation Board
Printed 24th April 2013.

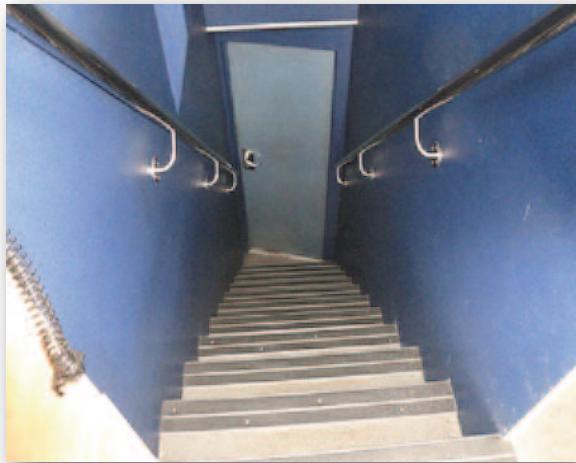
- 2.5 The stairs from the main deck to the wheelhouse consisted of 11 steps, the stairwell being 880mm wide. Each step had a riser of 240mm and a tread width of 235mm. A handrail was fitted to both sides of the stairwell 1,050mm above the steps. Each step was fitted with a slip resistant surface.

View of Stairwell from Top

- 4.3 There was no means at the top of the stairwell to prevent any person inadvertently stepping into a gaping void.
- 4.4 It is apparent that Mr McLean accidentally lost his footing when going to change his position from at the top of the stairwell to a position by the chart table.

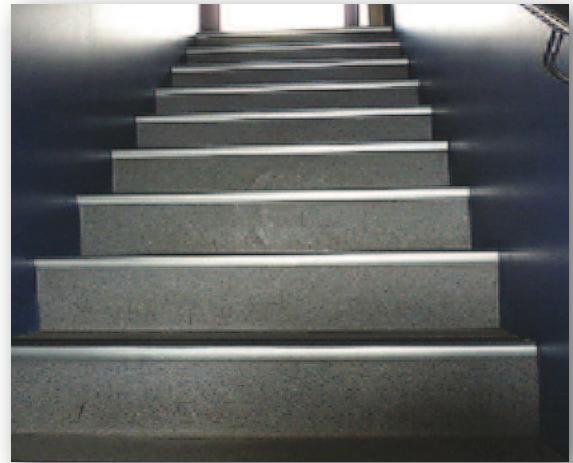
View of Stairwell from Bottom

- 4.1 The vessel was built in 2001 and had undergone no modifications in the area of the incident since the vessel was built.
- 4.2 At the bottom of the stairs there was fitted a heavy steel door with a handle situated 1,060mm above deck.

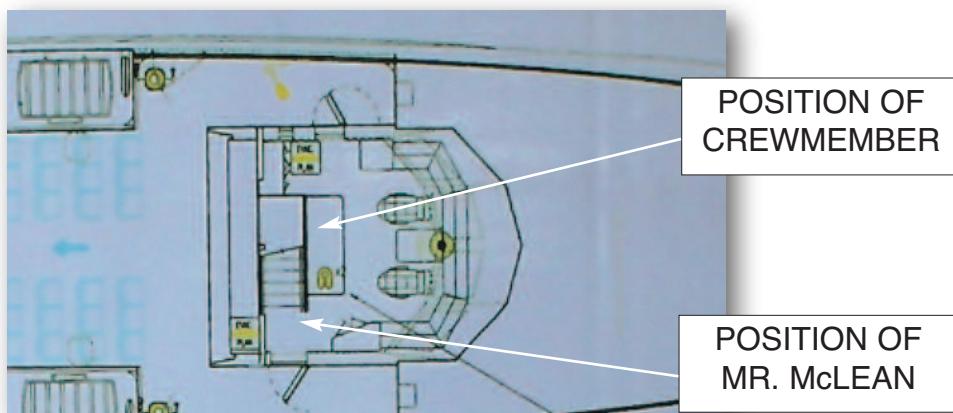
- 3.9 To change his position from the top of the stairwell to in front of the chart table, Mr McLean turned to his left and in so doing his right foot stepped backwards onto the first downward step. Caught unawares by this loss of footing he lost his balance and fell backwards and headfirst down the stairway, striking the back of his head against the door at the bottom of the 11-step stairway.
- 3.10 The crewmember went down the stairway to find Mr McLean lying unconscious at the foot of the stairway with blood coming from a wound at the back of his head. His feet and lower legs were inside the door and in contact with the lowest step. His head and upper body were in the port aisle.

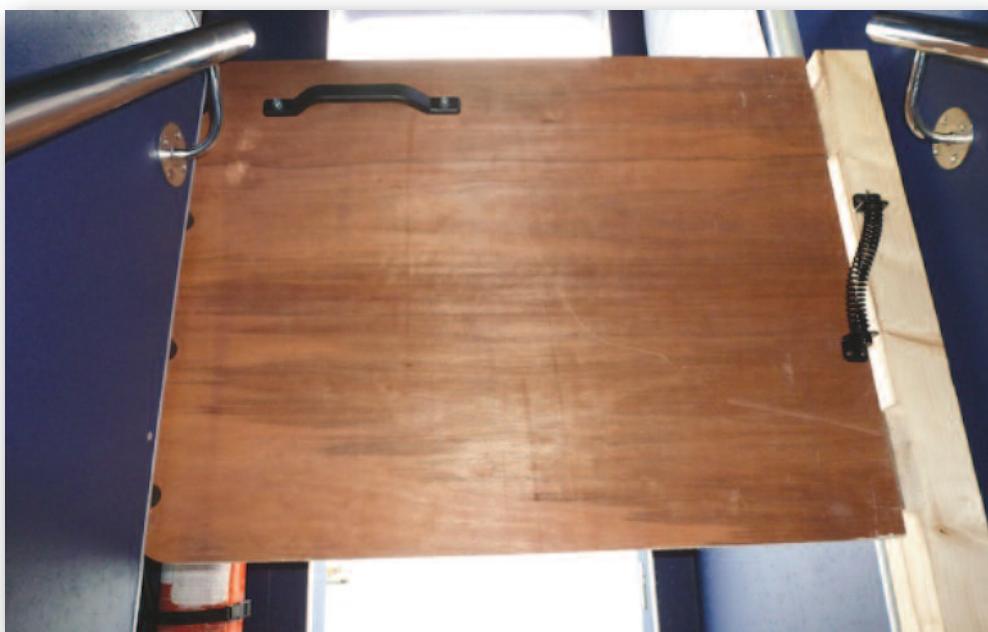
Spring Loaded Gate Subsequently Fitted at Top of Stairs, Preventing Accidental Stepping onto Stairs.

- 4.8 Since the incident the Owners have fitted spring-loaded doors at the top of the stairwell, which will prevent anyone unintentionally stepping into a void.

- 6.1 The Board notes that the Owners have taken the necessary actions to prevent a similar incident occurring by fitting a spring loaded gate at the top of the stairwell on both the MV Draiocht Na Farraige and MV Ceol Na Farraige. No further actions are required.
- 6.2 It is recommended that a Marine notice be issued for owners reminding them of the need to carry out a risk analysis in accordance with the Domestic Safety Management code. This should address all risks including open stairwells leading from the wheelhouse and take any necessary precautions resulting out of the analysis.
