**REPORT OF INVESTIGATION
INTO CASUALTY OFF
AUGHRIS POINT,
CLADDAGHDUFF, CO. GALWAY
21st APRIL 2009**

**REPORT No. MCIB/166
(No. 5 of 2010)**

Report MCIB/166 published by The Marine Casualty Investigation Board
17th June 2010

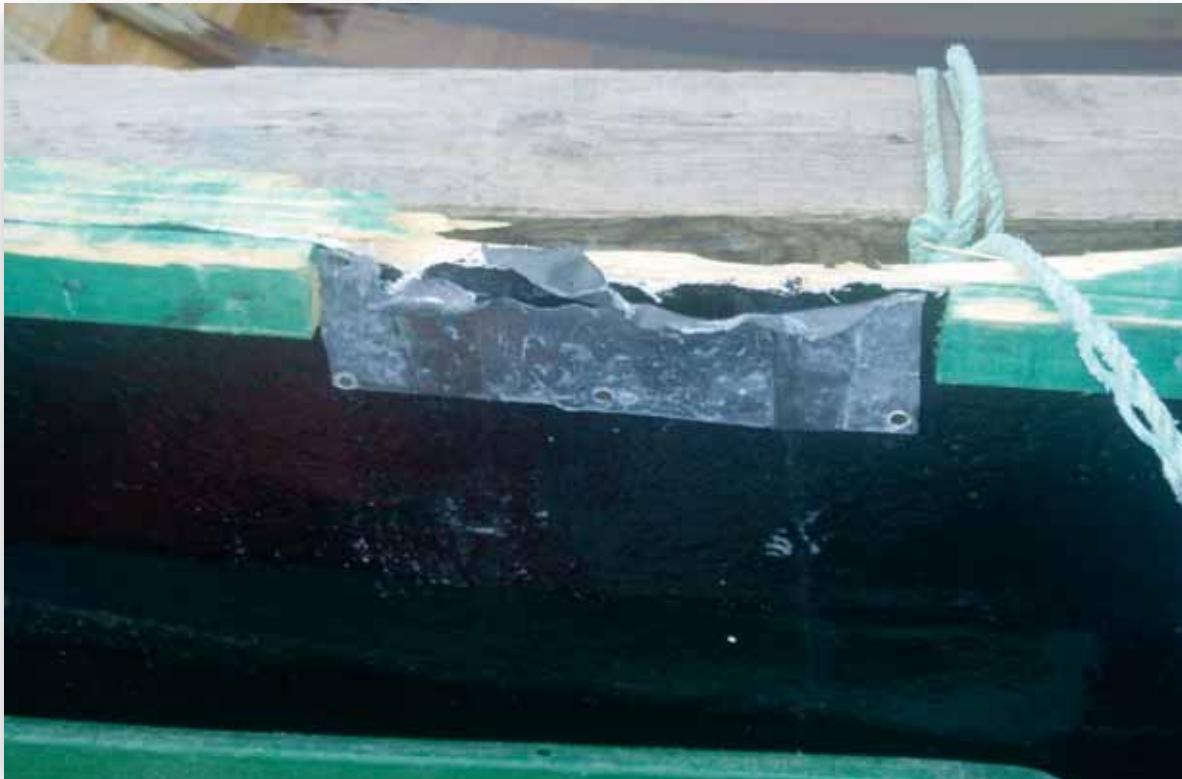
- 4.5 The vessel was, for the most part, found intact apart from some damage to the transom at the mounting for the outboard engine. The engine was not attached to the boat. Local fishermen eventually towed the vessel into port.

Appendix 8.3 Photographs of the currach, lobster pots, engine & location.**Photo 1:** Damaged engine mounting on transom.

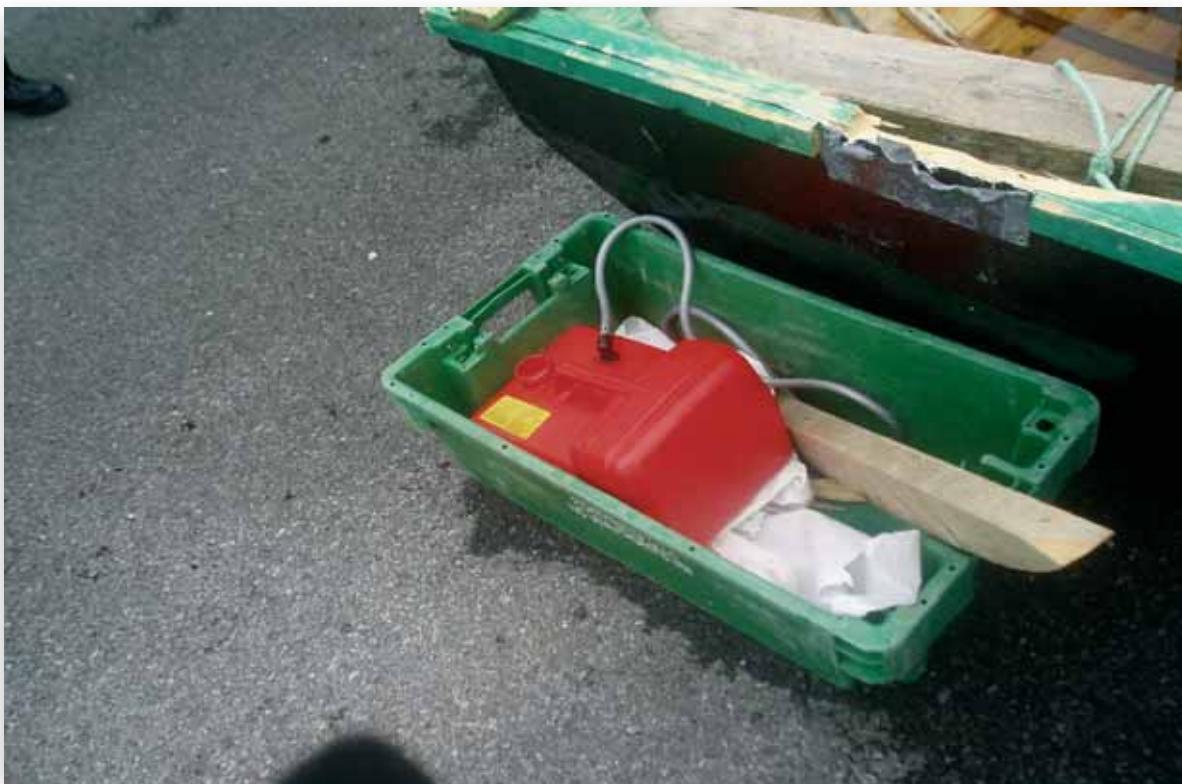
**Photo 2:** Engine fuel tank and feed hose. Also in the picture is the foot lock.

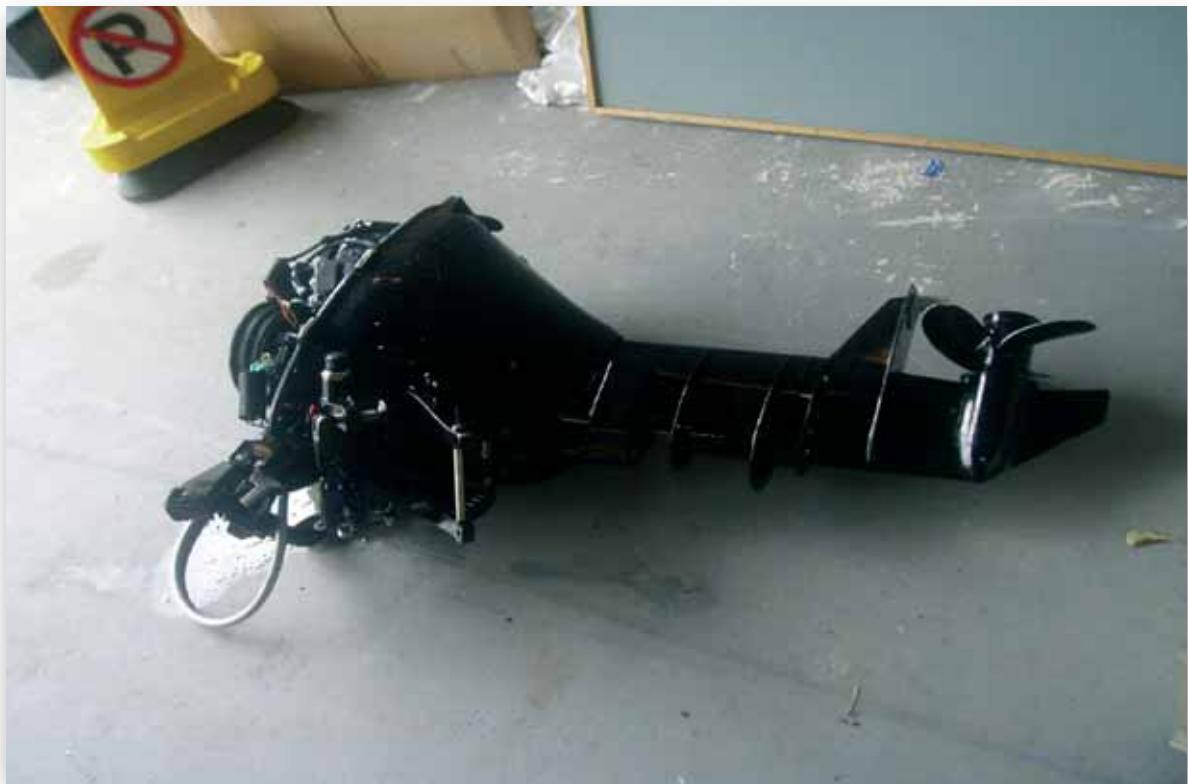
Photo 3: Outboard engine recovered near scene of incident.

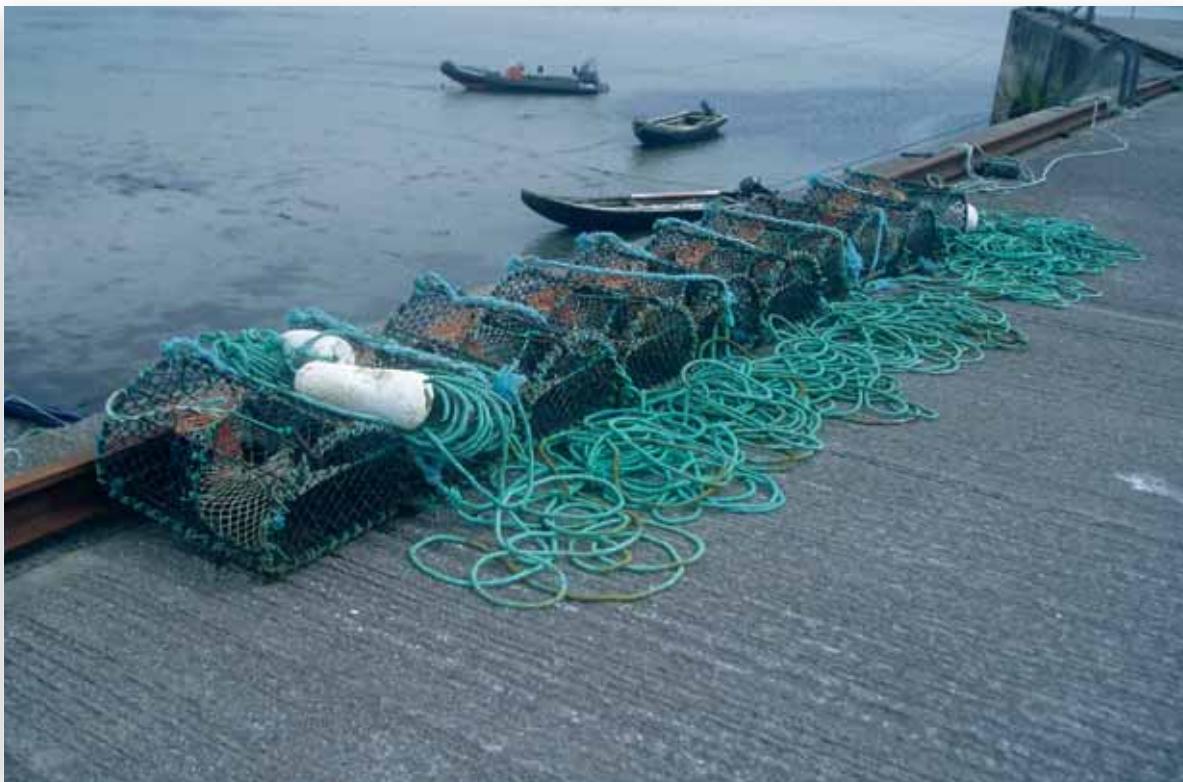
- 4.4 The line of pots was made fast to the currach between pots 4 and 5 indicating that during the hauling of these pots, for whatever reason, it became necessary to tie them off. Each pot when empty and dry weighs approximately 10 kg. These pots would have been manhandled, as the currach did not have a mechanical hauler.

- 6.9 The most significant factor in establishing the cause of this incident is the fact that when the vessel was found, a line of pots were tied off to the thwart (seat) between pots number 4 and 5. This indicates that of the string of 10 pots, (each pot weighing approximately 10 kg when dry and empty), 4 were onboard and the remaining 6 were hanging over the side and along the seabed in an approximate depth of 8 to 10 metres. This would at best restrict the vessel's vertical motion in a seaway and at worst snag the seabed thus compromising the stability/survivability of the vessel. Eventually the rolling accelerations would result in the vessel capsizing. See simplified explanation at Appendix 8.4.

Photo 5: String of pots recovered.

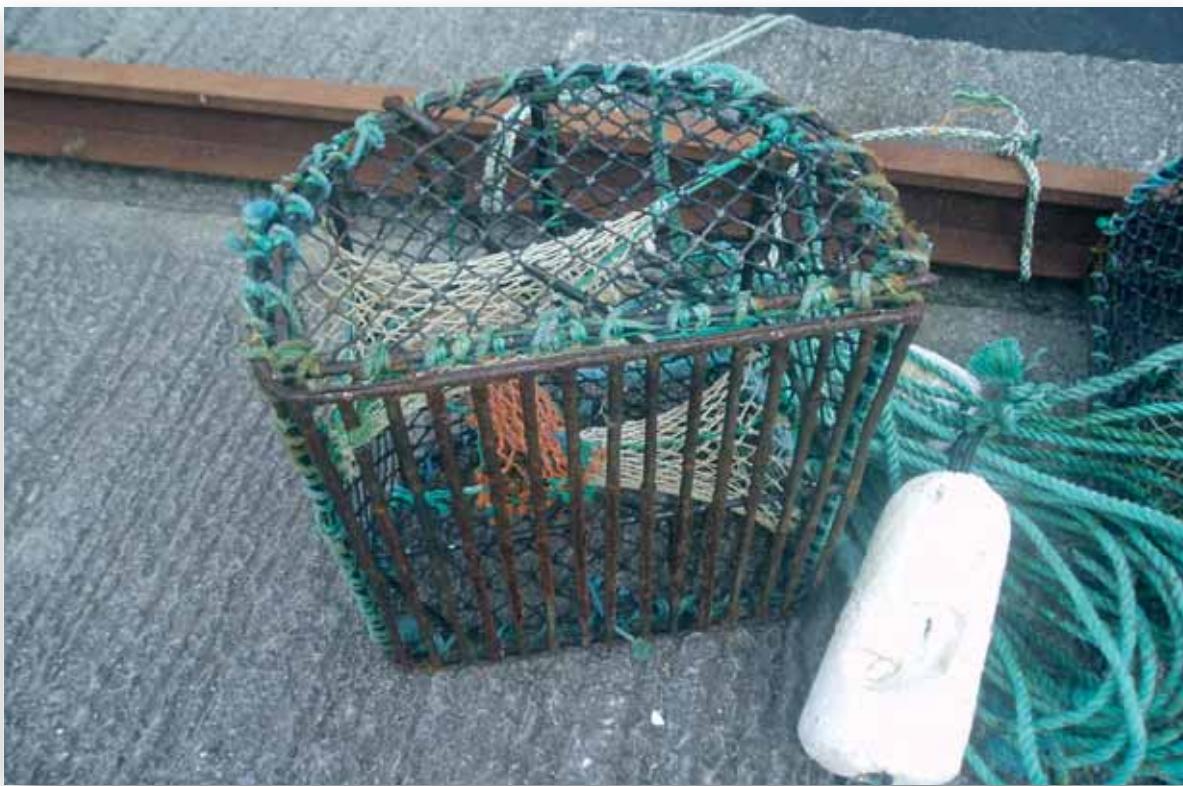
Photo 6: Single pot.

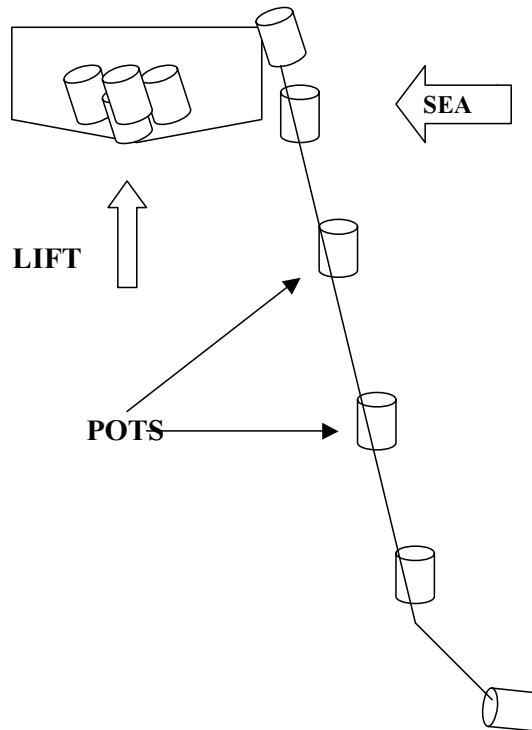
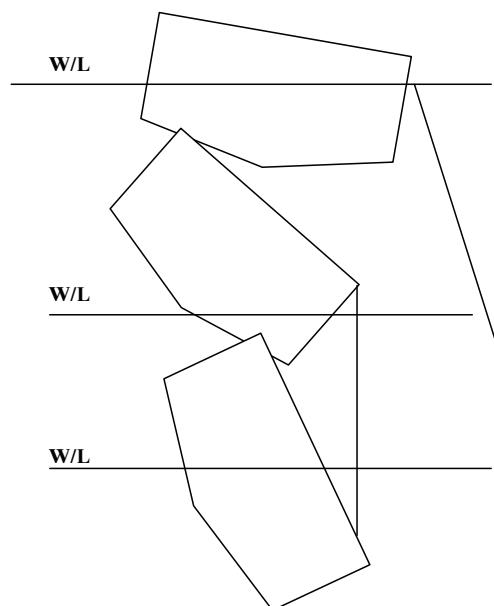
Here the vessel is in the upright position engaged in hauling. Wave action will tend to lift and lower the vessel and apply side or lateral forces, which will result in rolling accelerations.

The weight of the pots now tethered to the side of the currach restricts **that** side of the vessel from rising freely as a result of wave action. The rolling period is also affected.

As the rolling increases due to energy dissipation combined with the vertical restriction, the net effect is to increase the movement of the extremities.

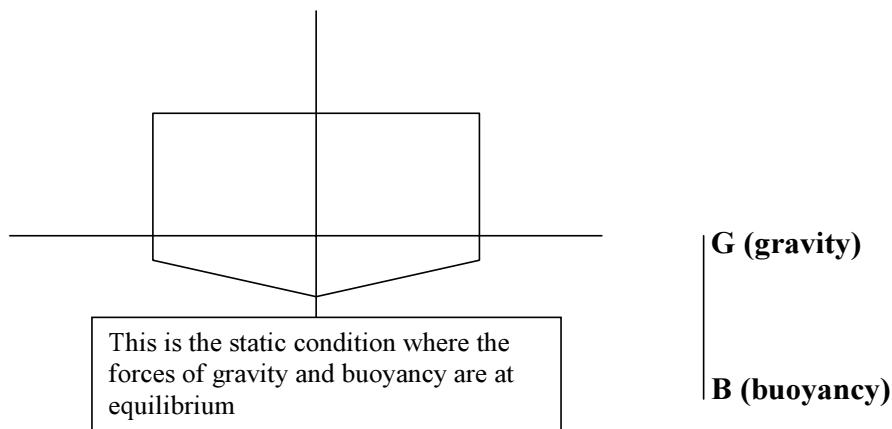
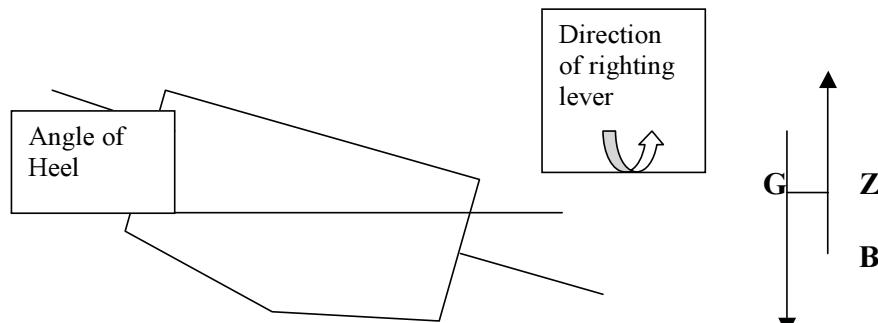
In actual fact the centre of gravity and buoyancy moving in relation to one another eventually sets up an upsetting moment culminating in the vessel capsizing as follows:

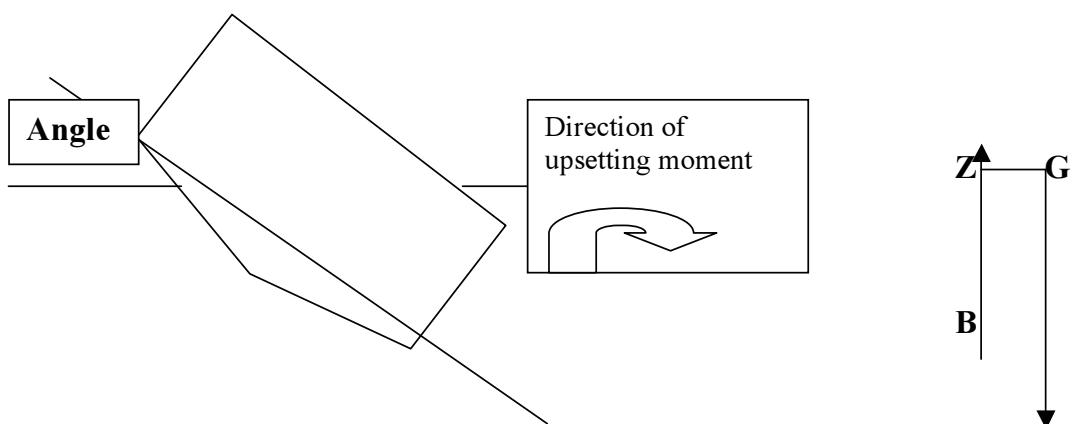
However: Conditions can exist where the centre of buoyancy does not move far enough in the direction in which the vessel rolls to place the buoyant force outside of the force of gravity. The net result of this is an upsetting moment, which causes the vessel to eventually capsize. It is believed that this is what occurred in the case of the currach capsized due to the pots been tied to the vessel as demonstrated.
