**REPORT OF INVESTIGATION
INTO INCIDENT ONBOARD THE
MV “CLAIRE BUOYANT”
ON
MONDAY 1st AUGUST 2011**

**REPORT No. MCIB/205
(No.3 of 2012)**

Report MCIB/205 published by The Marine Casualty Investigation Board
Published 8th March 2012.

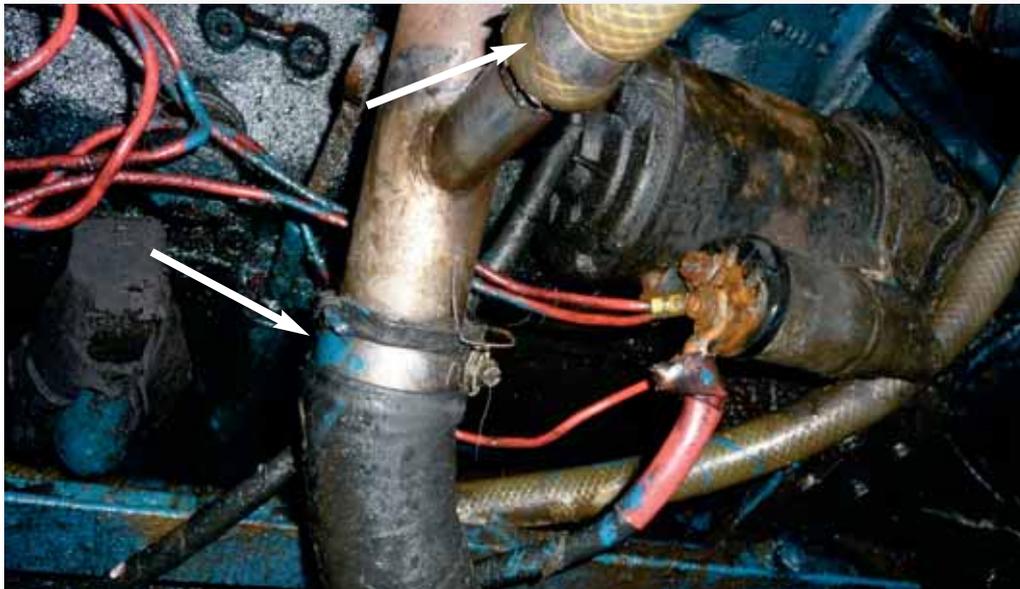
- 4.1 Whilst on passage between Beginish and Ventry the skipper noted the boat becoming tender and the deck edge becoming submerged, thus indicating stability issues.
- 4.2 On investigation it was found that water was entering the engine room from the water-cooled exhaust system, due to the water injection pipe coming adrift from the exhaust pipe. The engine was stopped to prevent a further ingress of water, the water level was stated to have been to a depth of approximately 280 mm.
- 4.3 The flexible pipework on the exhaust system was only secured with single hose clamps instead of industry standard of two per connection. If the pipes had been adequately secured in the normal manner the chances of the flooding would have been vastly reduced.

Single Hose Clips on Exhaust System

- 7.1 All craft should develop a maintenance regime and regularly check all fittings, both internal and external, which are open to the sea. Bilge pumps should be regularly inspected to ensure that they are clear from blockage and that no loose debris is in the bilge area.
- 7.2 The carriage of livestock should only be undertaken in appropriately certified vessels.

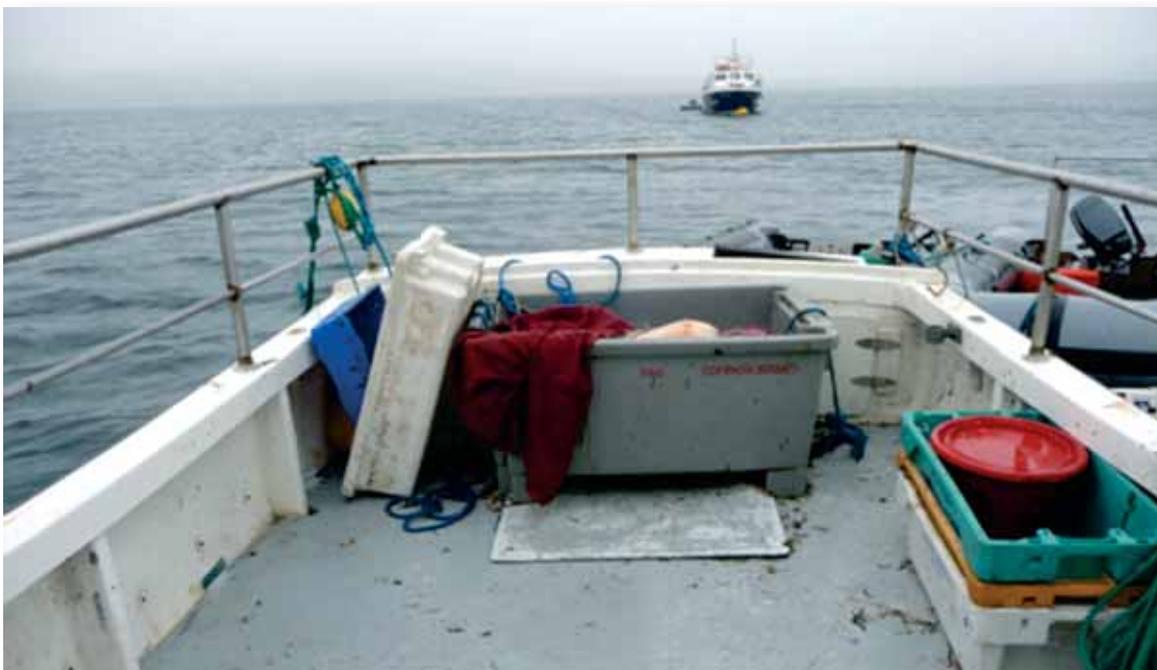
(a) Deck of boat looking from Forward to Aft.

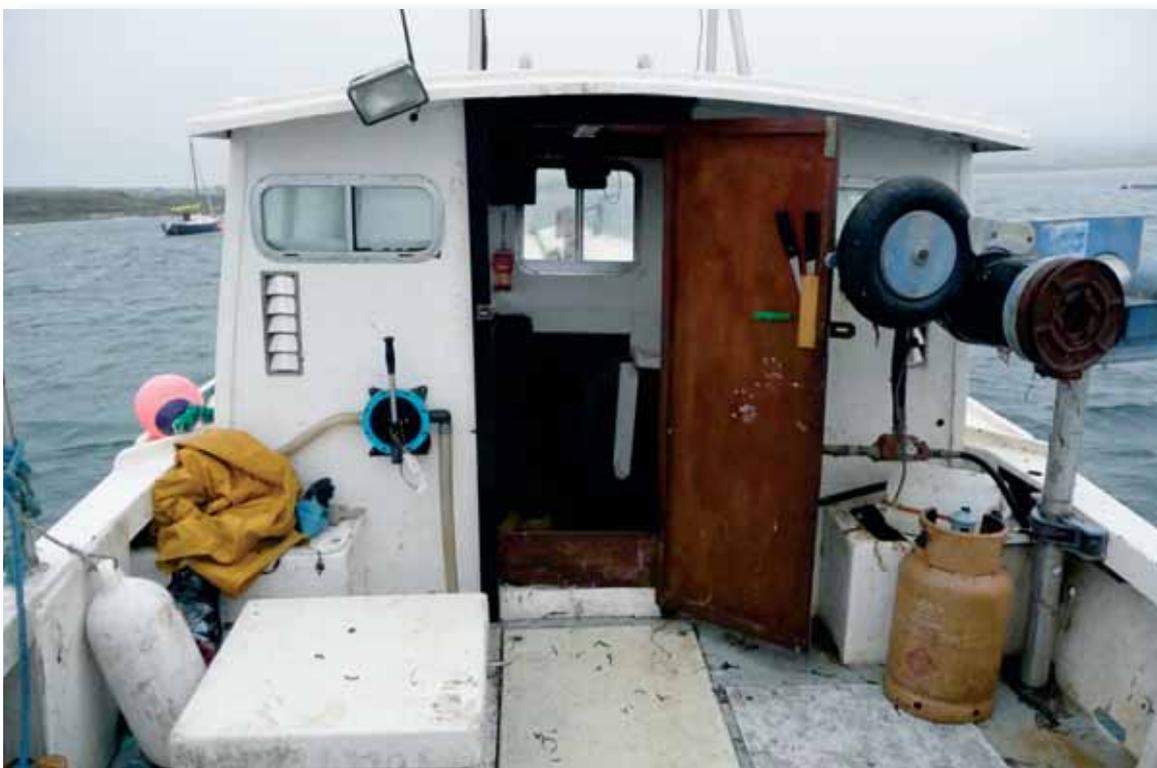
(b) Deck of boat looking Aft to Forward.
