**REPORT OF THE
INVESTIGATION INTO
THE SINKING OF THE M.V.
"CLIPPER CHEYENNE" AT
FOYNES ON THE 3RD JUNE
2002.**

The Marine Casualty Investigation Board was established on the 5th, June 2002 under The Merchant Shipping (Investigation of Marine Casualties) Act 2000

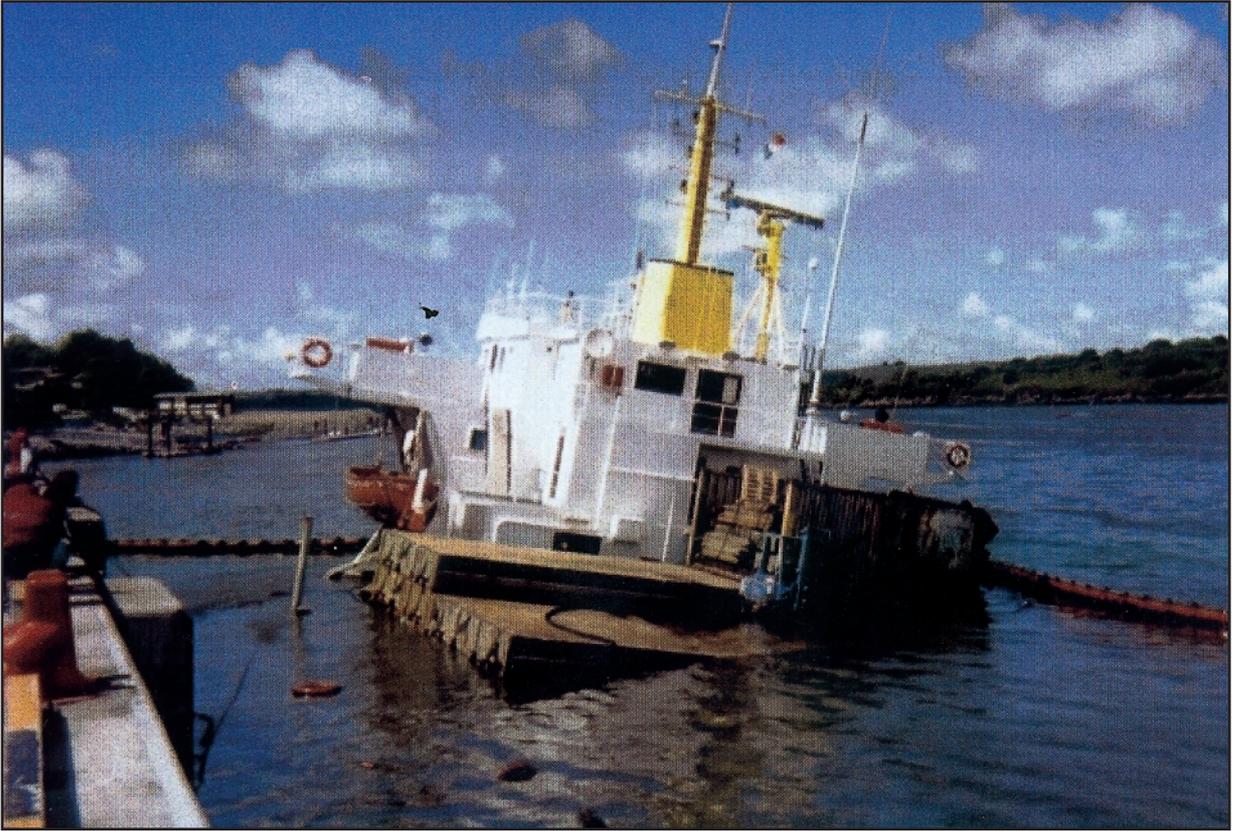
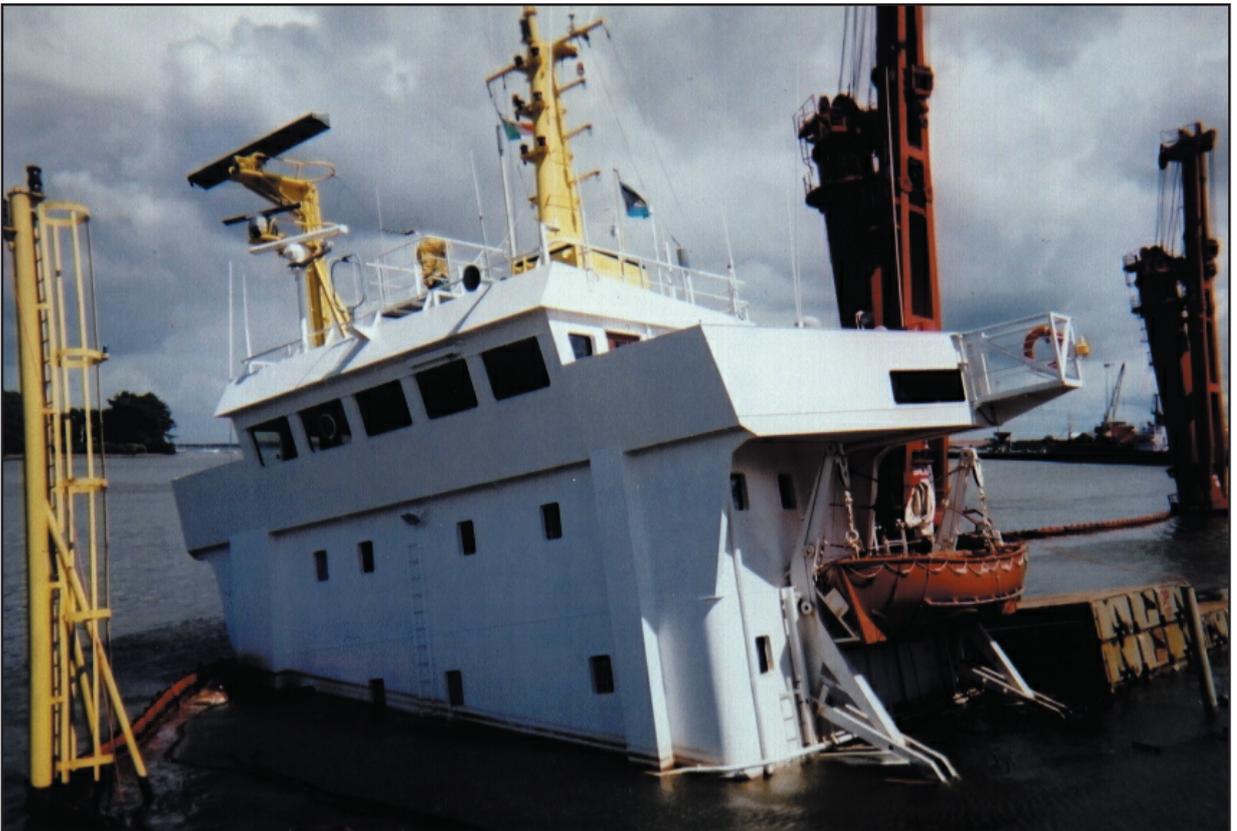
8.6: Photographs of sunken vessel.

- 6.1 The vessel sank due to a progressive loss of buoyancy and inadequate righting moment. This probably was caused by the low stability of the vessel when in the submerged semi-submersible mode. The range of stability of the vessel at this stage would have been very low and the righting moment small. In addition at the deep float-in draft the down-flooding points could have been immersed at low angles of heel. Any down flooding would have reduced the stability of the vessel and thus lead to a progressive flooding of the vessel and consequent overturning and subsequent sinking. The stability of the flo-flo operation was assessed by means of GM alone. The range of stability was not assessed during the operation. The vessel could have a positive GM but a very low range of stability and therefore would not be able to withstand significant overturning moments.

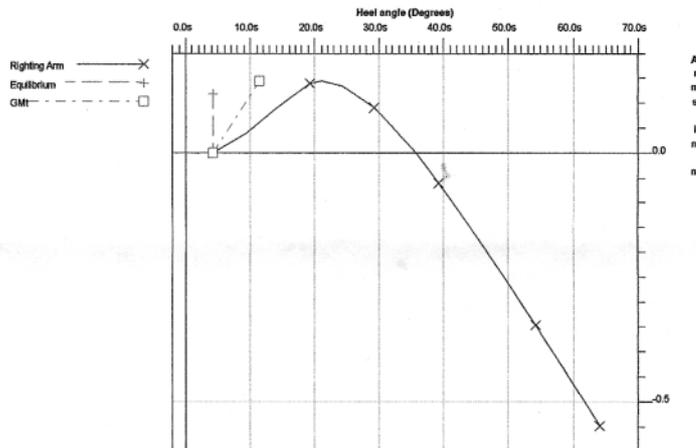
Righting Arms vs. Heel

8. As it is now understood that the cranes access doors were open at the time of the incident (it is to be noted that each crane winch compartment has a capacity of about 60 cbm), taking into account a water depth of 3.5/3.6m in the dock, the flood point of same compartment is reached at about 4 degrees list on starboard. Due to trimming by bow, the winch compartment of the fore crane was first flooded, followed by flooding of the winch compartment of the aft crane and, later on, by flooding of the engine room via the starboard side emergency exit.. I can also point out that, with 4 degrees list on SB, the fluid GM was 1.14 metres yet while the range of stability was about 30 degrees. This also means that there was no capsizing situation if the cranes doors had been shut.

For your guidance, please find here-after the stability simulation and related R.A. curve corresponding to the moment when the crane nr. 1 compartment began to be flooded.

Heel Angle (deg)	Trim Angle (deg)	Origin Depth (m)	Righting Arm (m)
4.12s	0.91f	7.650	0.000
9.12s	0.78f	7.887	0.039
14.12s	0.70f	7.998	0.093
19.12s	0.69f	8.008	0.141
20.96s	0.67f	8.042	0.144
24.12s	0.61f	8.135	0.135
29.12s	0.48f	8.331	0.092
34.12s	0.32f	8.556	0.023
35.52s	0.27f	8.617	0.001
39.12s	0.15f	8.780	-0.059
44.12s	0.04a	9.000	-0.151
49.12s	0.21a	9.186	-0.247
54.12s	0.37a	9.339	-0.345
59.12s	0.51a	9.447	-0.446
64.12s	0.63a	9.508	-0.546
