**REPORT INTO GANGWAY
ACCIDENT INVOLVIING THE
DANISH REGISTERED CARGO
VESSEL "DANIA KIRSTEN"
AT SOUTH JETTIES IN THE
PORT OF CORK ON
21ST JANUARY, 2003.**

The Marine Casualty Investigation Board was established on the 5th, June 2002 under The Merchant Shipping (Investigation of Marine Casualties) Act 2000

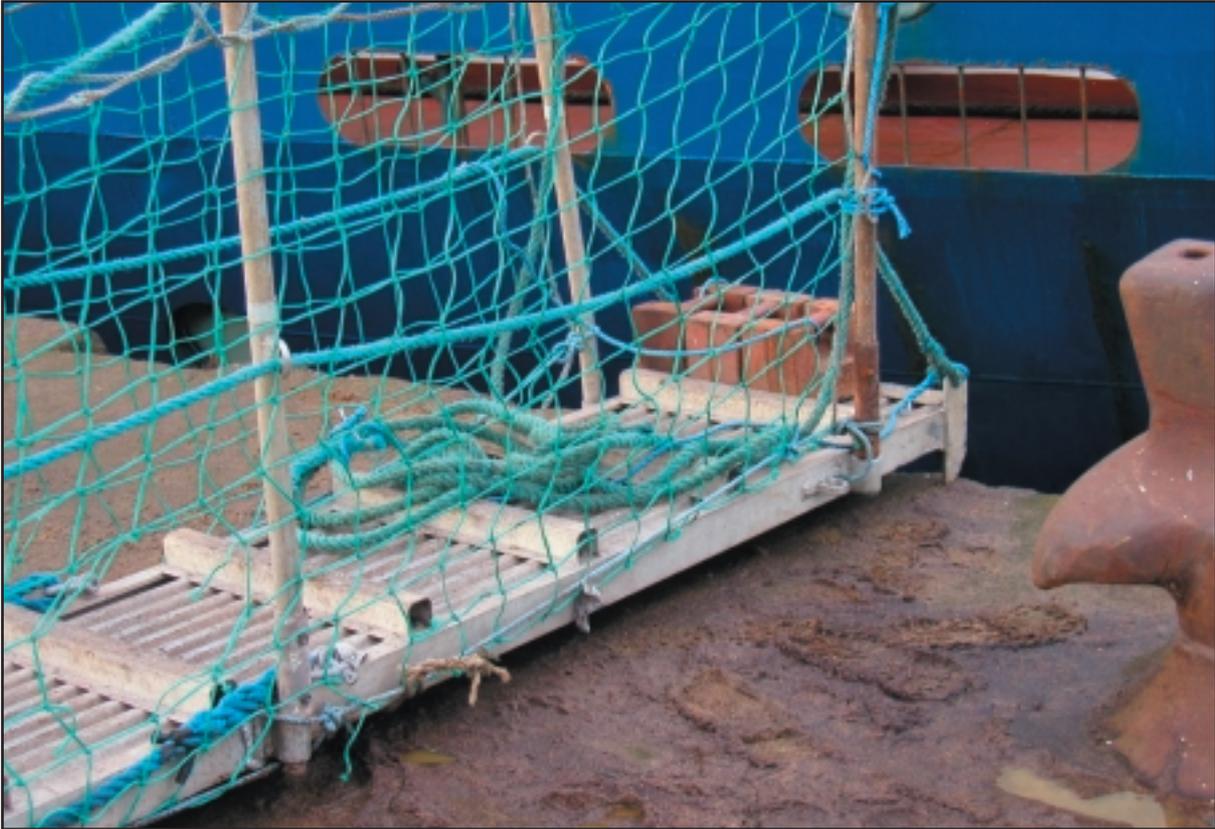
8.2.11 Weights being added to end of gangway.

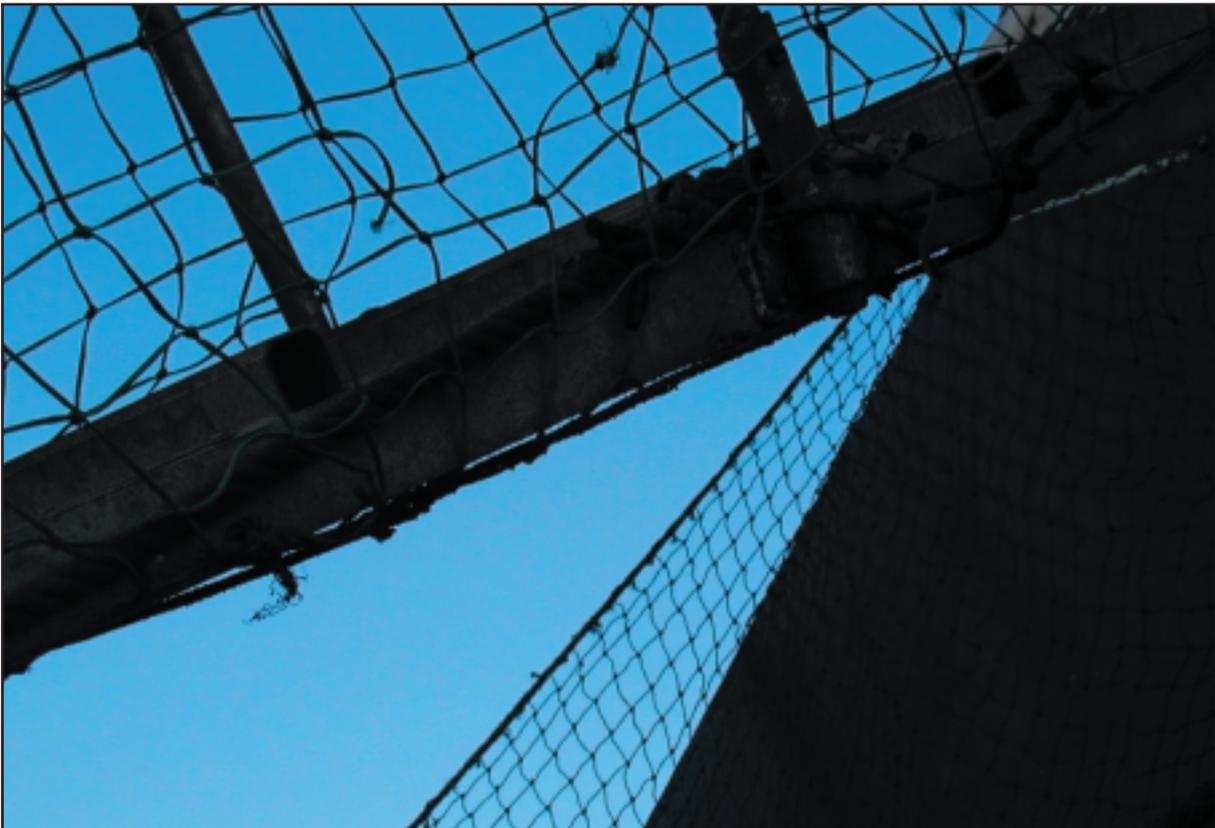
8.2.12 Gangway rigged after recovery with safety net beneath.

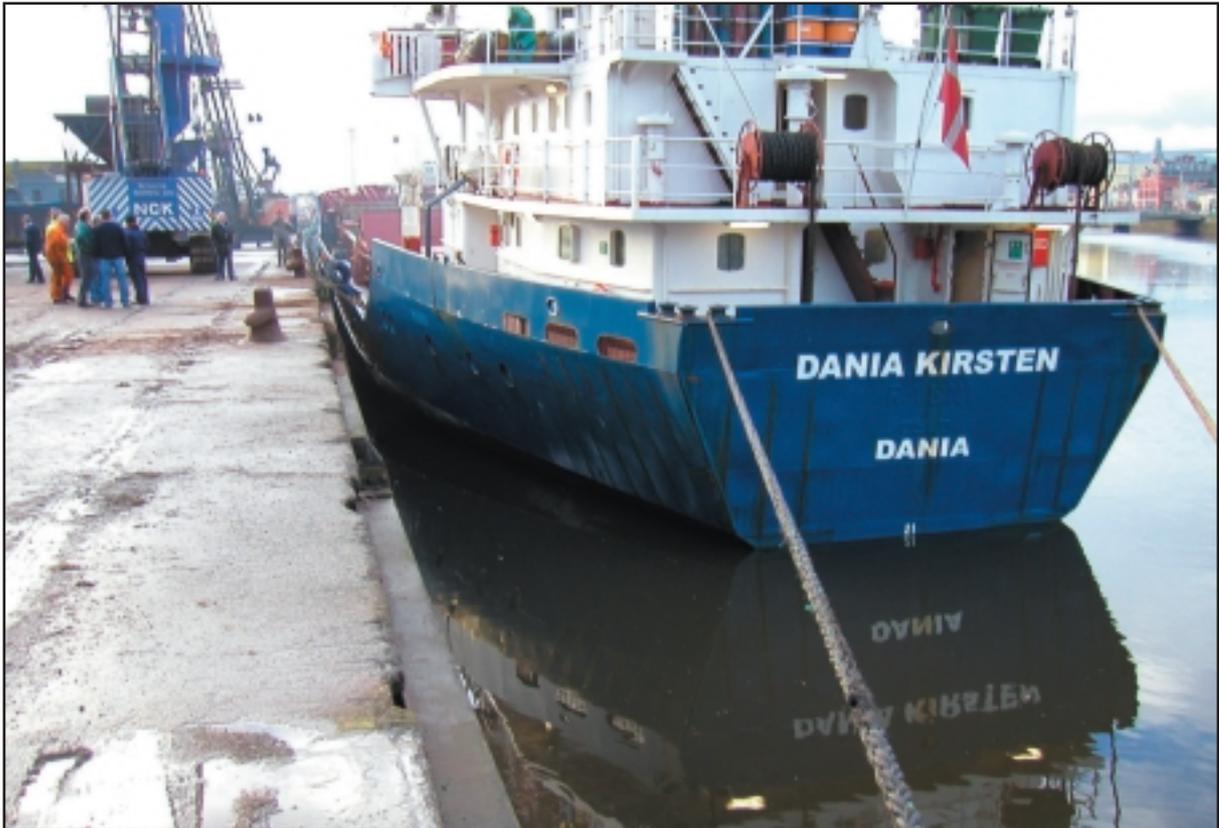
8.2.1 The position of the bulwark door and distance from quayside. At the time of the accident the ship was reported to be even further away from quayside

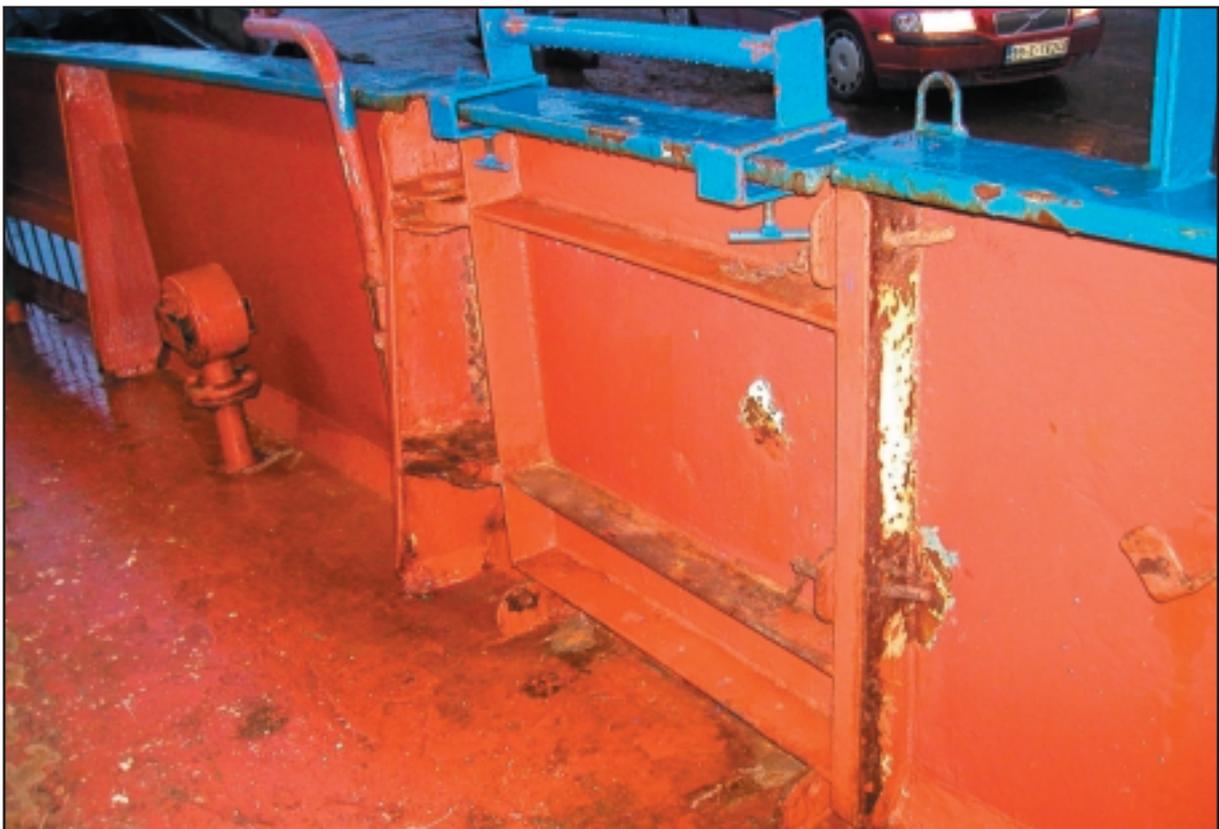
- 3.4 The Captain had instructed the deck crew to keep a regular watch on the gangway as the tide was falling. At 12.00hrs the gangway was shifted due to the falling tide. It was shifted aft of its original position to the Poop Deck level at the position of the Port side bulwark door. As the level of the ship continued to fall relative to the quay the bulwark door was closed at approximately 13.30hrs by the Chief Officer, Mr. Iversen and Mr. Corpuz and the gangway was lifted up to the level of the top of the bulwark where it rested on a removable securing bracket which was clamped to the top of the bulwark door.

8.2.2 Bulwark door - Portside with removable bracket

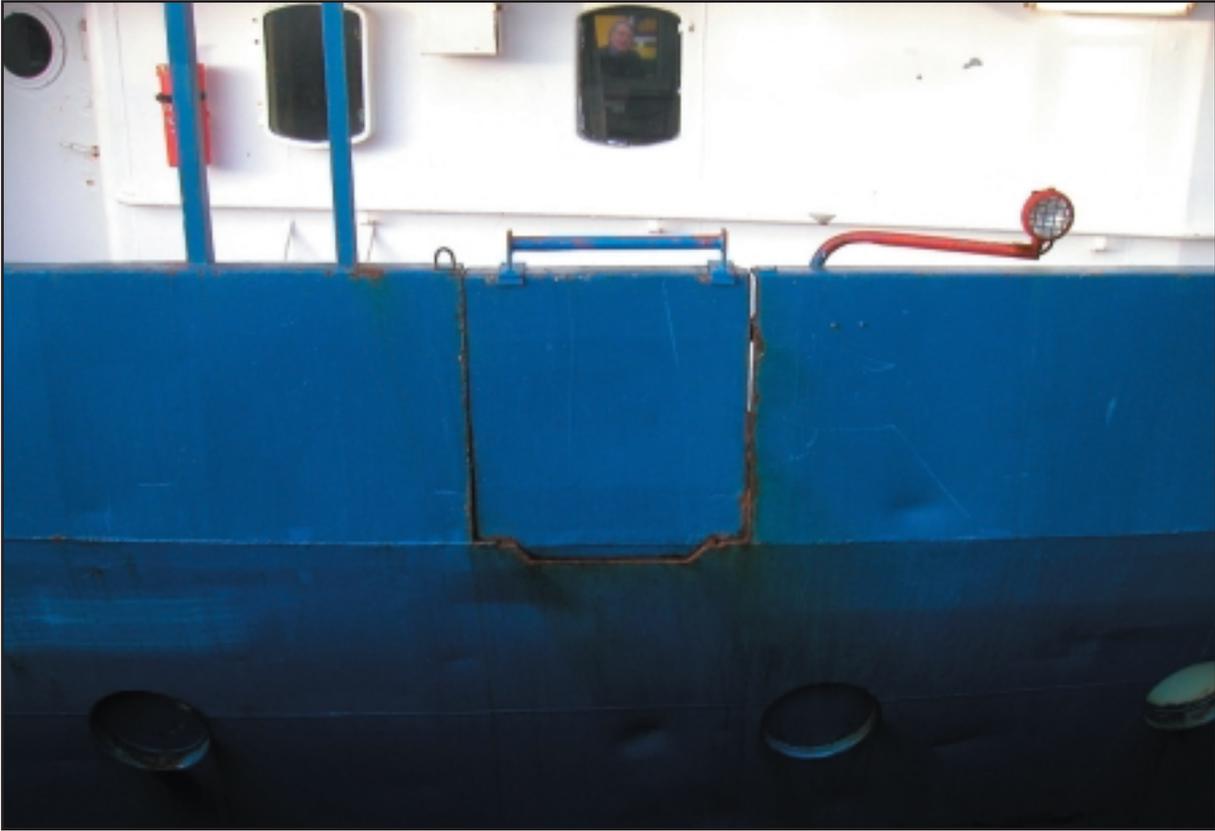
8.2.3 Bulwark door - Portside

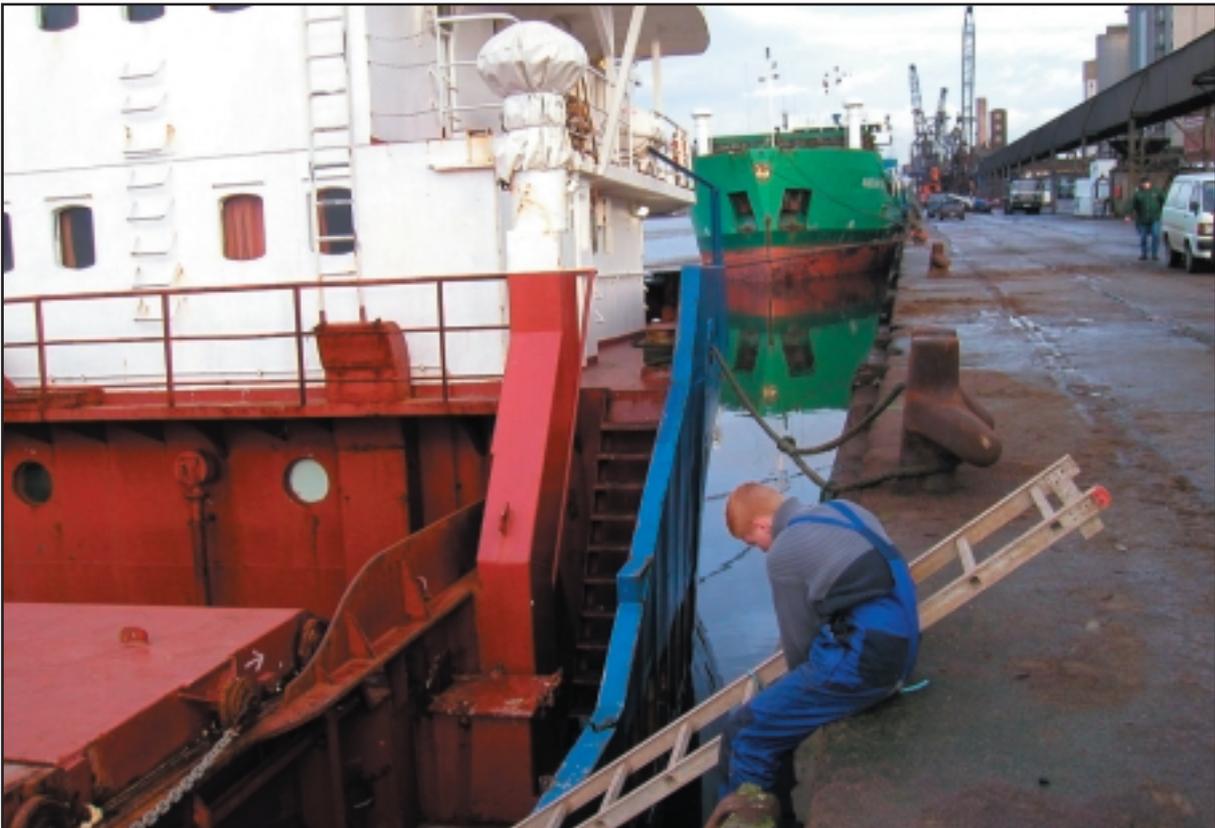
8.2.4 Temporary access being rigged until gangway recovered

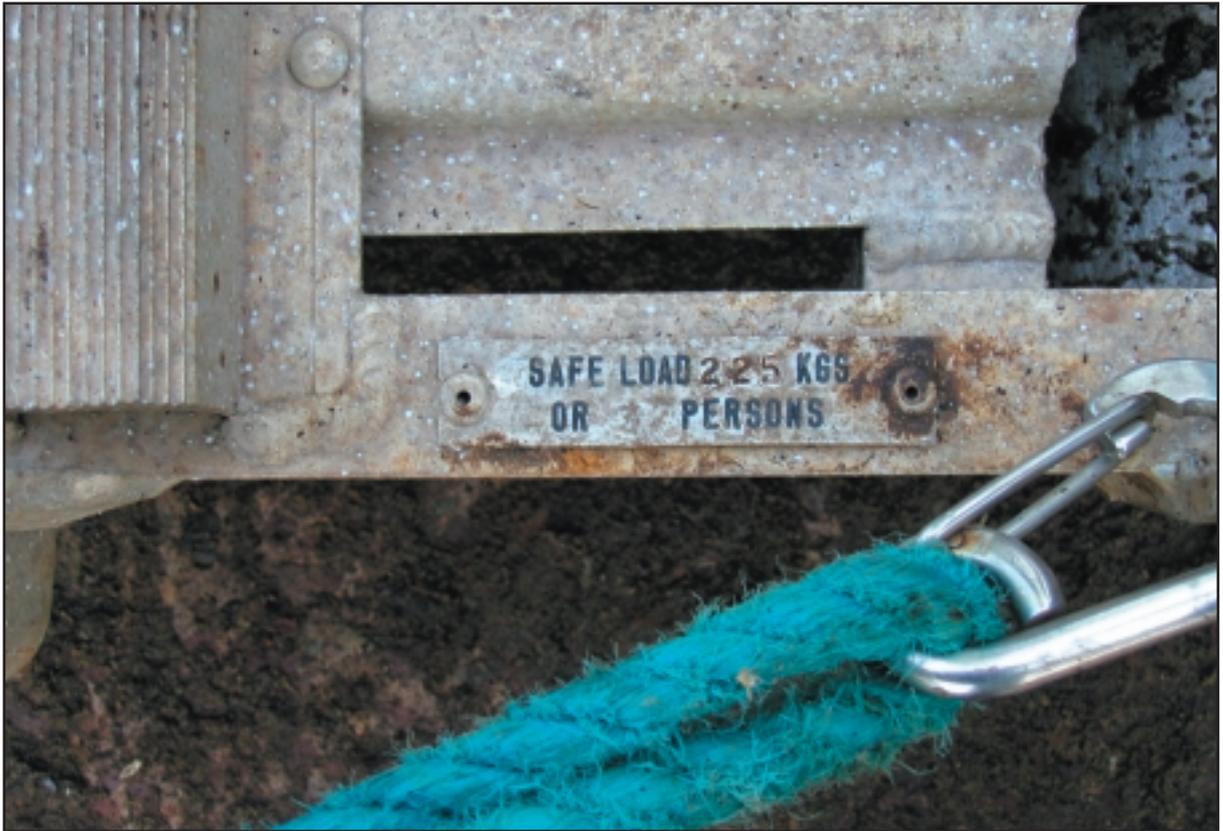
8.2.5 Plate on gangway "safe load 225kg or 3 persons"

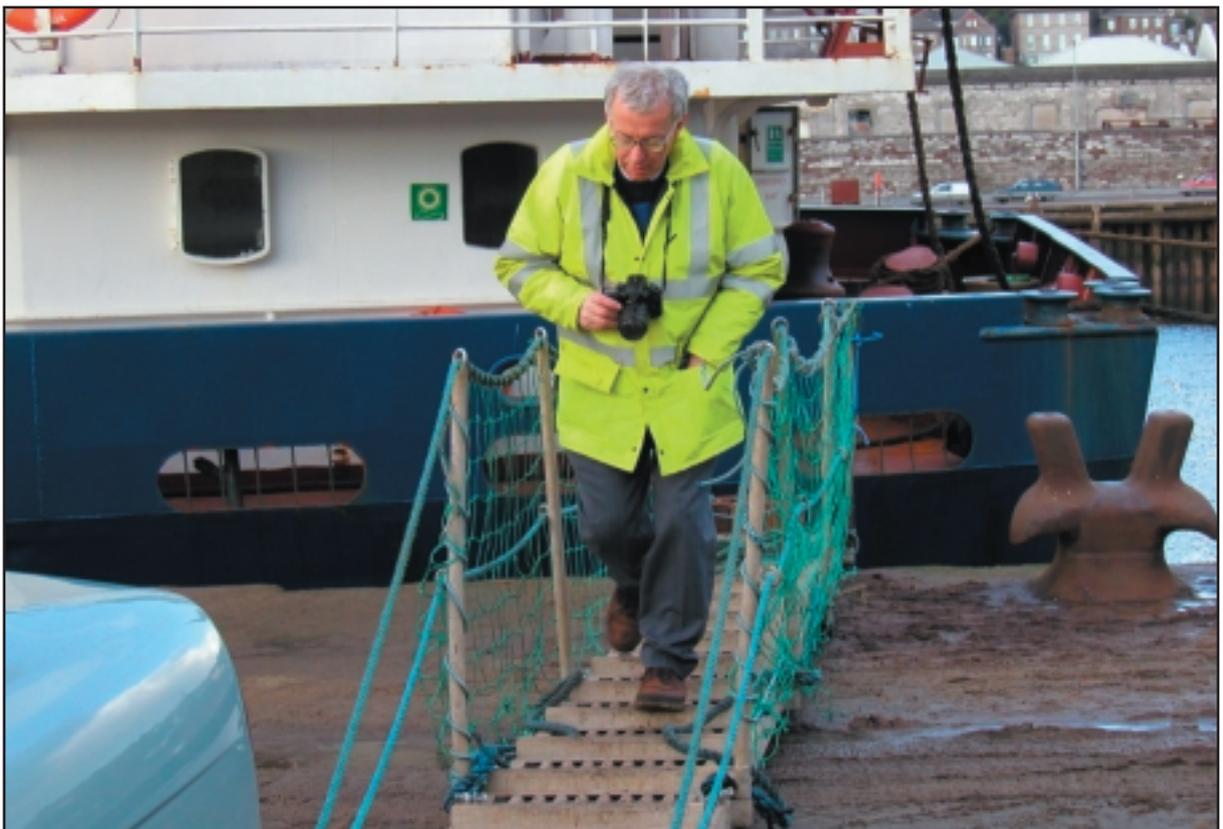
- 3.3 The gangway (6 metre long by 0.560m wide with 0.360m centre on steps) was rigged at a position which placed it between the ships bulwark on the port side on the main deck and the quay side. The gangway has provision for five stanchions on each side but only four were fitted. The two stanchions nearest to the quayside are missing. The upper safety lines on each side are of 3-strand polypropylene 16mm diameter. A safety net was not rigged in the normal way, which would be to attach it to the ship and splay the net out and away from each side of the gangway. Instead, the net with mesh of 90mm x 90mm was permanently attached to the gangway sides and this did not allow for the net to be splayed out.

8.2.6 Side end of gangway. First set of stanchions not fitted, but roped off.

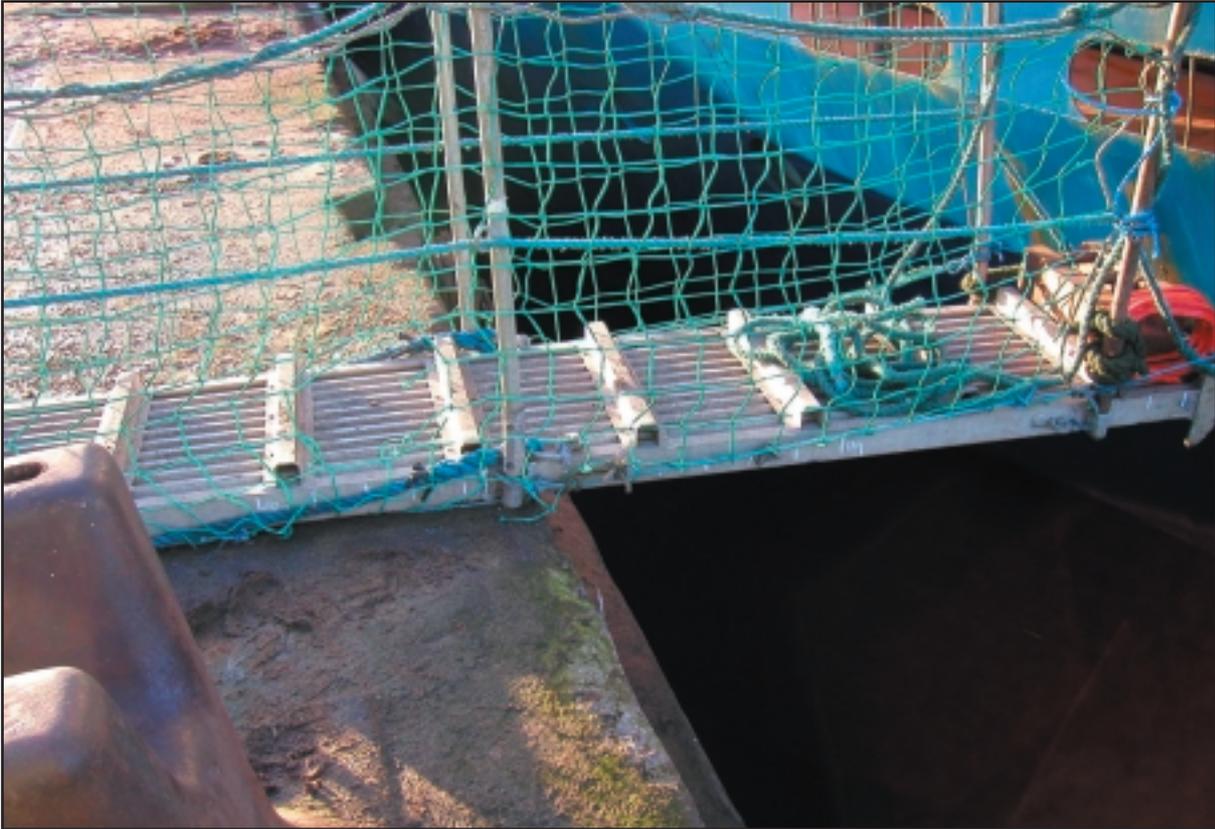
- 5.2 In order to establish the minimum amount of overhang that the gangway would have to have in order to tip into the river with the weight of a person standing at the overhanging end arrangements were made for the following test to be carried out. It is understood that Mr. Geary weighed approximately 86Kg and weights equivalent to this amount were secured to the end of the gangway and the gangway was then slowly pushed over the quayside until it started to tip. The amount of overhang was measured at this point and found to be 1.7 metres. At the time of the accident the distance of the ship's bulwark door from the quayside was estimated to be approximately 2.5 metres. Therefore it can be estimated that the distance between the ships end of the gangway and the ship's bulwark would be 0.8 metres which would be consistent with the distance that someone on the ship would be able to push the gangway away from the ship.

8.2.7 Gangway at 1.7m overhang and starting to tip

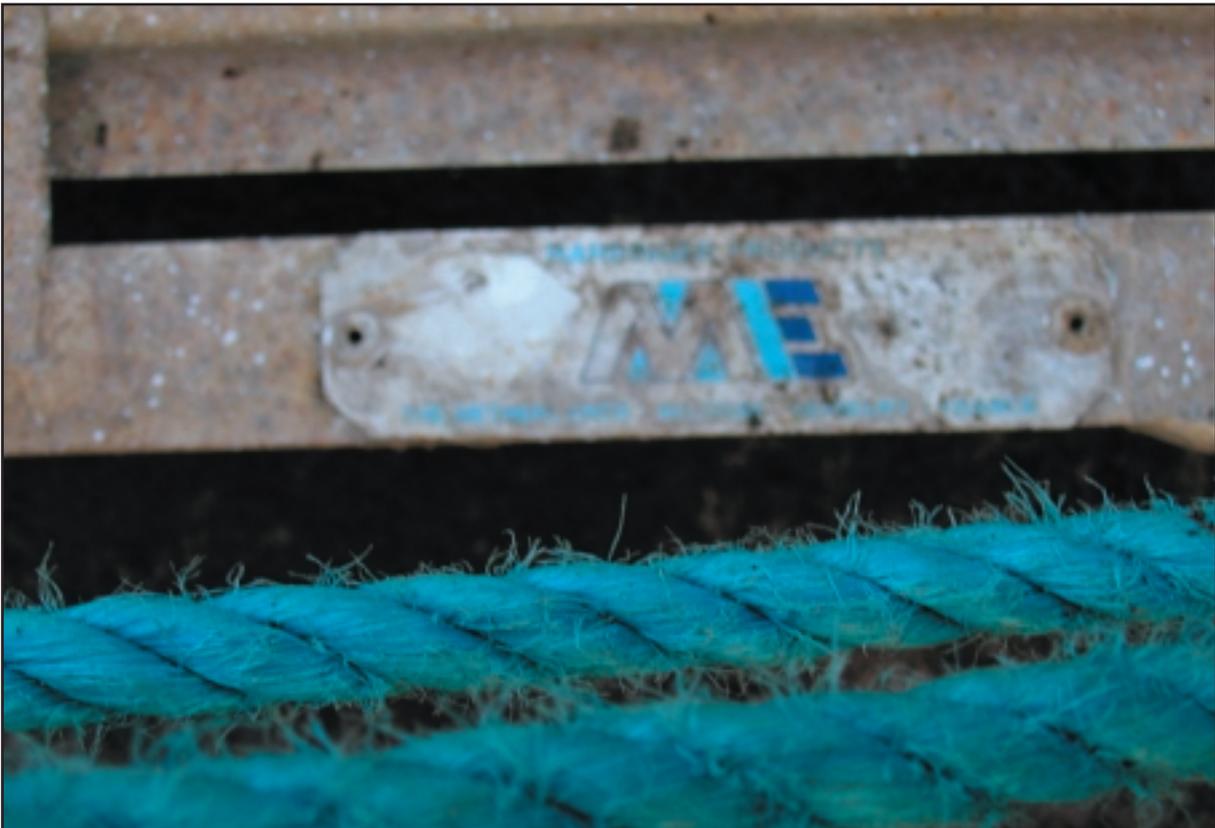
8.2.8 Name plate of manufacturer: Harbinger Products - Netherlands, Belgium

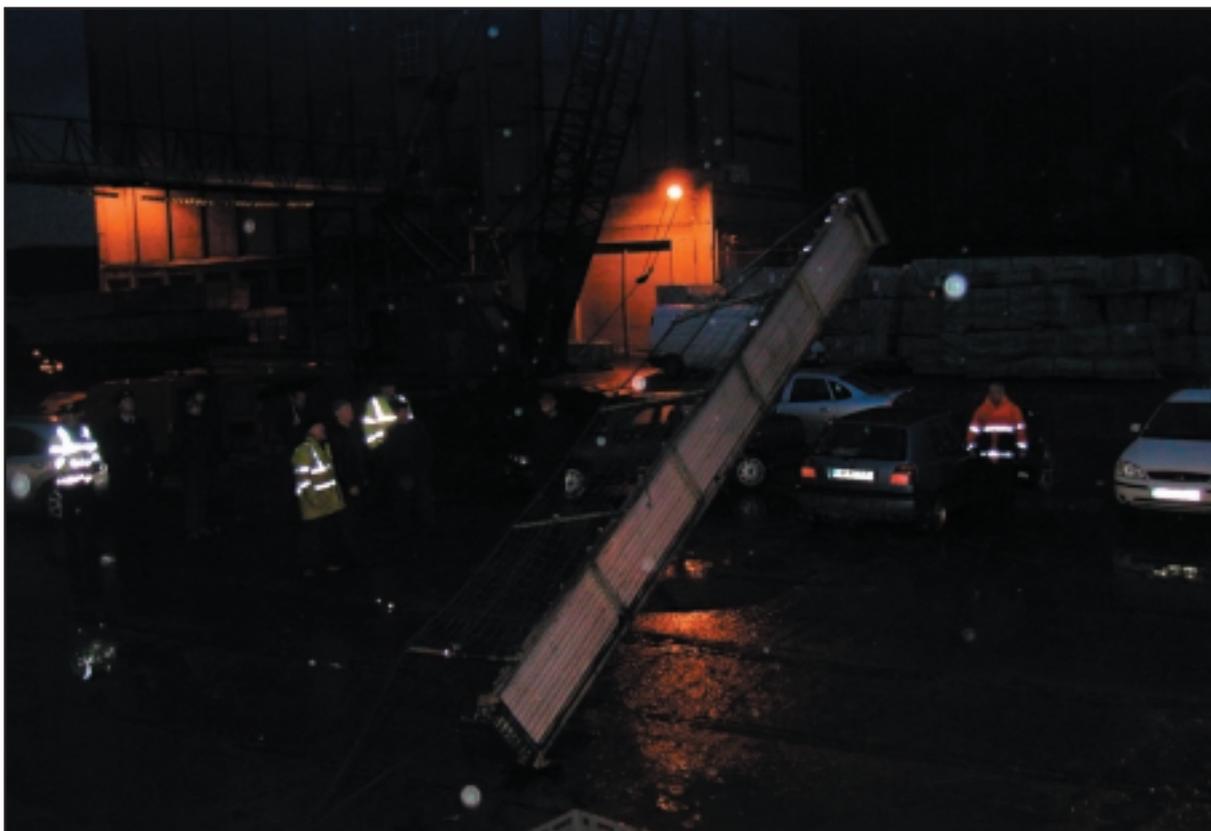
- 5.1 The gangway was subsequently recovered from the water with the assistance of a diver and the ship's rescue boat davit. There was no damage caused to the gangway and it did not require any further repairs.

8.2.9 Gangway being recovered from water.

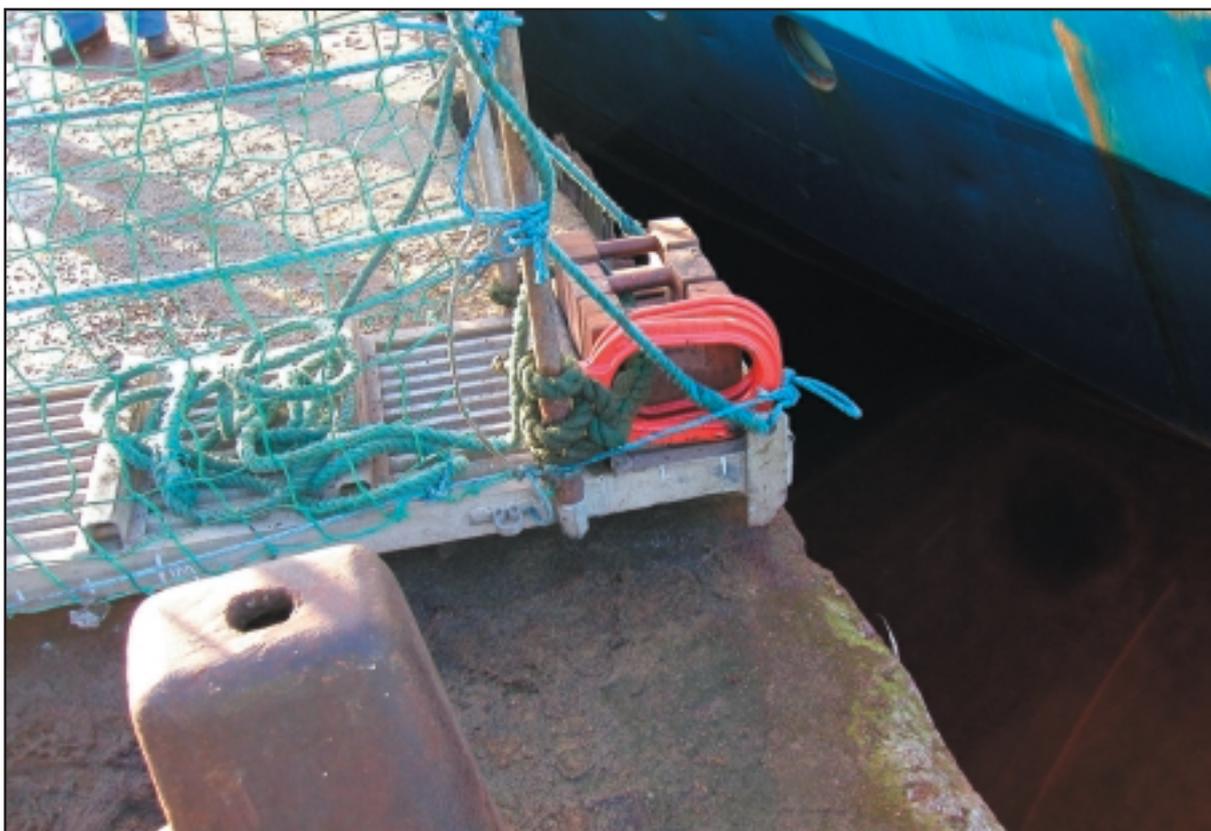
8.2.10 Weights = 86kg
