**REPORT into
A FIRE
ON BOARD
THE MFV "DERISA"
OFF HOOK HEAD,
CO. WEXFORD
ON 06 JANUARY, 1997**

The Marine Casualty Investigation Board was established on the 5th, June 2002 under The Merchant Shipping (Investigation of Marine Casualties) Act 2000

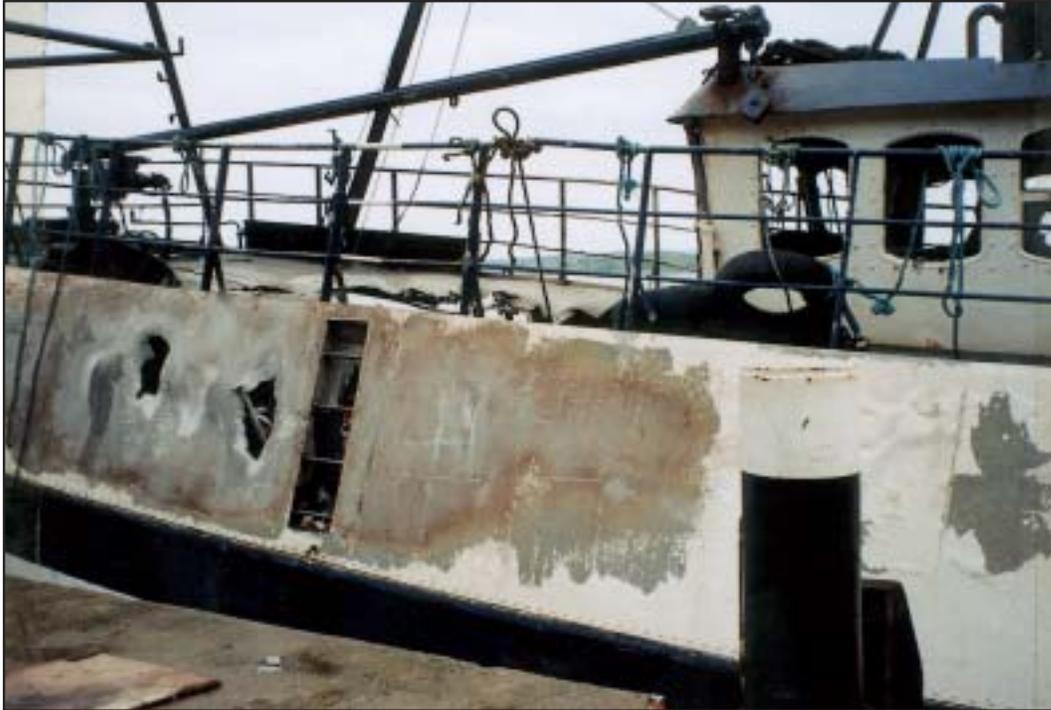
- 6.4 It is understood that the reason for keeping the lobby hatch and the engine room door in the open position was to ventilate the lobby. Electric fans also ventilated the engine room. The fact that the door and hatch were open, greatly contributed to the rapid spread of the fire, as they would have ensured a plentiful supply of air. There would have been a funnelling effect also and this could be seen where the fire spread out through the steel hatch to the shelter deck burning its way forward causing the overhead hydraulic flexible hoses to take fire. This literally added oil to the fire and spread it even more rapidly and intensely. The temperature and heat subsequently rose to a sufficient degree so as to cause the aluminium shelter deck to melt and collapse.

Top: Shelter Deck Fire Damage

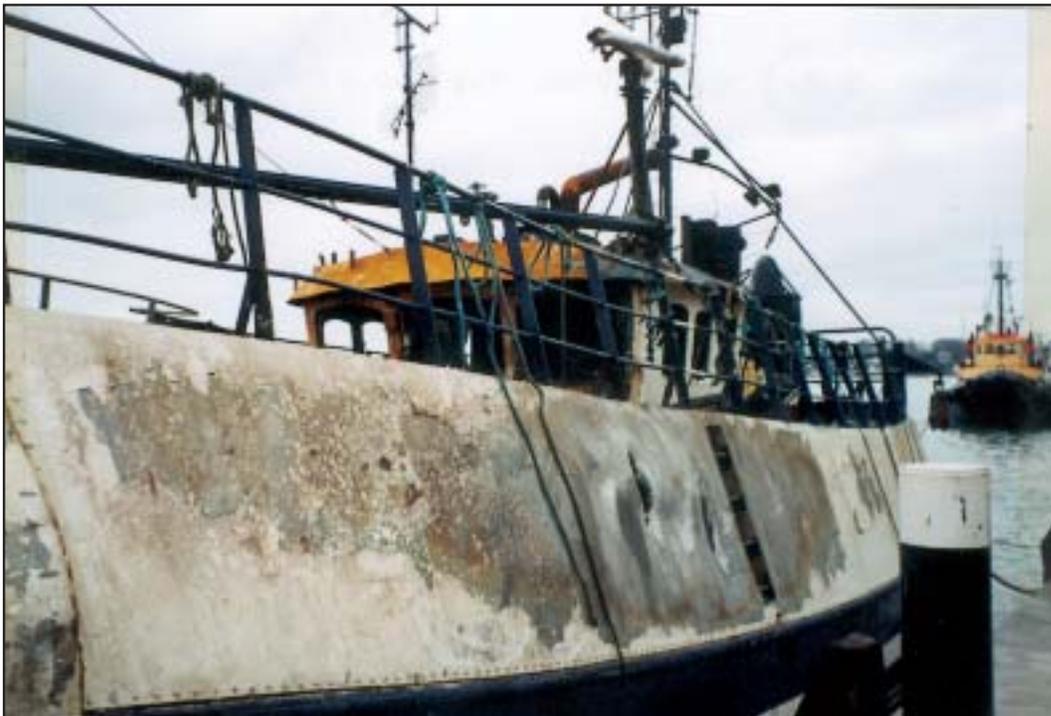
Bottom: Shelter Deck Fire Damage

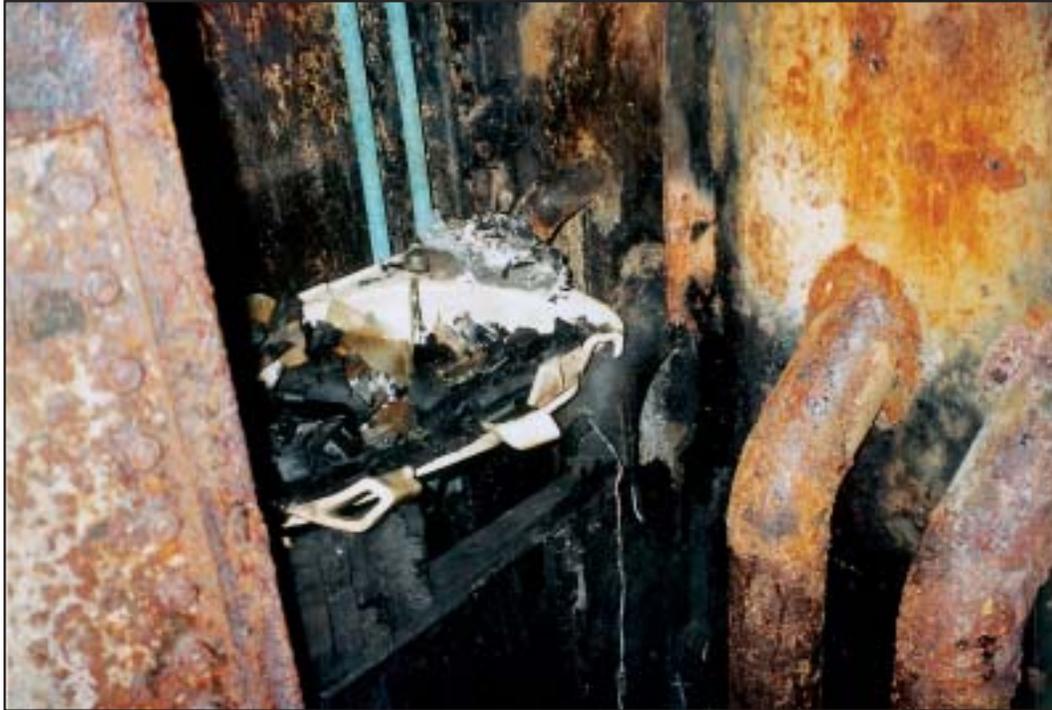
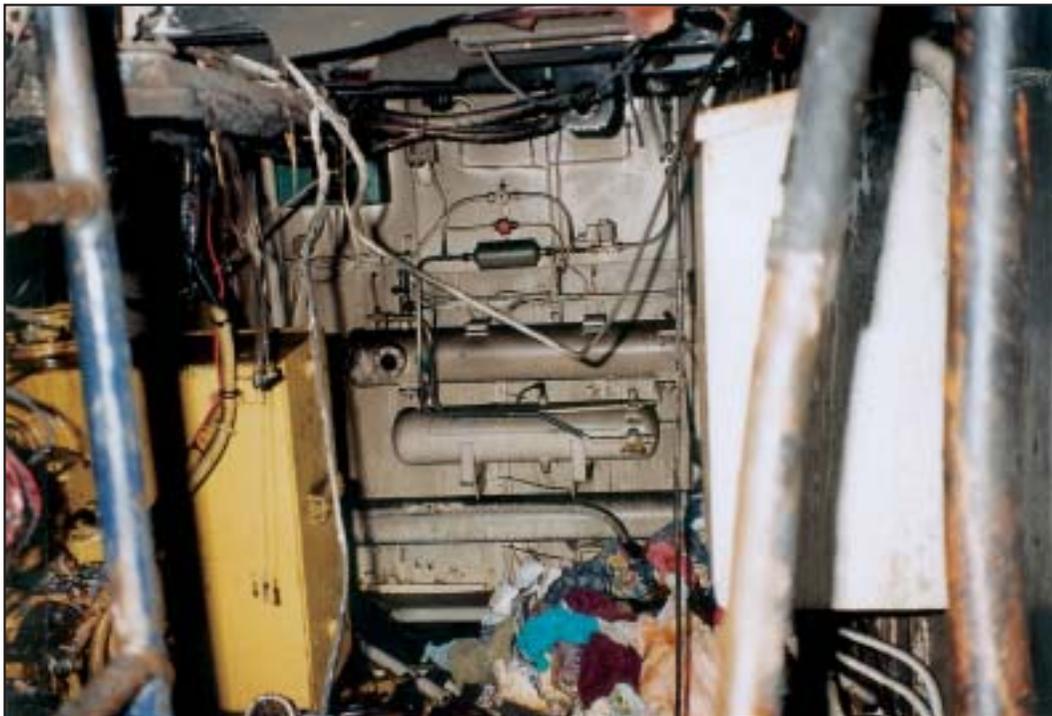
Top: Wash Hand Basin In Lobby
Bottom: Engine Room Looking Forward

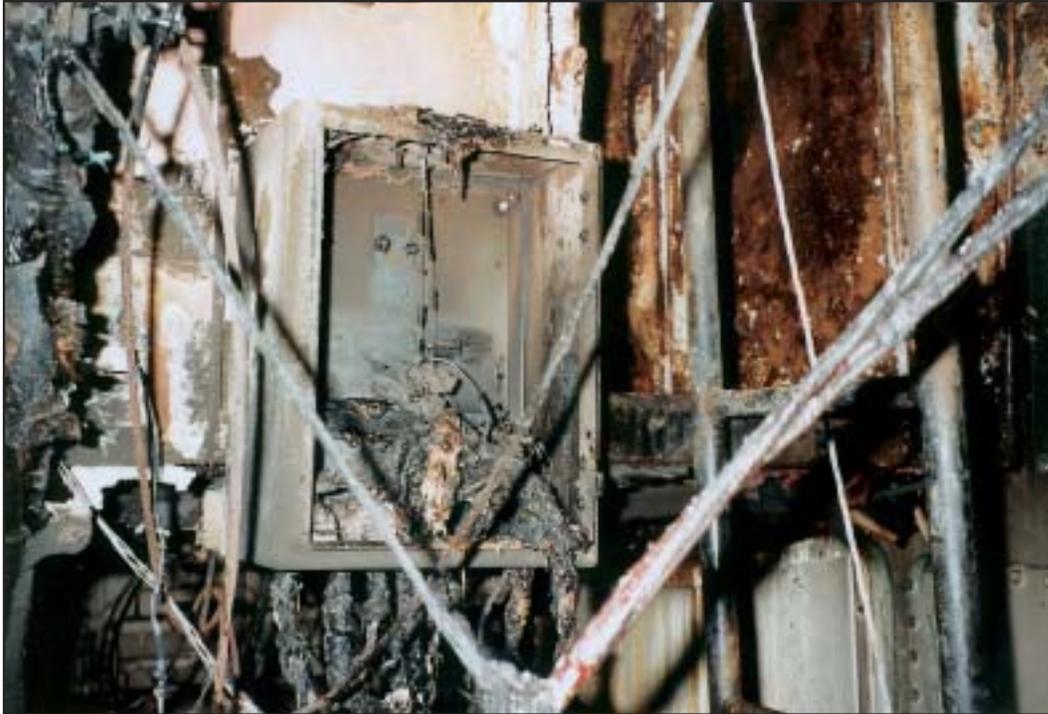
- 6.1 It would appear that the fire might have started in an electrical panel contained inside a steel cabinet, which was mounted over the main engine. This panel was the main engine/gear box protection alarm panel, which gave an audible alarm in the wheelhouse in the event of a malfunction in the engine or gearbox. It was not designed to detect a fire or give an alarm in the event of a fire occurring.

- 6.2 An electrical fault probably occurred within the panel, which gave rise to a short circuit and consequent heat. The insulation material would have taken fire and may have caused further short circuits. It is probably due to such short-circuiting that the alarm sounded in the wheelhouse, alerting the Skipper that something was wrong. The Skipper assumed that it was an engine fault.

Top: Electrical Box where fire started

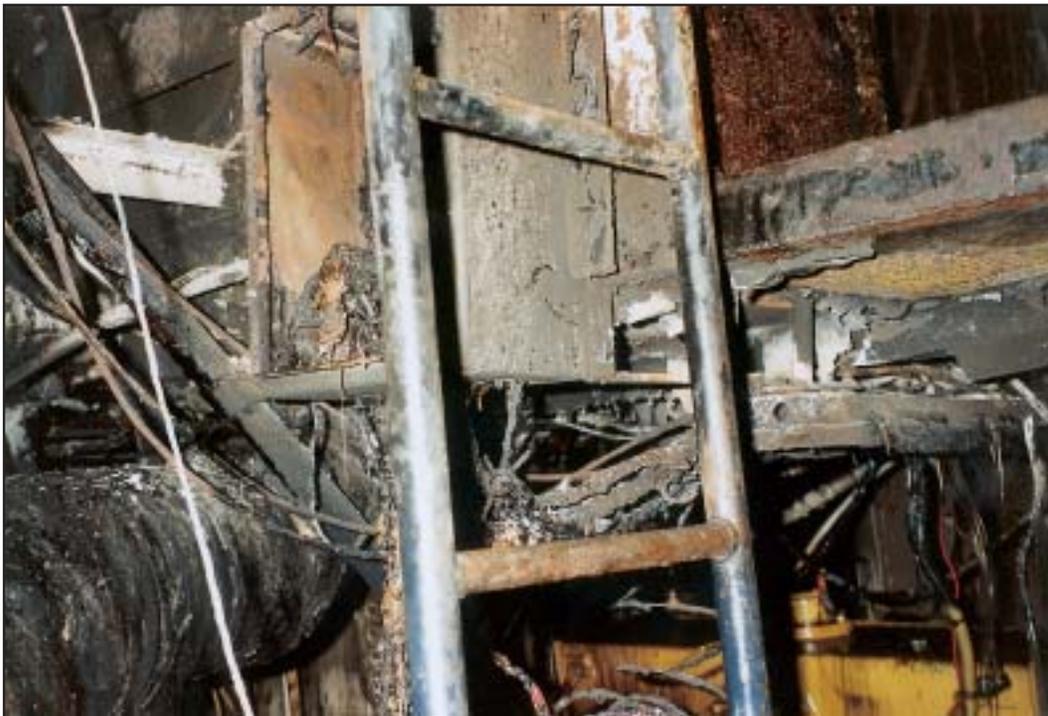
Bottom: Electrical Box where fire started

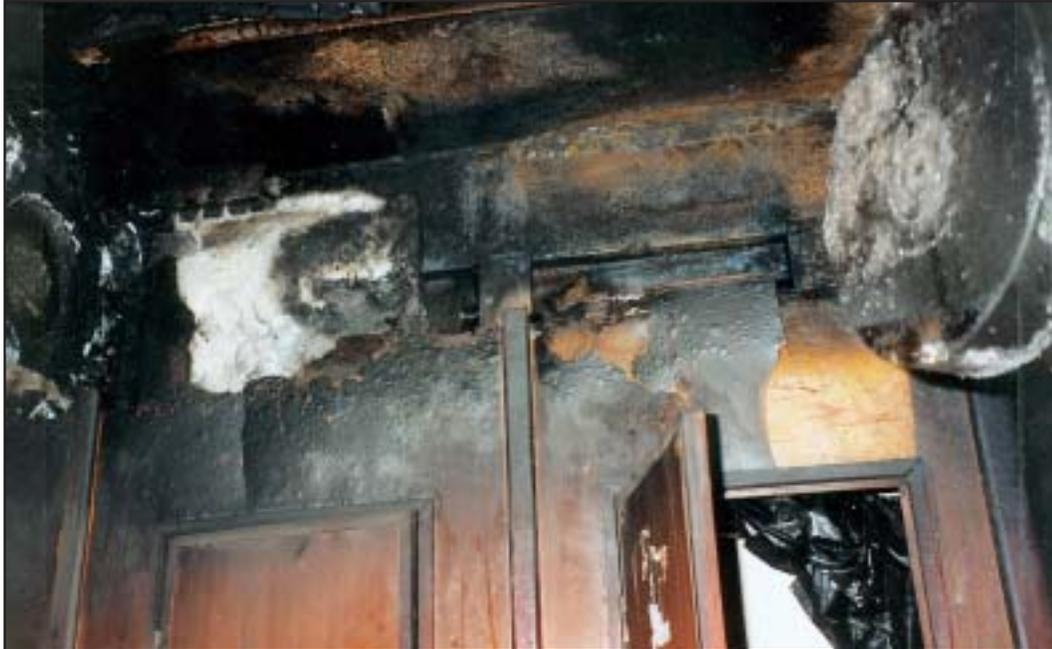
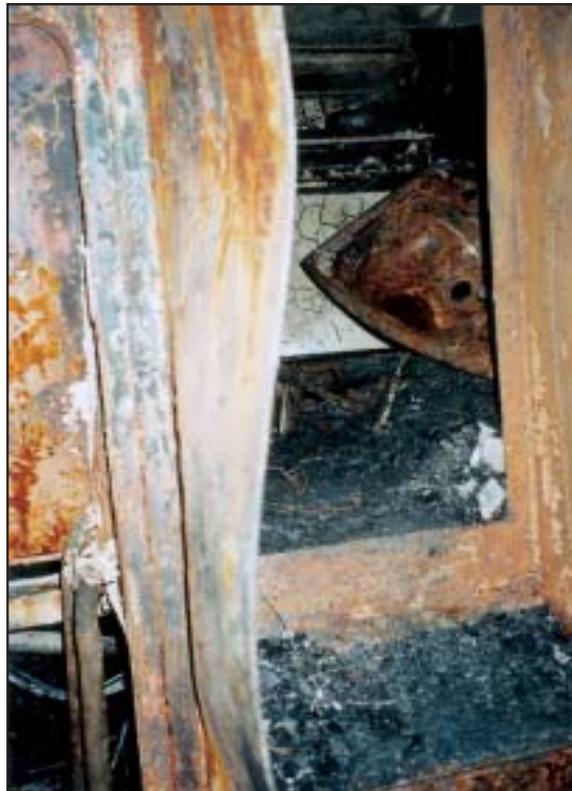
Top: Top of Handrobes in Crew Accommodation
Bottom: Steps up from Lobby to Galley Mess

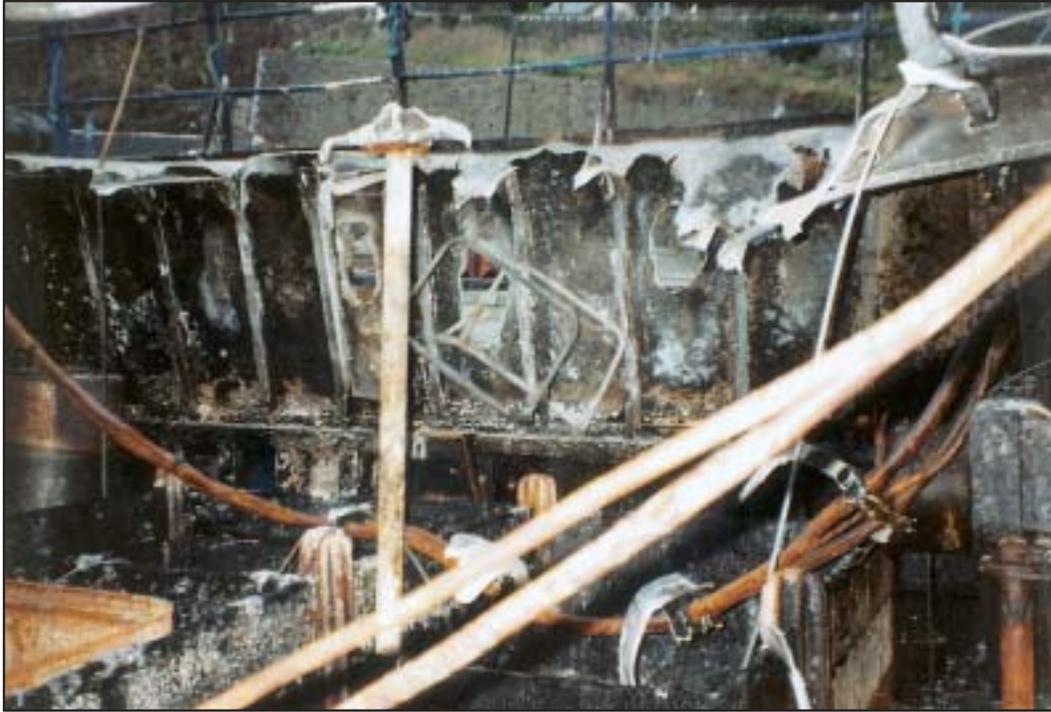
Top: Wheelhouse Front

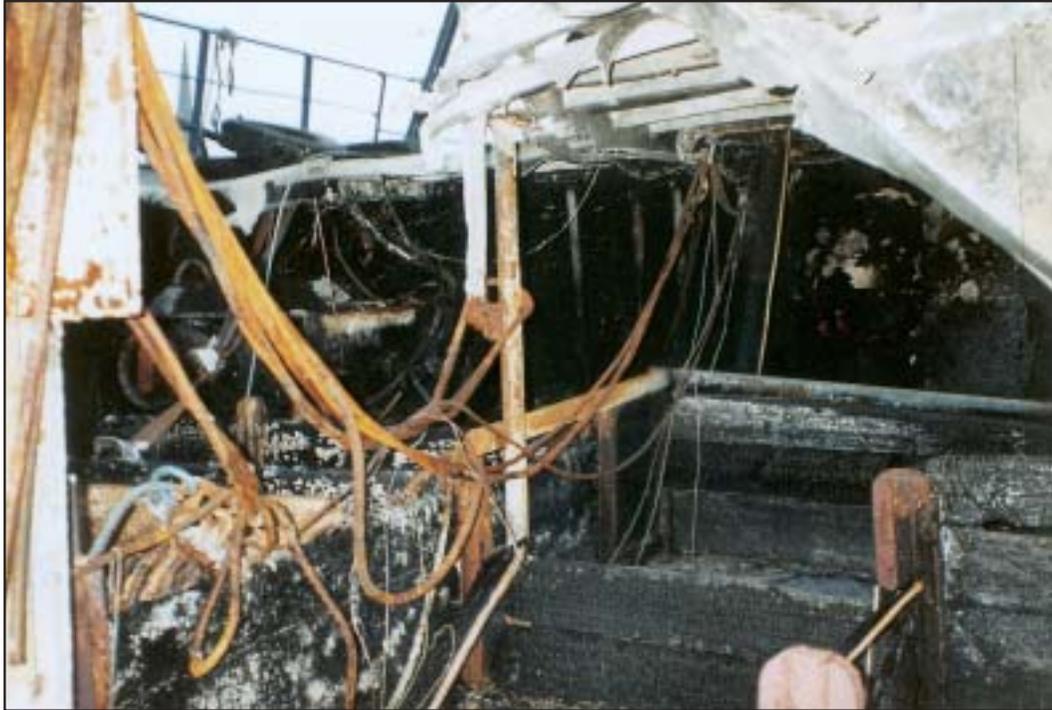
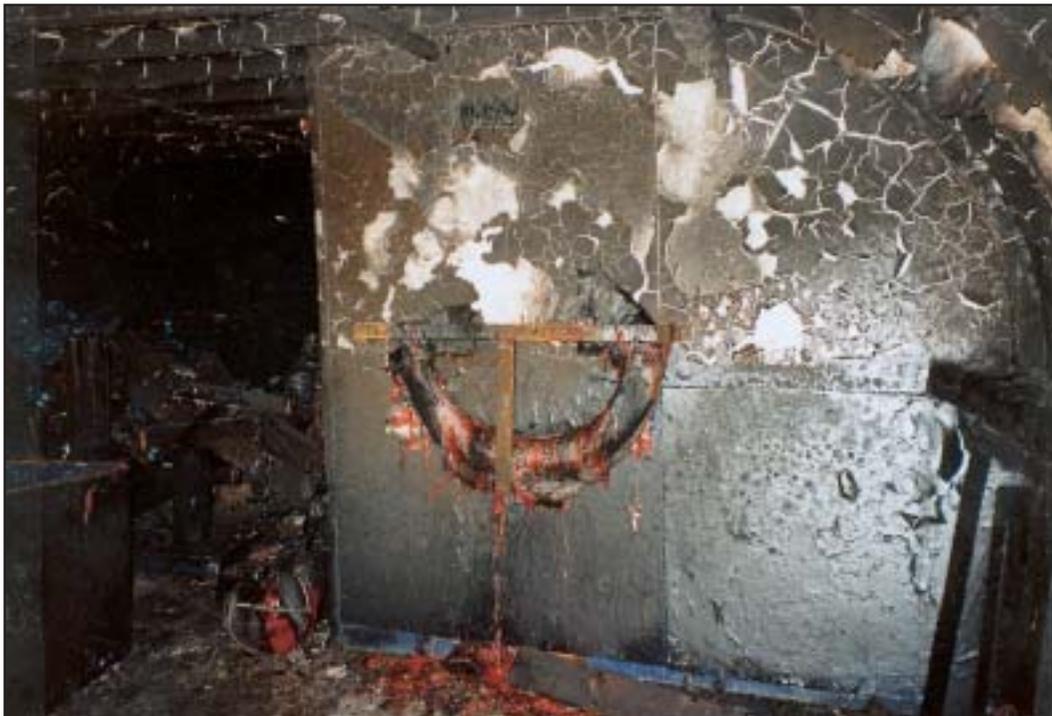
Top: Collapsed Shelter Deck and hydraulic oil hoses charred net bins.
Bottom: Remains of Lifebuoy situated at forward end of Shelter Deck.

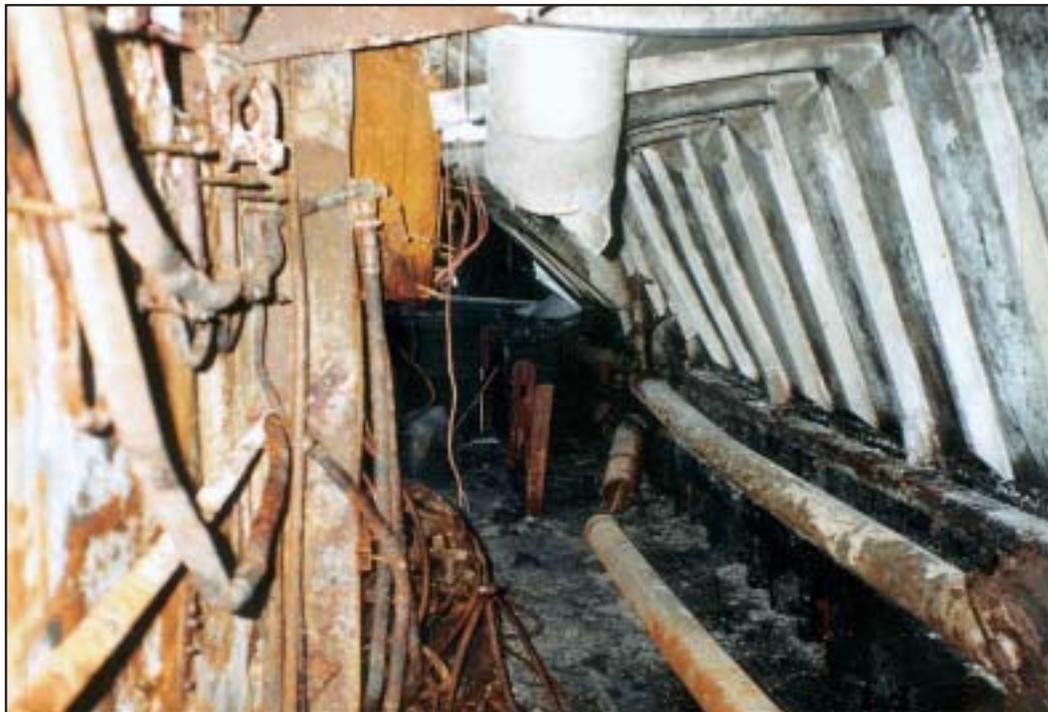
Top: Looking forward on starboard side of Shelter Deck

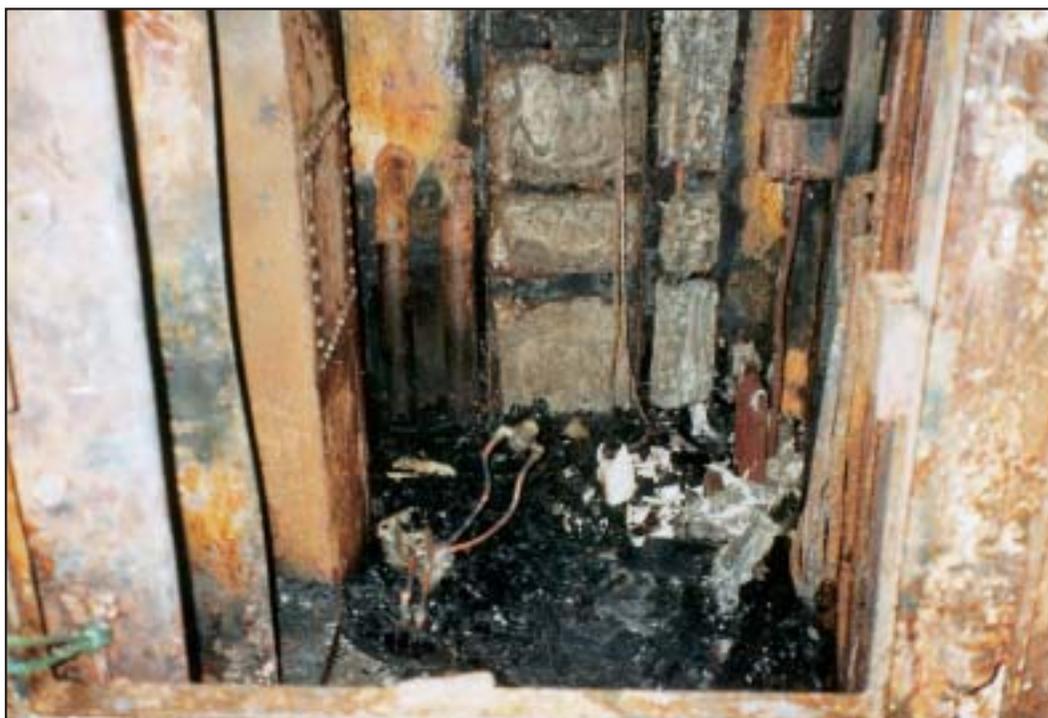
- 6.5 If the engine room door and the steel hatch leading out on to the shelter deck had been kept closed the fire would almost certainly not have spread with such rapidity and could have been confined to the engine room. The engine room was protected by a carbon dioxide gas flooding fire extinguishing system and this could have been used to extinguish the fire once all other openings and vents has been closed. Because of the speed with which the fire spread it was not possible to control it and the crew were lucky to escape with their lives.

Bottom: Looking through open hatch from Shelter Deck into Lobby.

- 7.1 It is recommended that the number of openings to machinery spaces be kept to a minimum as is appropriate to the effective working of fishing vessels. Such openings should be capable of rapid closure in the event of a fire.
- 7.2 It is recommended that a Marine Notice be issued to bring to the attention of Skippers and owners of fishing vessels in particular that the prevention of a serious fire is possible if the necessary precautions are taken to close down openings to machinery spaces.

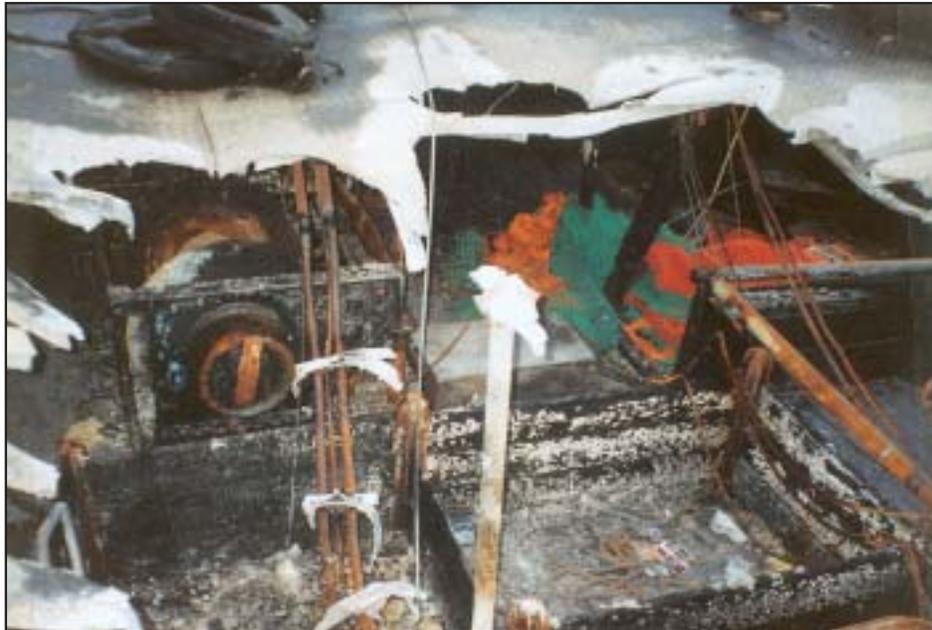
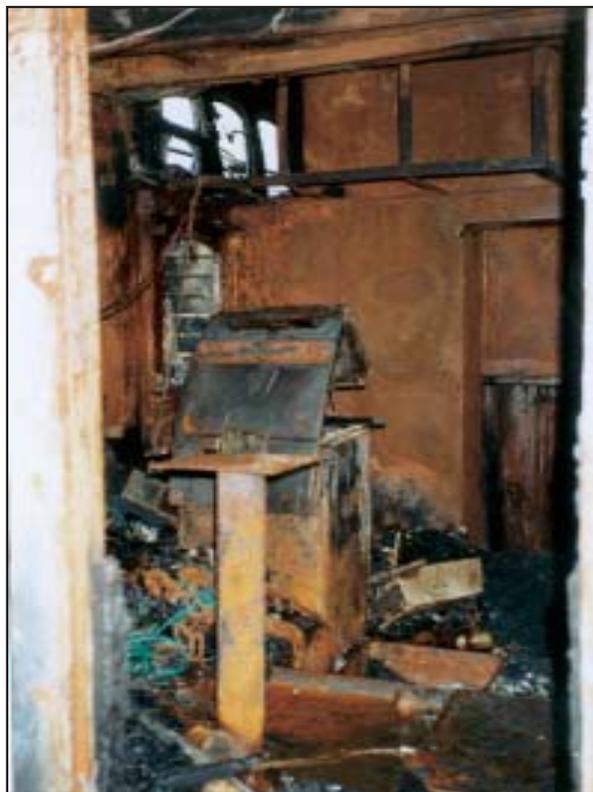
Top: Looking through collapsed Shelter Deck (from above).
Bottom: Galley Mess.
