**REPORT
OF THE INVESTIGATION
INTO THE LOSS
OF THE FISHING VESSEL
MFV “DISCOVERY”
OFF THE SOUTH WEST COAST
OF IRELAND
ON 29th JANUARY 2007**

REPORT No. MCIB/137

Report MCIB/137 published by The Marine Casualty Investigation Board
23rd January 2009

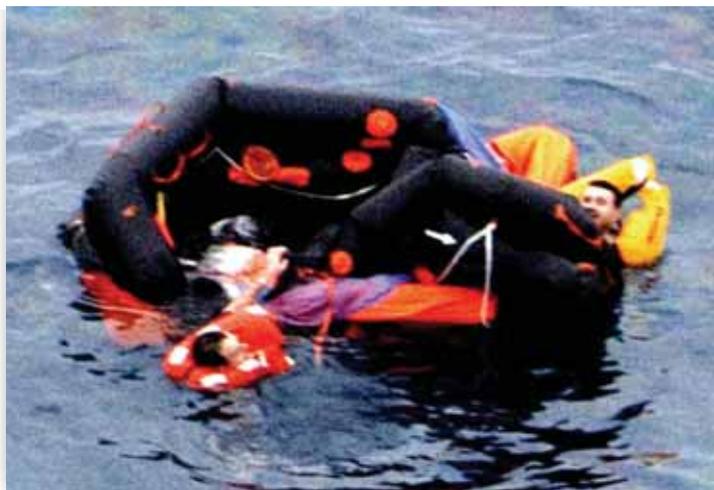
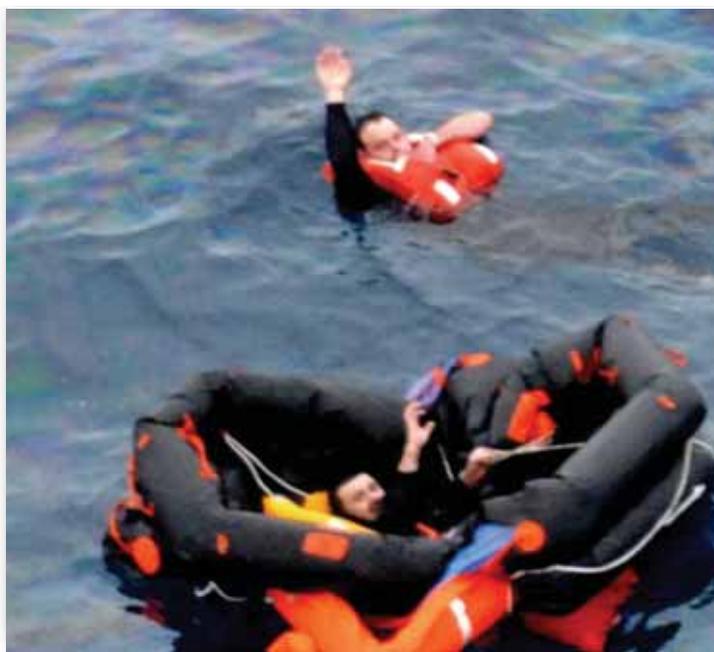
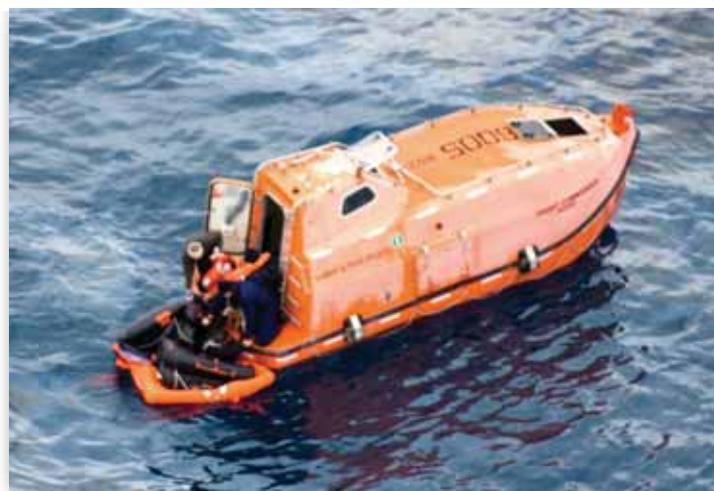
APPENDIX 8.1

Appendix 8.1 Photographs of the incident.
