**REPORT OF INVESTIGATION  
INTO INCIDENT AT  
DONEGAL POINT,  
KILKEE, CO.CLARE  
ON  
5th NOVEMBER 2011**

**REPORT No. MCIB/208  
(No.12 of 2012)**

Report MCIB/208 published by The Marine Casualty Investigation Board  
Printed 4th November 2012.

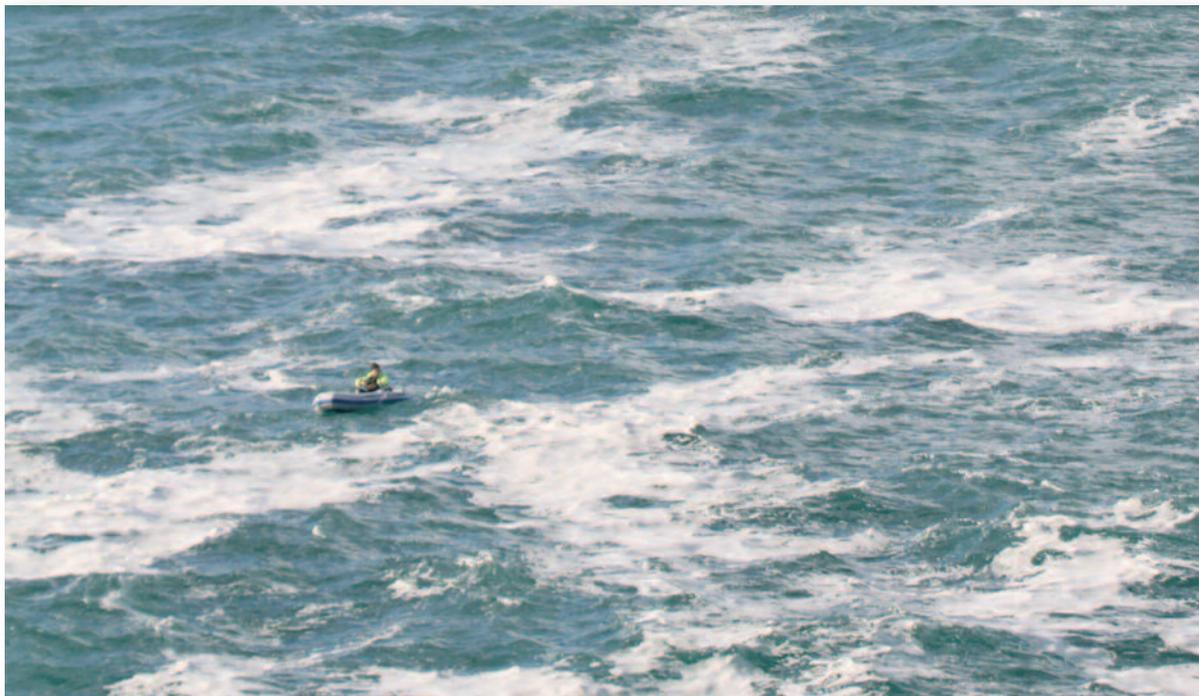
(a) Initial sighting of Mr. Silins in dinghy

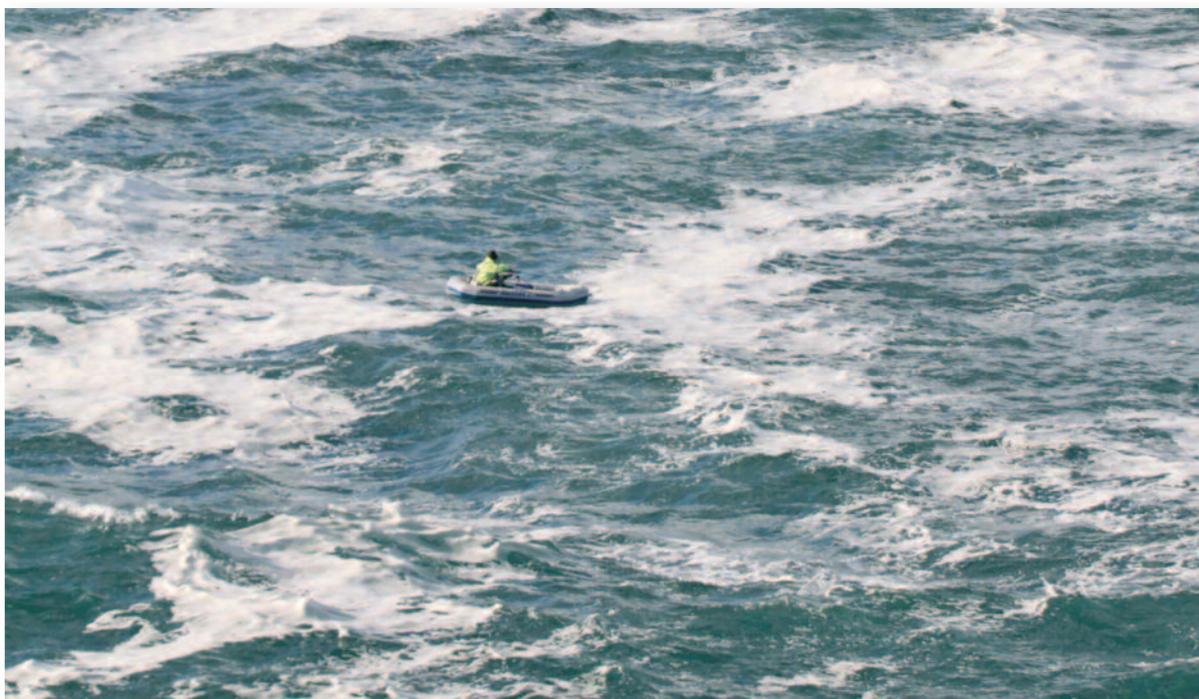
In addition, as observed from the shore, it would appear that he was unaware of the appropriate drill/procedure to right the dinghy following capsizing. The Investigation notes that the dinghy was set about with a becketted line which could have been used for this purpose.

The manufacturers of the dinghy class it as a one engine three-person craft. In this instance with only a single occupant and in the prevailing swell conditions, the craft would have been vulnerable to capsizing in a beam sea/breaking swell.

(b) Subsequent sighting of Mr. Silins in dinghy

In the context of capsize of an inflatable - be familiar with the method of righting the craft in the water by standing in the beackets on one side and heaving on the beackets on the opposite side.

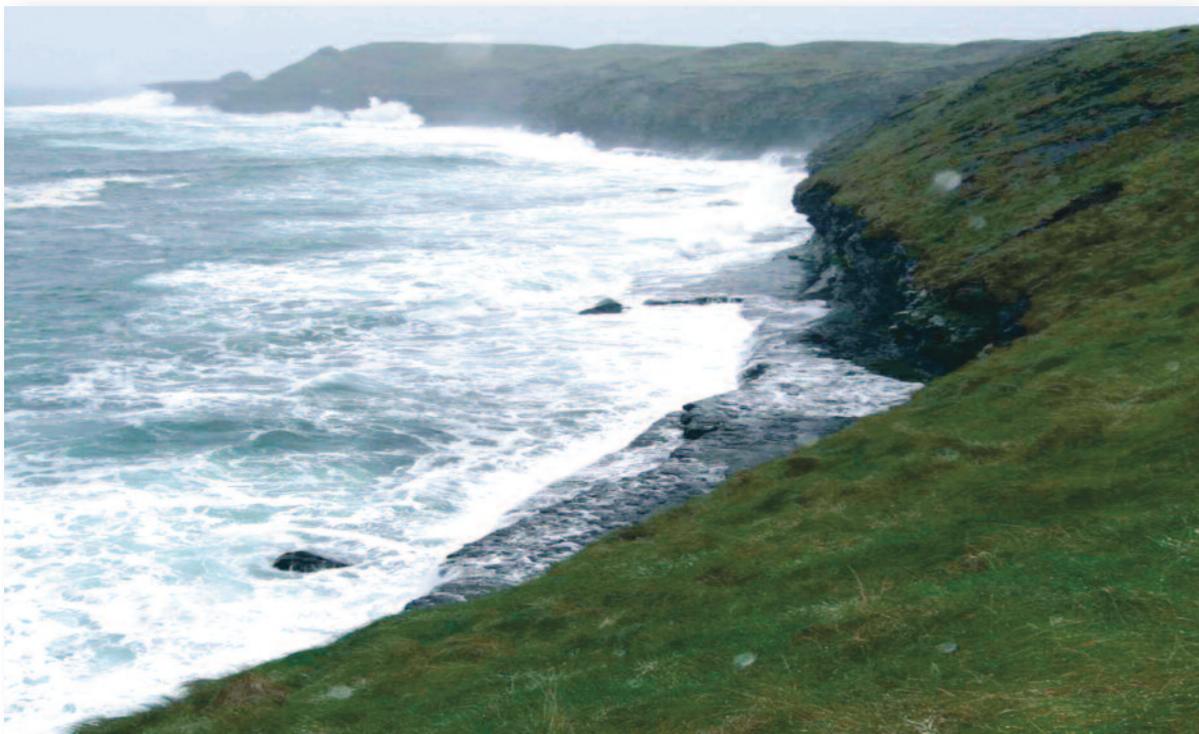
(c) View of inner sweep of northern side of the "Horseshoe"

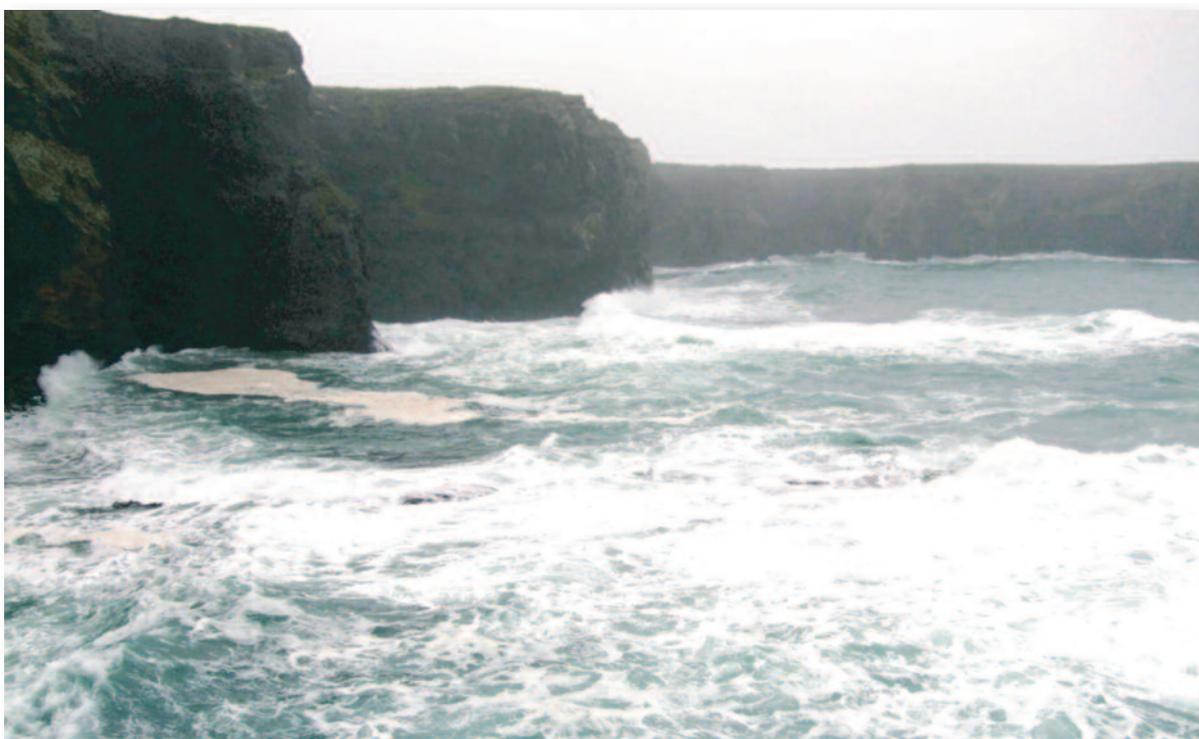
(d) Inner sweep of southern side - exposed rocks and breaking swell

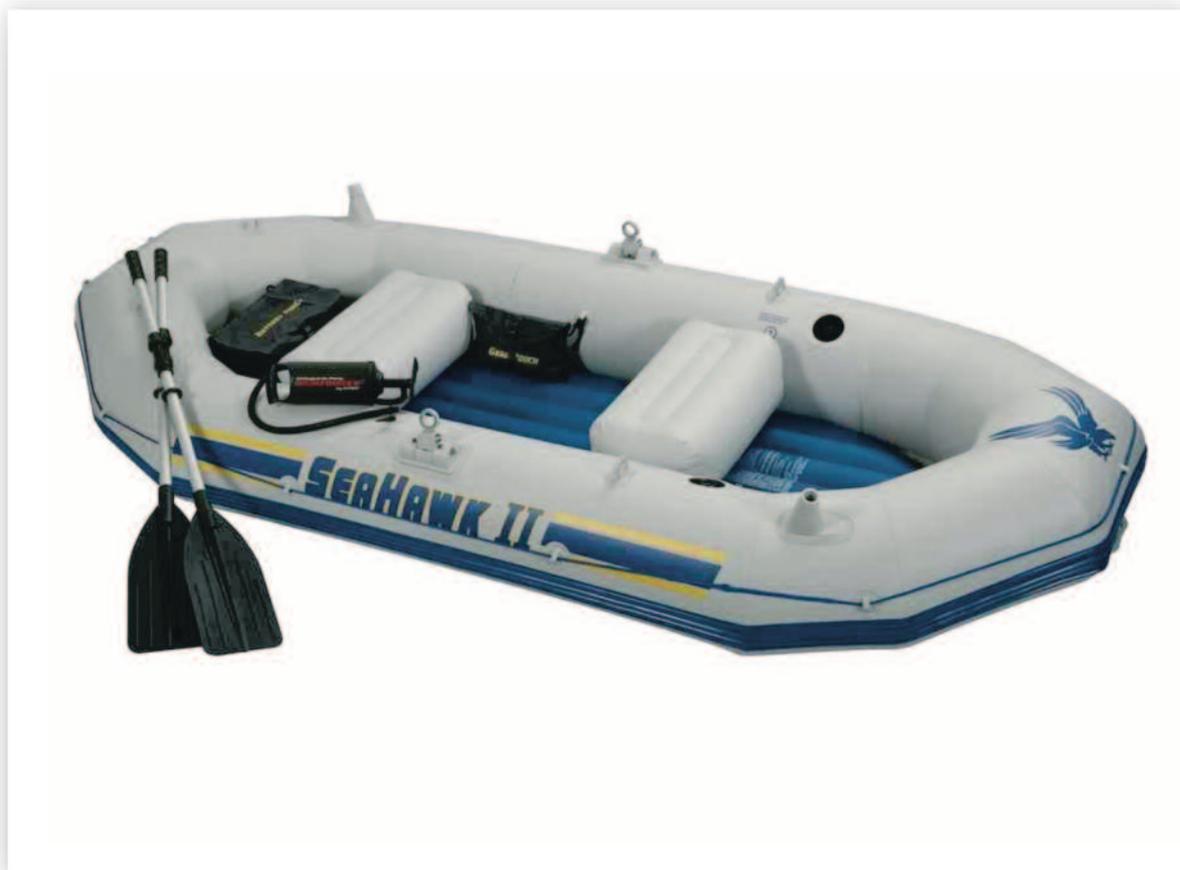
Appendix 7.3 Illustration of inflatable dinghy - SeaHawk 11.

The craft was a Seahawk 11 inflatable dinghy of 2.97 metre length and 1.27 metre breadth, manufactured by Intex of China and described as a heavy duty dinghy. It was constructed in extra heavy duty reinforced vinyl material and it is understood that the vessel complied with the Recreational Crafts Directive. The design of this dinghy incorporates twin safety main chambers with an inflatable floor, easy inflate/deflate screw-in marine valves, and double action air hammer pump. It had a pair of alloy oars in rowlocks integral with the pontoons. The empty weight was approximately 34 lbs.
