**REPORT INTO FATAL INCIDENT  
INVOLVING A CAPSIZED PUNT AT  
DUNDALK HARBOUR,  
CO. LOUTH  
ON  
12th FEBRUARY 2012**

**REPORT No. MCIB/212  
(No.4 of 2013)**

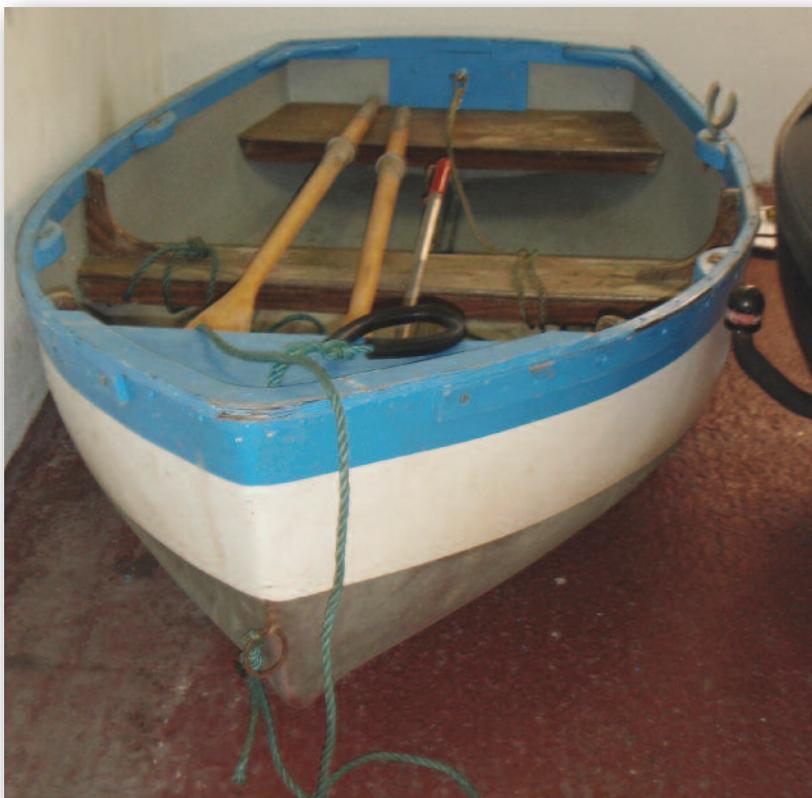
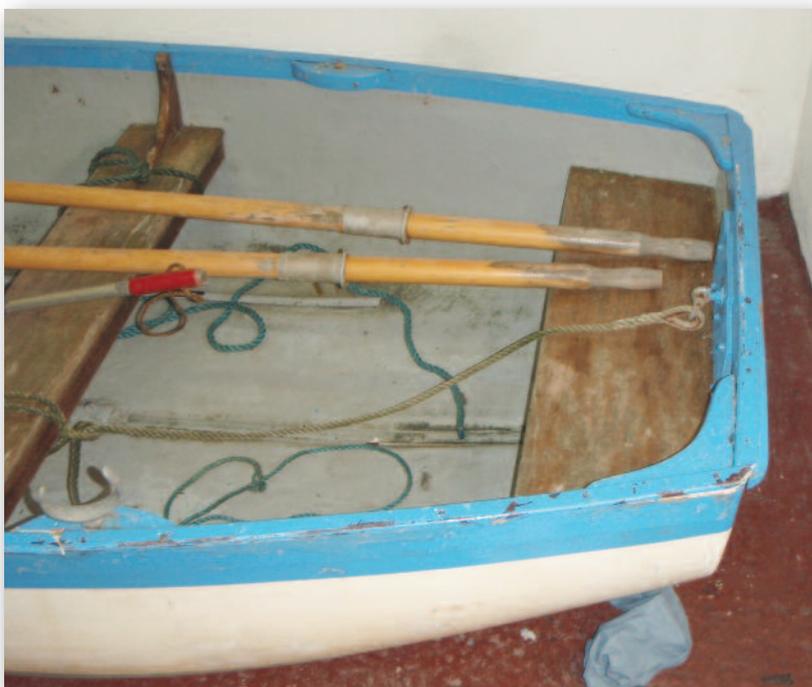
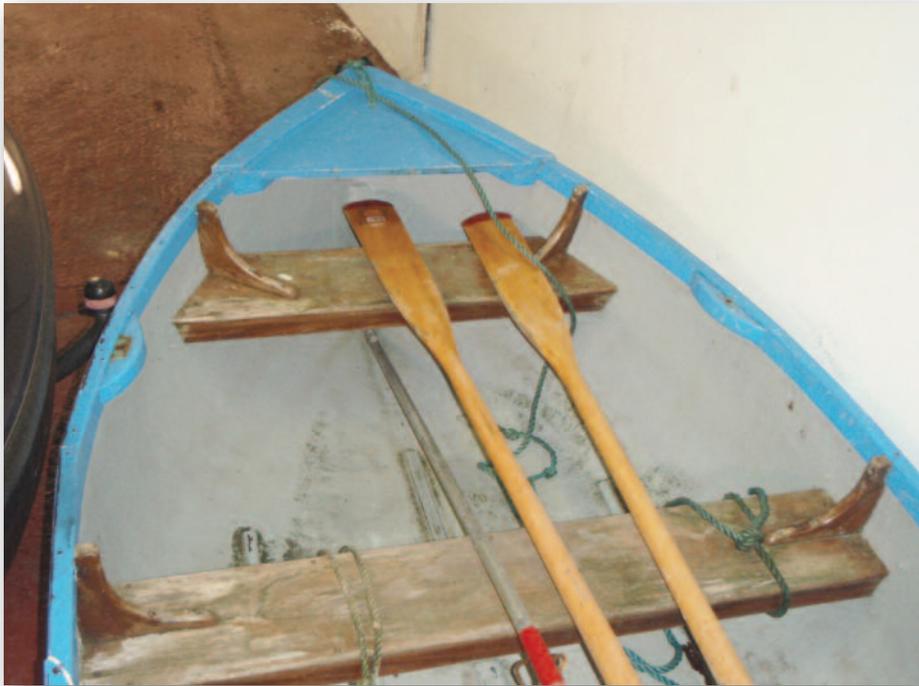
Appendix 7.1 Photographs of the punt.

<b>Punt:</b>	Owned by Mr John Tuite. Mr Fergus had use of the punt to access his boat.
<b>Markings:</b>	Norden NYC on transom.
<b>Hull:</b>	GRP. With timber trim at bow, gunnels and transom.
<b>Dimensions:</b>	Length 2.48m, Breadth 1.31m, Depth 0.47m.
<b>Arrangement:</b>	Open Boat.  Three seats one forward, one mid boat and one at stern. Extra buoyancy added under seats. Bow covered back to 380mm. Two oar-locks sockets on each gunnel.
<b>Lines:</b>	One painter forward 10mm diameter 4.6m long.  One fibre rope tied at centre seat starboard side and loose in boat, 12mm diameter 3.9m long.  One line attached to transom and lead forward, wrapped around and tied to centre seat 10mm diameter.
<b>Boat contents:</b>	Two timber oars 2m long 43mm diameter max.  One metal boat hook 25mm diameter, 1380mm long.  One plastic bailer.  One piece of rope 8mm diameter 1.8m long.  One metal oar-lock. The Board understands that the other metal oar-lock was inadvertently retained by a member of the RNLI crew that recovered the punt and it is available if required.

See Appendix 7.1 for photographs of the punt. These were taken on 06/04/2012 at secure storage facility at Dundalk town arranged by An Garda Síochána.	
<b>Boat:</b>	Owned by Mr Stephen Fergus.
<b>Markings:</b>	Sticker on cabin glass No. 2732 Office of Public Works Shannon Navigation.

The punt was found partially submerged but upright at 17:28hrs by Clogher Head Lifeboat at co-ordinates 5358.1N 00617.45W. It was brought ashore and taken to a secure storage by An Garda Síochána.

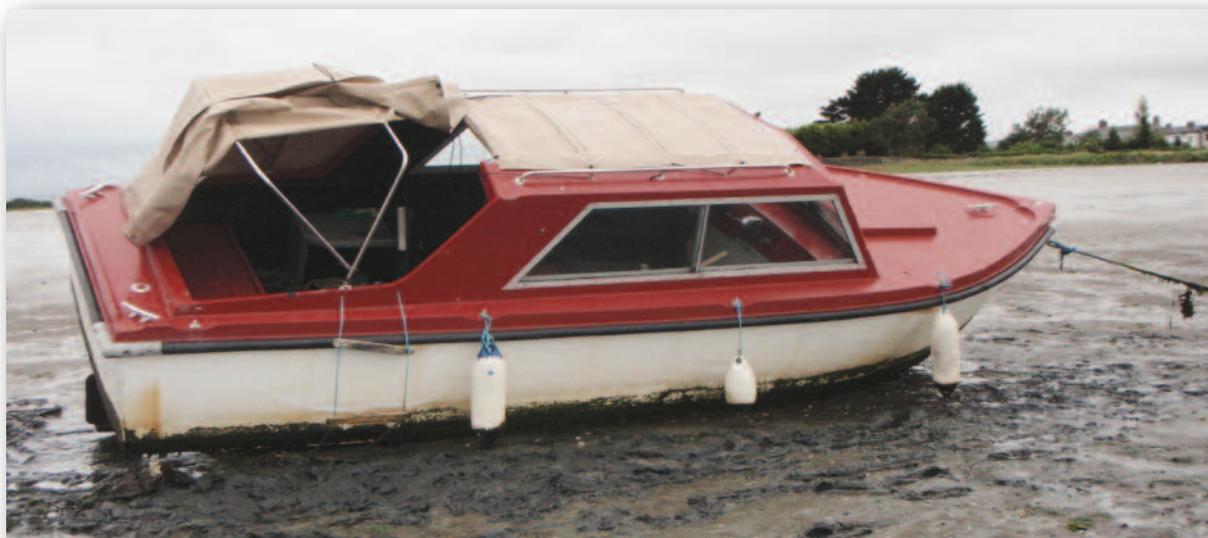
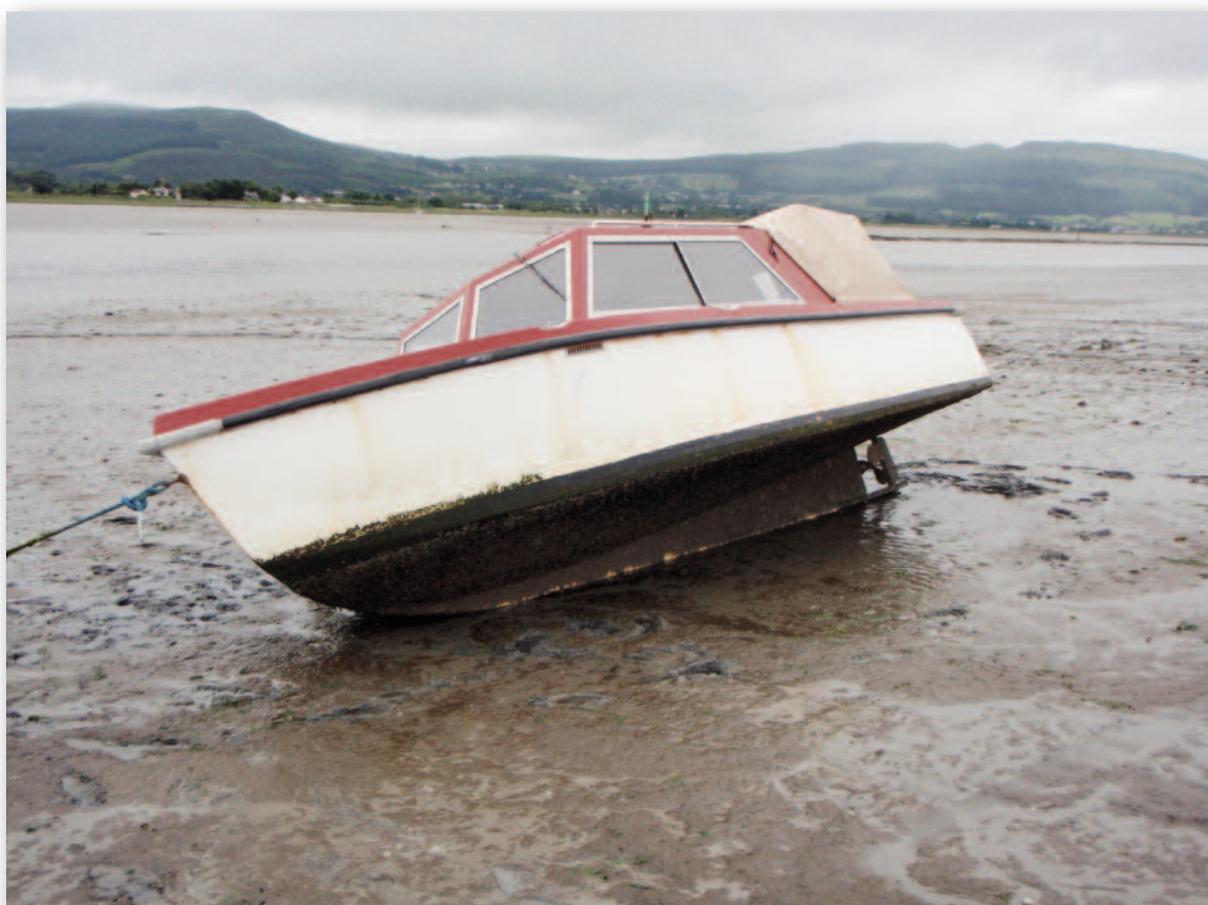
Appendix 7.2 Photographs of the boat.

Hull:	GRP. Partial cabin and removable rear canvas cover. Decked forward for 650mm.
Dimensions:	Length 5.8m Breadth 2.0m Freeboard 0.5m.
Propulsion:	Inboard two cylinder diesel engine mounted forward under deck area.  Access to engine via hatch in deck.  Engine driving single fixed pitched propeller via propeller shaft.
Steering:	Steering wheel at console at forward end of cabin connected to single rudder.
Lines:	Single line forward attached to buoy.
Additional:	Three fenders on Starboard side.  One rope ladder attached to Starboard side.

See Appendix 7.2 for photographs of the boat. These were taken on 15/08/2012 at low tide. The Board understands that this is where the boat was moored to the buoy at the time of the incident.

There were no witnesses to the circumstances of the incident. Mr Fergus may have been in the process of getting into the punt or transferring from the punt to his boat when he got into difficulties. The canvas cover on Mr Fergus's boat had not been disturbed indicating that he did not actually gain access to his boat.

The following day at low tide Mr John Tuite carried out a search of the mudflats in the vicinity of Mr Fergus's boat and where the punt had been moored. He found Mr Fergus's waders in the mud adjacent to Mr Fergus's boat. One was about 10m off the stern and one was about 3m off the port side of the boat which was lying with the bow facing west. He handed these over to An Garda Síochána.

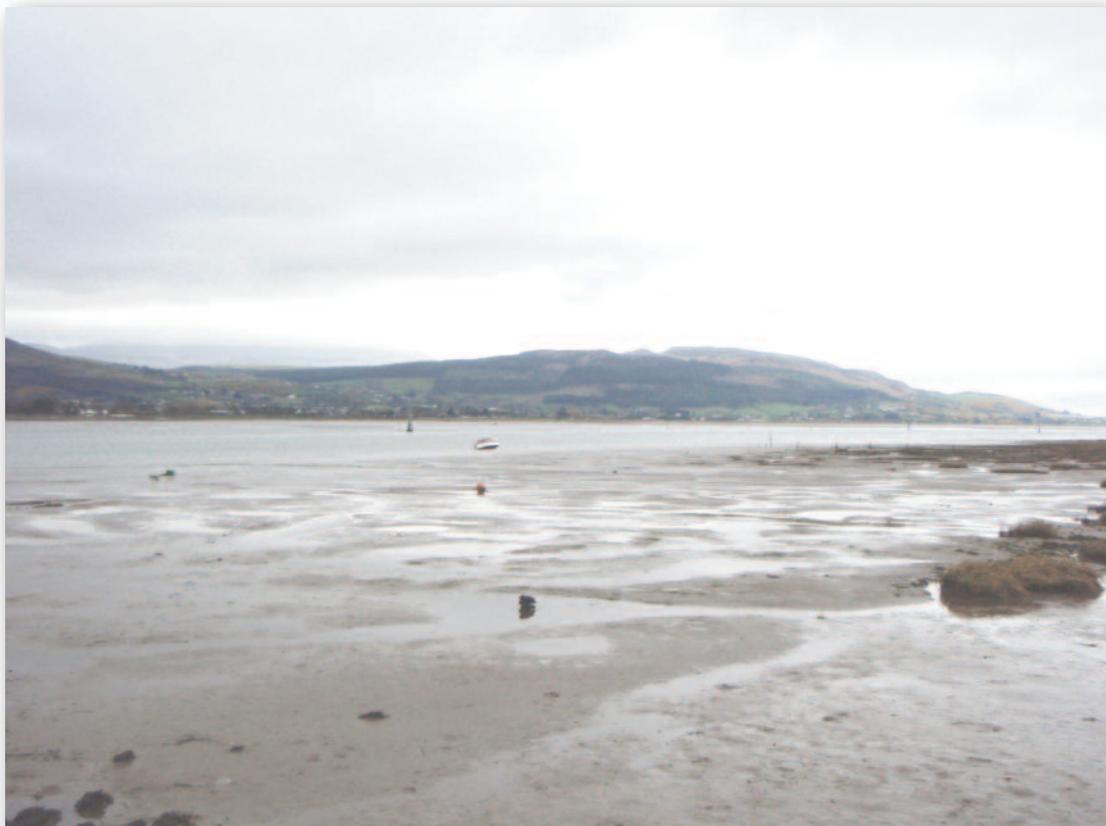
Appendix 7.4 Photo of the mudflat on the southern shore of Dundalk Estuary.

See Appendix 7.4 for a photo of the mudflat on the southern shore of Dundalk estuary at low tide taken on 06/04/2012. This is approximately the location from which Mr Fergus would have walked out to the small punt and then proceeded out to his boat. Mr Fergus's boat can be seen in the distance across the mudflat.

- 4.2 An MCIB inspector visited the mudflats on the south shore on two occasions. It was found that the consistency of the mud is quite cloying and arduous to walk on in parts. The Board understands that it is also changeable over time due to tidal and weather conditions and that the guts (small rivulets) that flow over it also alter their course over time.

Photo of the mudflat on the southern shore of Dundalk estuary at low tide taken on 06/04/2012. This is approximately the location from which Mr Fergus would have walked out to the small punt and then proceeded out to his boat. Mr Fergus's boat can be seen in the distance across the mudflat.
