**REPORT OF THE  
INVESTIGATION INTO  
THE FATALITY THAT  
OCCURRED ON BOARD MV  
"DUNKERQUE EXPRESS"  
AT FELIXSTOWE, ENGLAND  
ON 26 AUGUST 1998**

**The Marine Casualty Investigation Board was established on the 23<sup>rd</sup>, May 2002 under The Merchant Shipping (Investigation of Marine Casualties) Act 2000**

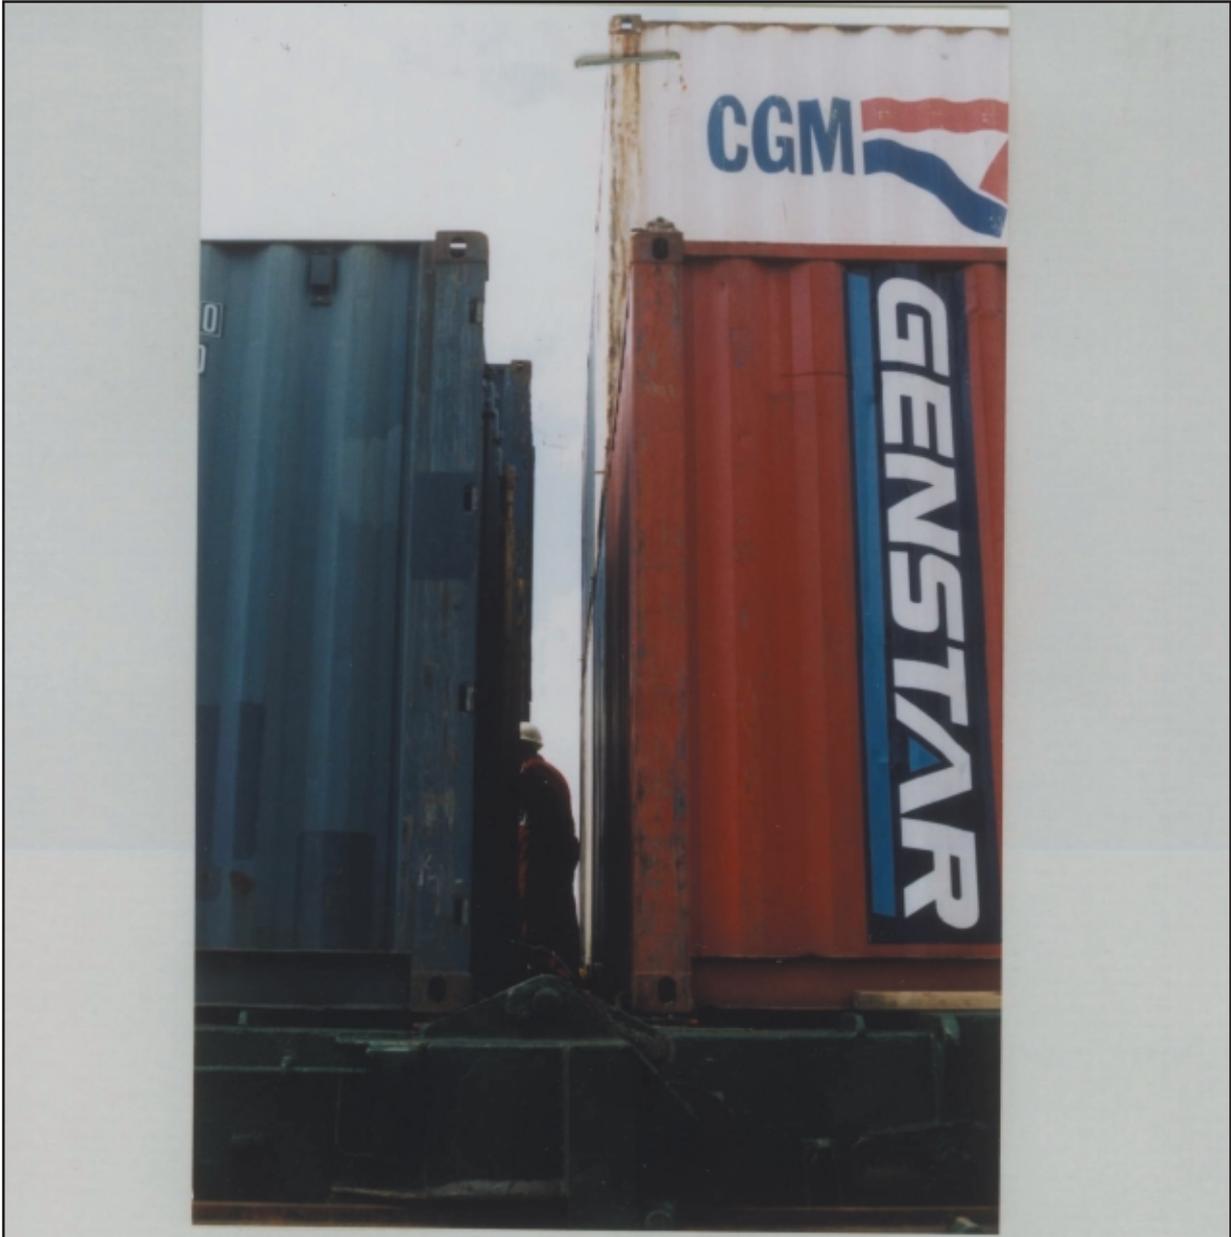
Photograph “a” shows the stowage arrangement that provides for an athwartships 18 inch corridor at 40 foot intervals between section 2 and section 3 . The photograph is taken from the quayside port side of the ship. See also photograph “g”

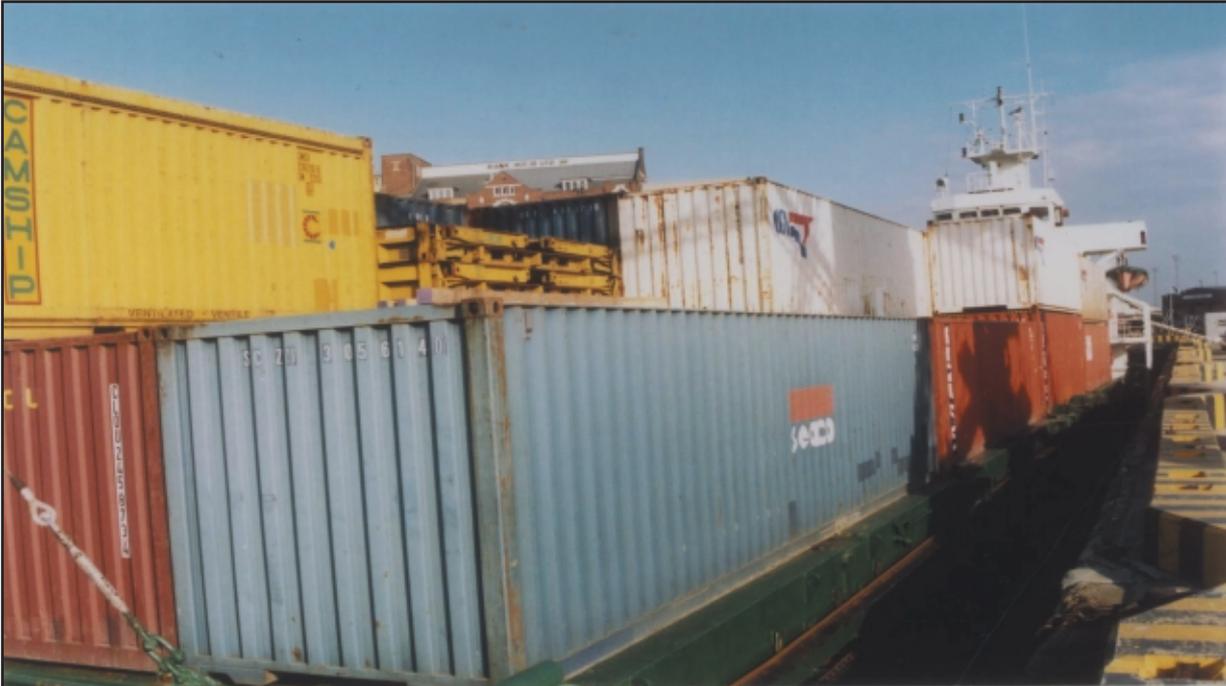
- 4.5.1 Towards the completion of loading at between 12.15 to 12.20 hours (BST) the penultimate load being handled was a stack of three flatbeds which were interlocked together to form a single lift and was to be landed on top of a first tier container "E". Refer to Photograph "b" at Appendix 8.1

Photograph “b” gives a view along the port side of the ship. It shows the stack of three flatbacks landed in position between containers “A” and “C”.

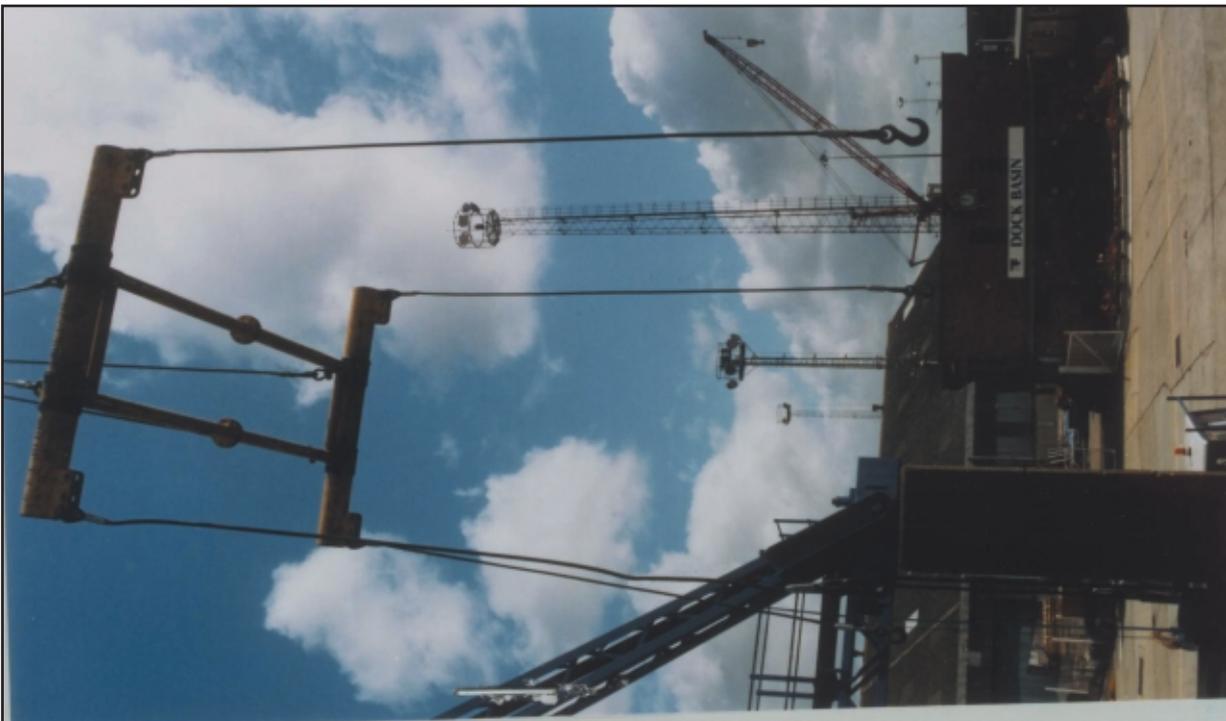
- 4.5.4 It was then decided to use a wire lift method which is not normally used though the Crane Drivers are said to be trained in such methods.
- 4.5.5 The method requires 4 wires shackled to special points on each corner of the spreader frame. The wires hang vertically with hooks attached to the trailing ends. Refer to Photograph "c" at Appendix 8.1.

Photograph “c” shows a wire lift with wires hanging from a manual spreader frame with the hooks connected to the trailing ends.

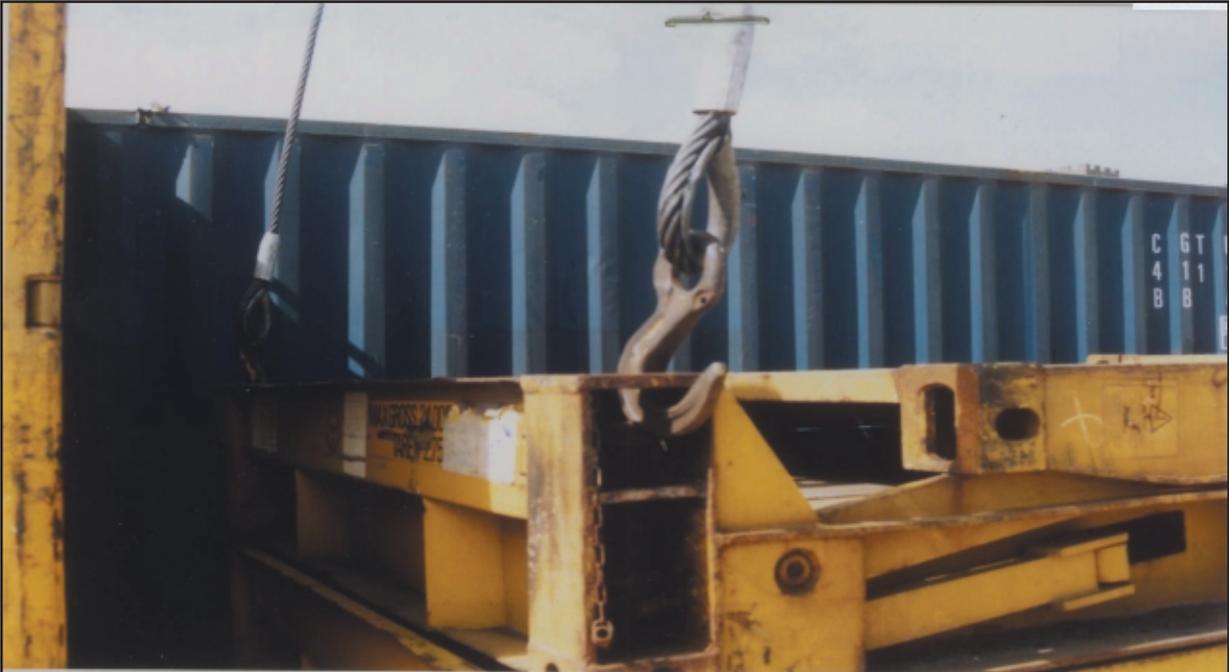
4.5.6 The Shift Foreman said that he and two Berth Operators (labourers) attached the hooks to the four corners of the flats and then moved to a safe position before he gave the signal to the Crane Driver to lift the load off the quayside. Refer to Photograph "d" at Appendix 8.1.

4.6.6 It was noticed that the hooks had been hooked into the sides of the corner castings from the outside hooking in as opposed to from the inside hooking out. This method of hooking on resulted in one of the inboard hooks becoming jammed against a container "B" when the stack had been landed in position. Refer Photograph "d" at Appendix 8.1.

Photograph “d” shows the hooks rigged to the top flatback in the correct manner that would avoid the inboard hook(s) being jammed against the inboard 40 foot container “B”. Refer to paragraph 5.15.6.

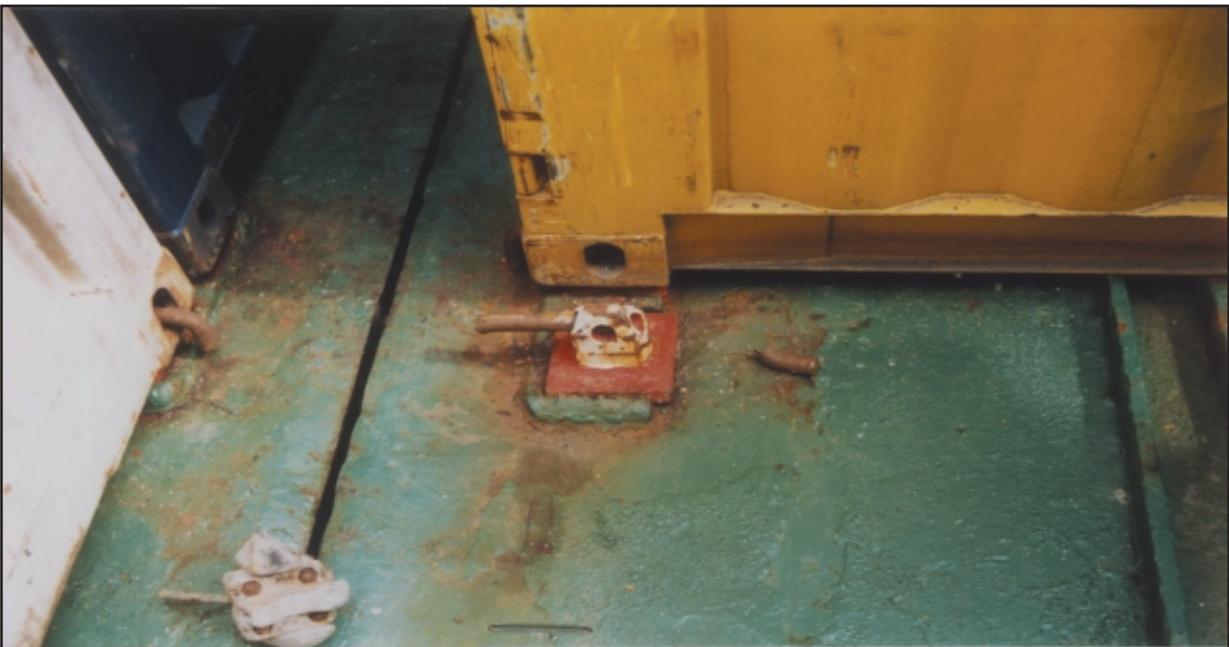
4.6.2 The lower part of the container was already secured at the corner castings to the hatch lid by a single stack cone. This cone slides into the permanent hatch lid shoe fitting and is then locked in place using a locking bar. Refer to Photograph "e" at Appendix 8.1.

Photograph “e” Shows the method of securing the first tier containers to the hatch lid as described in paragraph 5.15.2. A sheared section of the locking bar is lying to the right of the shoe and a twistlock can be seen in the front and to the left of the photograph.

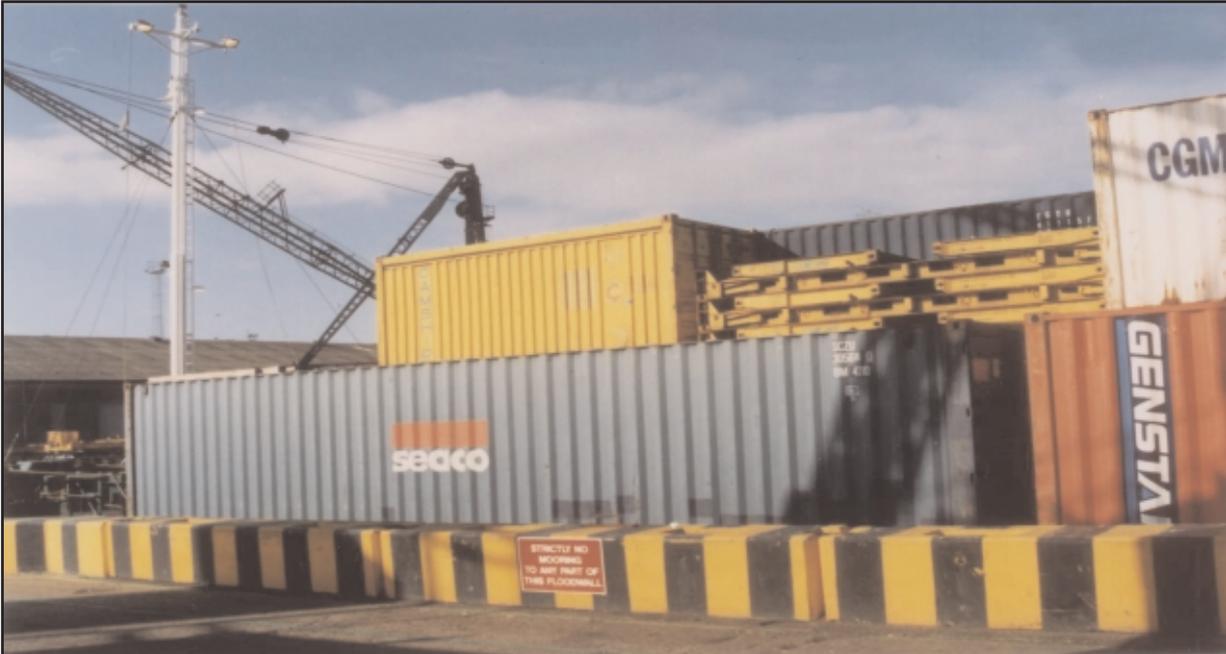
Photograph "f" is a view of the port side of the ship with the white foremast to the left of the picture. It shows the set of flatbacks in position over container "E" with yellow container "A" forward of it and a blue 40 foot container outboard of the flatbacks..

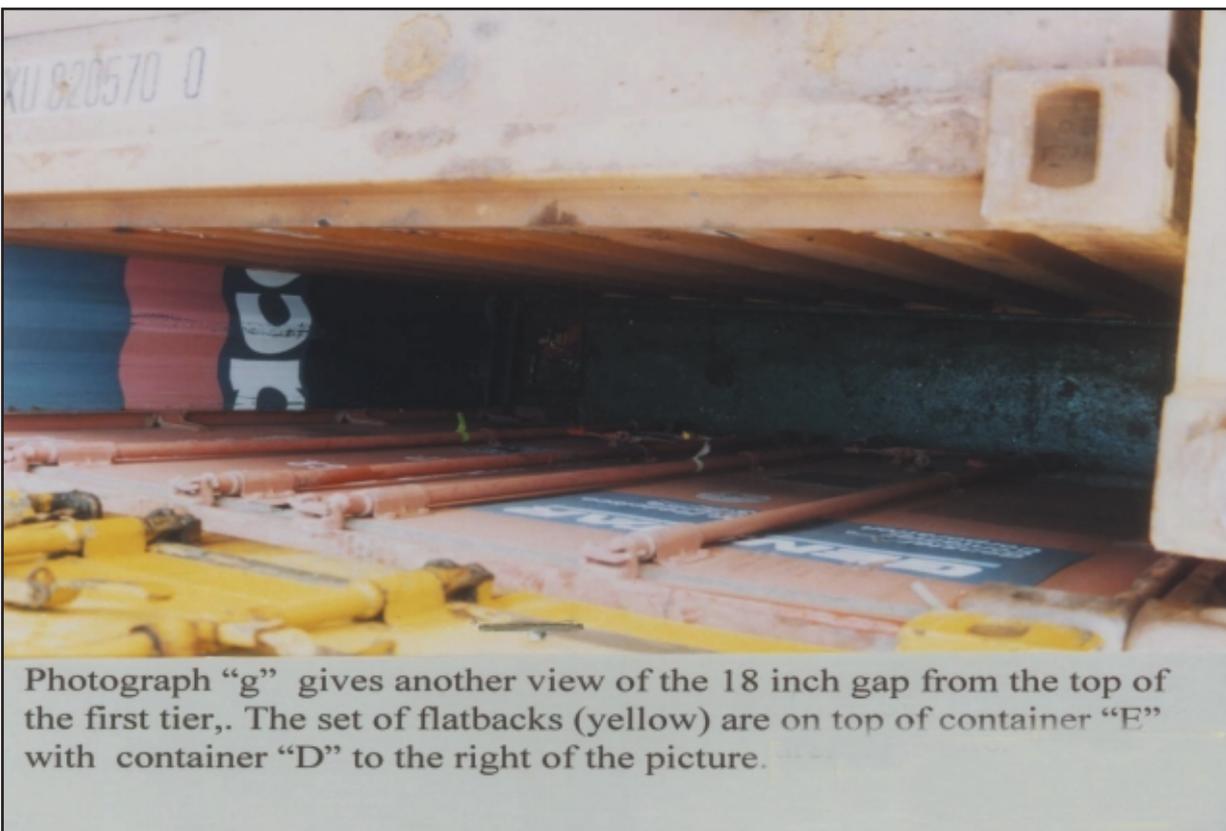
Photograph "g" gives another view of the 18 inch gap from the top of the first tier,. The set of flatbacks (yellow) are on top of container "E" with container "D" to the right of the picture.

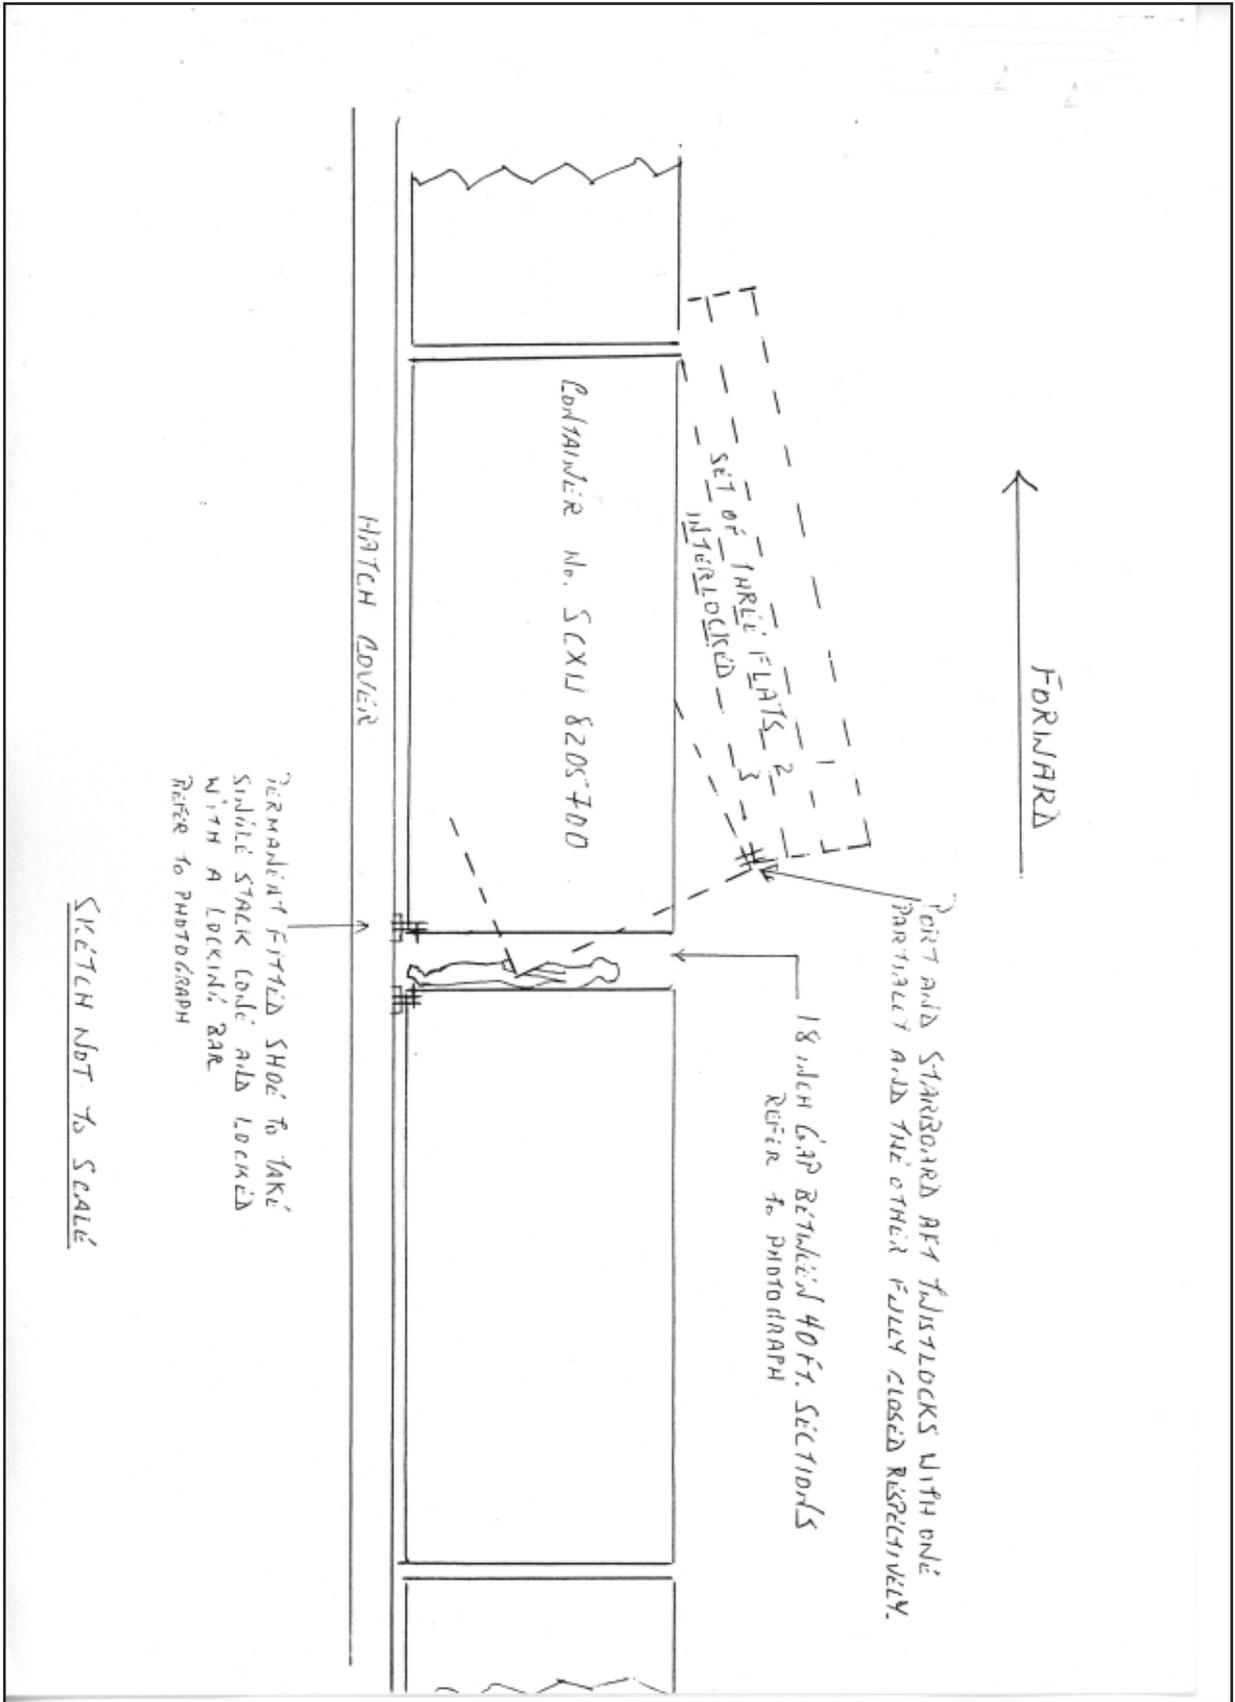
8.2 Sketch of the area in which the accident occurred.

- 4.7.3 The bottom corner castings of the container which were secure to the hatch lid by stack cones which slide into the permanent hatch shoe fittings and then locked using a locking bar, ripped away from the attachment. The combined weight lifted up and shifted aft resulting in Mr. Ackon being pinned up against container "D". Refer to the sketch in Appendix 8.2.
