**REPORT OF THE  
INVESTIGATION INTO  
THE GROUNDING OF  
THE M.F.V. "ELSINOR" AT  
FOILNABOE, IRELAND ON  
THE 15TH SEPTEMBER,  
2001.**

The Marine Casualty Investigation Board was established on the 5<sup>th</sup>, June 2002 under The Merchant Shipping (Investigation of Marine Casualties) Act 2000

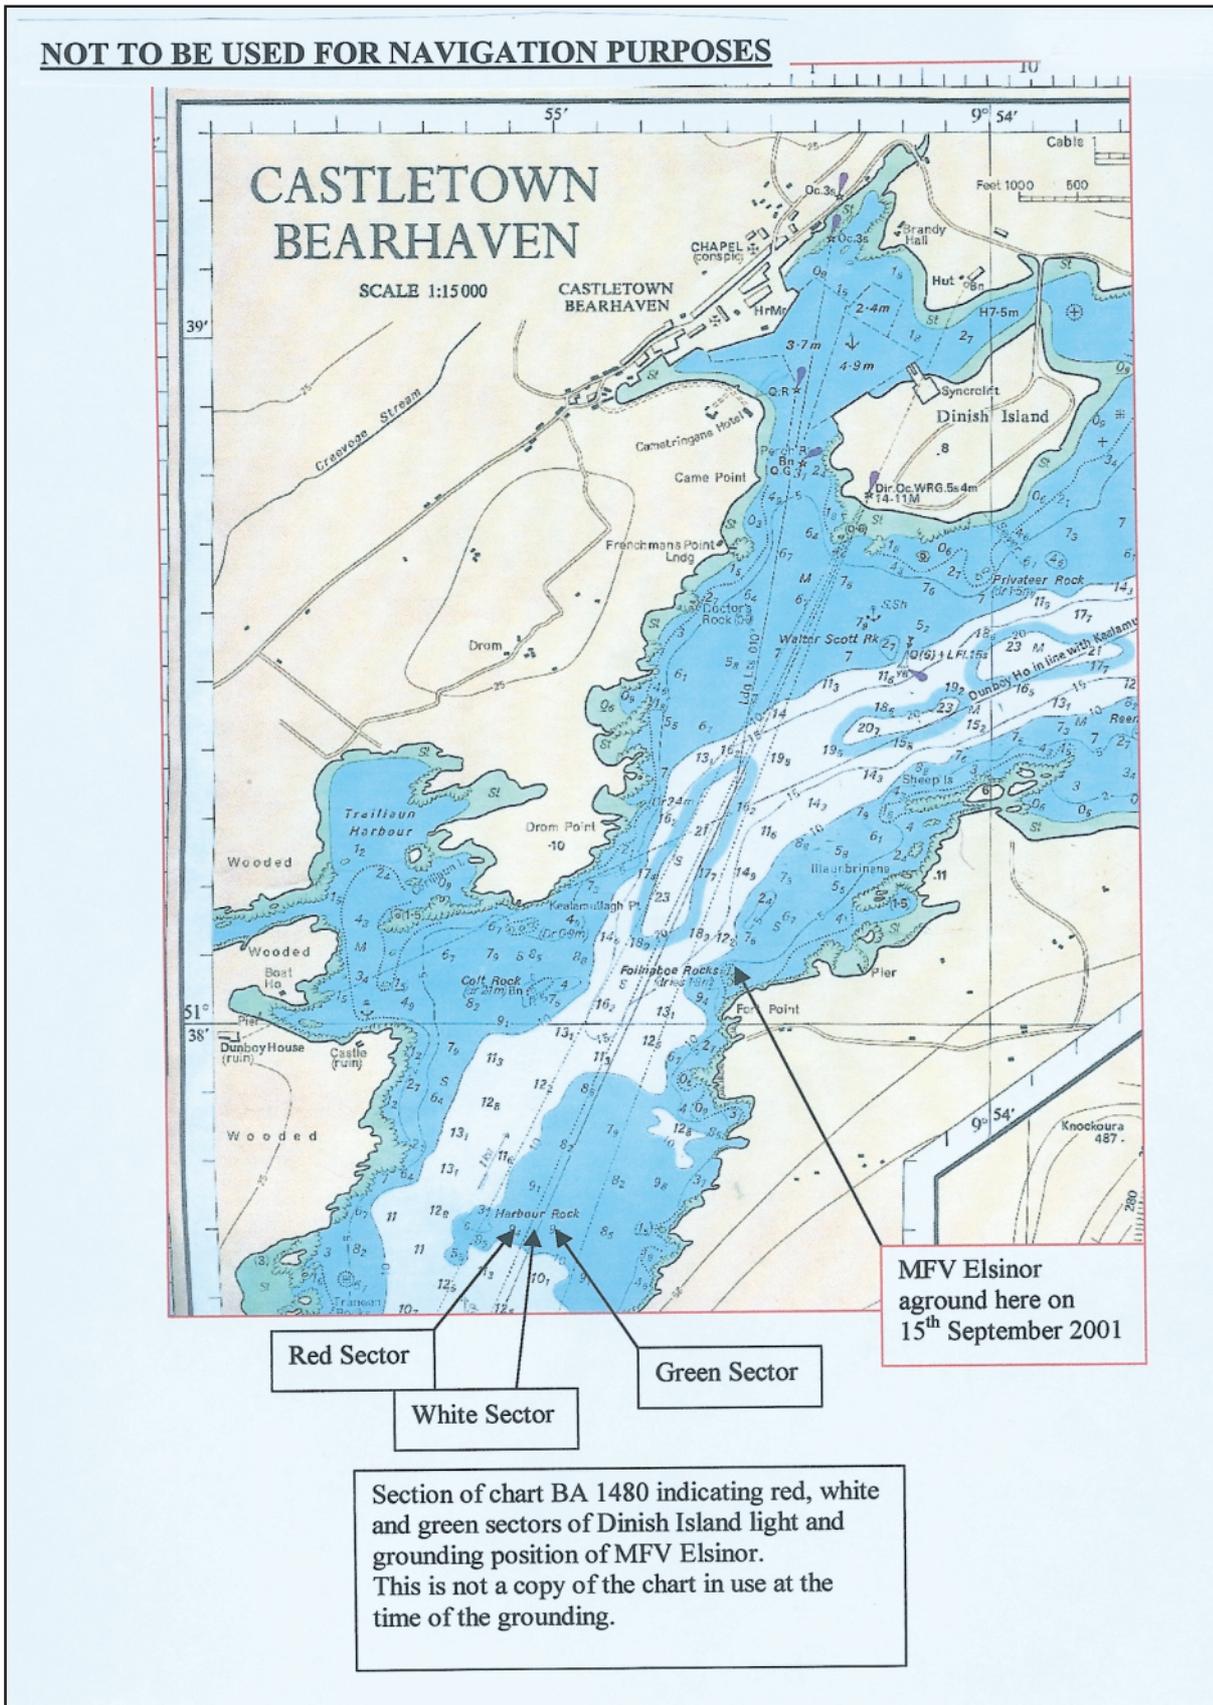
## 8.1 Section of Chart BA 1480 showing grounding position of M.F.V. "Elsinor".

- 4.1 The first indication that anything was wrong was when the vessel went aground on Foilnaboe rocks in approximate position 51° 38.08'N, 009° 54.64W at approximately 01.20 hours local time on the 15th September 2001. (See Appendix 8.1)

- 7.2 Foilnaboe rocks dries out to a height of 1.8 metres but they are submerged at high tide. It is recommended that a study be undertaken by the appropriate authorities to assess the risks and make recommendations as to whether an Aid to Navigation buoy with light should be located in the vicinity of Foilnaboe Rocks.

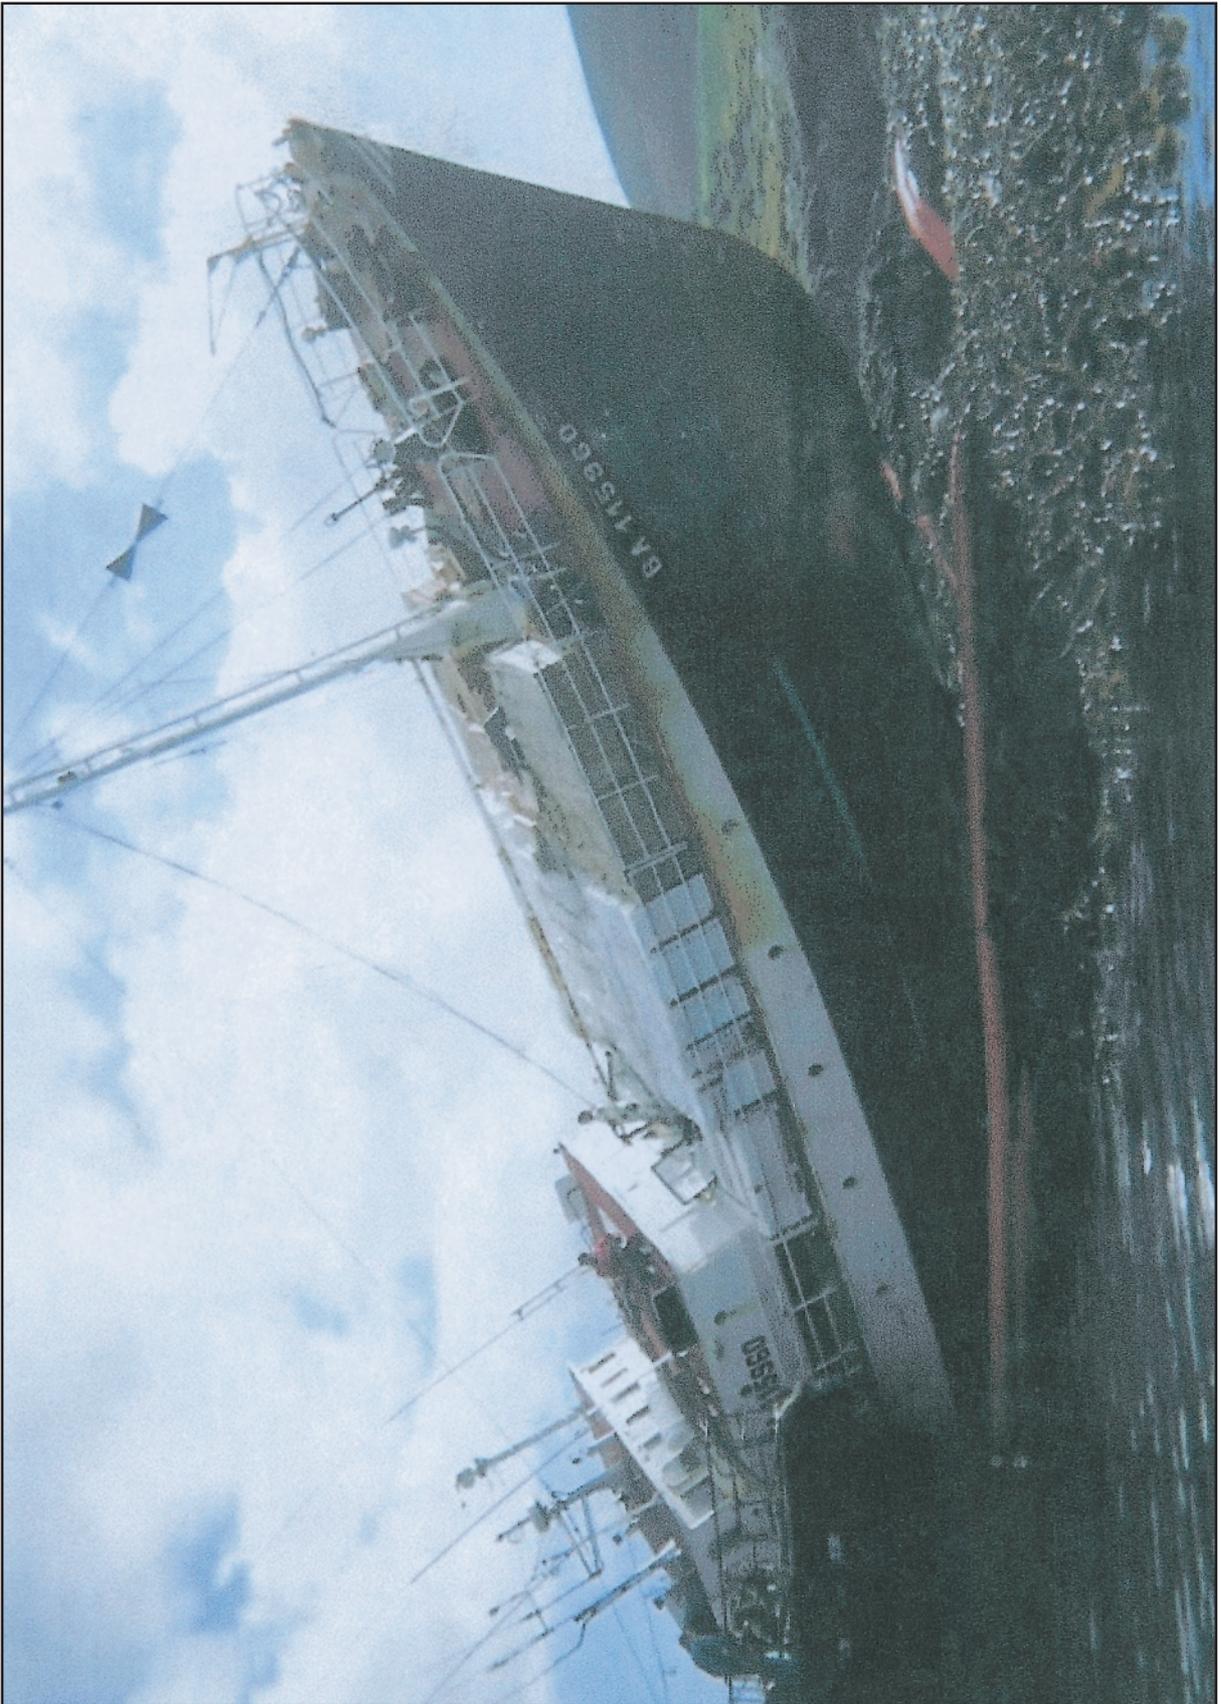
8.2 Photograph of M.F.V. "Elsinor" aground.

- 5.2 The crew of the "Elsinor" all disembarked into one of the two onboard 12 person liferafts.
- 5.3 The agent proceeded to the "Elsinor" with his launch and arrived at the scene shortly before the lifeboat. At the scene he found the "Elsinor" at a steep angle and listing heavily to starboard (See Appendix 8.2). The crew disembarked from the liferaft onto the agents boat.

- 5.4 An access hatch on the poop deck of the "Elsinor" was open. As the vessel settled on the rocks with a large stern trim seawater flooded the engine room and the accommodation.

- 6.8 The vessel was not properly secured for sea. The poop deck hatch was left open which caused the engine room and other spaces to be flooded.
- 6.9 The 'Capitan' said that some items of navigation equipment went missing after the vessel went aground and that charts and publication were destroyed by the ingress of water.
