**REPORT OF THE
INVESTIGATION INTO THE
GROUNDING OF THE IRISH
FISHING VESSEL “FELUCCA”
IN DUBLIN PORT
ON 3RD JUNE 2006
AND THE SUBSEQUENT
VESSEL TRAFFIC SERVICE
CONTROL OF THE INCIDENT
INVOLVING TWO PASSENGER
VESSELS**

REPORT No. MCIB/126

Report MCIB/126 published by The Marine Casualty Investigation Board
12th May 2008

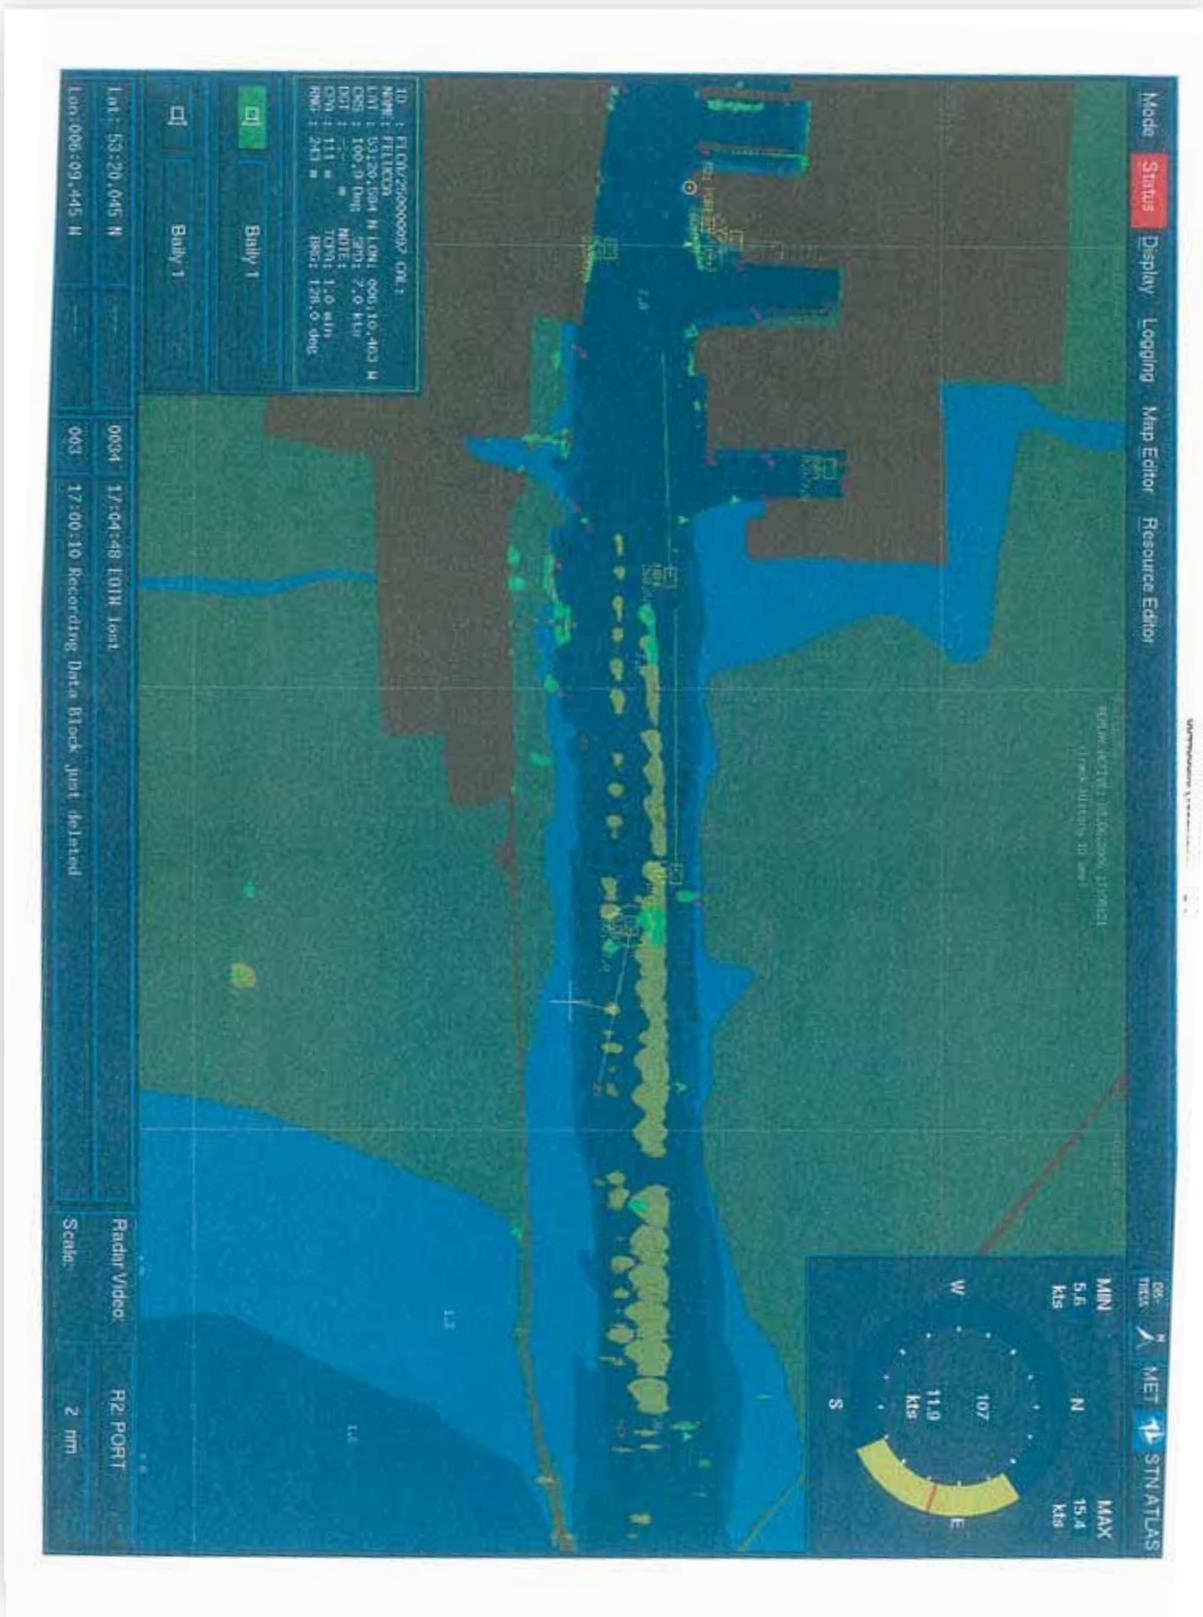
Appendix 8.4.3 Radar recording for 17.05.21

- 4.1 The recording for the time 17:05:21, (given at Appendix 8.4.3) shows the “Felucca” veering to starboard having just passed the “Liverpool Viking”. At this time the Skipper of the “Felucca” advised Port Radio that the fishing vessel had lost engine power. Shortly afterwards the fishing vessel grounded on the south side of the channel about 250 metres to the west of No. 10 buoy.
- 4.2 The recording for the time 17:06:45, (given at Appendix 8.4.4) shows the inward bound passenger vessel “Stena Adventurer” approaching the Rosbeg South buoy followed by the inward bound Passenger High Speed Craft “Jonathan Swift”. At 17.10 hours, Port Radio advised them both to pass at reduced speed.

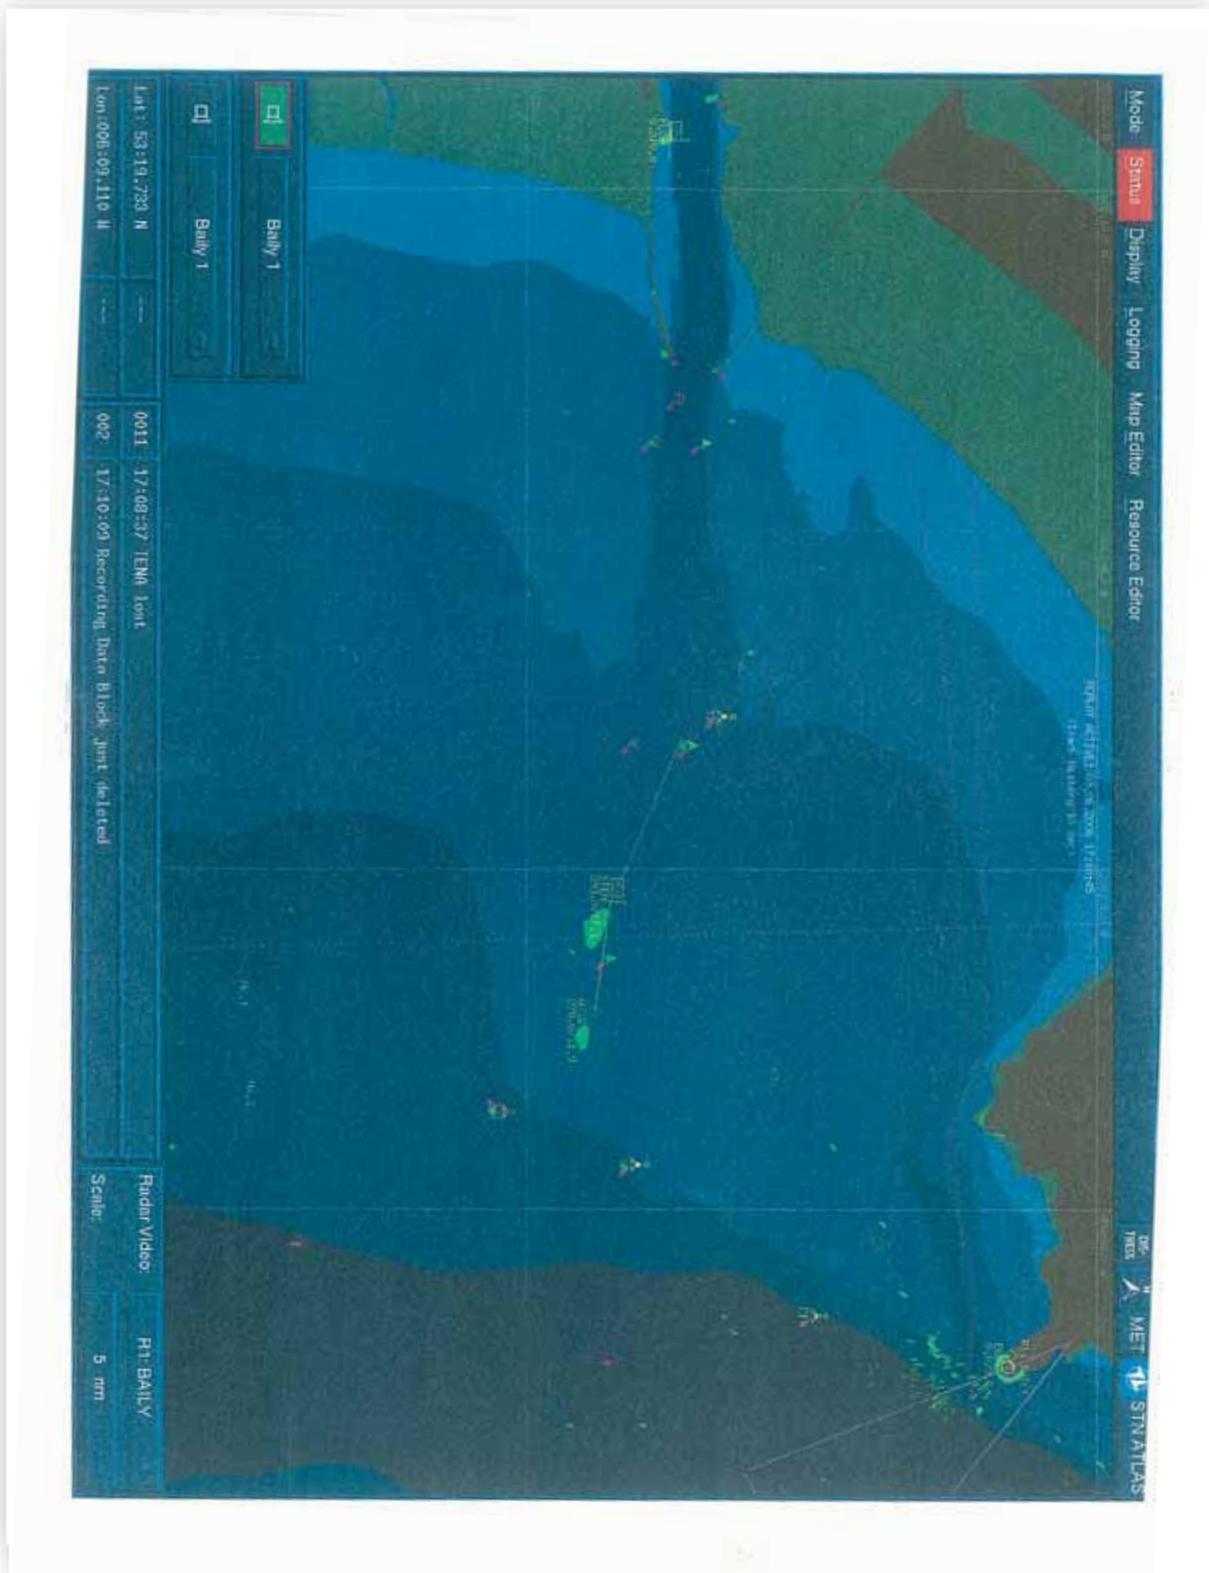
Appendix 8.4.5 Radar recording for 17.10.45

- 5.1 At 17.11 hours, Port Radio was advised by the Skipper of the “Felucca” that the vessel was still aground and that the engine had stopped a second time. The Skipper also advised that a tug was the best option and that the “Felucca” would try using one tug initially. Appendix 8.4.5 shows the positions of the “Stena Adventurer” and “Jonathan Swift” at 17:10:45 hours.

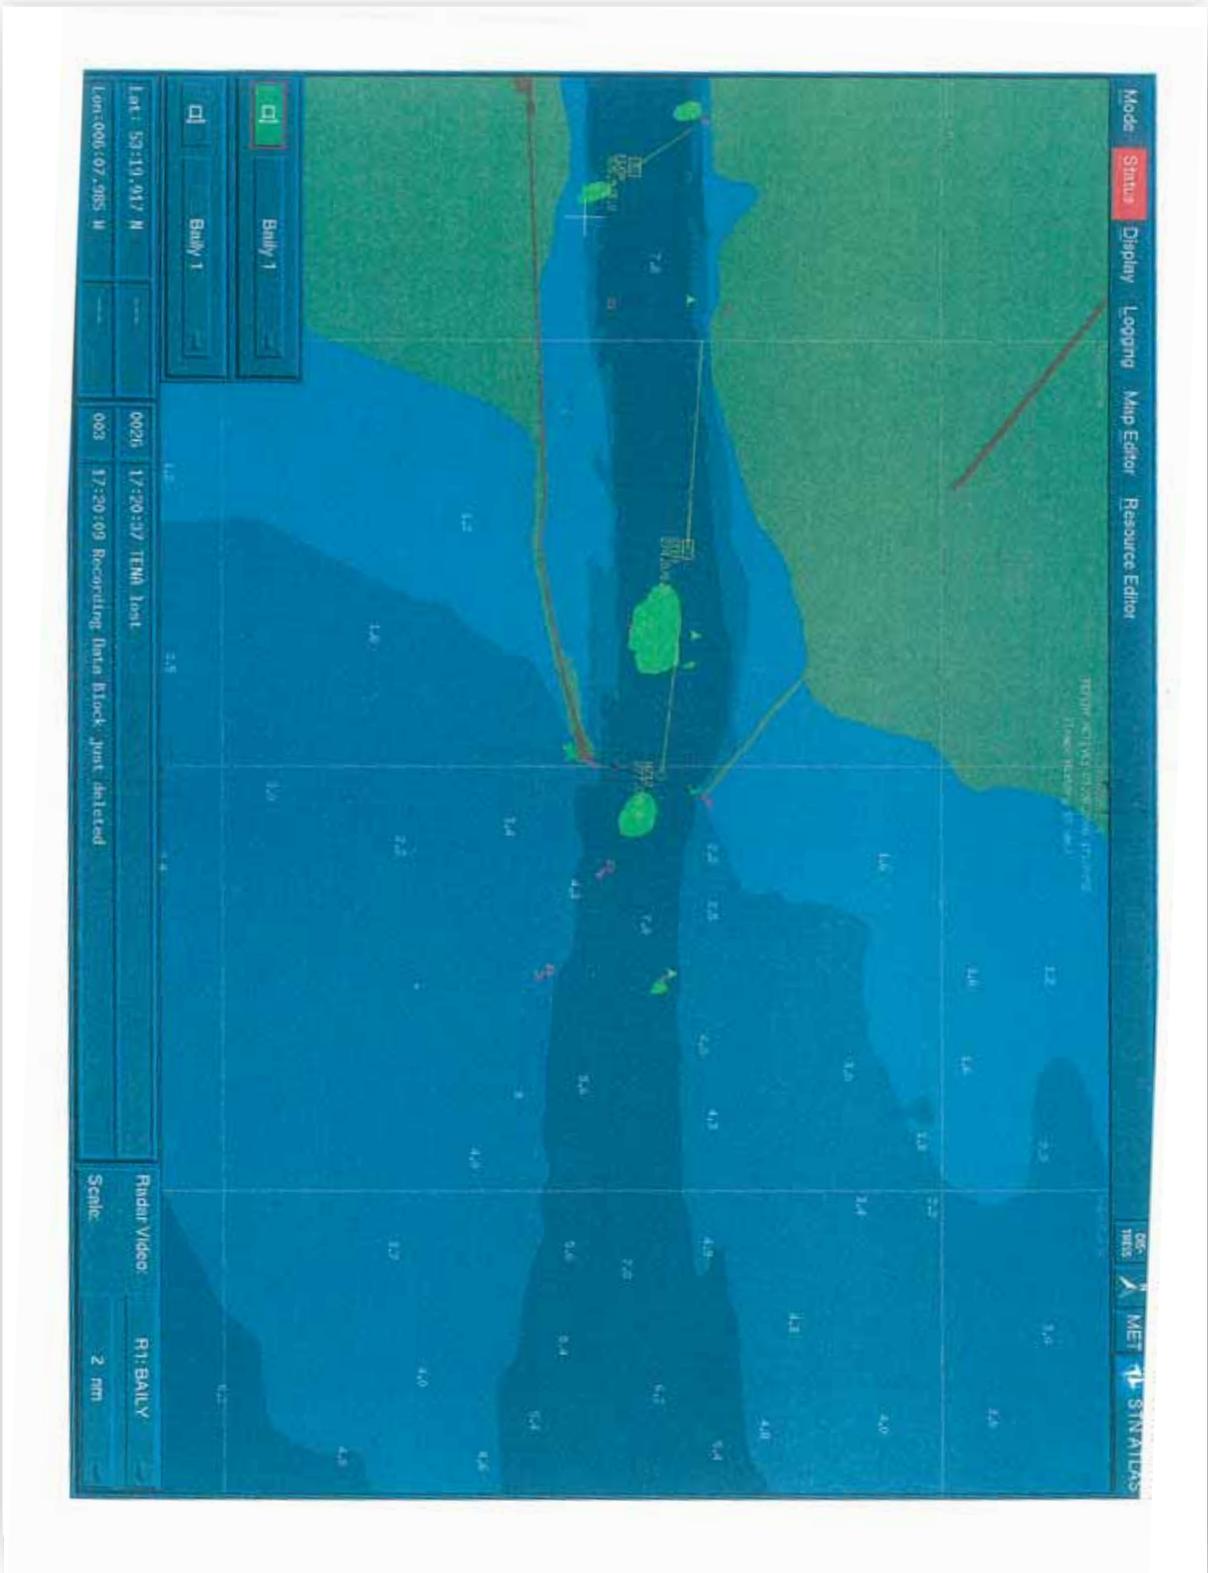
Appendix 8.4.6 Radar recording for 17.20.52

- 5.3 At 17.20 hours the fishing vessel confirmed to Dublin Port Radio that it was no longer aground and that its engine was restarted. Port Radio advised the “Felucca” to allow the passenger ferries to pass and to get in line of the channel. The recording for the time 17:20:52, given at Appendix 8.4.6, shows the “Stena Adventurer” passing No. 7 buoy followed by the “Jonathan Swift”.

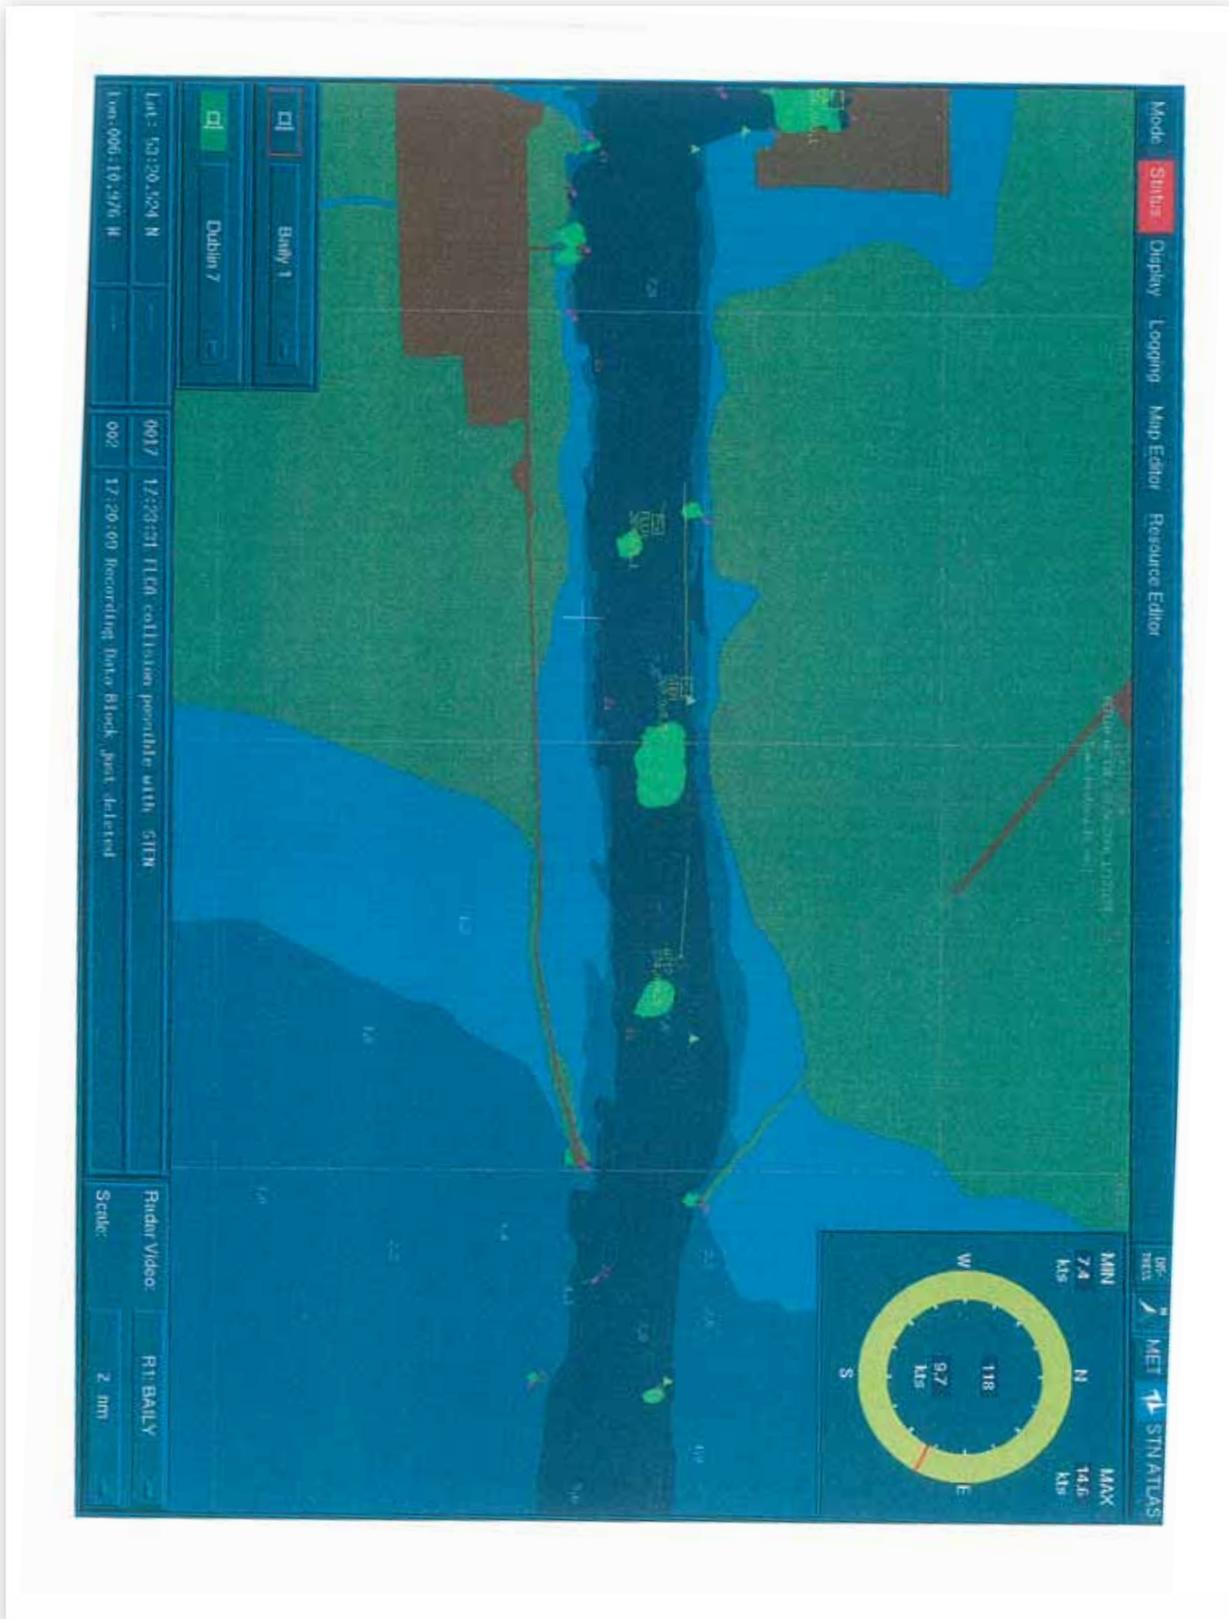
Appendix 8.4.7 Radar recording for 17.23.33

- 5.4 At 17.21 hours, Port Radio advised the “Felucca” that the tug was departing its berth en route to it. The recording for the time 17:23:33, given at Appendix 8.4.7, shows the “Stena Adventurer” approaching No. 9 buoy followed by the “Jonathan Swift”.

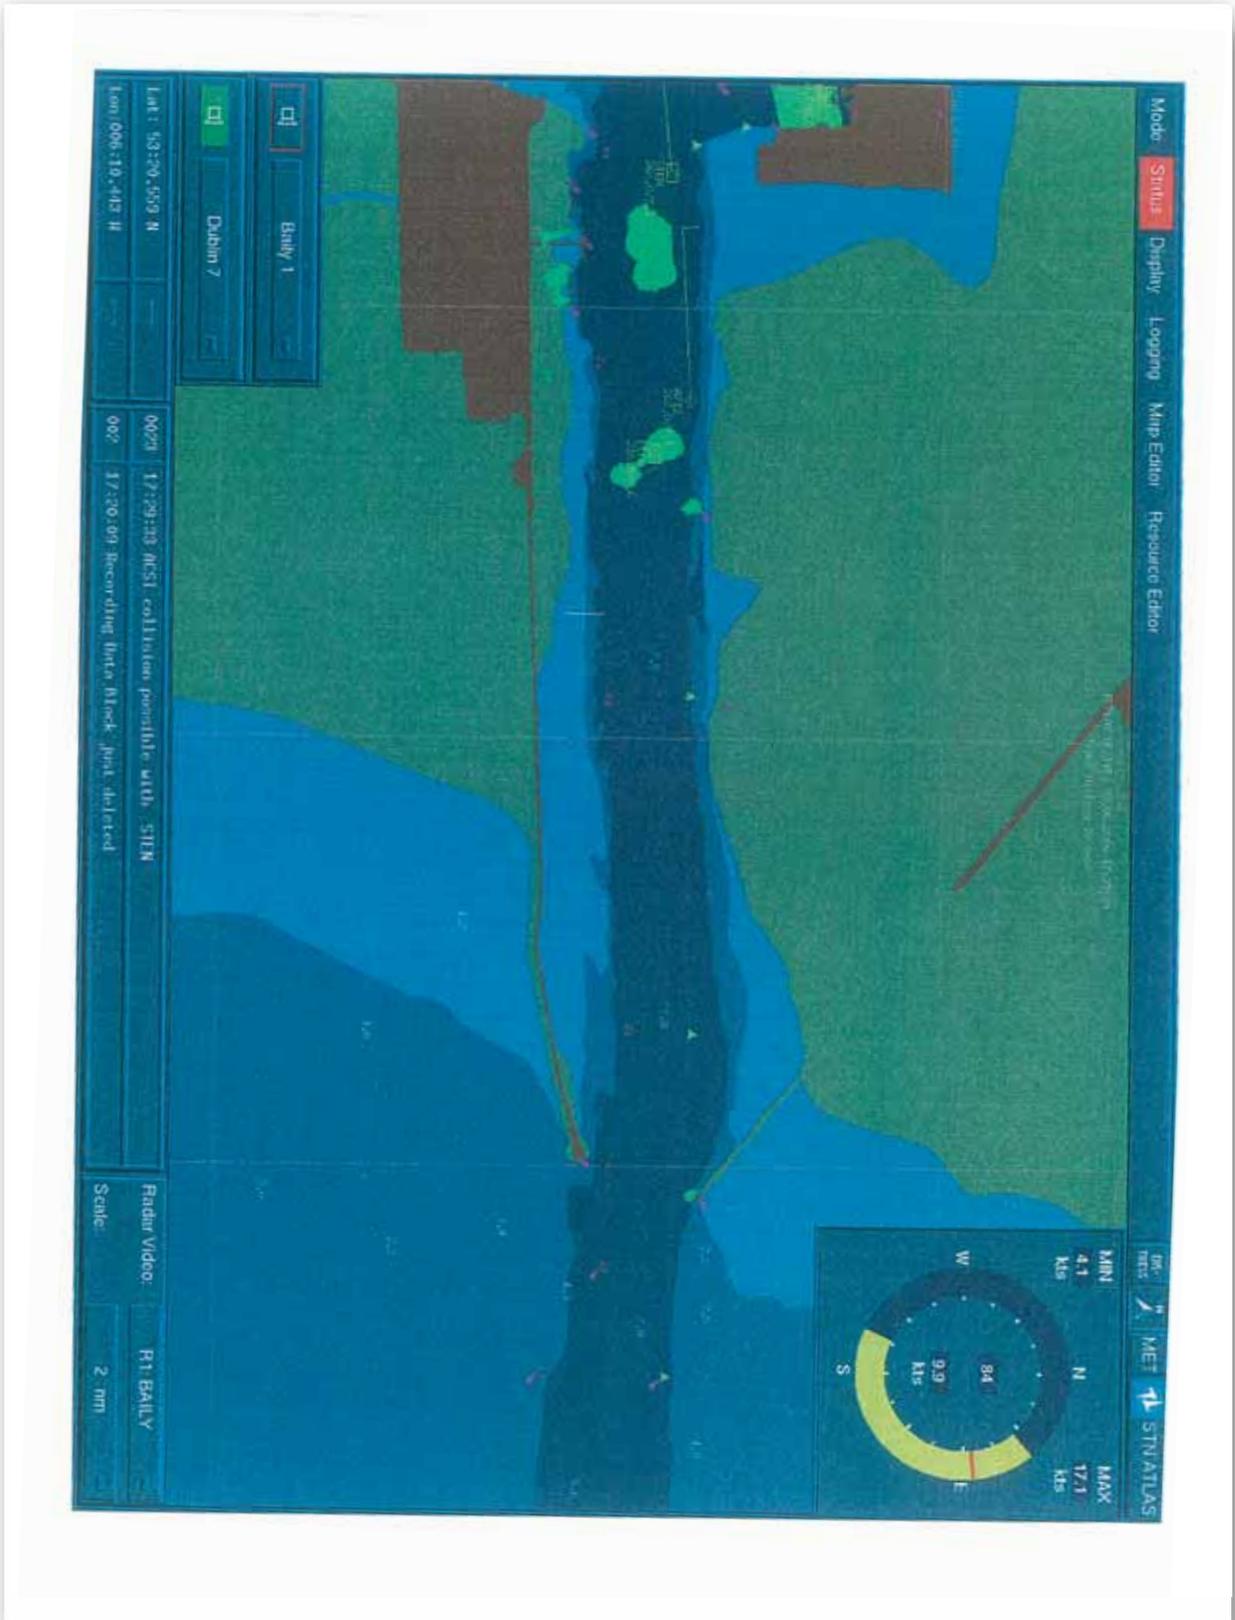
Appendix 8.4.8 Radar recording for 17.29.39

- 5.6 At 17.29 hours, the “Jonathan Swift” passed the fishing vessel. The recording for the time 17:29:39, given at Appendix 8.4.8, shows this. After this the “Felucca” proceeded back to Alexandra Basin West.
