**REPORT OF INVESTIGATION
INTO A FIRE ON-BOARD
THE MOTOR FISHING VESSEL
"GROVE" ON
19TH NOVEMBER 2002.**

1. SYNOPSIS.

- 1.1 On Tuesday, 19th November 2002 at approximately 11.30 hours while fishing off the Mayo Coast a fire occurred in the engine room of the Fishing Vessel "Grove". There were no injuries.

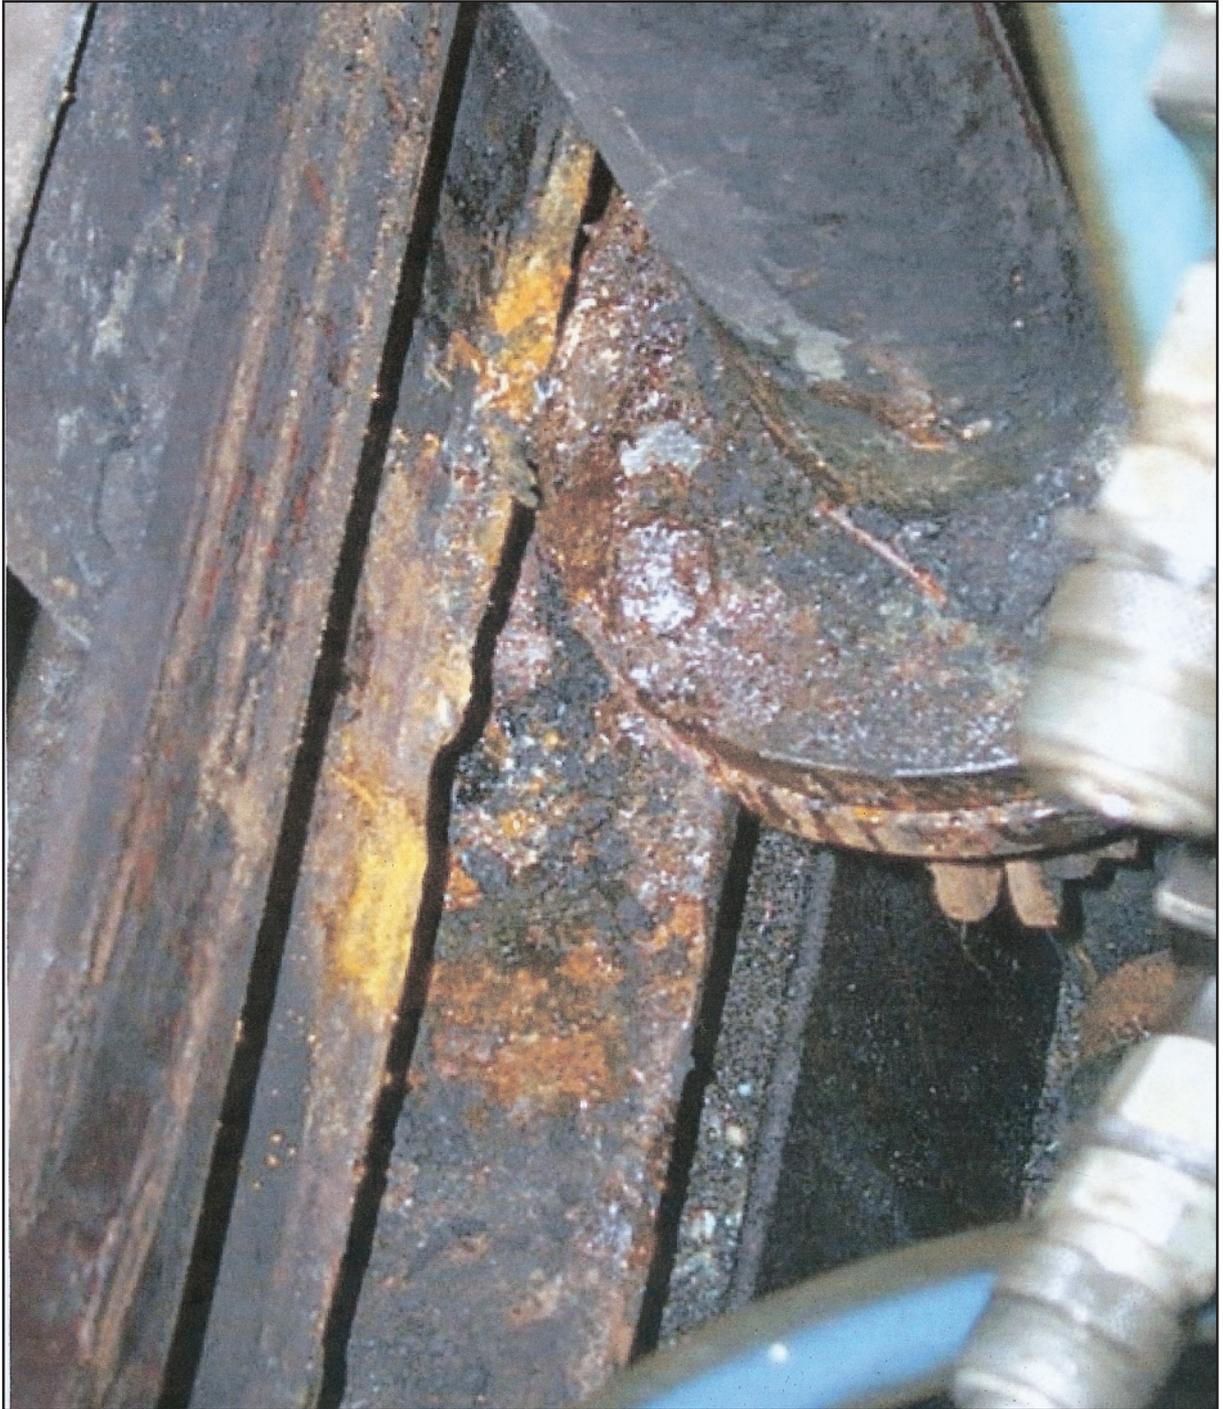
APPENDIX 8.2

- 6.1 The Starboard Generator Unit is located on the Starboard side of the engine room with the engine forward and the generator aft. The layout of the main supply cables from this generator (consisting of seven cables i.e. two for each phase and a single neutral cable) is as follows:

The cables exit the connection box on the generator and run downwards on the inboard side to the stool that supports the generator unit. The cables then run horizontally forward to the main switchboard. In the area of the generator stool the cables are supported by cable ties to a flat bar that is welded to the foundation stool.

It would appear from the damage to the cables that the cable ties had broken allowing the cables to hang and sway with the movement of the vessel. The insulation was completely worn and burnt exposing the conductors over a distance of about 250mm, some of the copper conductors were themselves burnt through.

The cables, while hanging, made contact with the flange of a vertical pipe, which is located alongside the cable run. There was some burning of the flange and securing nuts probably caused by arching (the Engineer did report seeing sparks). As the main engine continued to run while the electrical power was off some damage occurred due to overheating.

8.2 Photograph, Starboard Generator Unit, cable support and vertical pipe.
