**REPORT OF INVESTIGATION
INTO FATALITY OVERBOARD
FROM MFV "HARBOUR PRIDE",
OFF HOOK HEAD,
CO. WEXFORD
17th SEPTEMBER 2009.**

**REPORT No. MCIB/177
(No. 1 of 2010)**

Report MCIB/177 published by The Marine Casualty Investigation Board
7th May 2010.

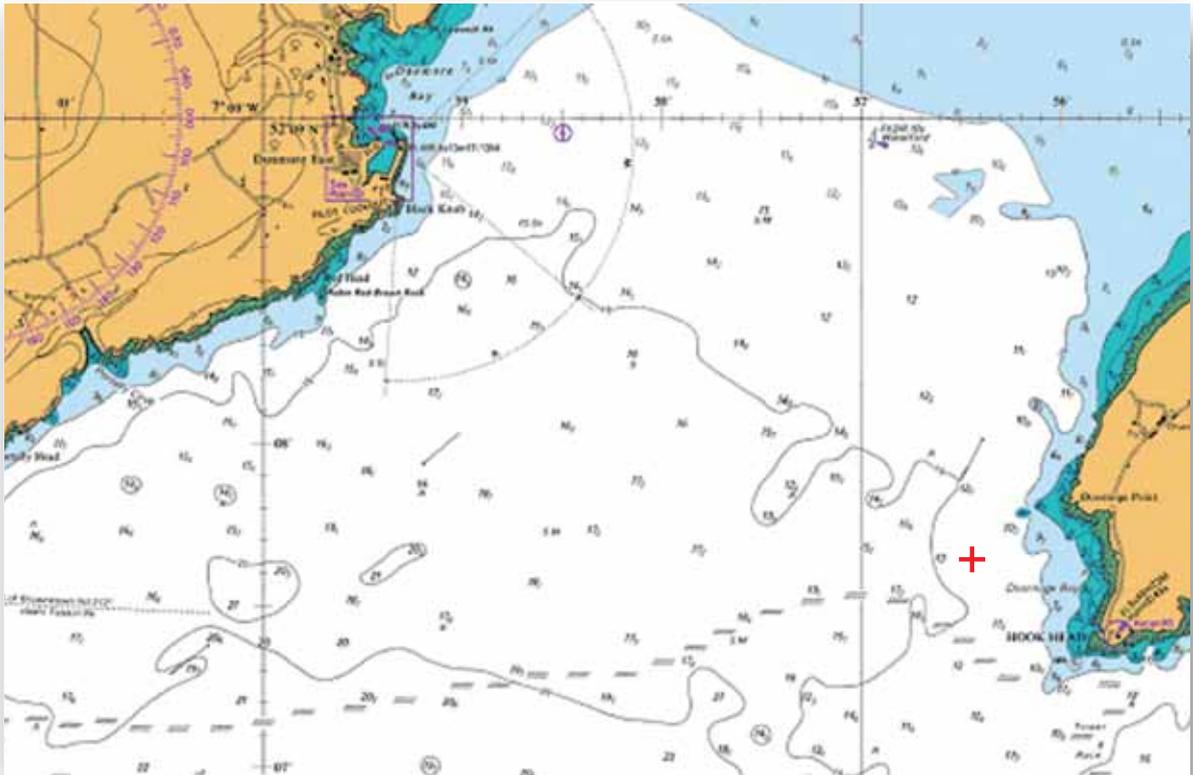
The + symbol marks the approximate location at which Mr. Paddy Mason's remains were recovered. Portally Cove can be located South and West of Dunmore East on the chart.
