**REPORT INTO THE COLLISION
BETWEEN THE ANTIGUA &
BARBUDA REGISTERED GENERAL
CARGO & CONTAINER VESSEL
"HOLGER" AND THE IRISH
REGISTERED FISHING VESSEL
"CREDO DU MARIN" OFF HOOK
HEAD LIGHT, CO. WEXFORD
ON 24TH AUGUST, 1997.**

1. SYNOPSIS.

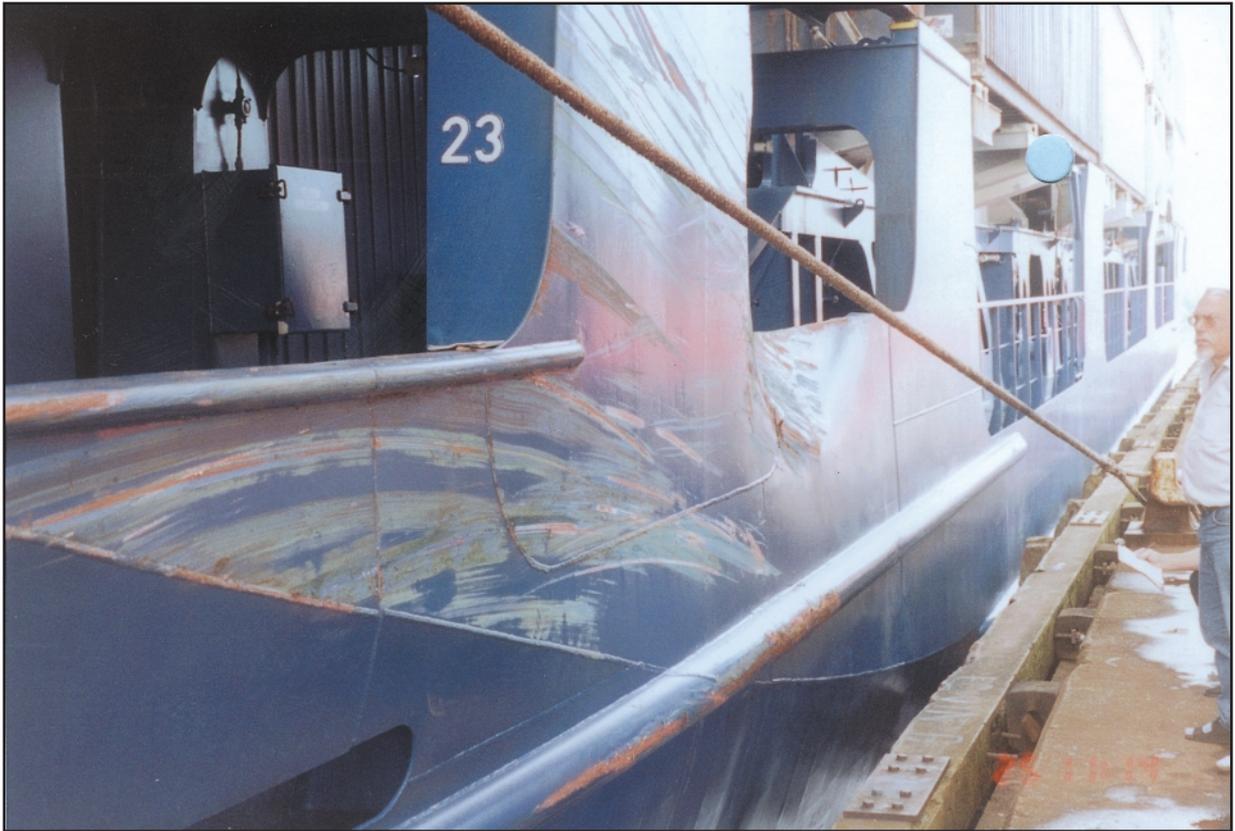
"Starboard side after quarter between frames 25 and 31 bulwark set in to 210mm over a length of 2,600mm and vertical height of 660mm. Vertical bulwark stringer at frame 25 distorted at forward edge over a height of 1,700mm. Scrape marks over a total length of 7,500mm with evidence of green paint of the same colour that was subsequently noted on "Credo Du Marin". Bunker save all (bund) aft edge distorted over width 430mm."

(1) View of scuffing and mechanical damage with indentation of steelwork to "Holger" in area of starboard aft quarter. This photograph was taken while "Holger" was alongside Tivoli Container Terminal, Cork on Sunday 24/08/1997.

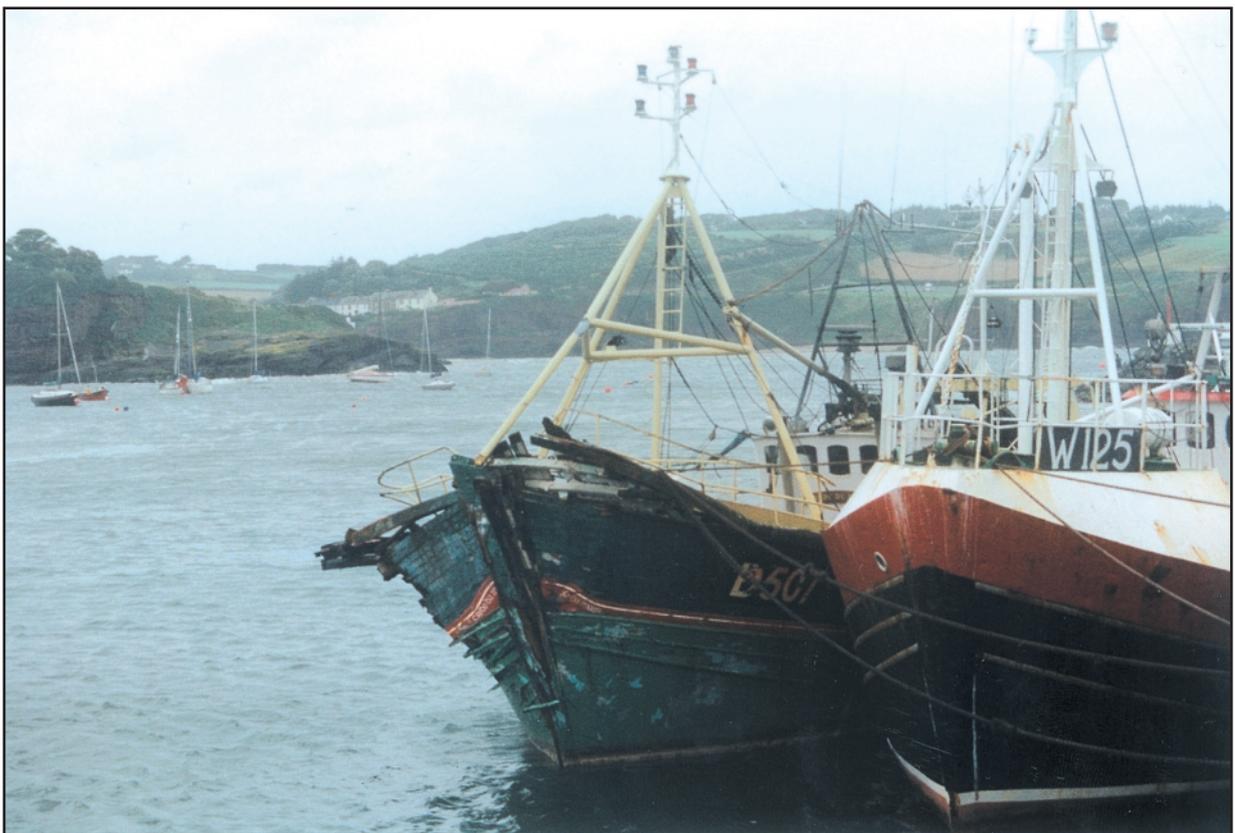
There were no apparent injuries to the crew of the fishing vessel though "Credo Du Marin" itself sustained severe damage to the bow area that resulted in the fishing vessel being declared a constructive total loss.

(2) The outboard vessel is "Credo Du Marin" at Dunmore East 26/08/1997.

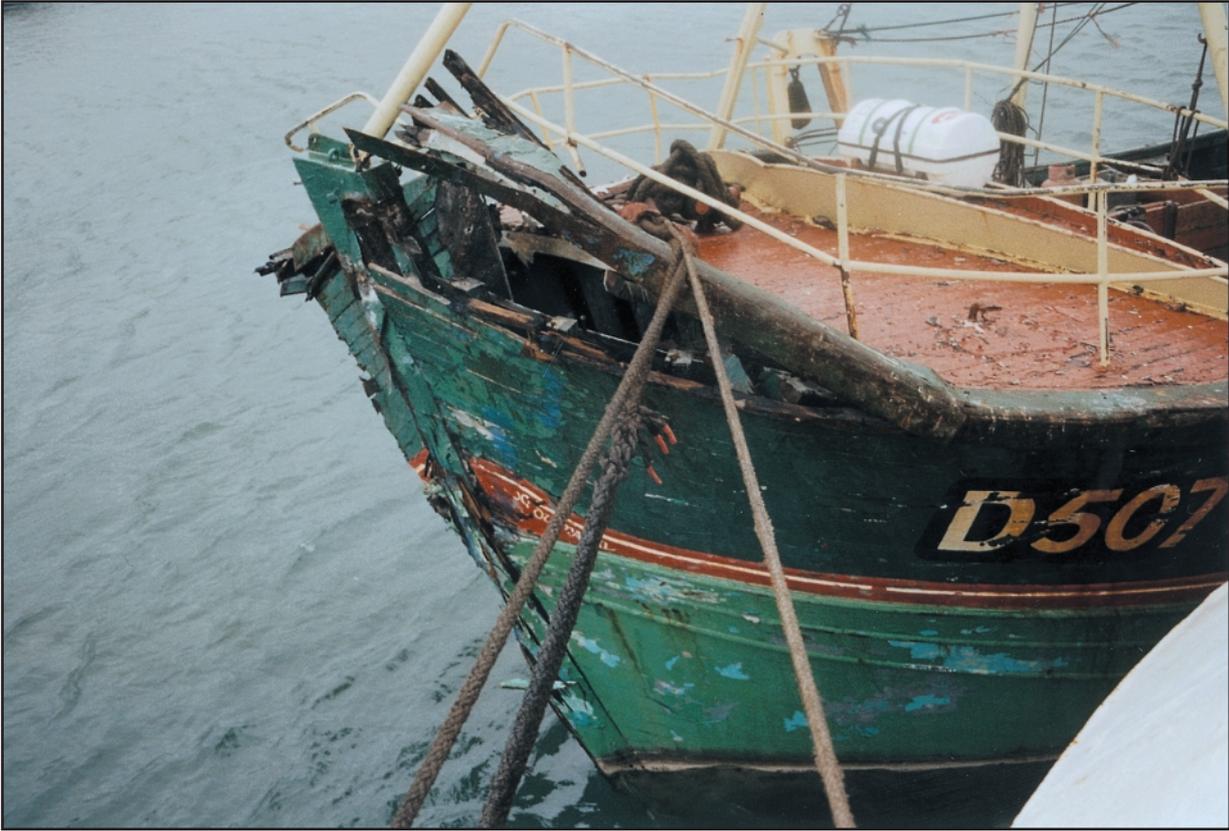
(3) A closer view of the bow damage to "Credo Du Marin".

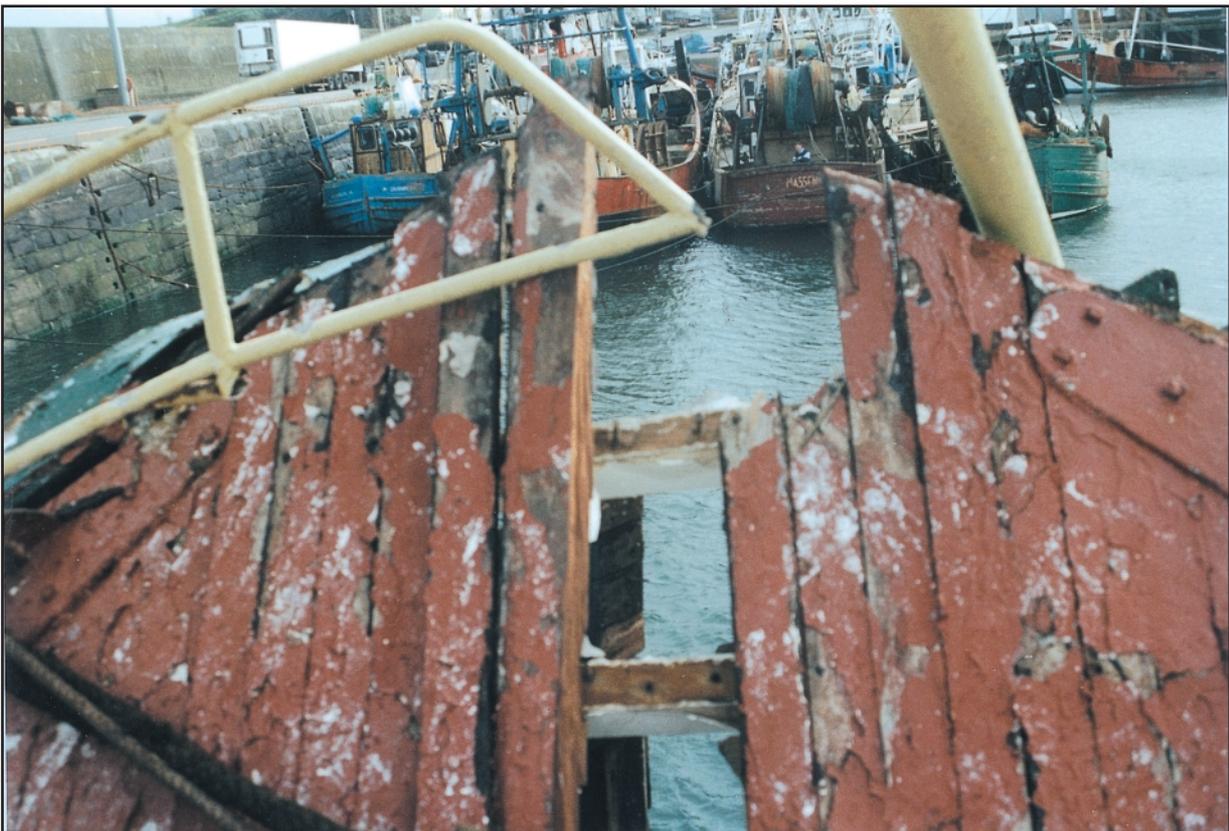
(4) A view of the bow damage to "Credo Du Marin" taken from a position aft of the bow area.
