**REPORT OF INVESTIGATION  
INTO THE LOSS OF THE  
FV "HONEYDEW II"  
OFF RAM HEAD,  
CO. WATERFORD  
ON 11th JANUARY 2007**

**REPORT No. MCIB/135**

Report MCIB/135 published by The Marine Casualty Investigation Board  
31st August 2009

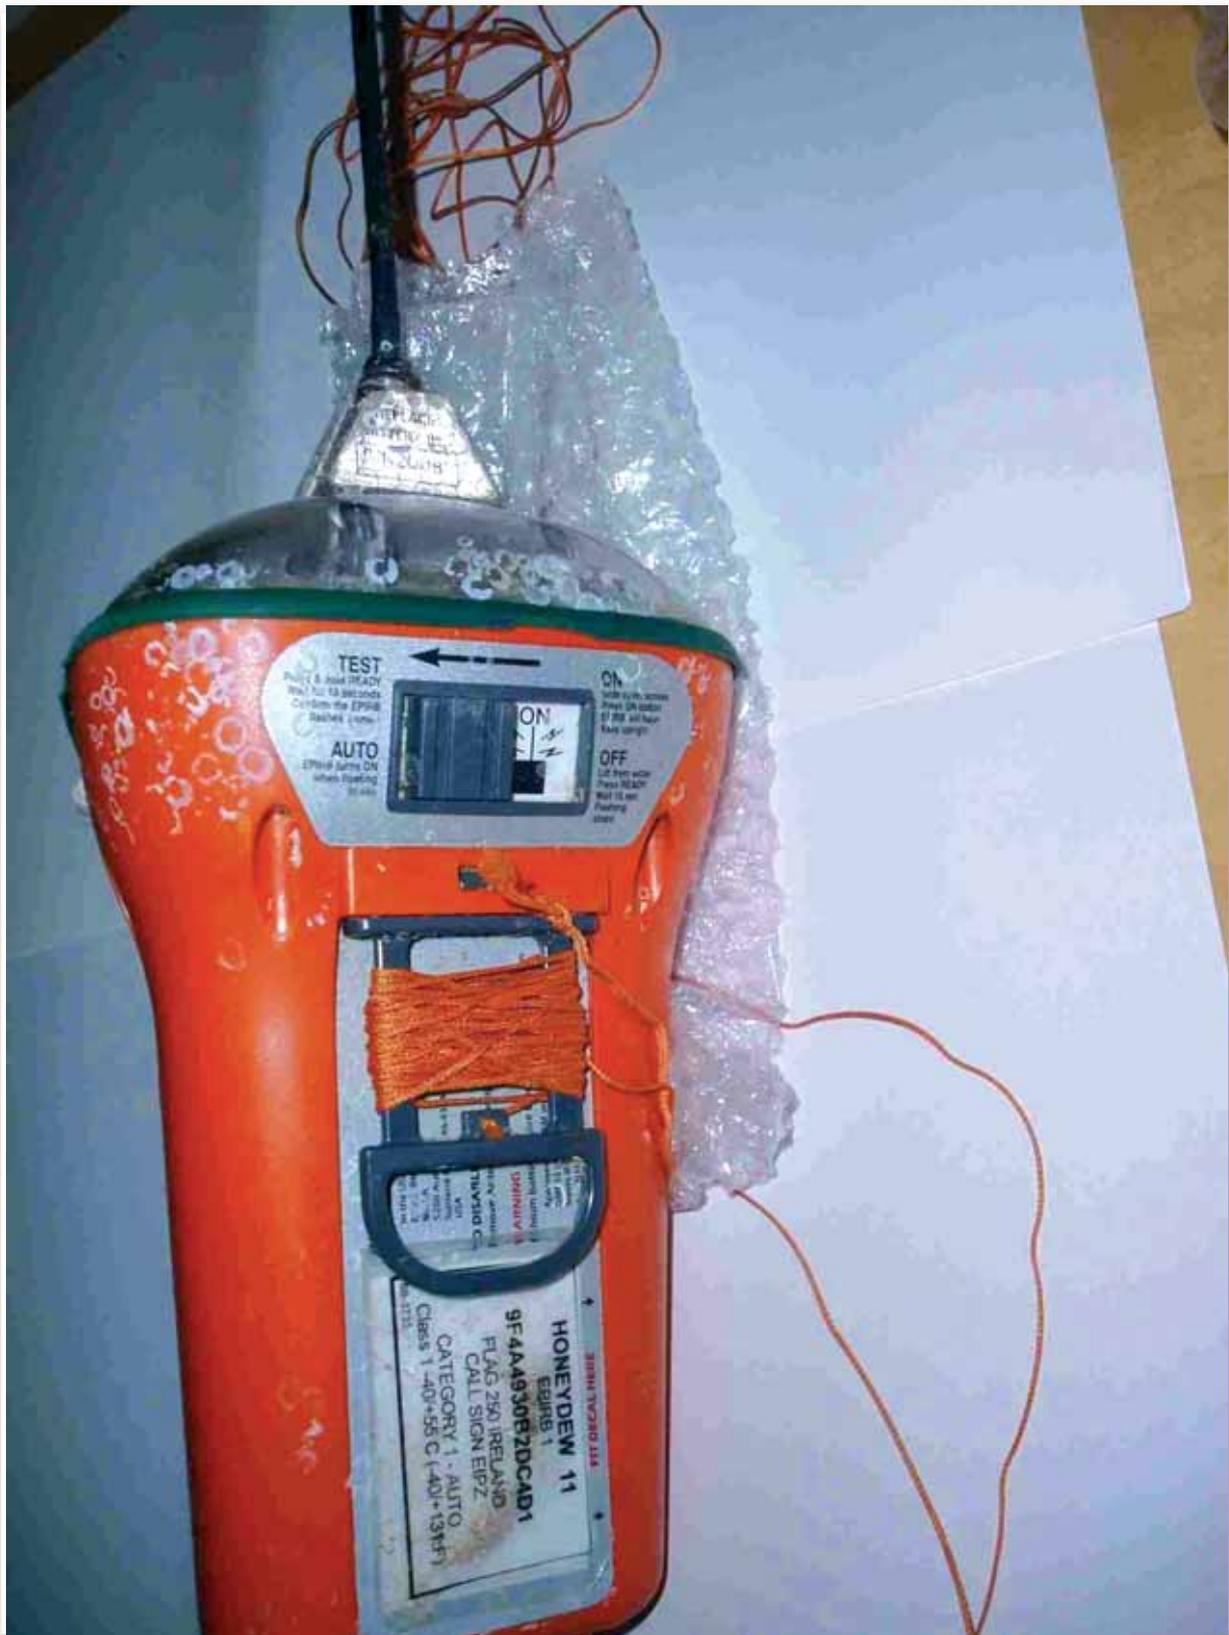
Appendix 9.12(e) EPIRB recovered

- 5.20 On the 18th December 2007 a member of the public reported on object marked FV "Honeydew II" on the beach in Courtown Co. Wexford. This was recovered by IRCG and identified as the Sailor EPIRB from the FV "Honeydew II". An initial examination showed the EPIRB to be in good condition and a more detailed examination was made in the presence of the equipment manufacturer and the principal radio surveyor. The results of the examination and tests carried out on the EPIRB are detailed in section 6.3

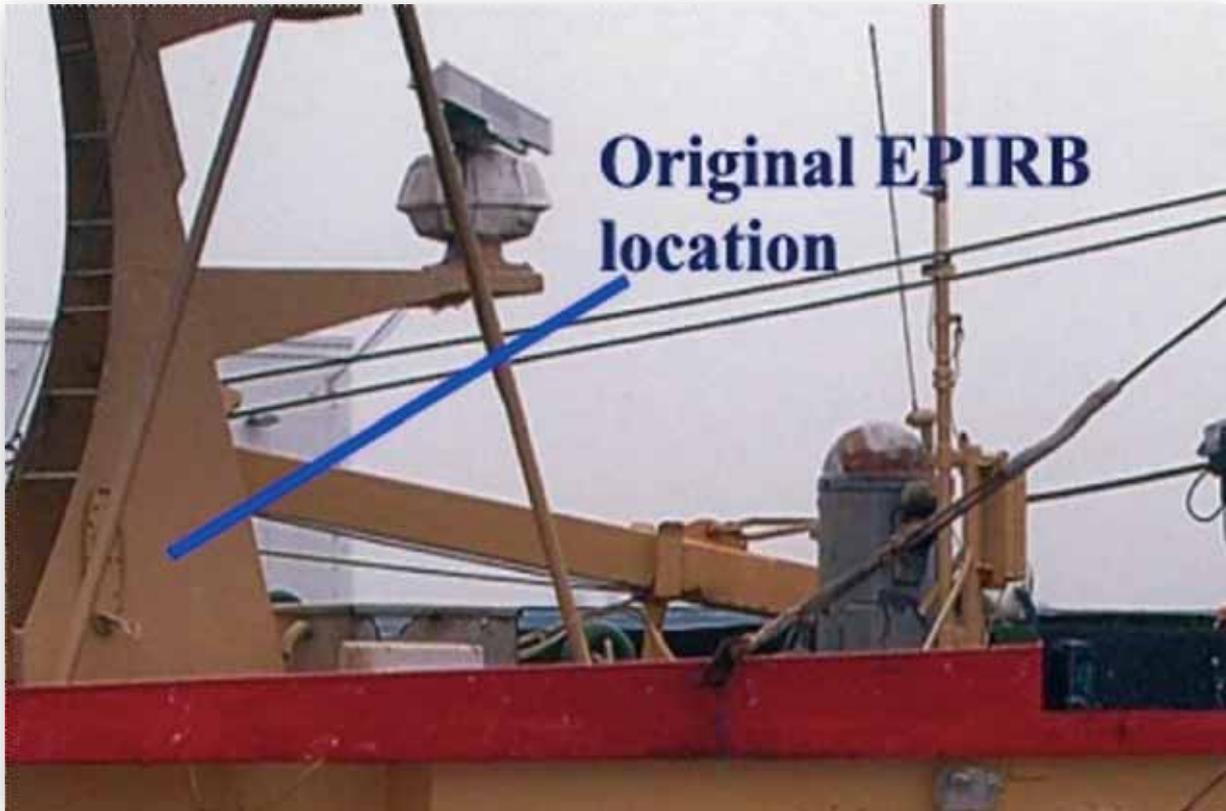
Appendix 9.12(f) EPIRB original location

- 6.3.3 IMEC have stated that the new EPIRB was fitted on the starboard side of the wheelhouse in August 2002. Photographs taken in February 2006 show the base bracket for the EPIRB but the EPIRB, hydrostatic release and cover are missing.

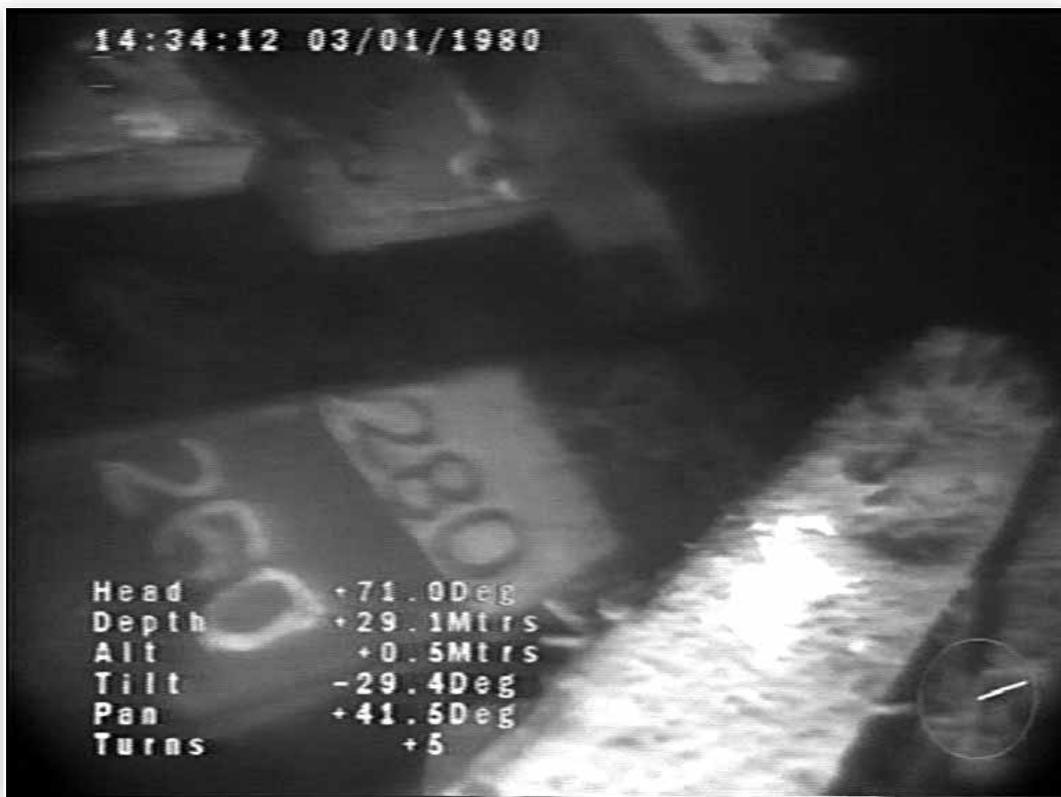
Appendix 9.15 Photograph of stem post from ROV.

- 5.19 The shelter deck had become detached from the vessel. The photograph in Appendix 9.15 shows the starboard of the stem post. In this photograph the starboard planking can be seen detached from the vessel frames. The ROV was also used to examine the seabed in the vicinity of the wreck. No significant new items of debris were noted. The condition of the vessel was such that it would have been futile to attempt to raise it from the seabed.

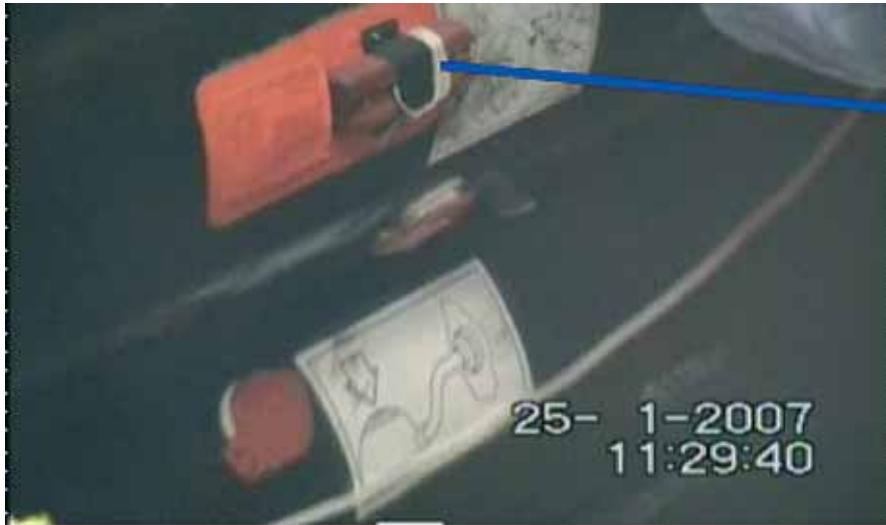
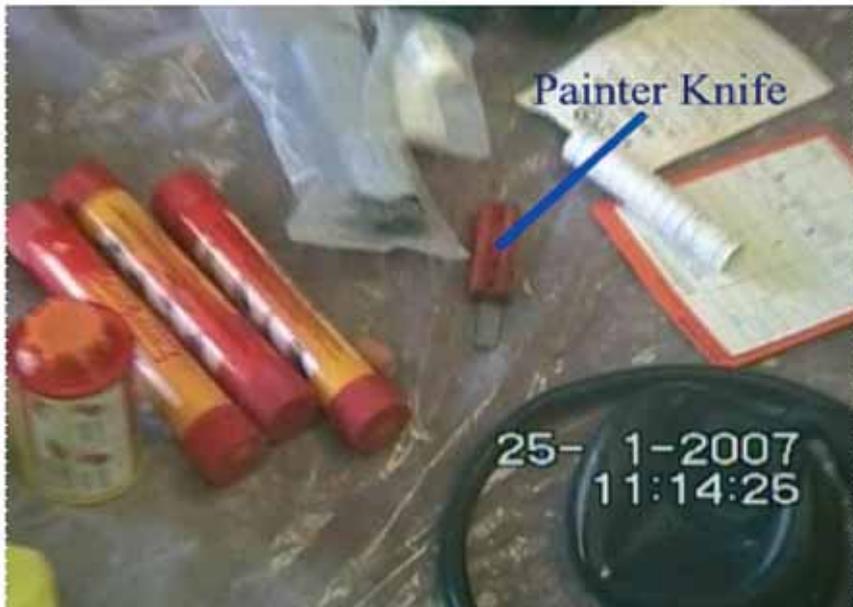
Appendix 9.17(a) Photograph showing painter knife/life raft contents

6.2.3 On inspection of the life raft it was noted that the righting ladder was cut at the rear of the raft. 18.2m of painter line were found with emergency pack contents (both ends cut). A further 2.7m of painter were found tied to outer grab lines (both ends cut). The painter had been cut 780mm from the buoyant tube. This combines to a total of 20.9 metres of painter line. Due to the absence of the rubber extrusion tube at the end of the painter it is concluded that approximately 7 metres of the onboard side of the painter were missing and mostly likely still attached to the vessel.

- 6.2.5 One drogue line was cut and found inside raft tied to grab lines. The second drogue was found with the emergency pack contents. The condition and position of the painter and drogue lines is consistent with the description given by Naval Service personnel of how the life raft was recovered including cutting and tying up of the ladder, painter and drogue lines

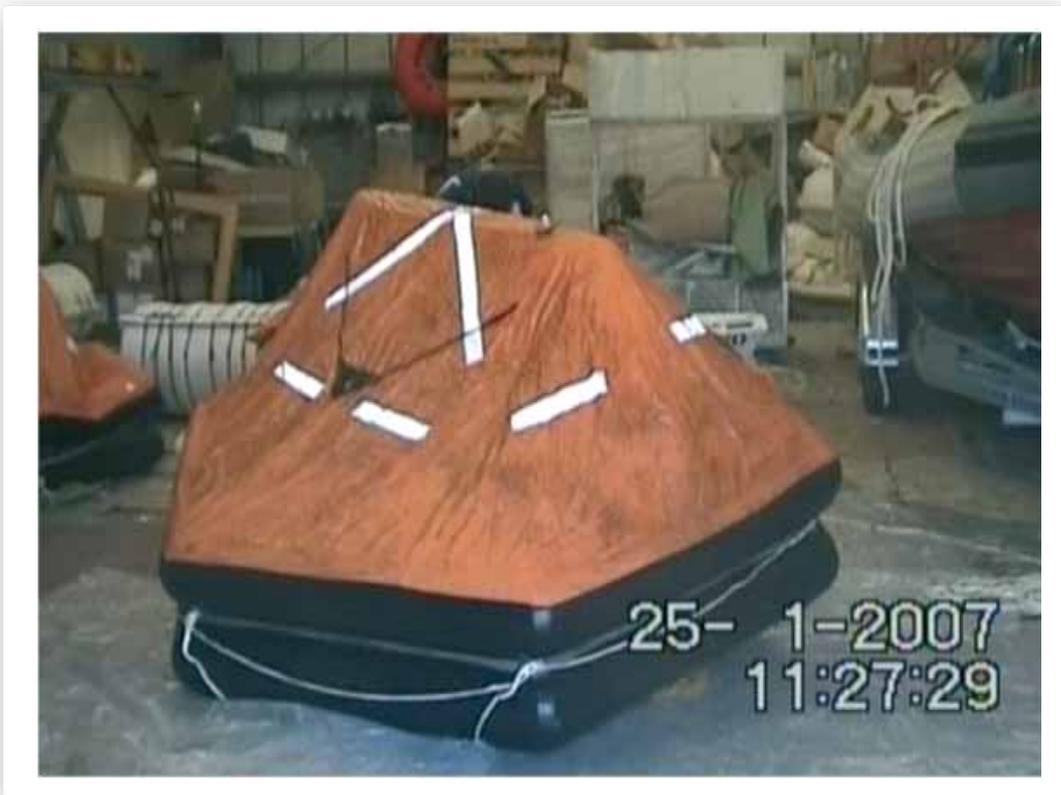
Appendix 9.17(b) Photograph showing port life raft inflated.

- 6.2.7 It is concluded that it was most likely the hydrostatic release functioned correctly to allow the life raft to be released. The reason for the life raft not inflating is that its painter was not connected to the deck of the vessel. A photograph of the inflated life raft is shown in Appendix 9.17(b).

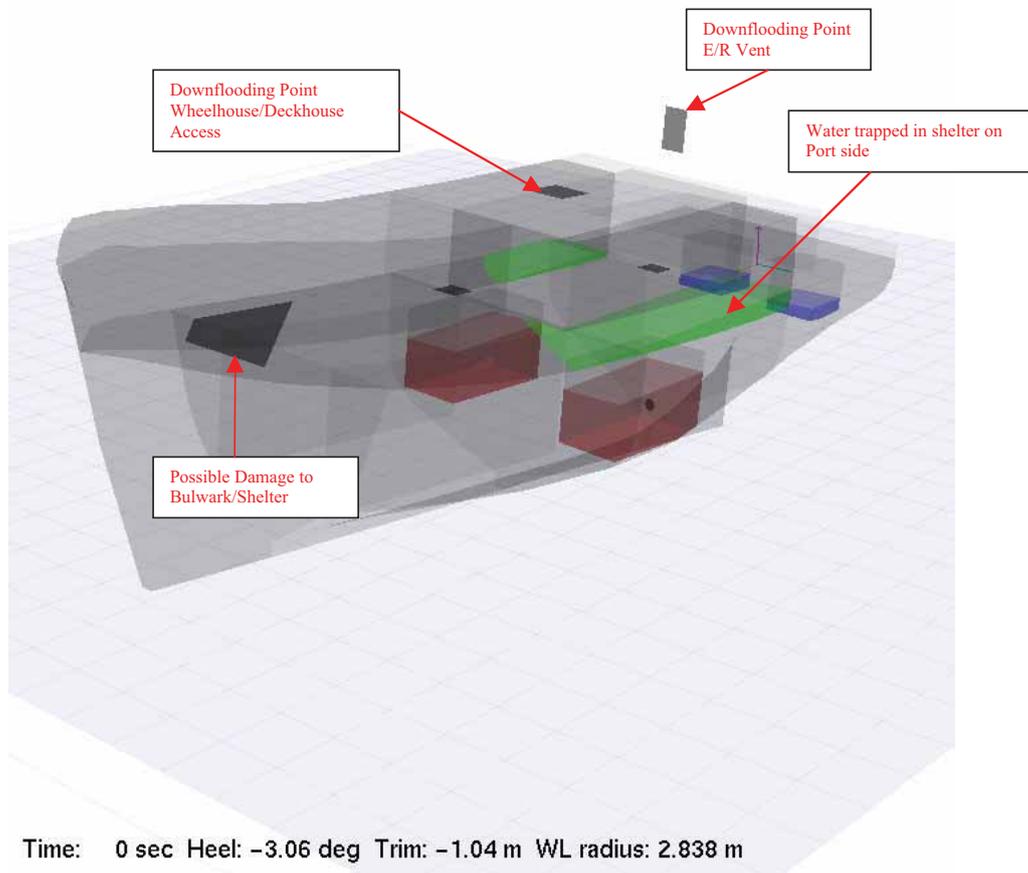
Initially at time equals zero it is assumed there has been ingress of water through the shelterdeck due to damage caused by a large wave.

Water is assumed to enter the shelterdeck space through the damaged bulwark/shelter.

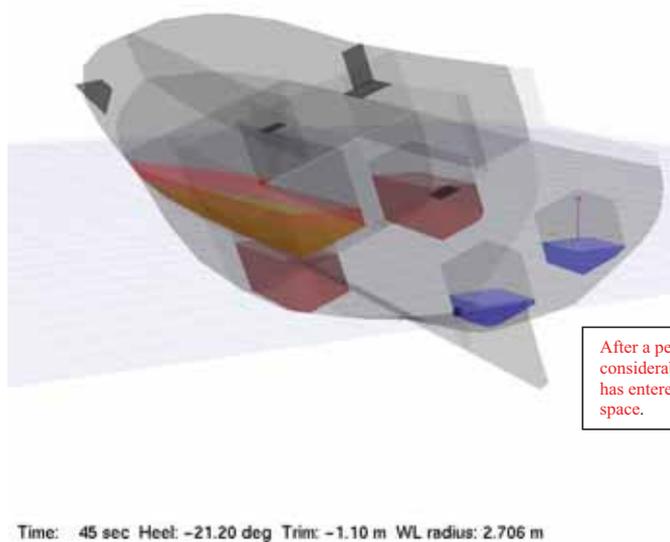
Floodwater accumulates on the Port side of the shelterdeck

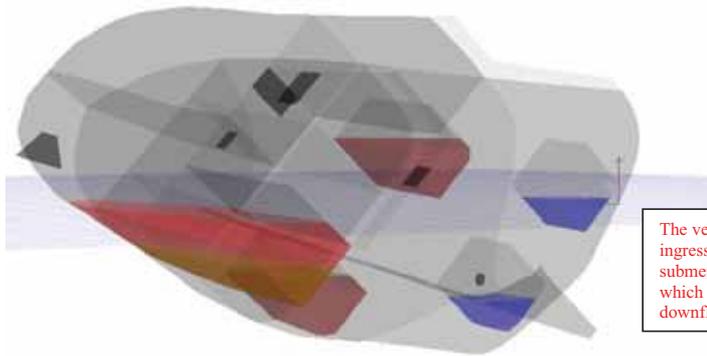
The vessel continues to list as water ingresses. The vessel is close to submerging the area of damage forward, which will lead to catastrophic downflooding.

Time: 105 sec Heel: -48.41 deg Trim: -1.64 m WL radius: 1.844 m

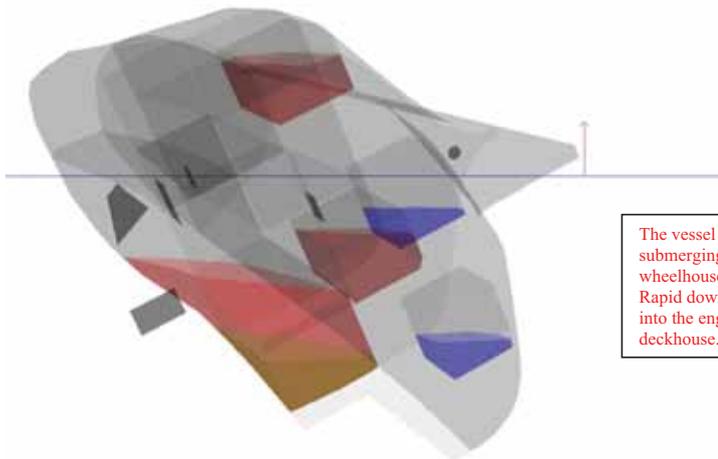
The vessel has capsized submerging the E/R Vent and wheelhouse/deckhouse access. Rapid downflooding will occur into the engine room and deckhouse.

Time: 120 sec Heel: -116.95 deg Trim: -3.82 m WL radius: -1.803 m

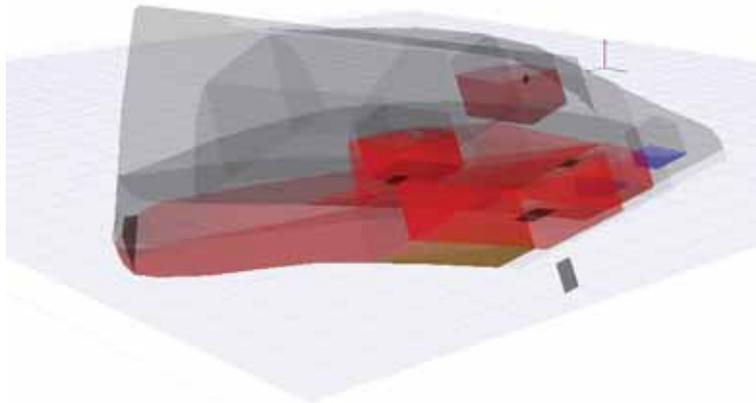
The vessel is now flooding the engine room through the submerged vents, the aft accommodation is flooding through the deckhouse access and the hold is flooding through the booby hatch.

Time: 150 sec Heel: -145.35 deg Trim: -4.95 m WL radius: -1.972 m

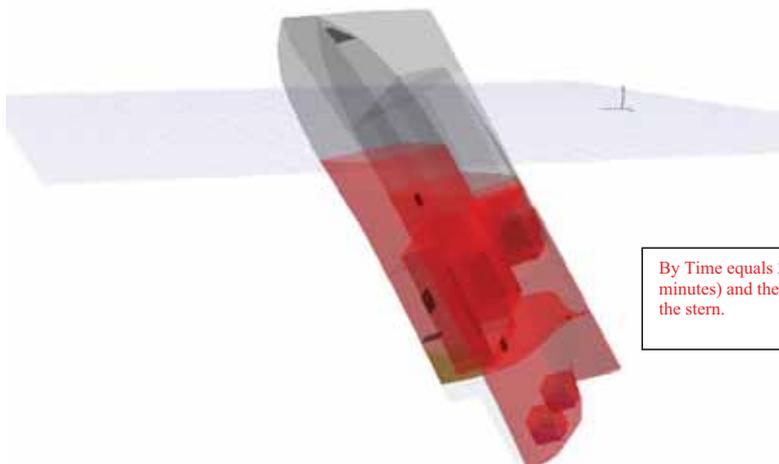
By Time equals 255 seconds (~4 minutes) and the vessel is sinking by the stern.

Time: 255 sec Heel: -221.16 deg Trim: -41.94 m WL radius: 3.838 m
