**REPORT OF THE  
INVESTIGATION INTO THE LOSS  
OF THE MSY "INIS MIL"  
ON 8TH SEPTEMBER, 2004  
WHILE ON PASSAGE FROM  
KENMARE TO THE SCILLY ISLES**

The Marine Casualty Investigation Board was established on the 25<sup>th</sup> March, 2003 under The Merchant Shipping (Investigation of Marine Casualties) Act 2000

Published by The Marine Casualty Investigation Board  
29th November 2006

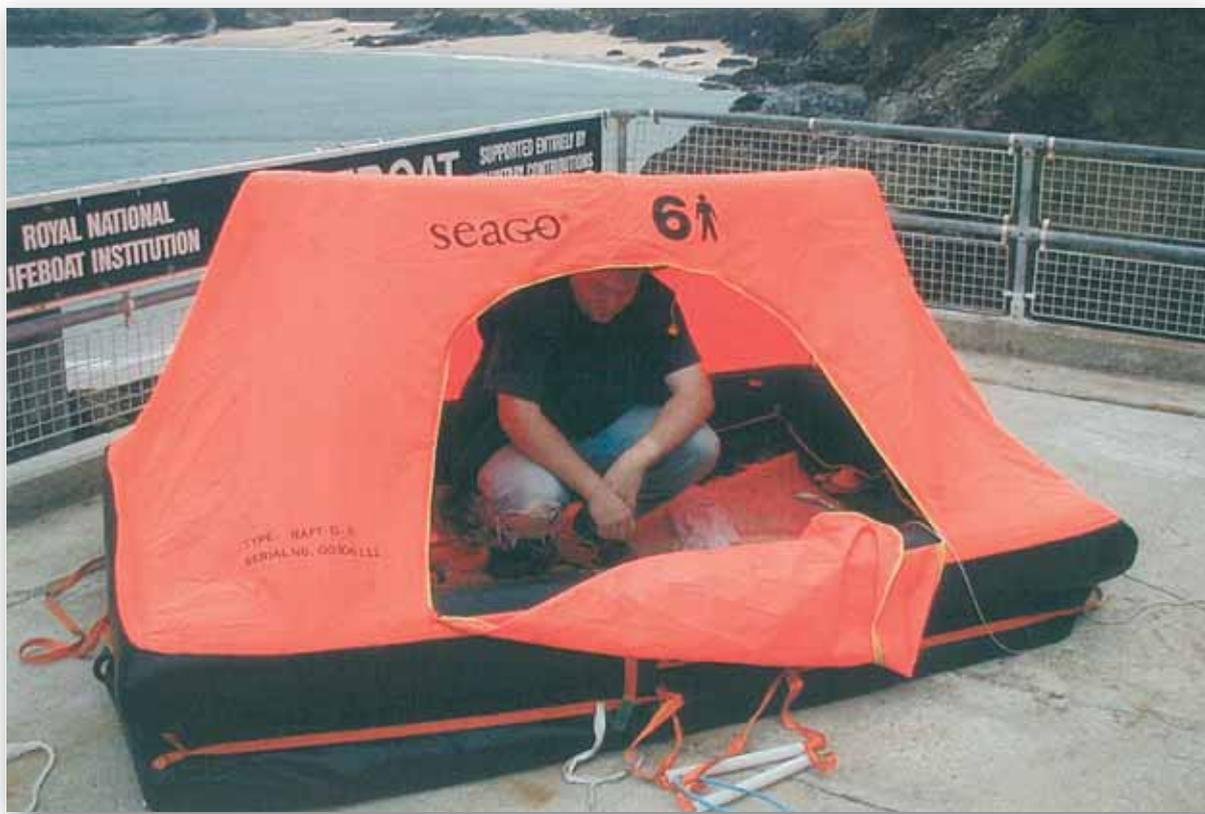
Appendix 8.1 The Seago 6 man liferaft.

At times during heavy rain the occupants felt they were suffocating. The survivors were also trying to maintain pressure in the liferafts chambers, which had been losing air through leaks caused by a sharp object in the first aid kit and shoes rubbing the protective material off the air chambers.

The lower chamber is partially deflated and on inspection damage caused by rubbing action probable from the shoes of survivors was apparent in a number of locations.

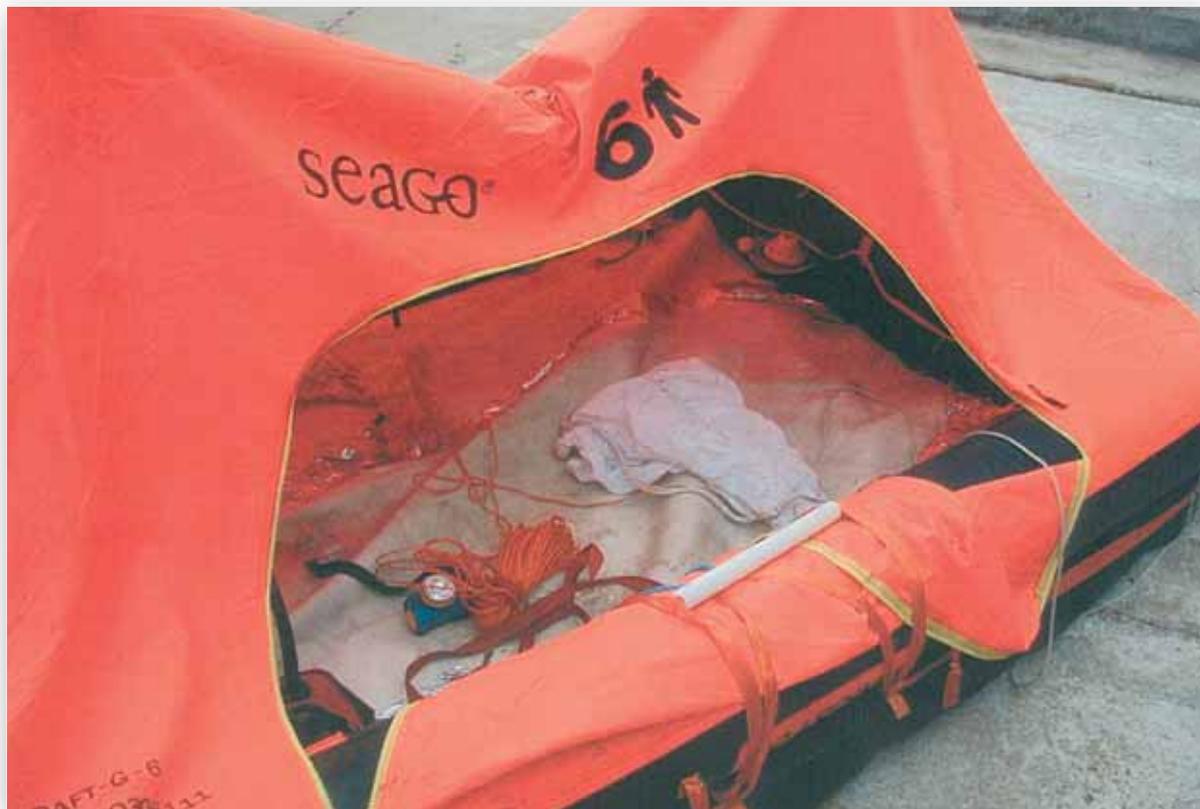
Appendix 8.1 cont. The Seago 6 man liferaft.

The interior of the liferaft with the floor insulation showing remnants of the aluminium outer cover that was removed by the survivors in an attempt to make a heliograph.
