**REPORT INTO INCIDENT ON
MFV JAMES COLLINS
NORTH EAST OF
ERRIS HEAD, CO MAYO
ON
20th APRIL 2012**

**REPORT No. MCIB/216
(No.1 of 2013)**

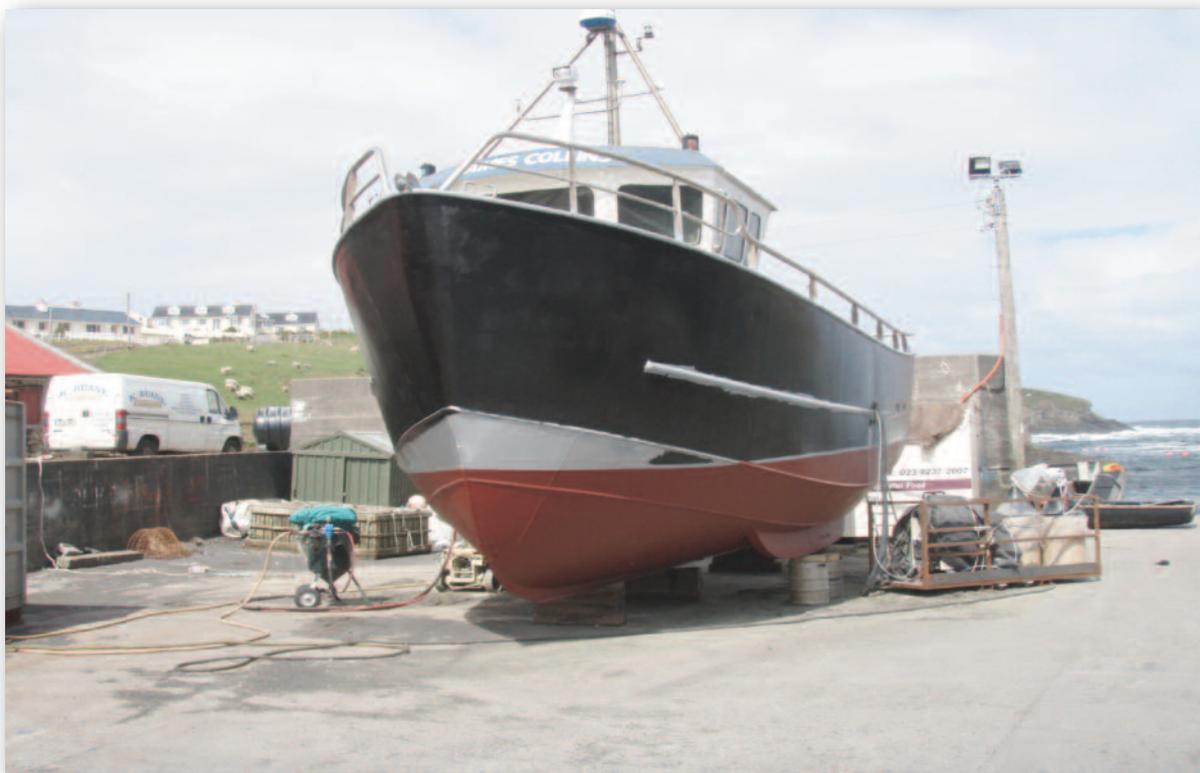
Name:	James Collins
Port of Reg:	Westport
Reg. No:	WT 202
LOA:	11.63m
GRT:	14.65T
Engine:	50Kw
Type:	Multipurpose
Built:	2002/2004 at Ballina
Construction:	Carvel steel
Skipper :	Jonathan O'Donnell
Crew:	Garry O'Malley
Crew:	Darren O' Doherty

Photo 1: MFV James Collins

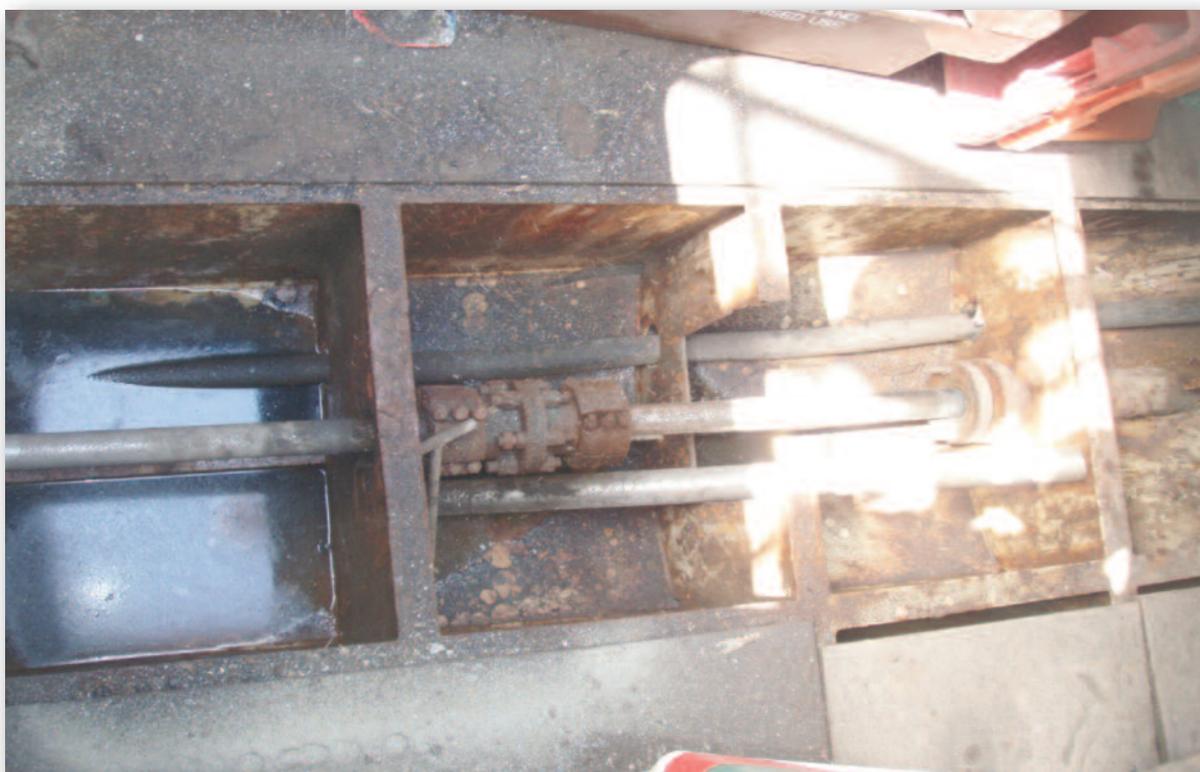
- 3.3. His waterproof leggings were caught by the coupling on the shaft (see Appendix 7.1 photo 2) and his left leg was wound around the shaft about two times. He shouted to the crew and the engine was quickly stopped.

- 4.1. The propeller shaft was located beneath the sole boards of the hold and thus screened from any contact from persons working in the hold. These sole boards were not secured and were easily removed thus exposing the revolving shaft. (See Appendix 7.1 photo 2).

- 4.7. The reason for lifting the covers was to clear fishing debris from the bilge pump. This apparently happened from time to time. The covering boards were loose fitting plywood panels with the possibility of dirt and small debris falling down into the bilge.

5.1.2. The shaft protection did not comply adequately with the regulations enabling it to be easily exposed and present a hazard.

Photo 2: Sole boards in fish hold lifted. Casualty's leg caught in coupling of the shaft.

- 6.1. That the Code of Practice for Fishing Vessels under 15 LOA section 4.1.1 General requirements and recommendations should be amended to include a paragraph highlighting the danger of accessing the bilge area when shafts are rotating.
- 6.2. That the Code of Practice for Fishing Vessels under 15 LOA section 4.3.3 Bilge Pumping could be amended to include assessment of the sole boards in fish holds to prevent debris passing through to the bilges. Routine cleaning of bilges may provide adequate protection.
