REPORT OF INVESTIGATION INTO
THE SINKING OF THE
MFV “*JEANETTE ROBERTA*” S58
OFF GLANDORE HARBOUR,
CO. CORK
ON
11th DECEMBER 2011

REPORT No. MCIB/209
(No.13 of 2012)

Report MCIB/209 published by The Marine Casualty Investigation Board
Printed 7th December 2012.

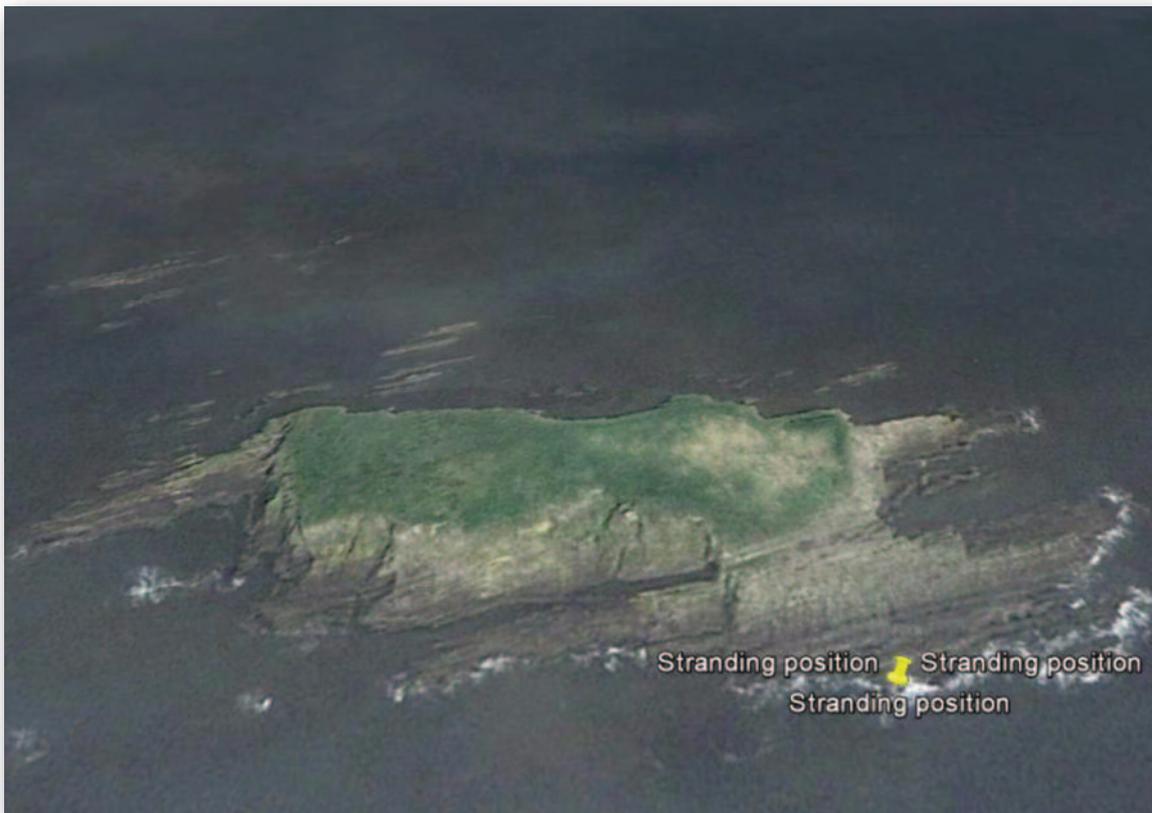
Appendix 7.4 Illustration - Adam's Island, viewed from southern side.

Entering Glandore Harbour at 14:20hrs the vessel encountered electrical and navigation equipment problems and steamed onto and stranded on the south-eastern side of Adam’s Island at the entrance to the harbour. The vessel was holed and making water and a Mayday was issued at 14:32hrs.

- 2.3.3 The incident occurred when the vessel was making her approach to clear Adam's Island on her port hand and entering the main channel. Adam's Island which divides the entrance into two channels is 27m (88.5ft) in height and steep on the southern side. Refer to Chart No.2092 - Toe Head to Old Head of Kinsale - inset extract Glandore Harbour and aerial view in Appendices.
