**REPORT OF INVESTIGATION
INTO
FIRE ABOARD ANGLING BOAT
"JEM" AT
CORK HARBOUR
ON
21st JULY 2011.**

**REPORT No. MCIB/204
(No.13 of 2011)**

Report MCIB/204 published by The Marine Casualty Investigation Board
Published 22nd November 2011.

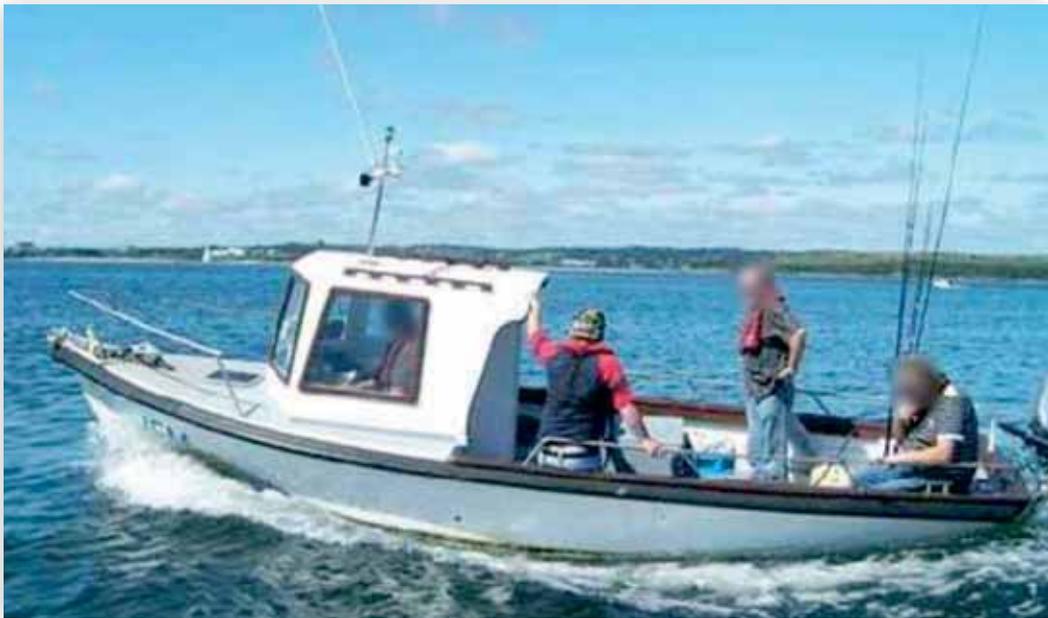
The boat is a Glass-fibre Reinforced Plastic (GRP) angling boat with buoyancy built in. She is arranged as a half-decker with a sealed fore-deck ahead of an enclosed wheelhouse. An inboard diesel engine drives a propeller shaft and an auxiliary petrol outboard is mounted on a lifting-bracket fixed to the transom. There is little information available about the boat.

Name: "Jem"
 Boat type: GRP Smuggler 21
 Length: 6.4m (est)
 Beam: 2.1m (est)
 Main Engine: Nissan Diesel Marinised rated at 30hp
 Auxiliary Outboard: Johnson outboard rated at 15hp

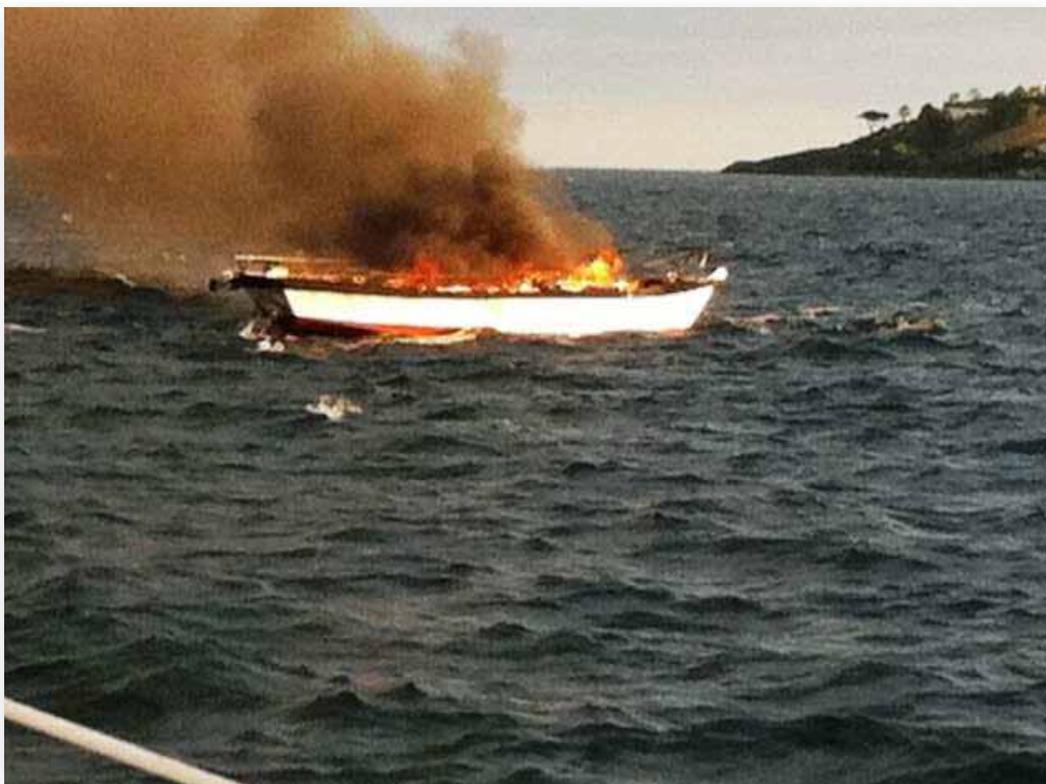
Appendix 8.1 Jem ablaze in Cork Harbour.

"Jem" ablaze after the rescue.
