**REPORT OF INVESTIGATION
INTO DUAL FATALITY OFF
GLENGAD, MALIN HEAD,
CO. DONEGAL
ON 1st NOVEMBER 2010**

**REPORT No. MCIB/194
(No.9 of 2011)**

Report MCIB/194 published by The Marine Casualty Investigation Board.
Published 22nd July 2011.

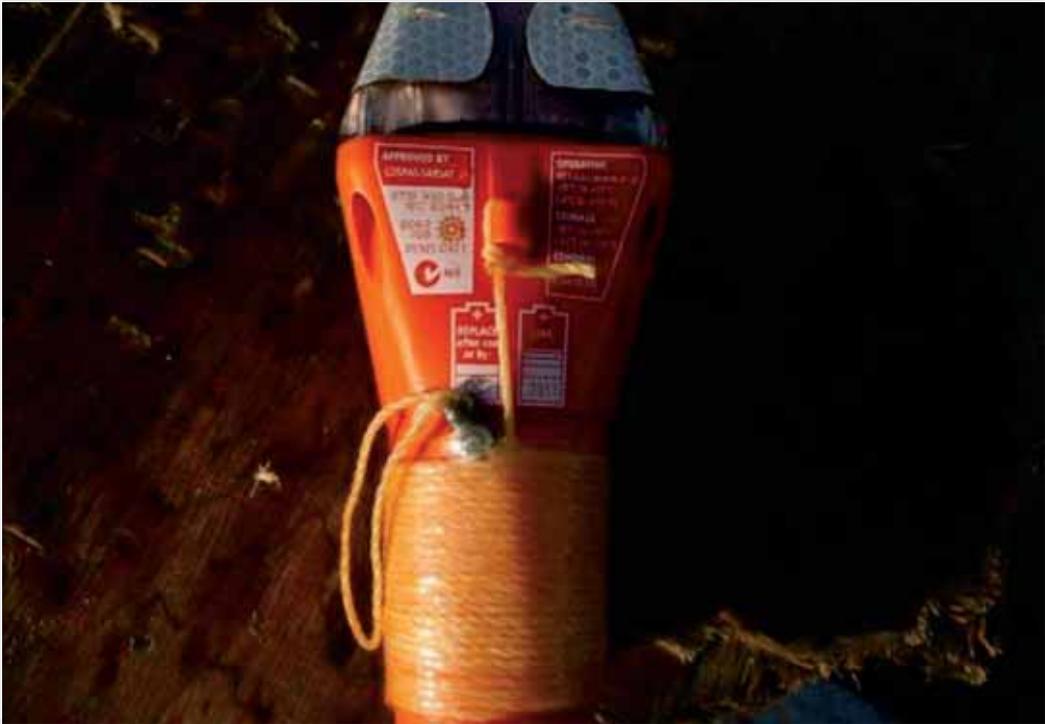
a) EPIRB front on.

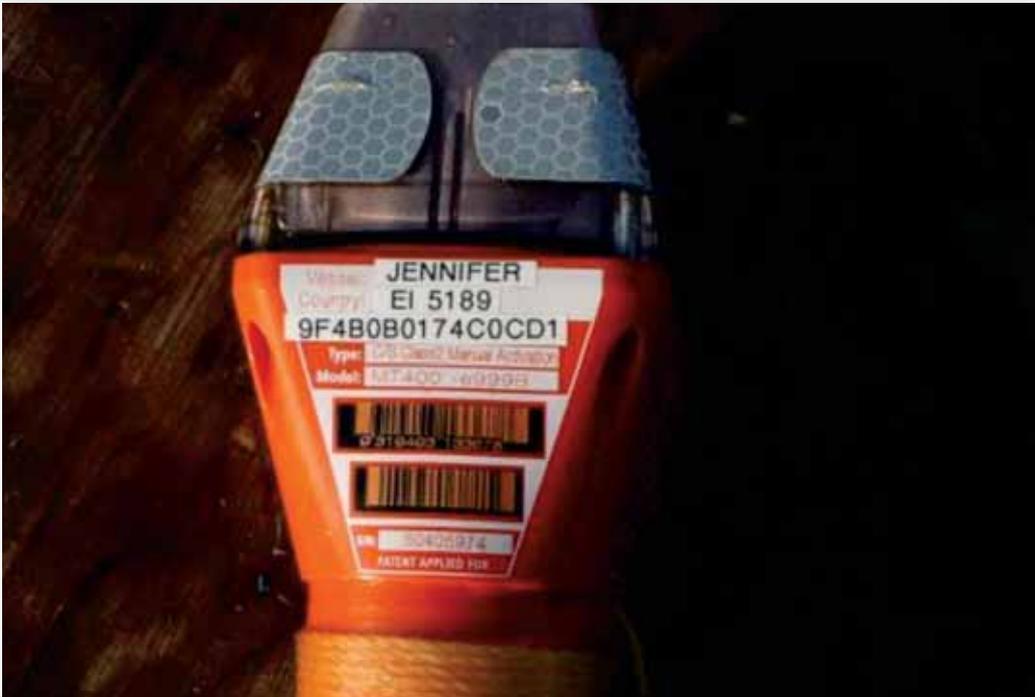
a) EPIRB side on.

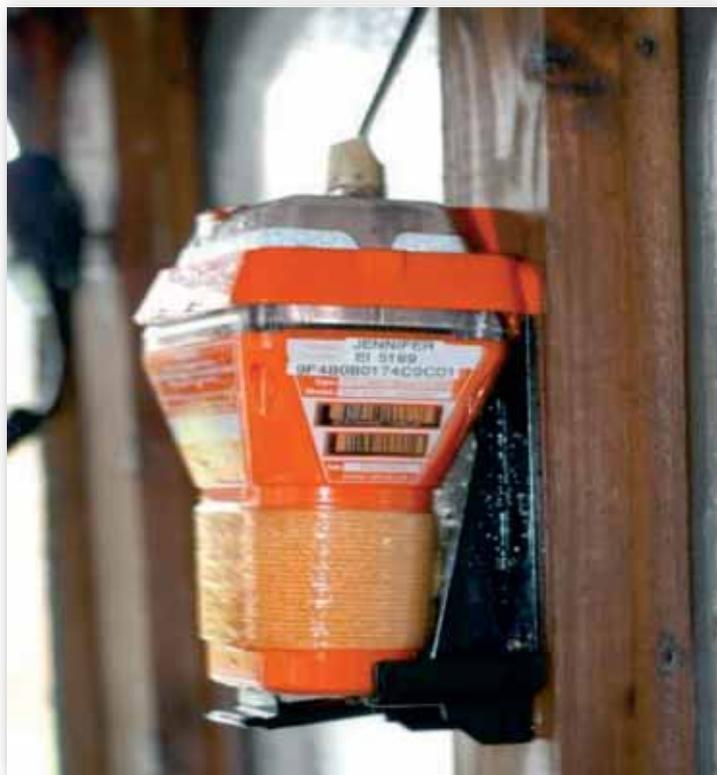
- a. There were no obvious structural defects or damages that could be considered contributory to the incident.
 - b. EIRPB was of the manual release type situated in the wheelhouse. The EPIRB had not been activated and was still in its holster.

c) EPIRB as found when boat was salvaged.

- 7.1 It is recommended that the Minister for Transport review the requirements of the Code of Practice for Fishing Vessels under 15m, with a view to establishing revised appropriate stability criteria, imposing an obligation to carry an appropriate liferaft at all times, and the installation of a float free, self - activating EPIRB.

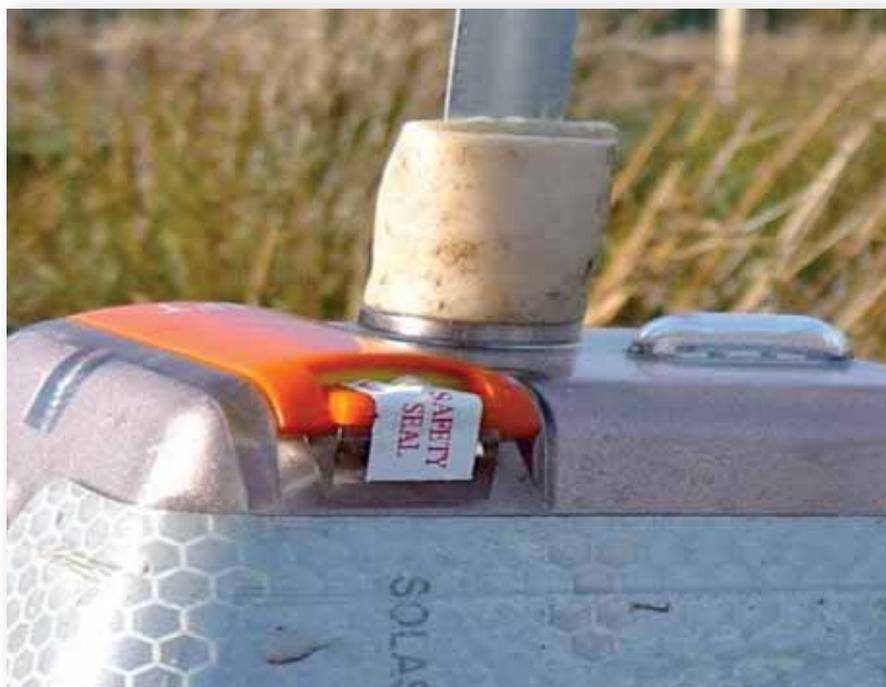
d) EPIRB Safety Seal still intact.

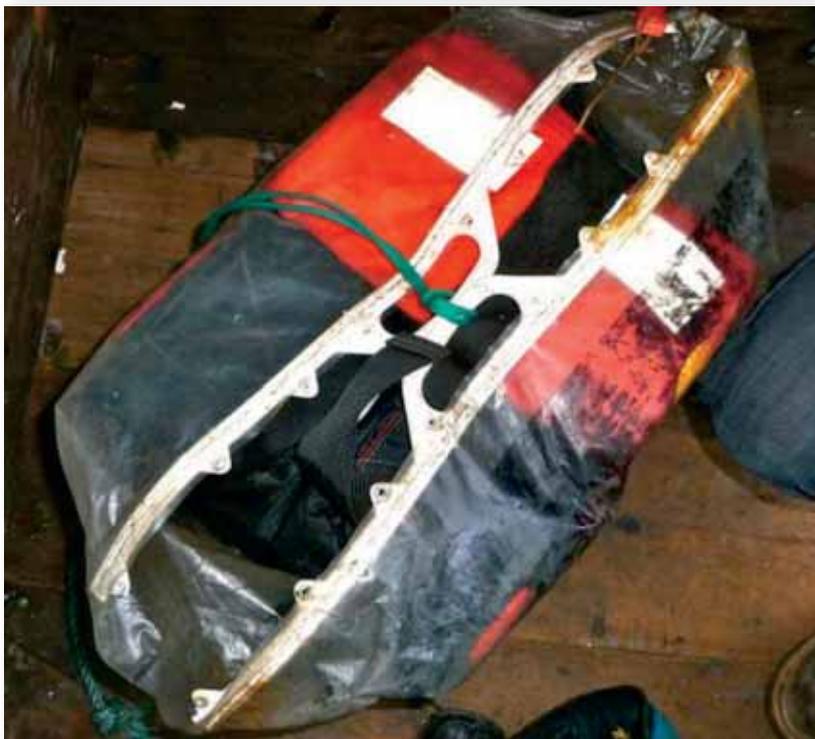
- c. Two SOLAS lifejackets were found in the wheelhouse still in their original packaging.
 - d. A 50 Newton Guy Cotton Buoyancy Aid found in wheelhouse.

e) Two SOLAS Lifejackets still in original bag.

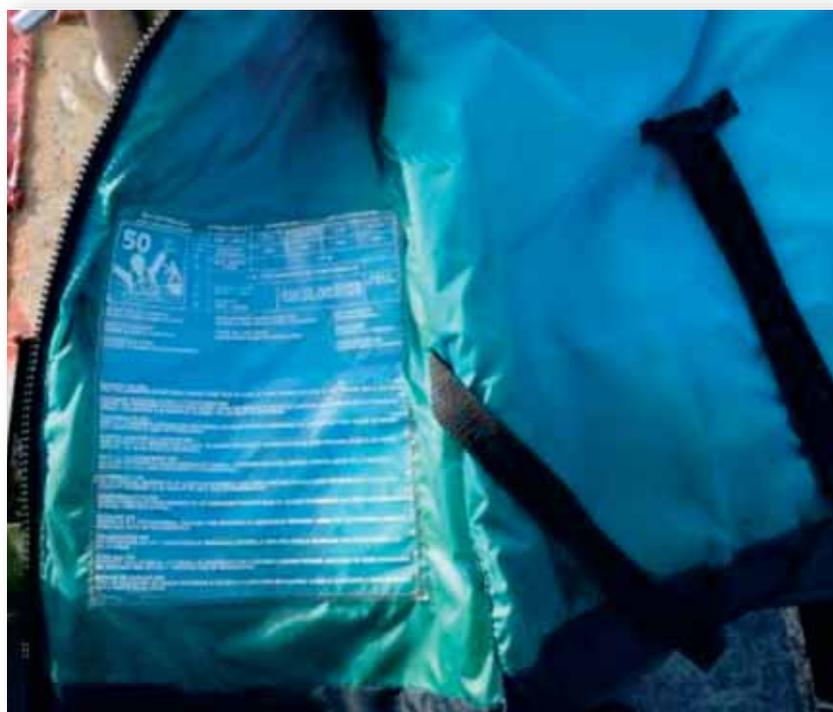
f) 50 Newton Guy Cotton Buoyancy Aid.

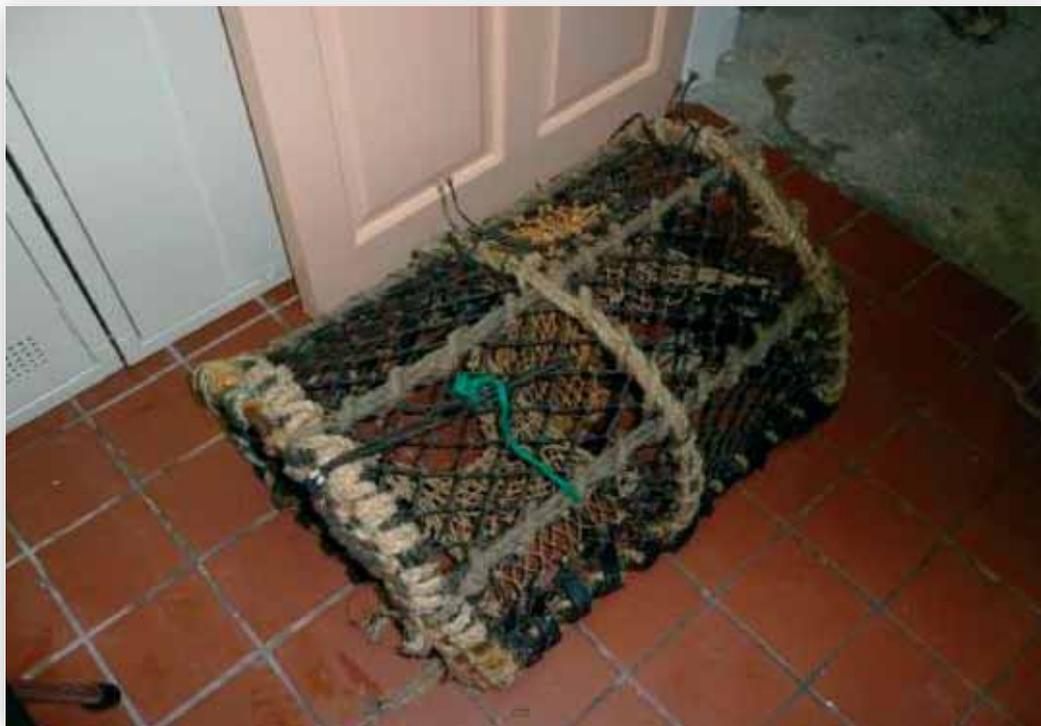
- 6.2 Structural failure seems unlikely, as there was no damage found to the vessel when salvaged.
- 6.3 A test weighing of a pot retrieved from the “*Jennifer*” had a weight of 15.5 Kgs. Similar pots were weighed and found to have weights between 15 and 16 Kgs. The usual procedure in the Glengad area was for approximately 10 fathom of rope to be left between each pot, plus the end ropes to buoys. Rope of a type similar to what was stated to have been used on the “*Jennifer*” was weighed and found when wet to weigh 260 grammes per fathom. Therefore, the total estimated weight of pots and ropes onboard the “*Jennifer*” at the time of the incident can be considered to be in the region of between 915 Kgs. and 1,096 Kgs. The equivalent of carrying between 12 and 14 extra persons aboard the “*Jennifer*”.

a) Photograph of Pot recovered from seabed.

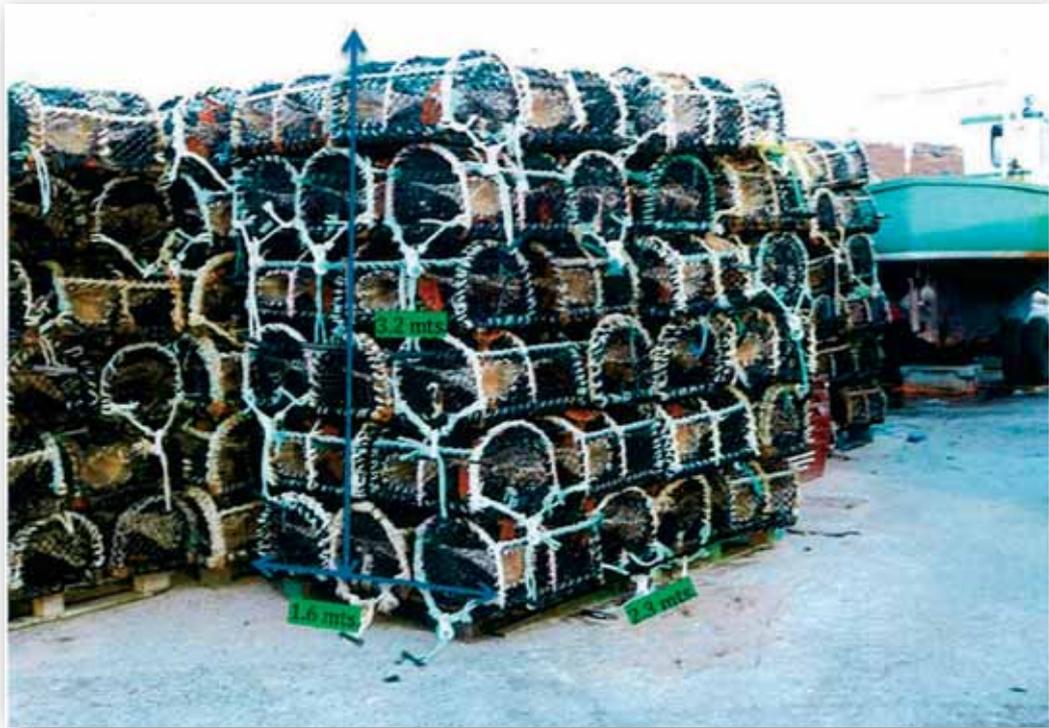
Appendix 8.4 Photograph of stack of 60 pots with dimensions.

- 6.4 A tightly stowed stack of 60 pots without ropes was measured and found to require a minimum volume of 11.78 cu/mts. Which would require pots to be stacked at least 3 & 4 high on parts of the deck of the “*Jennifer*”, effectively reducing the vessels GM (Metacentric Height) and righting lever.

- 6.5 The carrying of 50-60 pots on a boat the size of the “*Jennifer*” would have a significant adverse effect on the stability of the boat.
- 6.6 At the time of incident southerly winds Force 6 to gale Force 8 were reported, which would be an offshore wind giving a lee for a boat working close inshore. However, in the area that the “*Jennifer*” sank eddies (a swirling of the sea running back in the opposite direction of the main flow of water) are known to be prevalent.

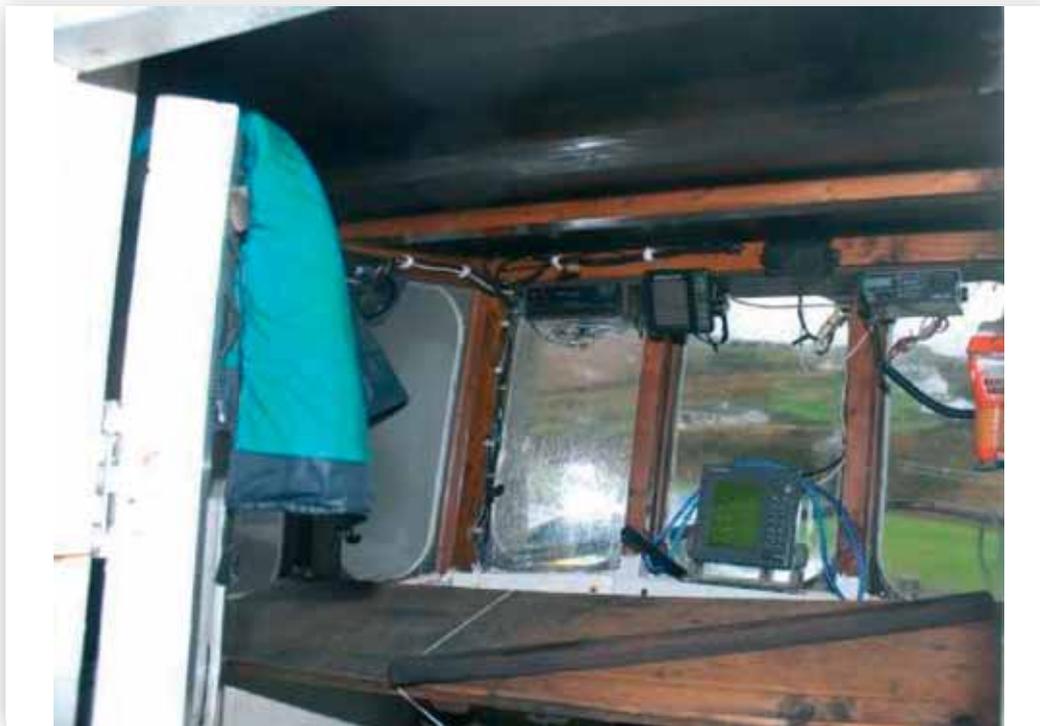
a) Photographs of Wheelhouse internally after salvage.
